**MINERALS PROGRAM INSPECTION REPORT**  
**PHONE: (303) 866-3567**

<b>MINE NAME:</b> Connell Carr Pit	<b>MINE/PROSPECTING ID#:</b> M-2014-001	<b>MINERAL:</b> Sand and gravel	<b>COUNTY:</b> Weld
<b>INSPECTION TYPE:</b> Monitoring	<b>INSPECTOR(S):</b> Peter S. Hays	<b>INSP. DATE:</b> May 6, 2019	<b>INSP. TIME:</b> 11:00
<b>OPERATOR:</b> Connell Resources, Inc.	<b>OPERATOR REPRESENTATIVE:</b> Kevin Anderson	<b>TYPE OF OPERATION:</b> 112c - Construction Regular Operation	
<b>REASON FOR INSPECTION:</b> Normal I&E Program	<b>BOND CALCULATION TYPE:</b> Partial Bond	<b>BOND AMOUNT:</b> \$146,495.00	
<b>DATE OF COMPLAINT:</b> NA	<b>POST INSP. CONTACTS:</b> None	<b>JOINT INSP. AGENCY:</b> None	
<b>WEATHER:</b> Clear	<b>INSPECTOR'S SIGNATURE:</b>

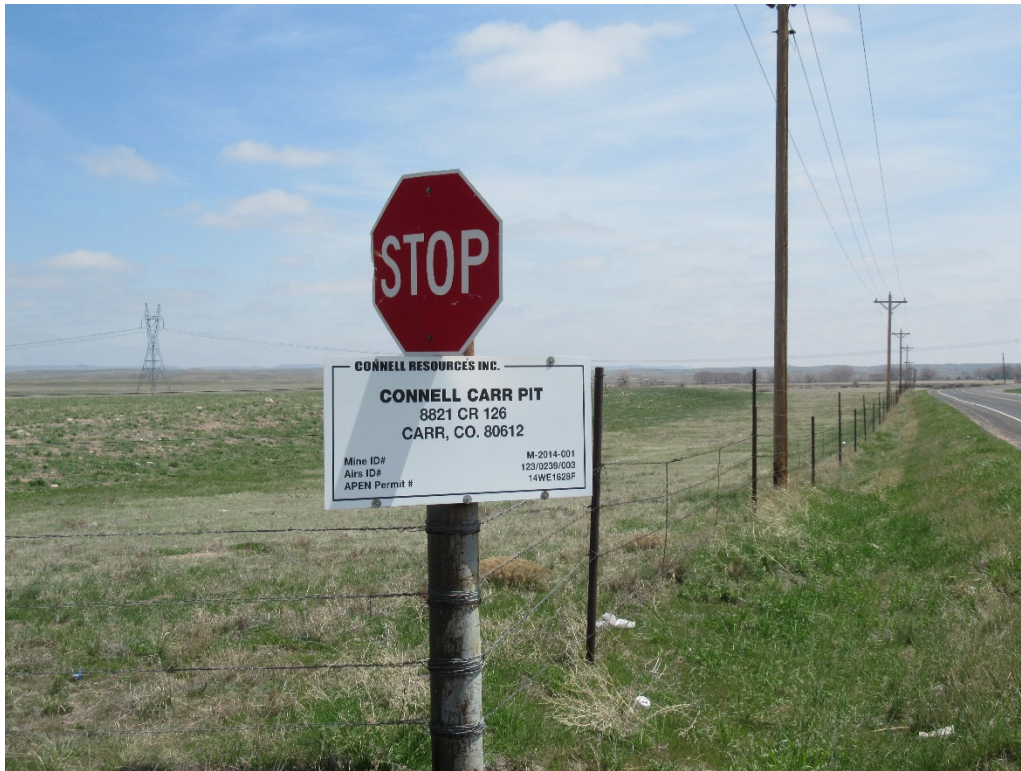
Connell Car mine sign

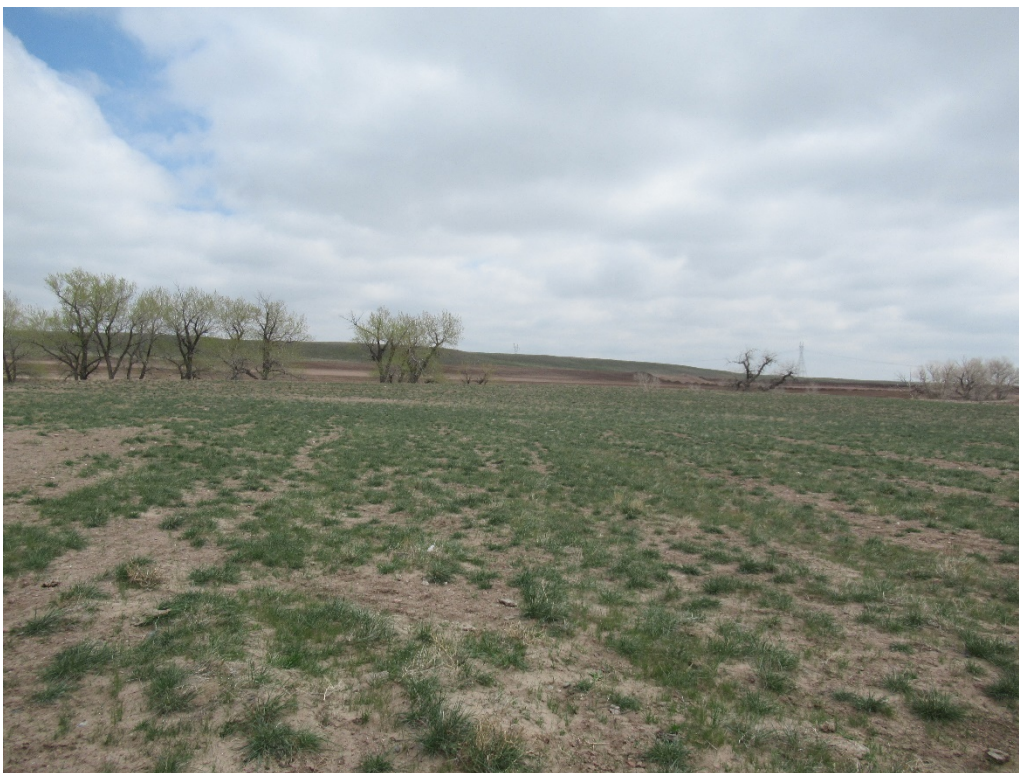
View of revegetated area located southeast of the main processing area

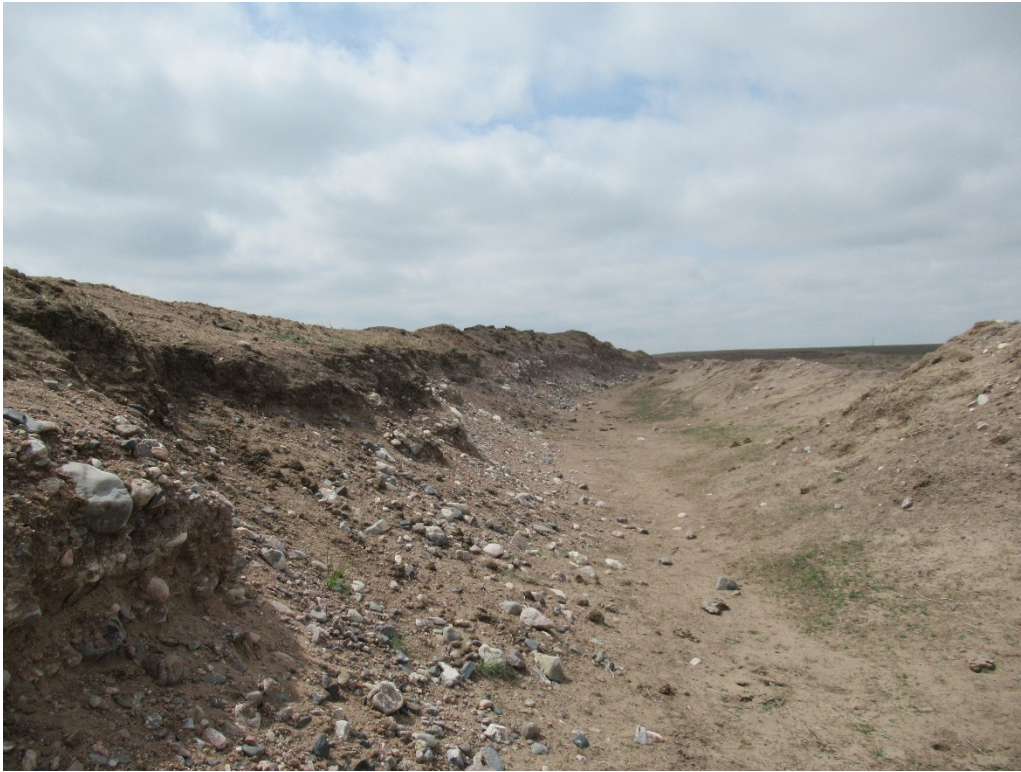
Highwall located southeast of the main processing area

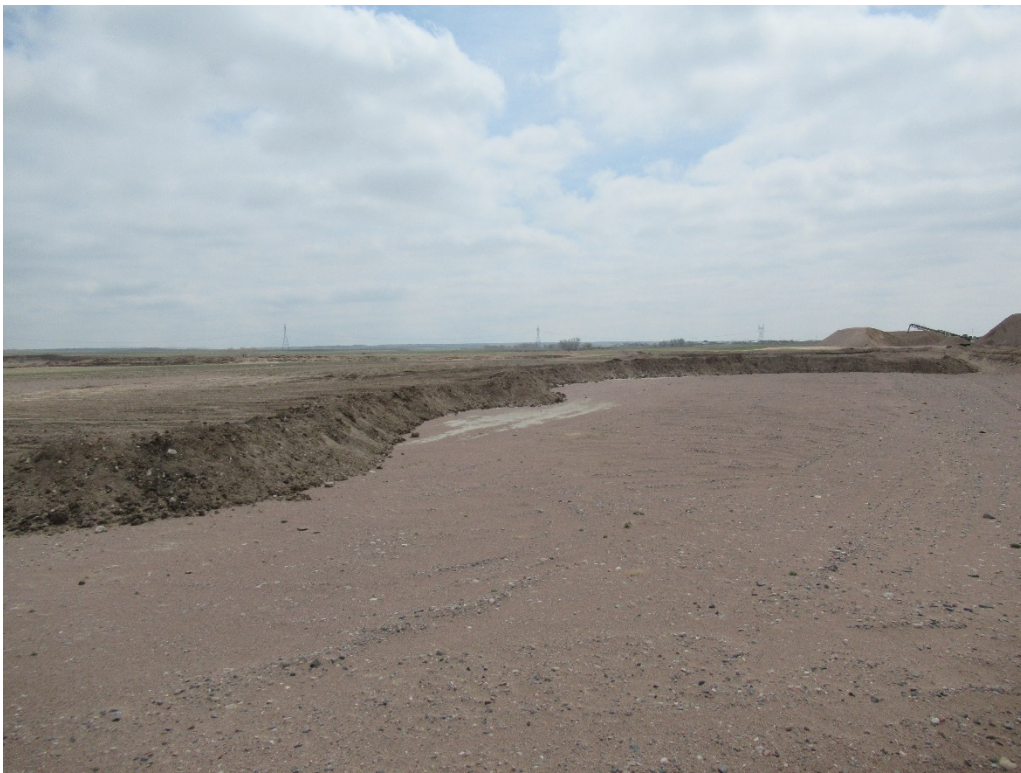
View of concurrent reclamation, overburden replacement, located south of main processing area

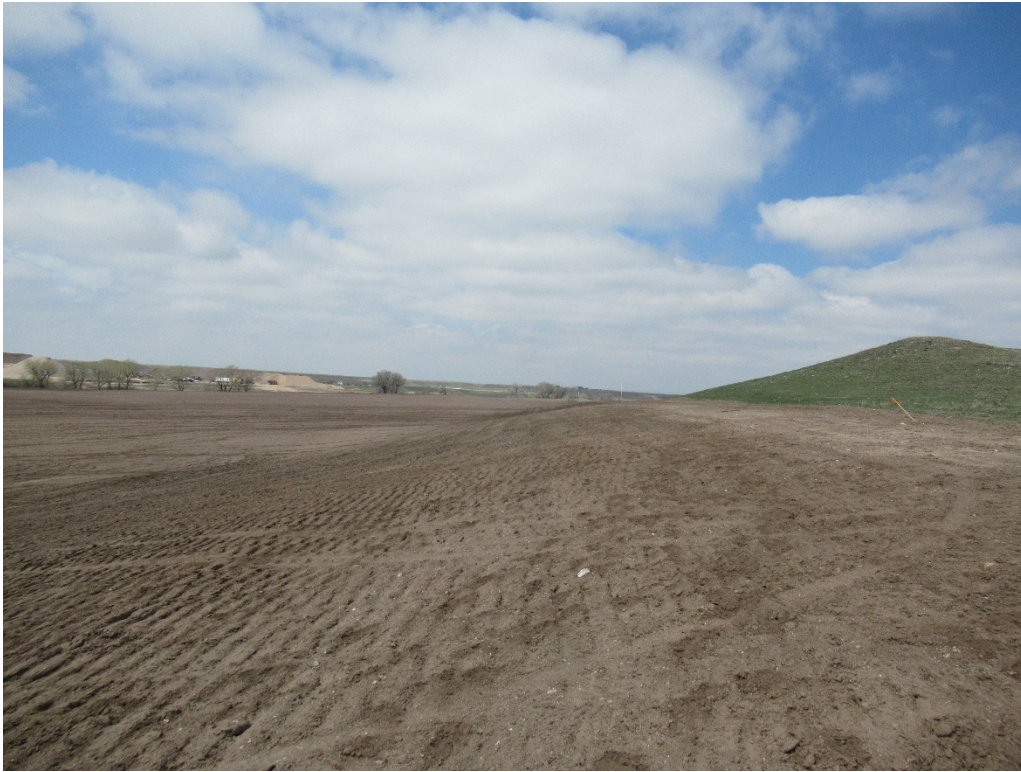
View of Phase 2 reclamation along north permit boundary looking west

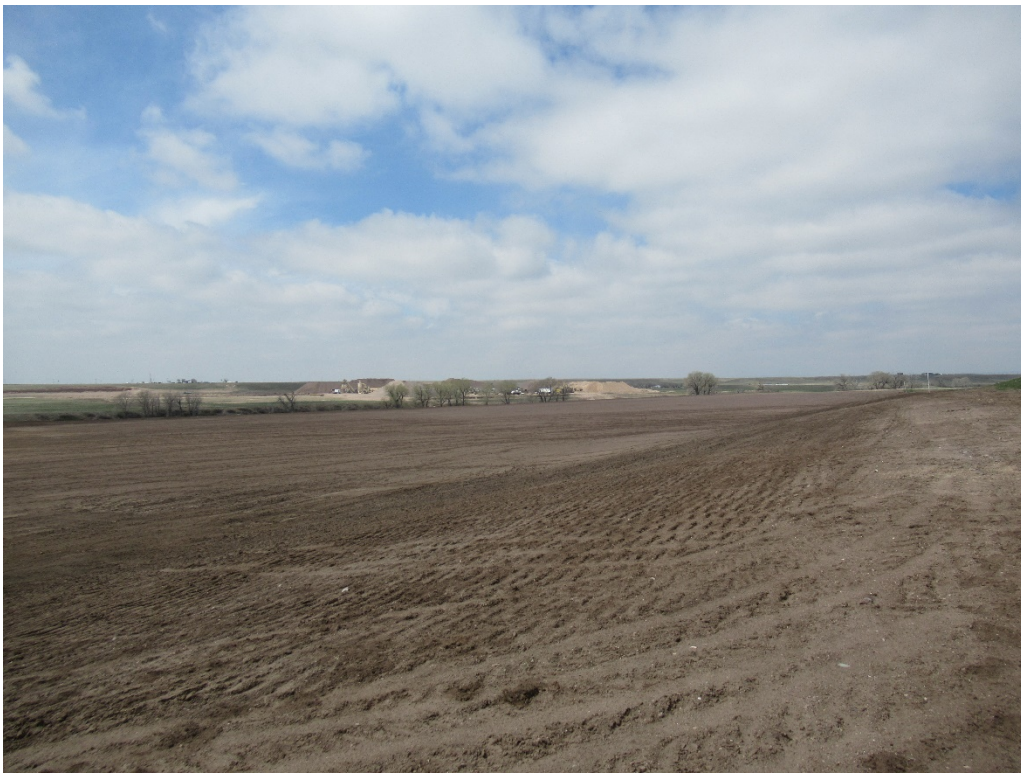
View of Phase 2 reclamation along north permit boundary looking southwest

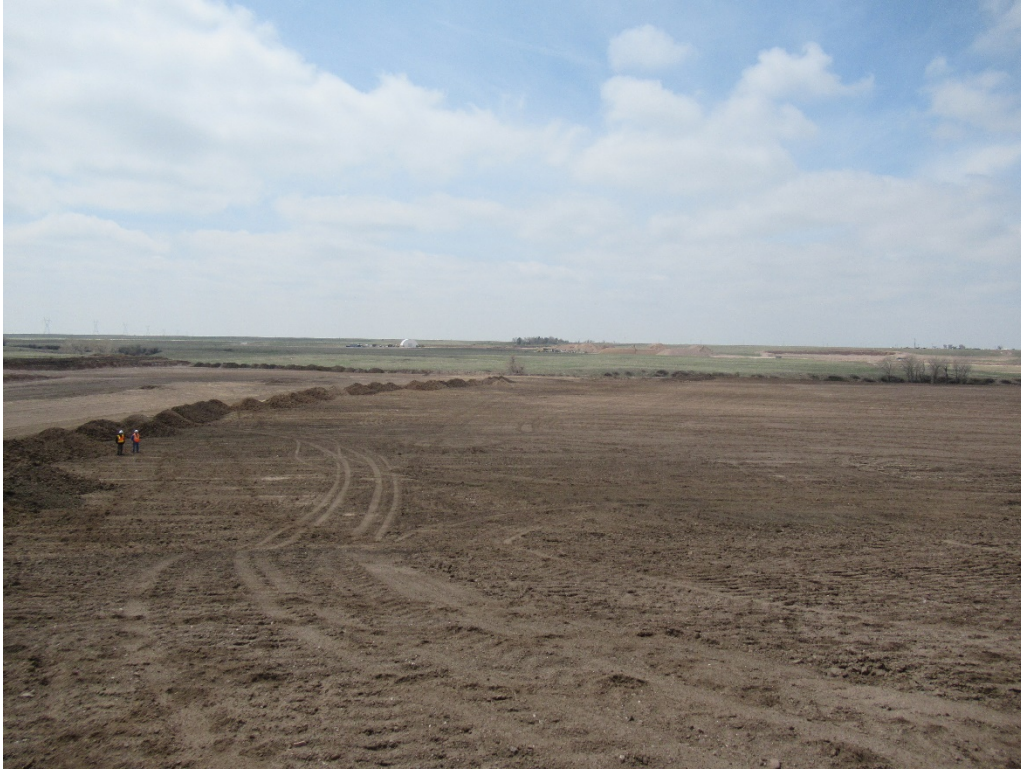
View of Phase 2 reclamation along north permit boundary looking south

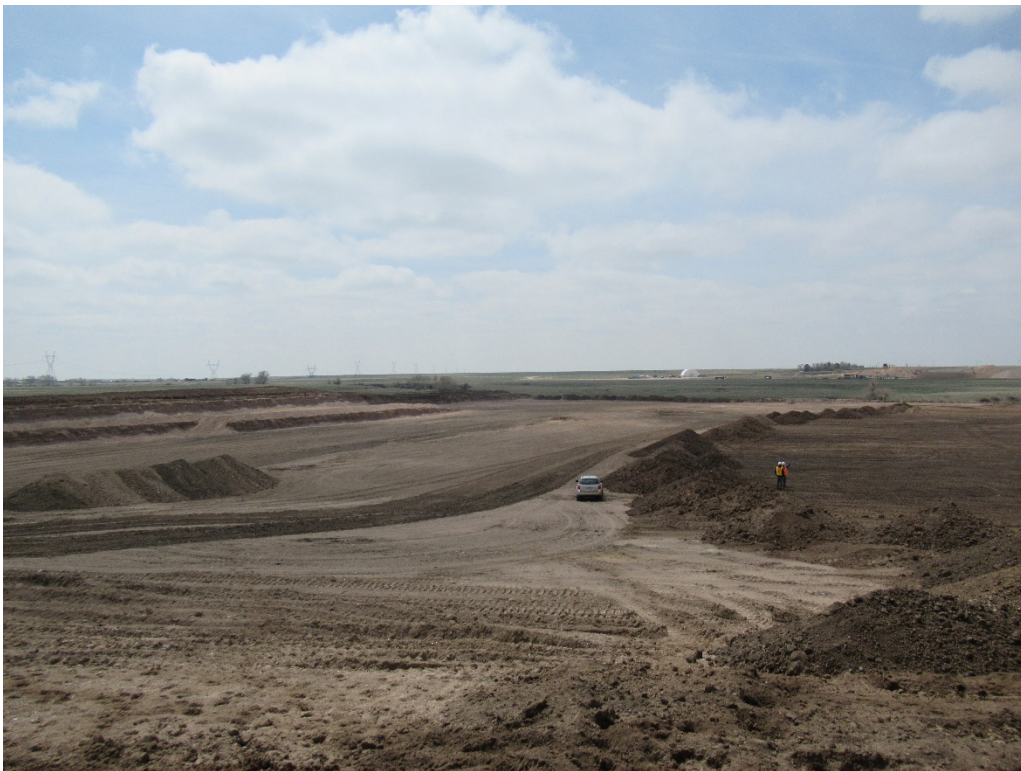
View of Phase 2 active highwall and concurrent reclamation activity

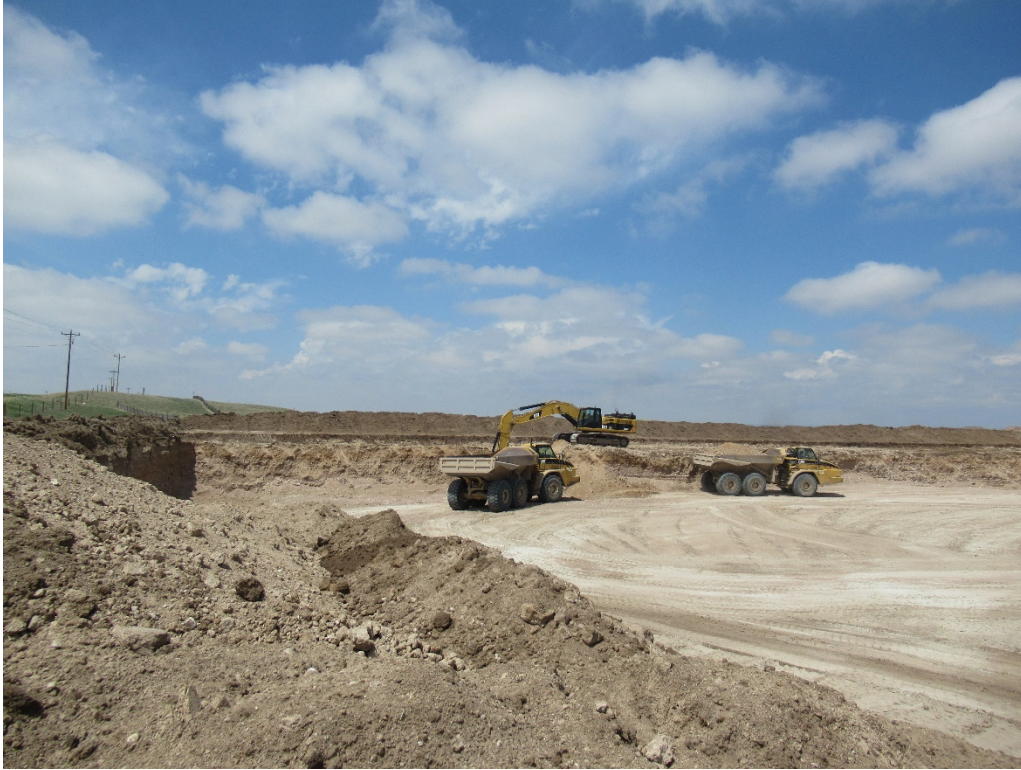
View of the highwall excavation located west of the southern processing area

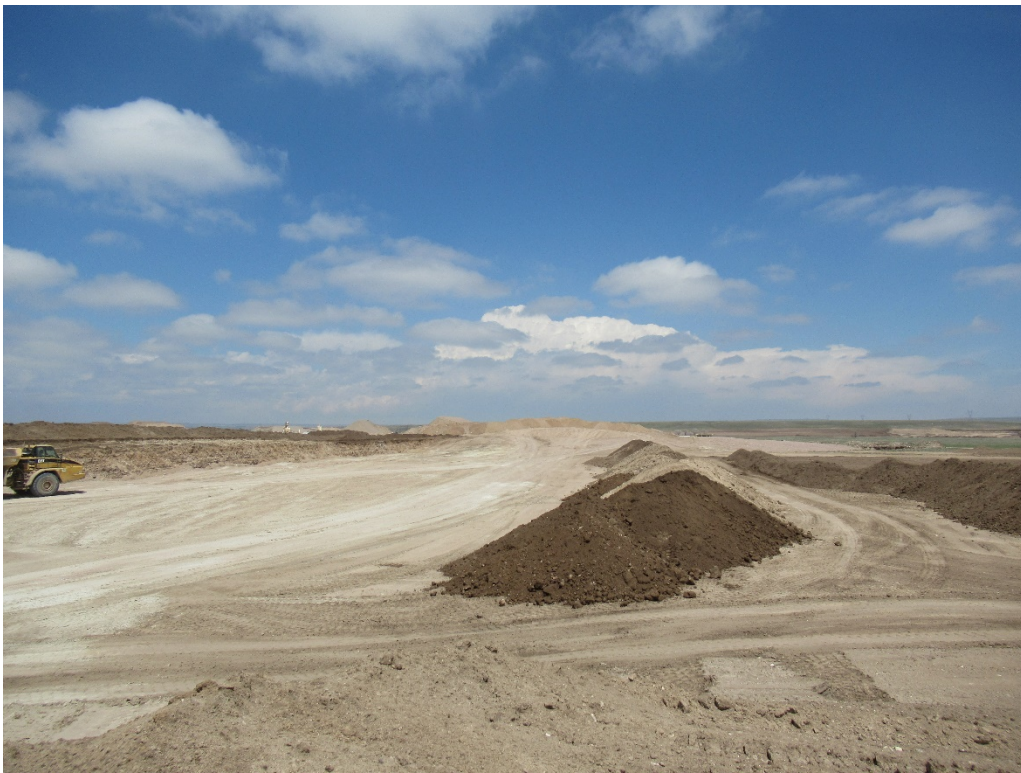
View of the concurrent reclamation located west of the southern processing area

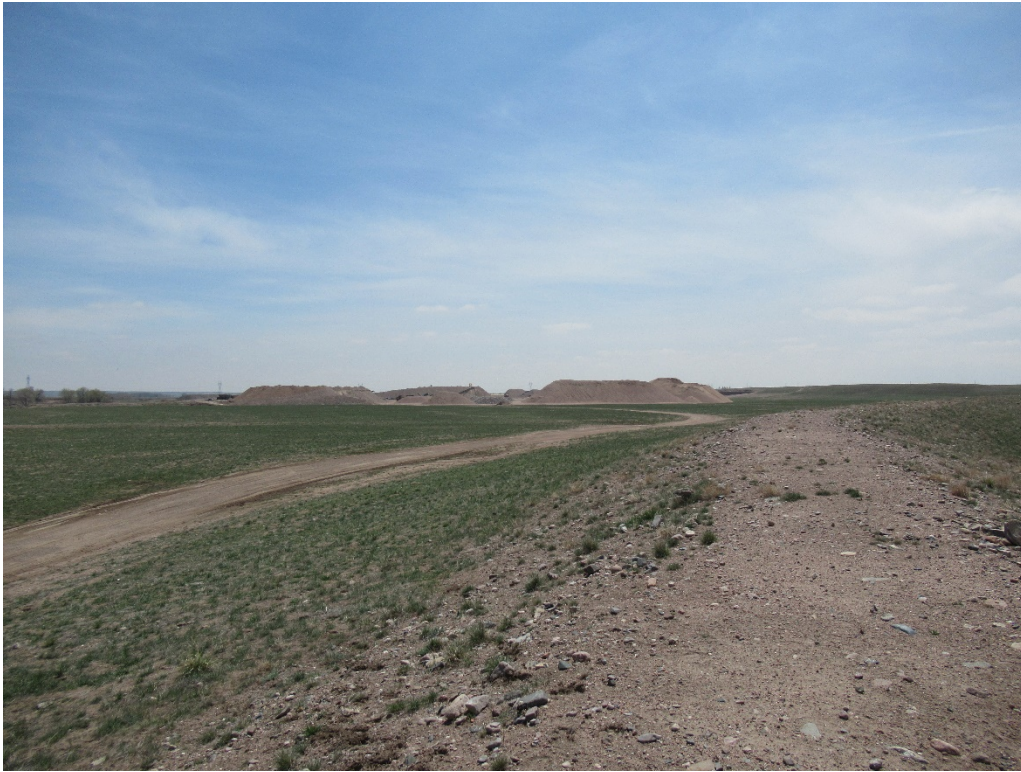
View of reclamation in the northwest portion of the site from the northwest corner looking southeast
