**MINERALS PROGRAM INSPECTION REPORT**  
**PHONE: (303) 866-3567**

<b>MINE NAME:</b> Bob Terrill Clay Pit	<b>MINE/PROSPECTING ID#:</b> M-1999-029	<b>MINERAL:</b> Clay (general)	<b>COUNTY:</b> Logan
<b>INSPECTION TYPE:</b> Monitoring	<b>INSPECTOR(S):</b> Brock F. Bowles	<b>INSP. DATE:</b> May 14, 2019	<b>INSP. TIME:</b> 13:00
<b>OPERATOR:</b> Logan County	<b>OPERATOR REPRESENTATIVE:</b> None	<b>TYPE OF OPERATION:</b> 110c - Construction Limited Impact	
<b>REASON FOR INSPECTION:</b> Normal I&E Program	<b>BOND CALCULATION TYPE:</b> None	<b>BOND AMOUNT:</b> \$0.00	
<b>DATE OF COMPLAINT:</b> NA	<b>POST INSP. CONTACTS:</b> None	<b>JOINT INSP. AGENCY:</b> None	
<b>WEATHER:</b> Clear	<b>INSPECTOR'S SIGNATURE:</b>

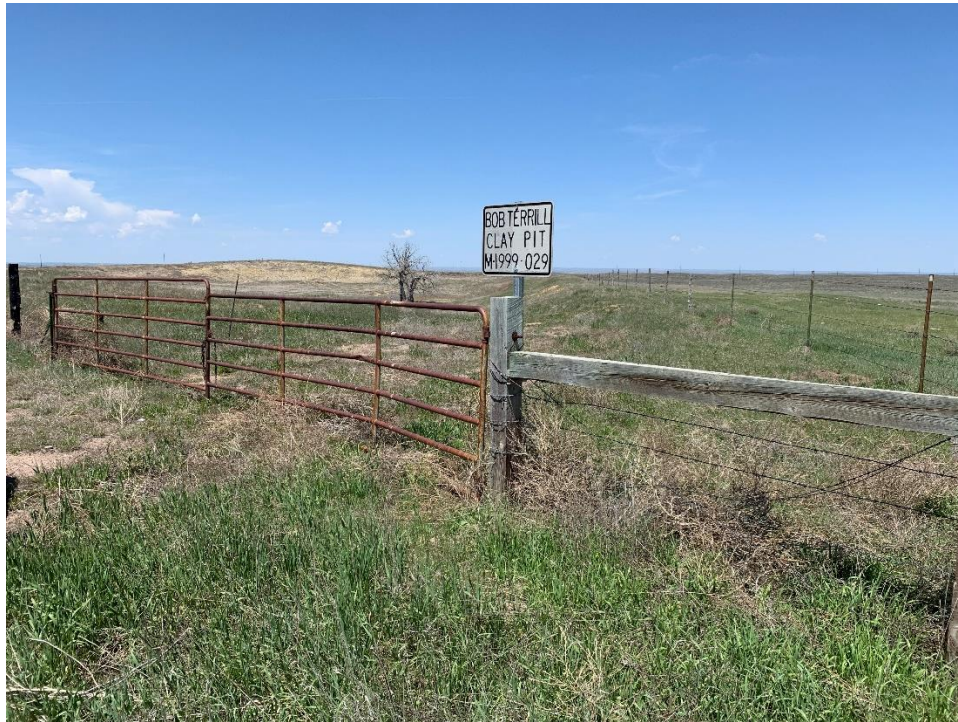
This inspection was a follow-up to the February 12, 2019 inspection that documented the mine identification sign was not posted at the entrance of the mine site. The mine identification sign has been bolted to the entrance gate and is clearly visible from the access road as per Rule 3.1.12(1).

Mine Identification Sign Mounted to Post
