**MINERALS PROGRAM INSPECTION REPORT**  
**PHONE: (303) 866-3567**

<b>MINE NAME:</b> Schumacher II	<b>MINE/PROSPECTING ID#:</b> M-2001-018	<b>MINERAL:</b> Gravel	<b>COUNTY:</b> Logan
<b>INSPECTION TYPE:</b> Surety Release Inspection	<b>INSPECTOR(S):</b> Brock F. Bowles	<b>INSP. DATE:</b> May 14, 2019	<b>INSP. TIME:</b> 11:30
<b>OPERATOR:</b> Nienhueser Construction & Excavating Co	<b>OPERATOR REPRESENTATIVE:</b> Keith Nienhueser	<b>TYPE OF OPERATION:</b> 110c - Construction Limited Impact	
<b>REASON FOR INSPECTION:</b> Surety Release Requested	<b>BOND CALCULATION TYPE:</b> None	<b>BOND AMOUNT:</b> \$6,100.00	
<b>DATE OF COMPLAINT:</b> NA	<b>POST INSP. CONTACTS:</b> None	<b>JOINT INSP. AGENCY:</b> None	
<b>WEATHER:</b> Clear	<b>INSPECTOR'S SIGNATURE:</b>

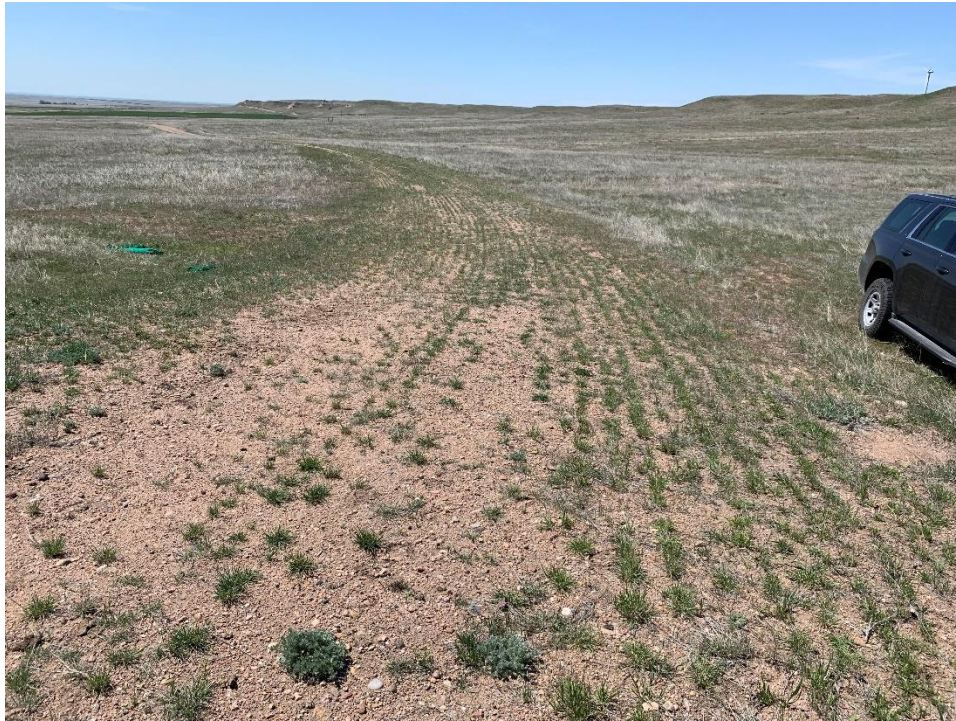
Access Road Looking West

The access road appeared to be stable and there were no signs of erosion. The vegetation on the road area was planted in June 2017 according to Mr. Nienhueser. The vegetation looks good for two growing seasons old but it is not well established yet. There are some bare spots and each plant is still small in size and have not filled in between the drill seeder rows.

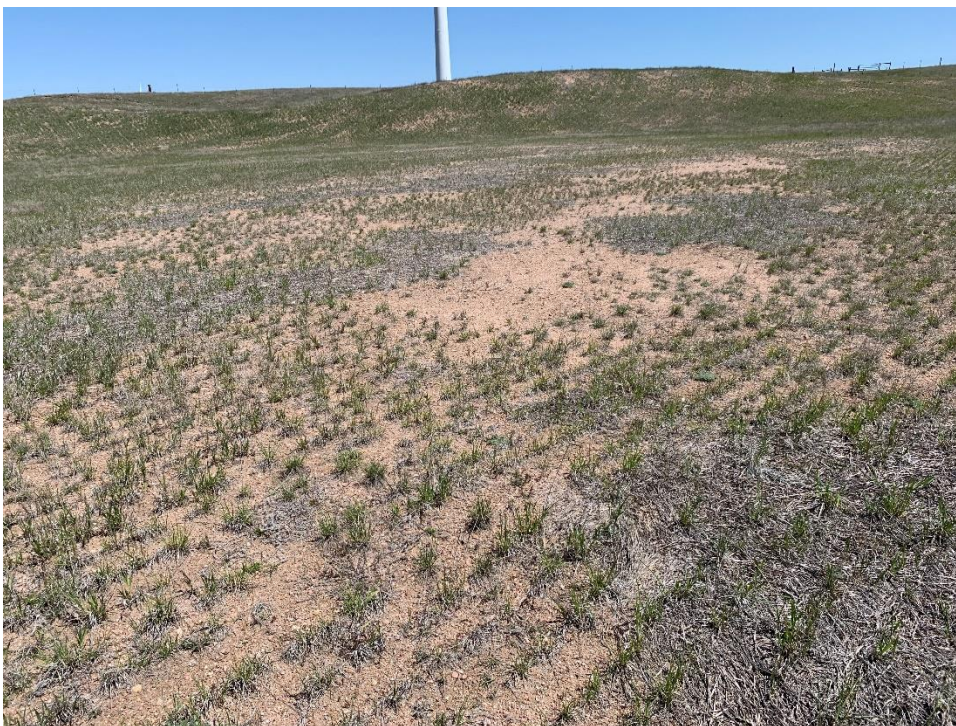
Pit Bottom Looking Northeast

The pit slopes appear to be stable and there were no signs of erosion.

The pit area was fenced and the gate was closed upon arrival. The pit area was seeded in June 2017 according to Mr. Nienhueser. The vegetation is starting to look good for being two growing seasons old but it is not well established yet and the cover is not close to being equal in extent to the natural vegetation (Rule 3.1.10(1)). The planted grass plants were still pretty young and most did not have a seed head and therefore it was not easy to determine the species of grass. There are several bare spots especially where the straw mulch created a thick mat. The planted grasses are small and have not begun to fill in between the drill seeder rows. There were several small patches of musk thistle (Colorado listed noxious weed) that need to be treated.

The vegetation of the site needs to be increased, the bare areas need to be reseeded and the thistles need to be treated prior to release of the site.

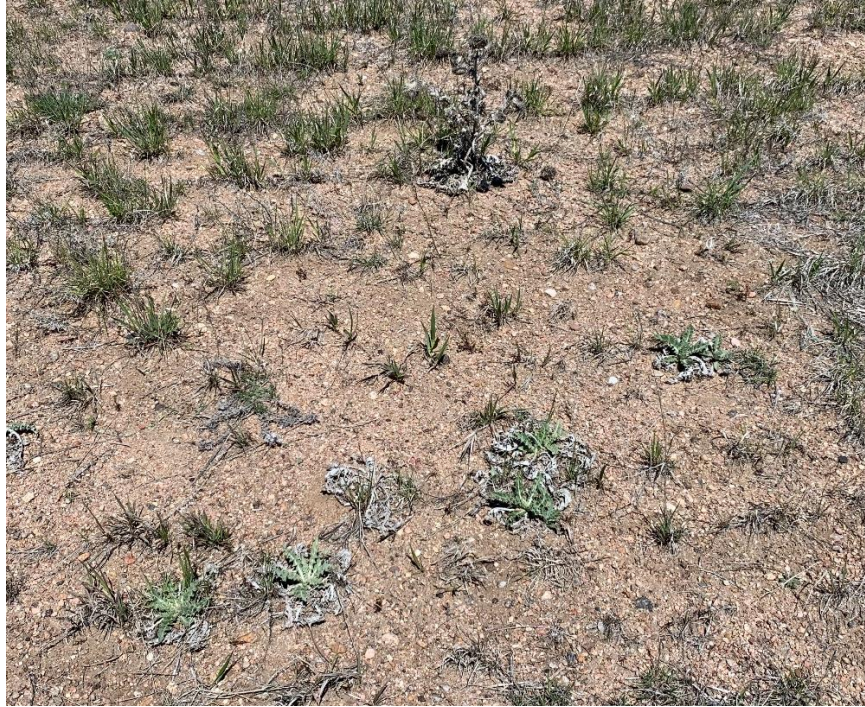
Musk Thistle Rosettes and Standing Dead

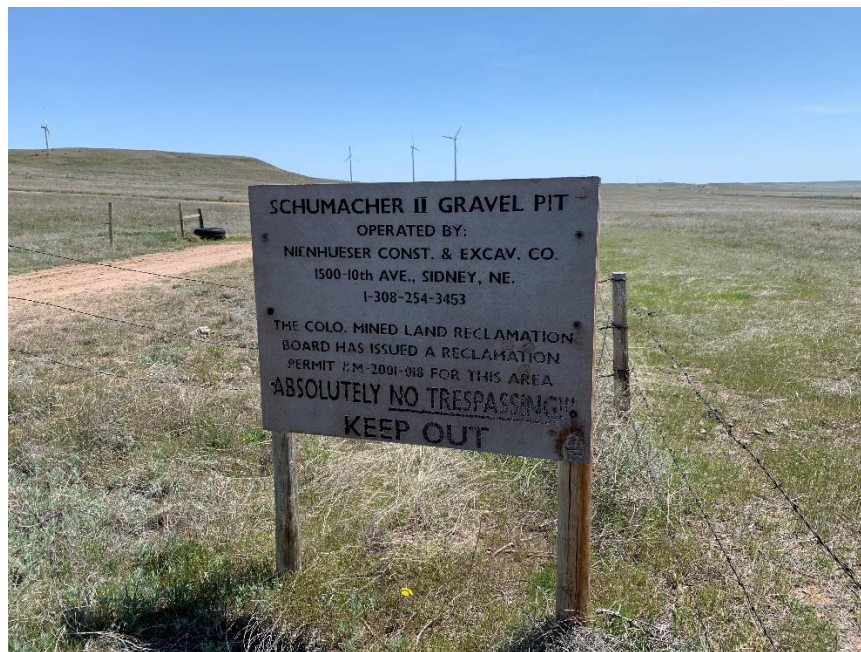
Mine Entrance Sign

An entrance sign was observed and the permit boundary markers were in place as required by Rule 3.1.12.
