MINERALS PROGRAM INSPECTION REPORT

MINE NAME: Spotted Burro Pit	MINE/PROSPECTING ID#: M-1979-192	MINERAL: Sand and gravel	COUNTY: Fremont
INSPECTION TYPE: Monitoring	INSPECTOR(S): Timothy A. Cazier	INSP. DATE: March 29, 2019	INSP. TIME: 09:25
OPERATOR: Rockbottom, LLC	OPERATOR REPRESENTATIVE: Andy & Becky Kagan	TYPE OF OPERATION: 112c - Construction Regular Operation	
REASON FOR INSPECTION: Normal I&E Program	BOND CALCULATION TYPE: Complete Bond	BOND AMOUNT: \$45,978.00	
DATE OF COMPLAINT: NA	POST INSP. CONTACTS: None	JOINT INSP. AGENCY: None	
WEATHER: Raining	INSPECTOR'S SIGNATURE:

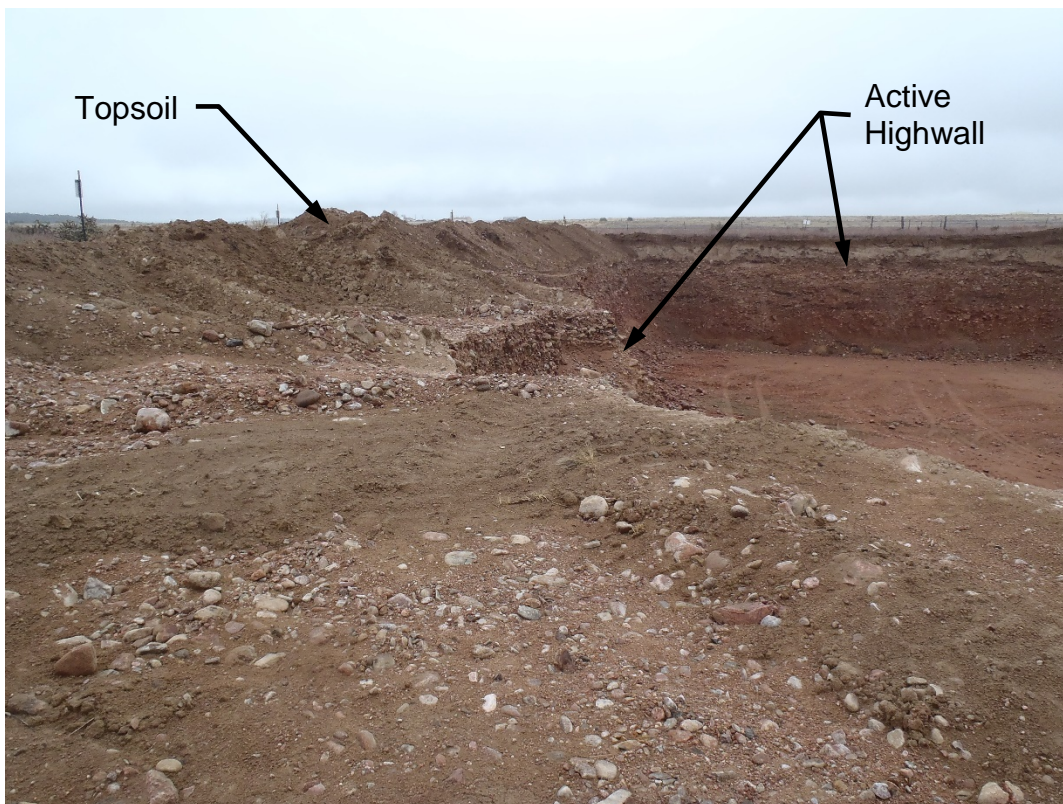
Topsoil: Topsoil is pushed off the area to be excavated prior to mining (see **Photo 1**).

Photo 1. Active highwall (north end, looking east).

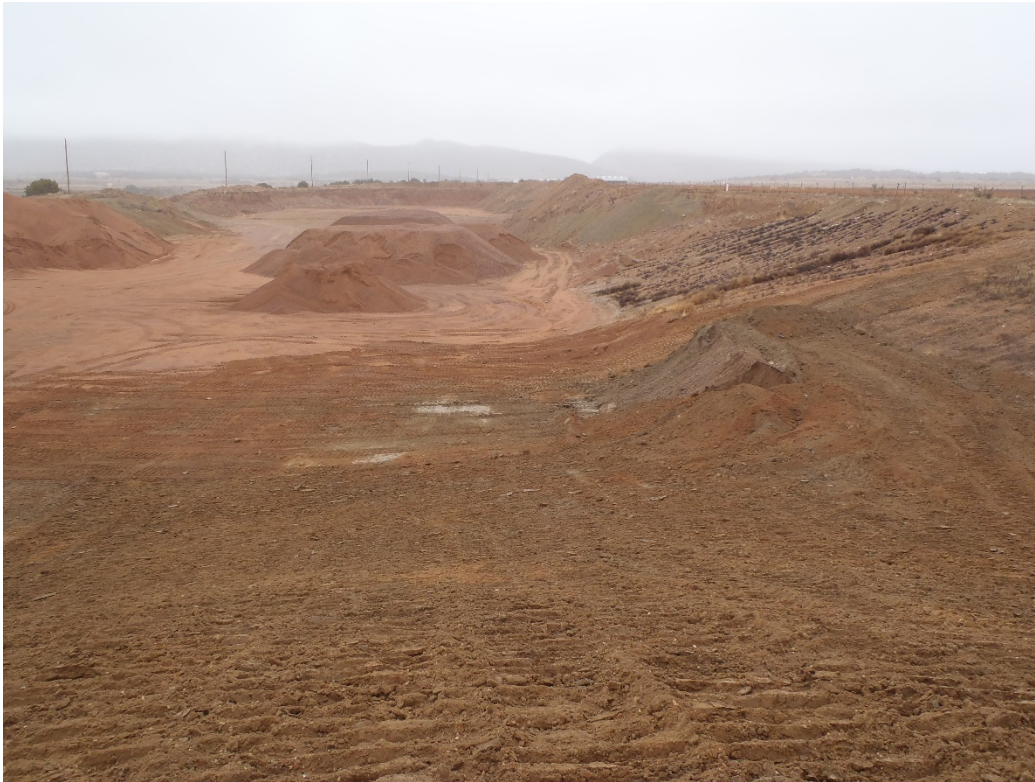
Gen. Compliance with Mine Plan: The operation appeared to be in compliance with the approved mine plan. Google Earth was used to measure the disturbed area, which was estimated to be approximately 14 acres, based on June 2017 imagery. Highwalls in the active area were near vertical and estimated to be 20 feet in height (see **Photo 1**) with an estimated length of 500 linear feet. The Operator utilizes available backfill material to flatten slopes to 3H:1V (see **Photo 2**) and seed them as part of the concurrent reclamation effort (see **Photo 3**).

Reclamation Success: The southwest corner of the pit has been reclaimed (see **Photo 4**). The south side and southeast corner have been backfilled and portions covered with topsoil (see **Photo 2**).

Photo 2. Highwalls flattened to 3H:1V (SE corner, looking north).

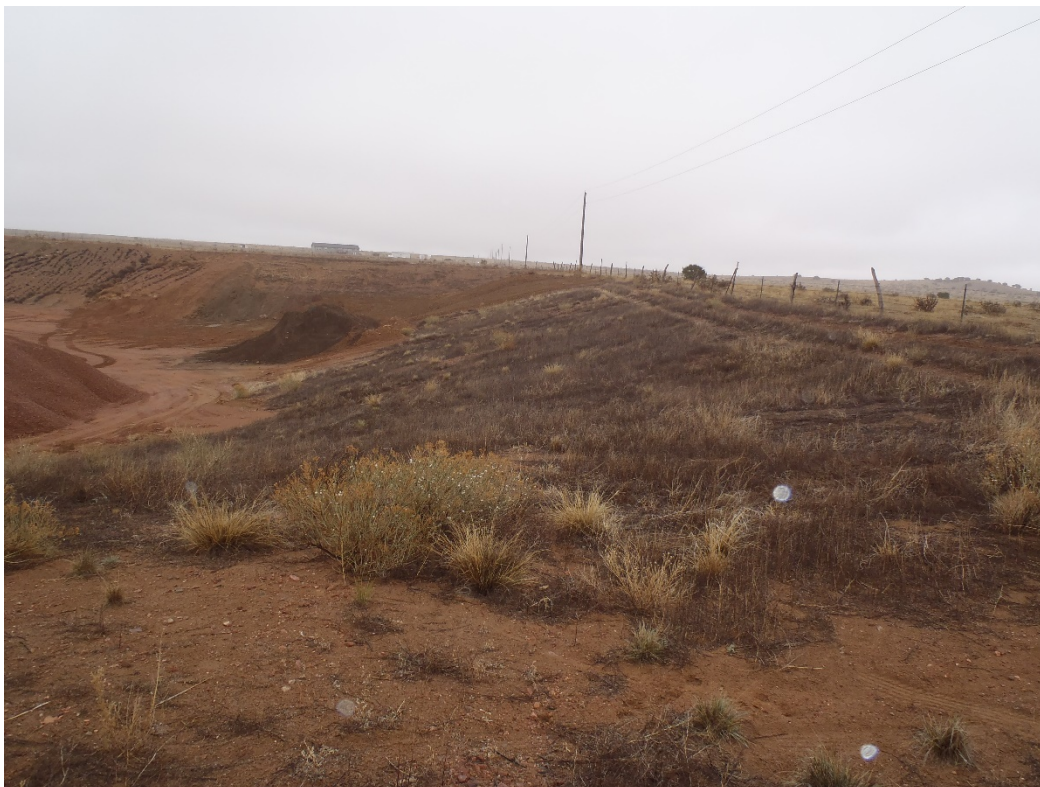
Photo 3. Reclaimed slopes (SW corner, looking east).

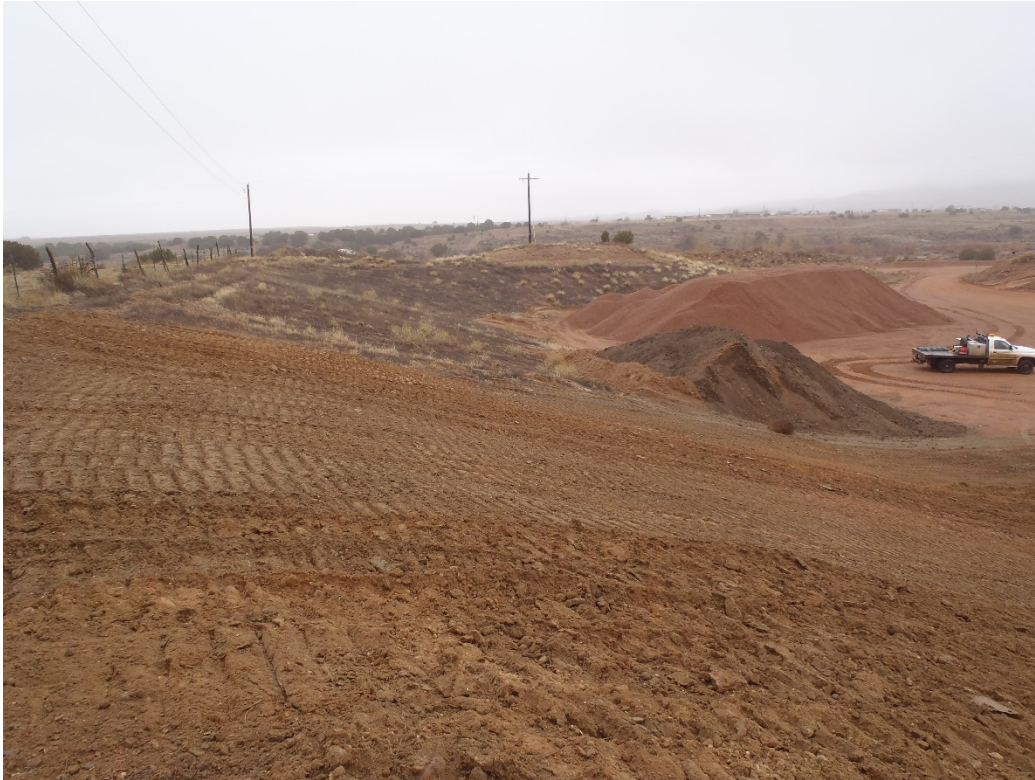
Revegetation: The southwest corner of the pit has been revegetated (see **Photo 4**). No noxious weeds were observed.

Photo 4. Concurrent reclamation (south end, looking west).

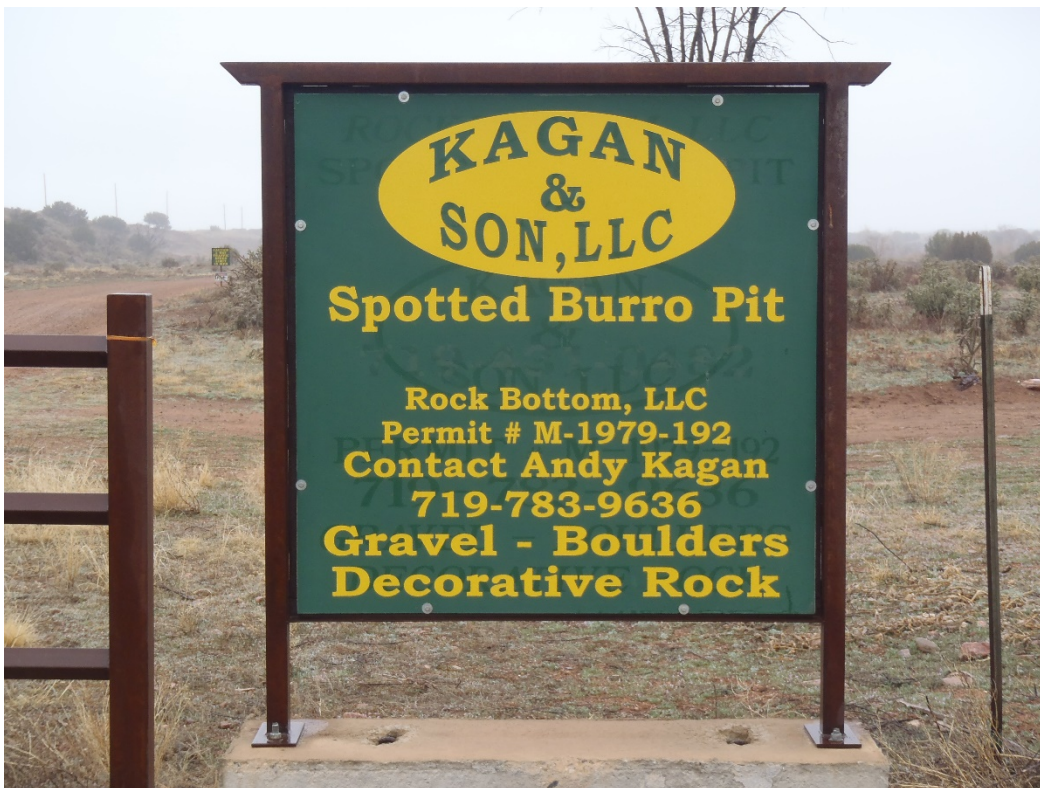
Signs and Markers: The permit sign was properly posted (see **Photo 5**) and boundary markers (fences and berms) were observed to delineate the permit boundary (see **Photo 6** and **2**).

Photo 5. Permit sign (at gate).

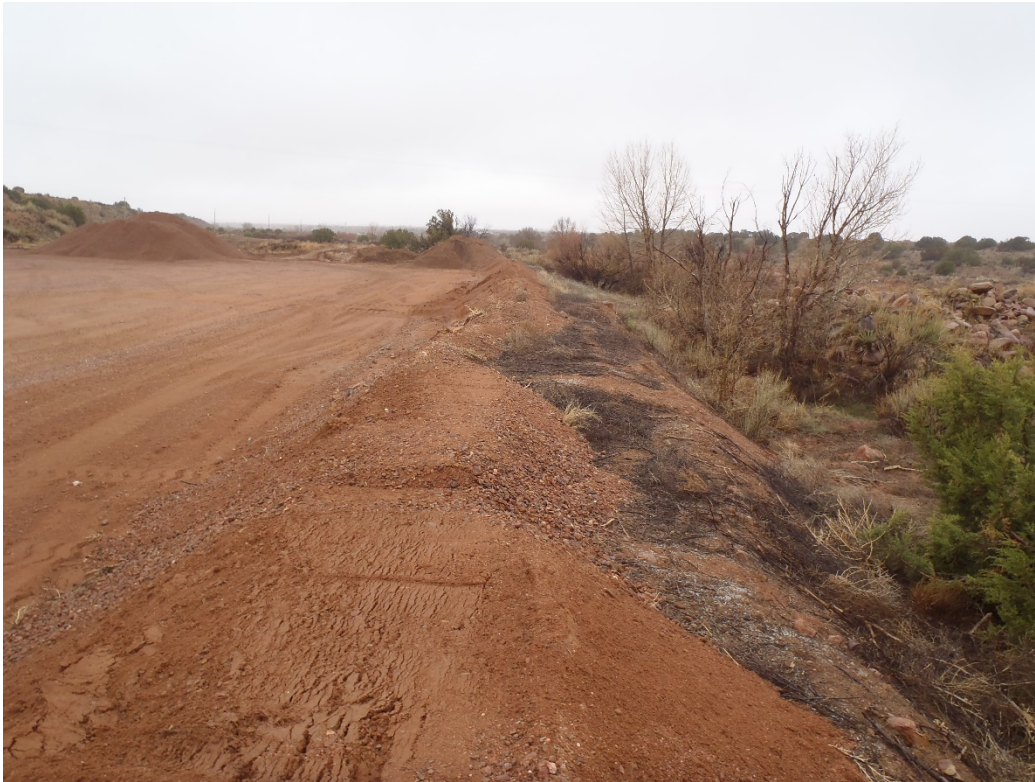
Photo 6. Berm marking affected area boundary (west side, looking south).

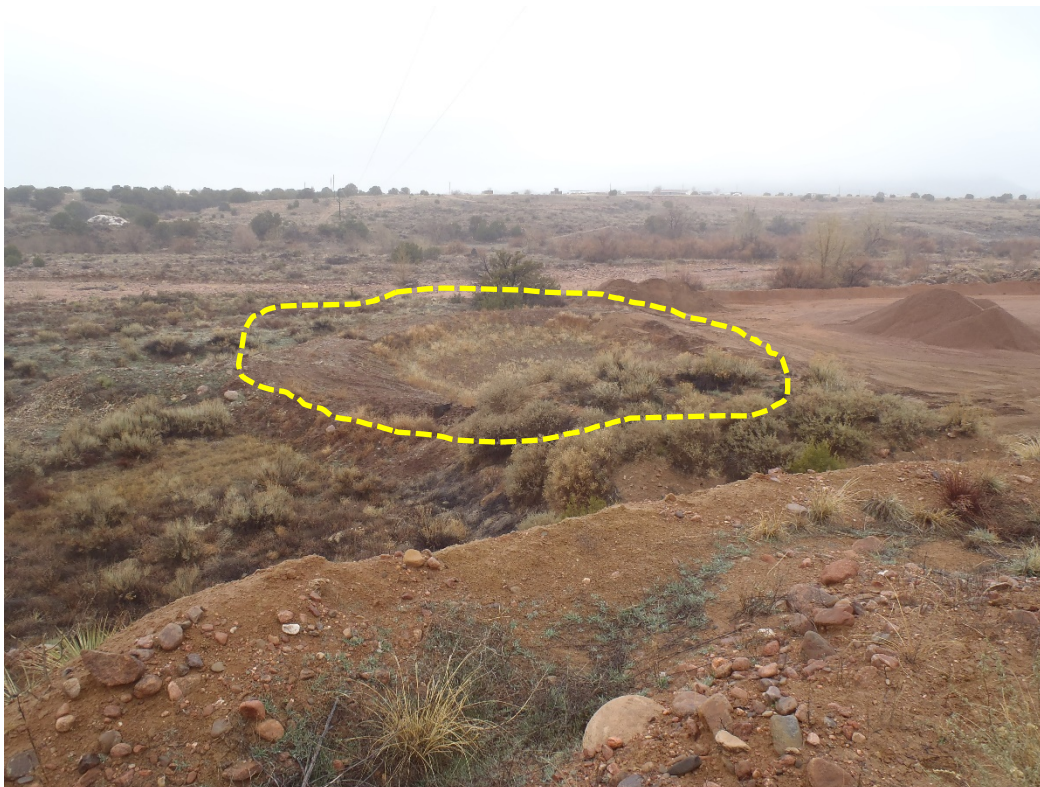
Storm Water MGT Plan: No oil or fuel spills observed. Stormwater drains west of the pit and enters the new sediment pond (see **Photo 7**) on the southwest corner of the site.

Photo 7. New sediment pond (SW corner, looking west).
