MINERALS PROGRAM INSPECTION REPORT**PHONE: (303) 866-3567**

MINE NAME: 6S Pit No.1	MINE/PROSPECTING ID#: M-1986-101	MINERAL: Sand and gravel	COUNTY: Pueblo
INSPECTION TYPE: Surety-Related Inspection	INSPECTOR(S): Patrick Lennberg	INSP. DATE: May 23, 2019	INSP. TIME: 11:00
OPERATOR: 6S Land & Cattle co.	OPERATOR REPRESENTATIVE: Richard Clennin	TYPE OF OPERATION: 110c - Construction Limited Impact

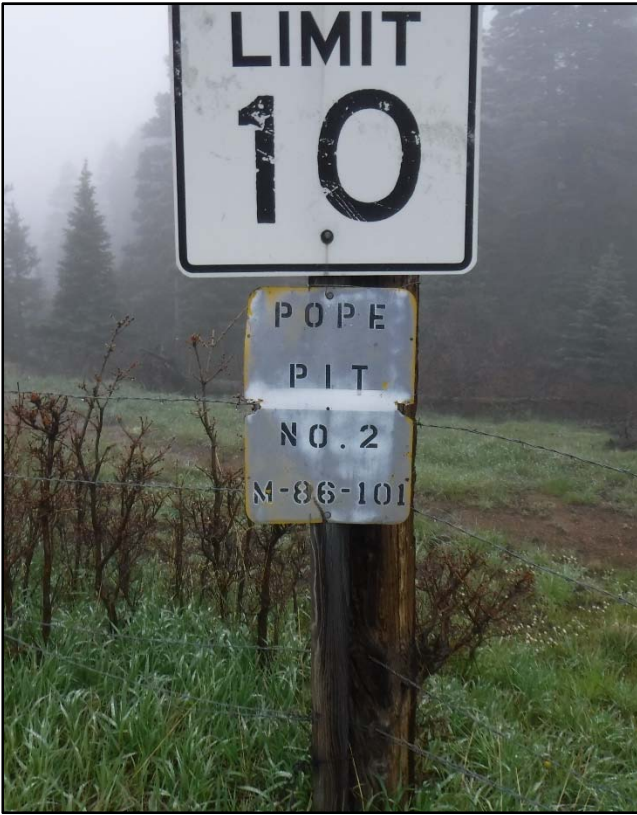
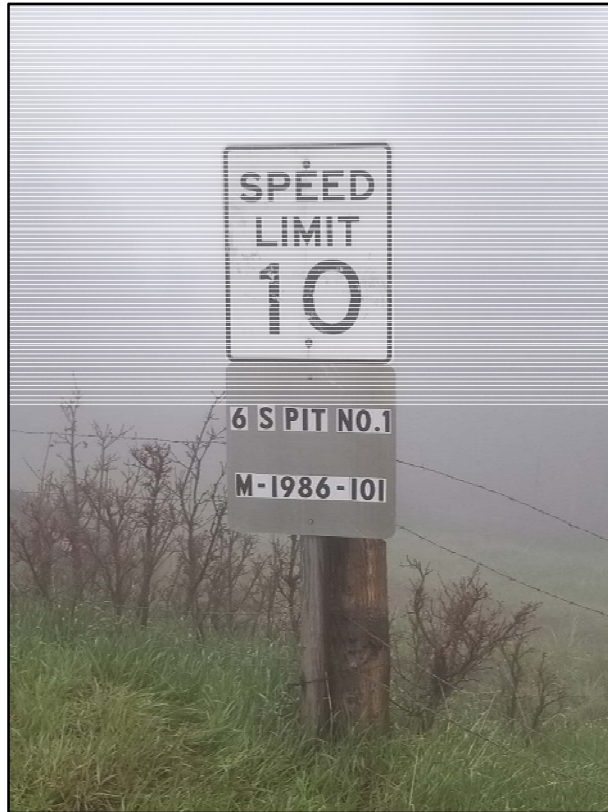
The 6S Pit is a 110c operation permitted for 9.2 acres to mine sand and gravel. The site is surrounded by a mix of rural residential and rangeland with the post-mining land use of rangeland. Although a mine sign was observed, as required by Rule 3.1.12, it had the wrong pit name. It was brought to the Operators attention and was updated before the end of the day of the inspection.

Photo 1: Mine sign at entrance, left picture taken at time of inspection right picture taken a few hours later.

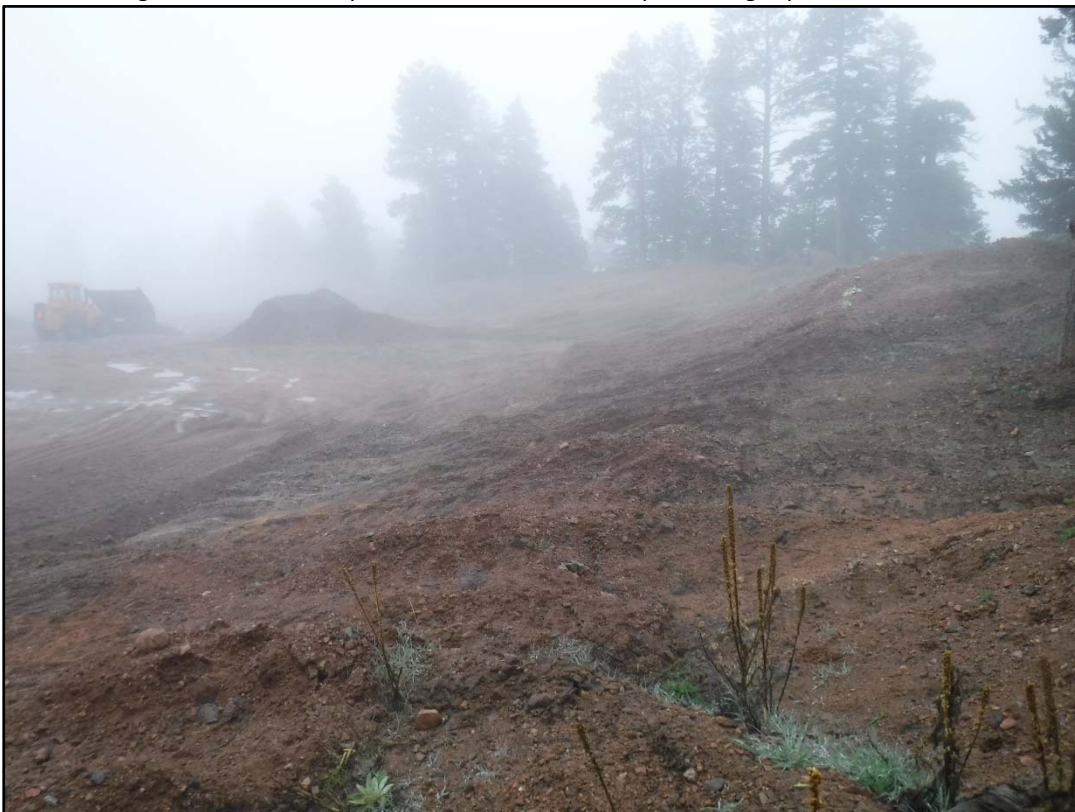
Mining is progressing from west to east. The mined area is surrounded by a berm that is anywhere from 3 feet to 25 feet in height. The slopes of the berm average 3H:1V with one section in the northwest corner has a highwall (1.5H:1V) that is 250 feet long and 15 to 20 feet in height. There was no evidence of excessive erosion. There were several areas of ponded water. However, recent snow fall and rain over the past couple of weeks have led to very wet month. The operator was informed that they are not allowed to impound stormwater longer than 72 hours. Mr. Clennin mentioned that the pit dries up quickly and they rip areas where there is water to promote quick drainage. Topsoil has been salvaged and stockpiled along the northern and southern boundaries of the pit and the stockpiles are stable. The amount of topsoil that has been salvaged appears to be adequate for reclamation.

Photo 2: Typical side slopes of southern pit area, note stockpiled material and loader

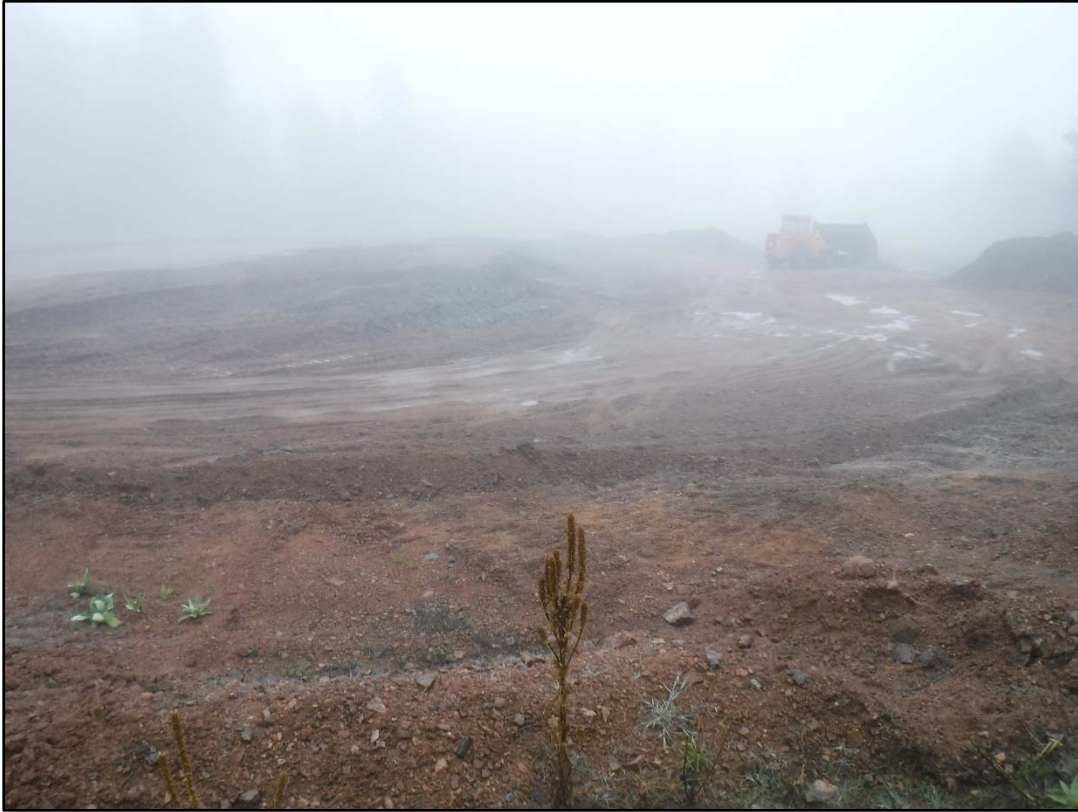
Photo 3: Pit floor area, standing water due to recent rain/snow storms and active rain shower

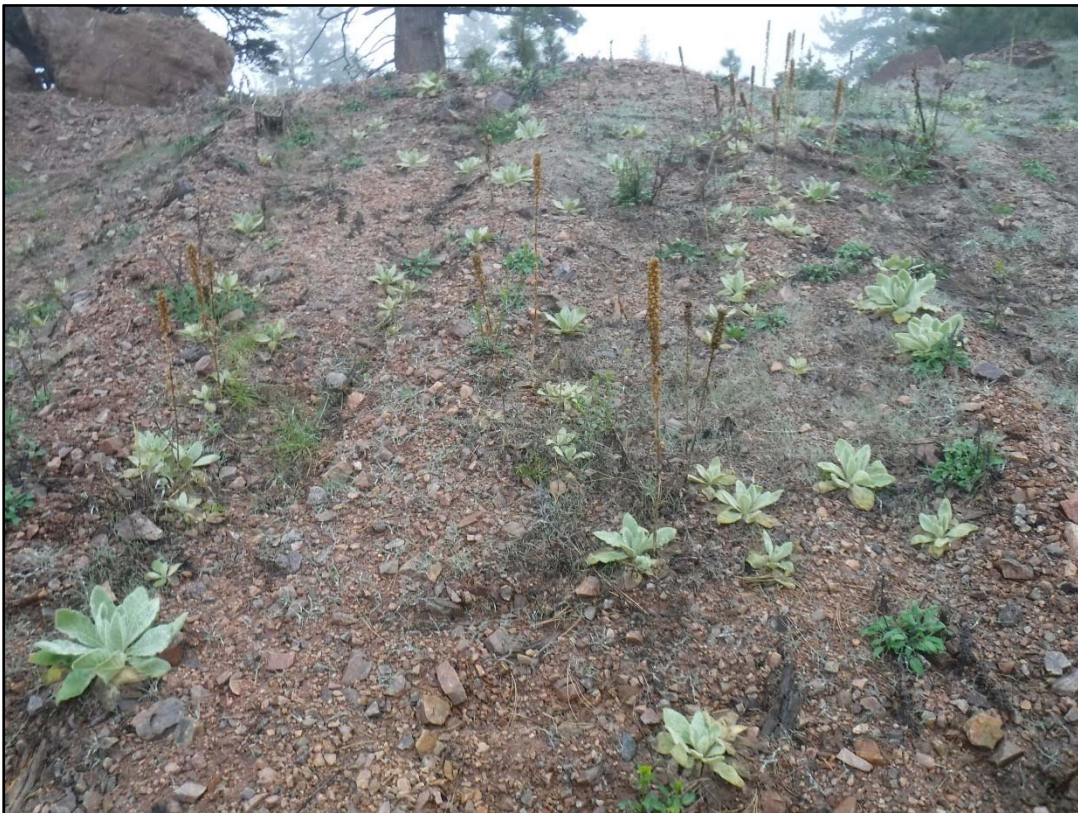
Common mullein was observed in a few areas of the pit, as was noted in the previous inspection. The Operator committed to begin treating and spraying to get rid of the mullein from within the mine area.

Photo 4: Mullein volunteering into mined area

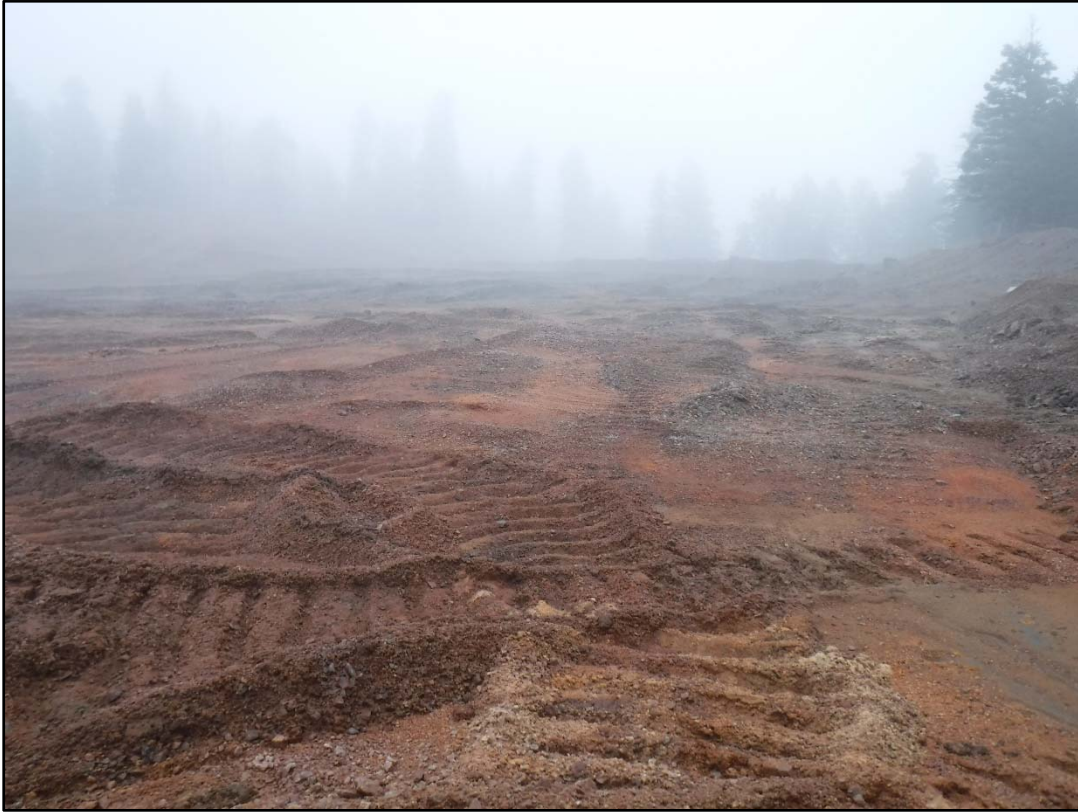
Photo 5: Mine floor area to the east

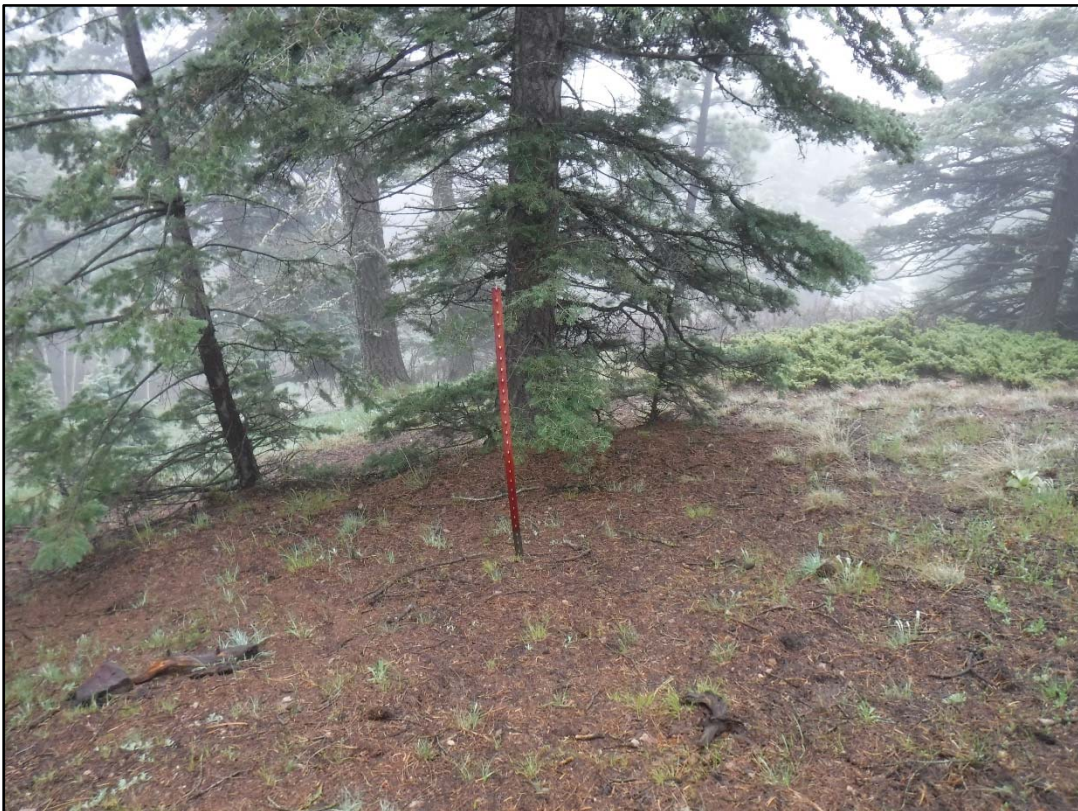
PROBLEM/POSSIBLE VIOLATION: The affected area boundary markers are incorrectly placed. This is a problem for failure to maintain boundary markers around the affected area as required by Section 3.1.12(2) of the rule.

During additional permit review after the inspection it was determined that the permit boundary markers in the field are not accurately located and this is being cited as a problem in this report. The map of the permit boundary in the original permit application and recently used in the Annual report shows the permit boundary to be rectangular in shape. The original permit application specifically states that the permit area is comprised of 4 acres in the SE ¼ SE ¼ of Section 7 and 5.2 acres in the SW ¼ SW ¼ of Section 8, T24S R68W. Attached to this report is a figure that the Division feels accurately depicts where the permit boundary markers should be located. The Operator

Photo 6: Incorrectly placed permit boundary marker

CORRECTIVE ACTIONS: The operator shall conduct a survey and replace the boundary markers in the correct location(s). The operator shall provide photographic documentation to the Division that this has been done by the corrective action date.

CORRECTIVE ACTION DUE DATE: 6/28/19

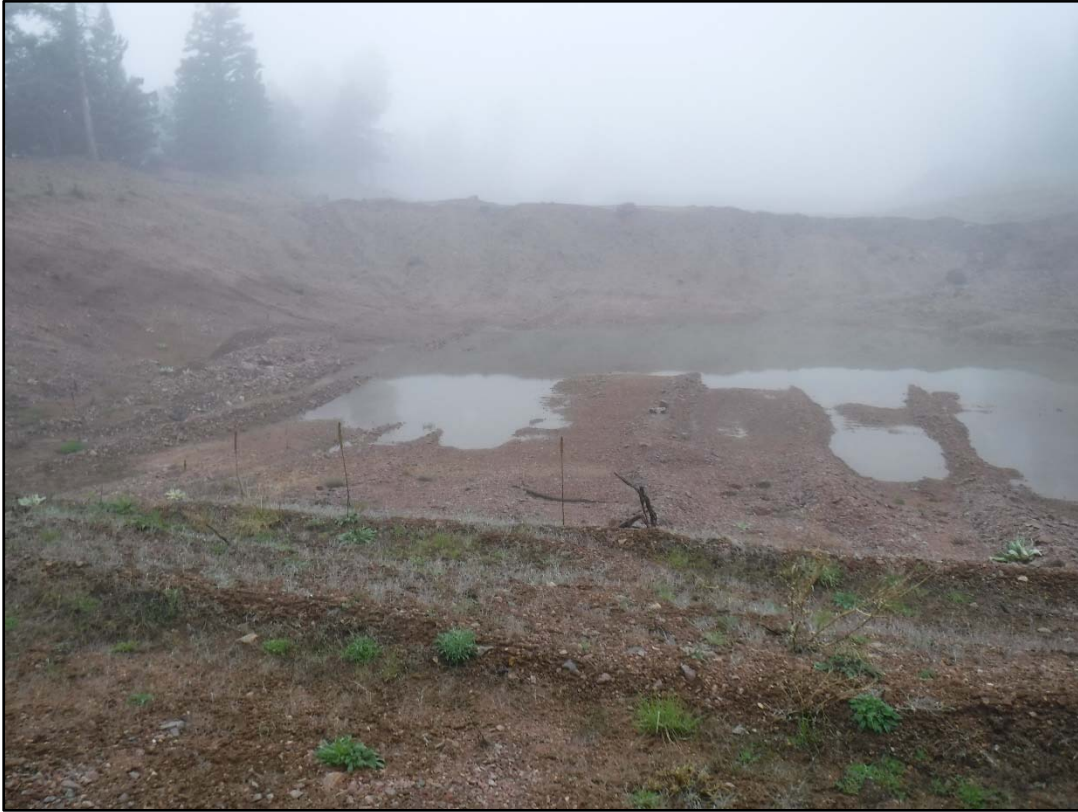
Photo 7: Eastern most area of pit, floor will be ripped to promote drainage or pumped into active pit to infiltrate

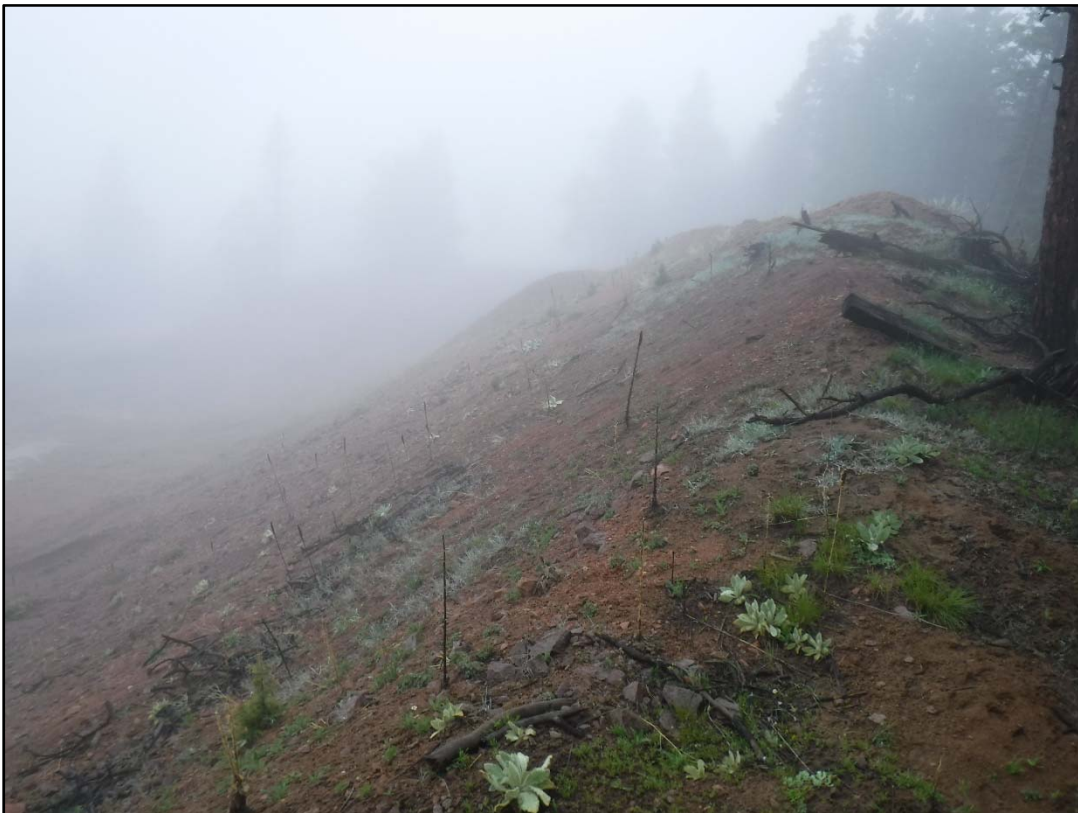
Photo 8: Topsoil stockpile along northern boundary of pit
