**COLORADO**Division of Reclamation,
Mining and Safety

MINERALS PROGRAM INSPECTION REPORT**PHONE: (303) 866-3567**

MINE NAME: Everhart Pit	MINE/PROSPECTING ID#: M-1997-081	MINERAL: Gravel	COUNTY: Pueblo
INSPECTION TYPE: Monitoring	INSPECTOR(S): Patrick Lennberg	INSP. DATE: May 23, 2019	INSP. TIME: 13:15
OPERATOR: Pueblo County	OPERATOR REPRESENTATIVE: Andrew Ruybal	TYPE OF OPERATION: 112c - Construction Regular Operation

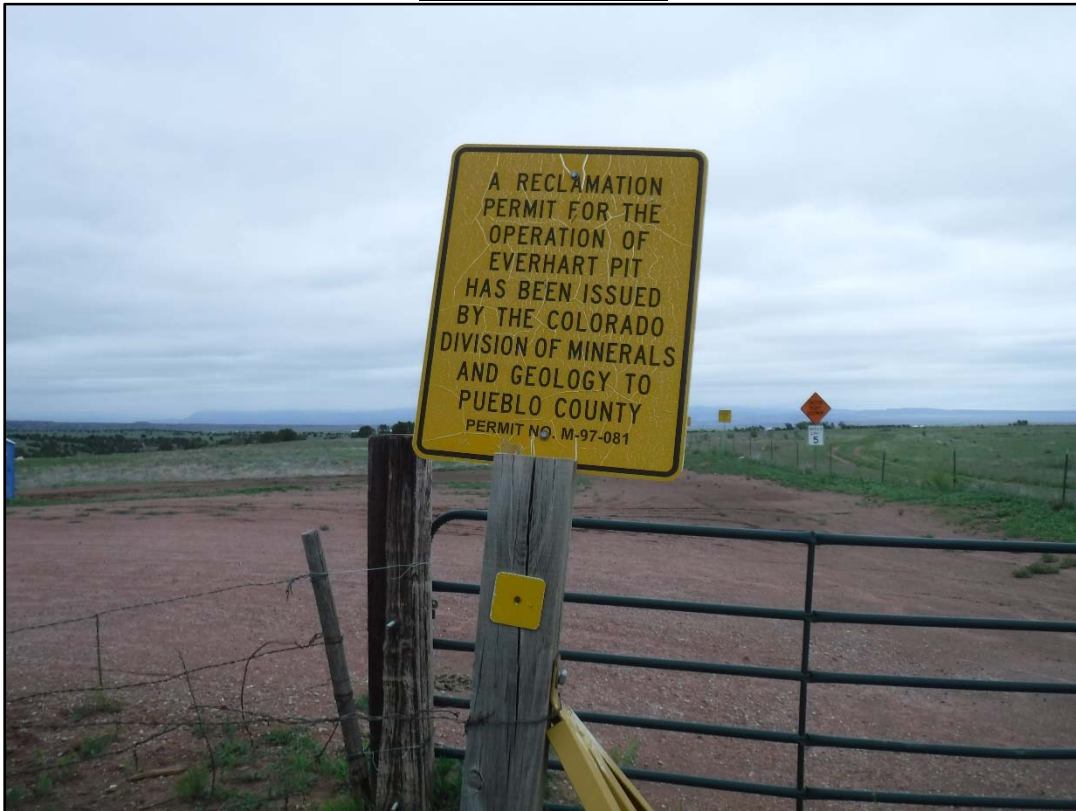
Photo 1: Mine sign at entrance off of County Road 201 (Siloam Road)

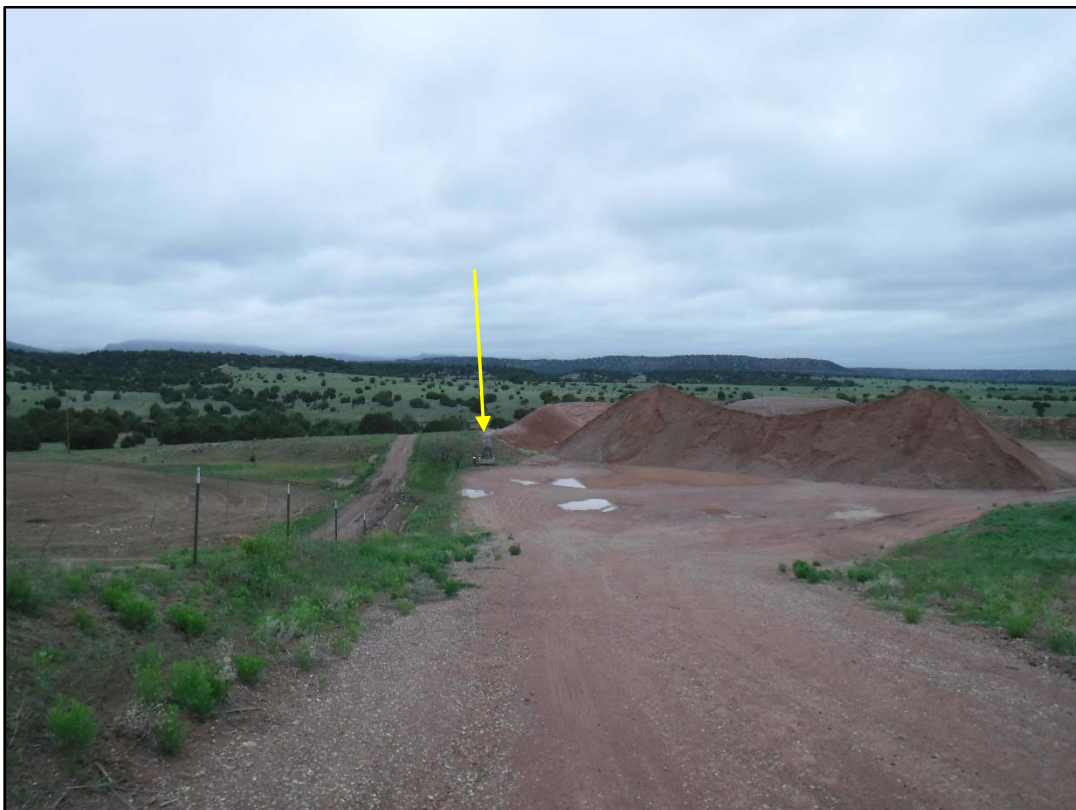
There was an above ground fuel storage tank located in the southern portion of the mine. There appeared to be an adequate secondary containment structure built around the fuel storage tank. The secondary containment structure appeared to have enough volume to contain all contents of the fuel tank, plus an additional 10% or more capacity beyond the total capacity of stored petroleum products.

Photo 2: Material stockpiles produced by Colorado Crushing and AST (yellow arrow)

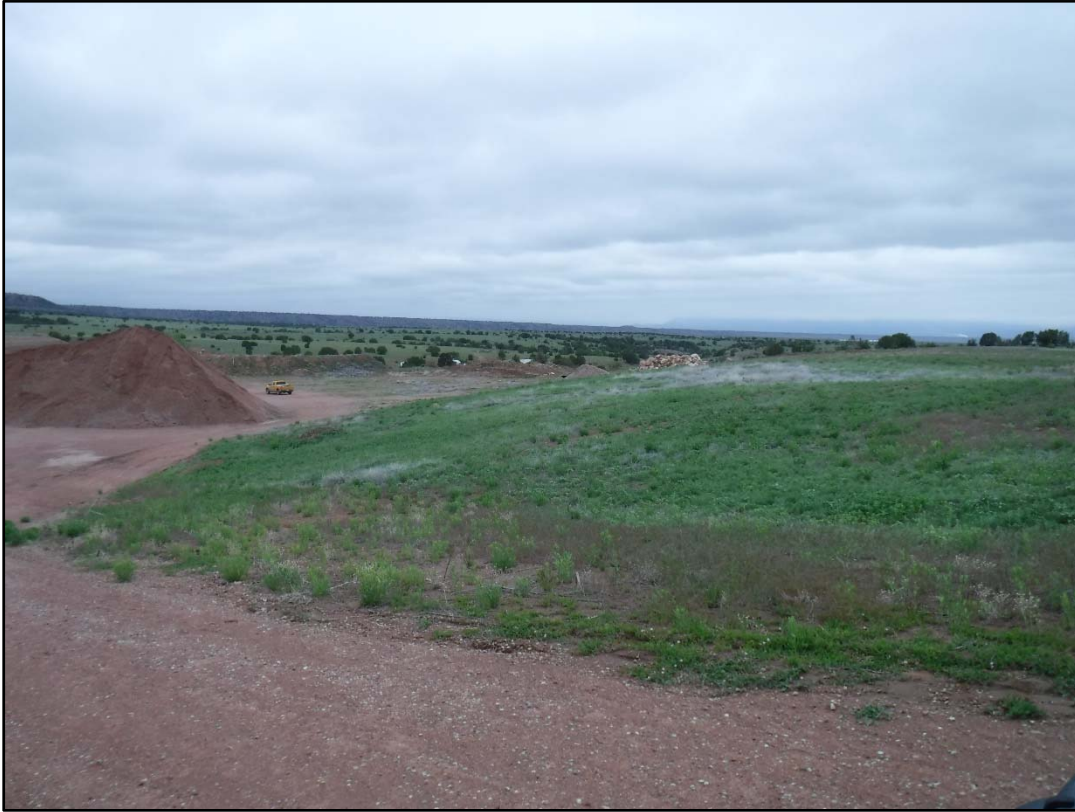
The mining operation was not active during the inspection. At the present time it appears that the mining operation has affected approximately 10 acres throughout the life of mine. The Operator has conducted partial concurrent reclamation of the 10 acres. The reclaimed portions are vegetated by volunteer grasses and forbs. Portions of the affected lands have been backfilled and graded to 3H:1V or shallower slope.

Photo 3: Reclaimed slope with volunteer vegetation well established

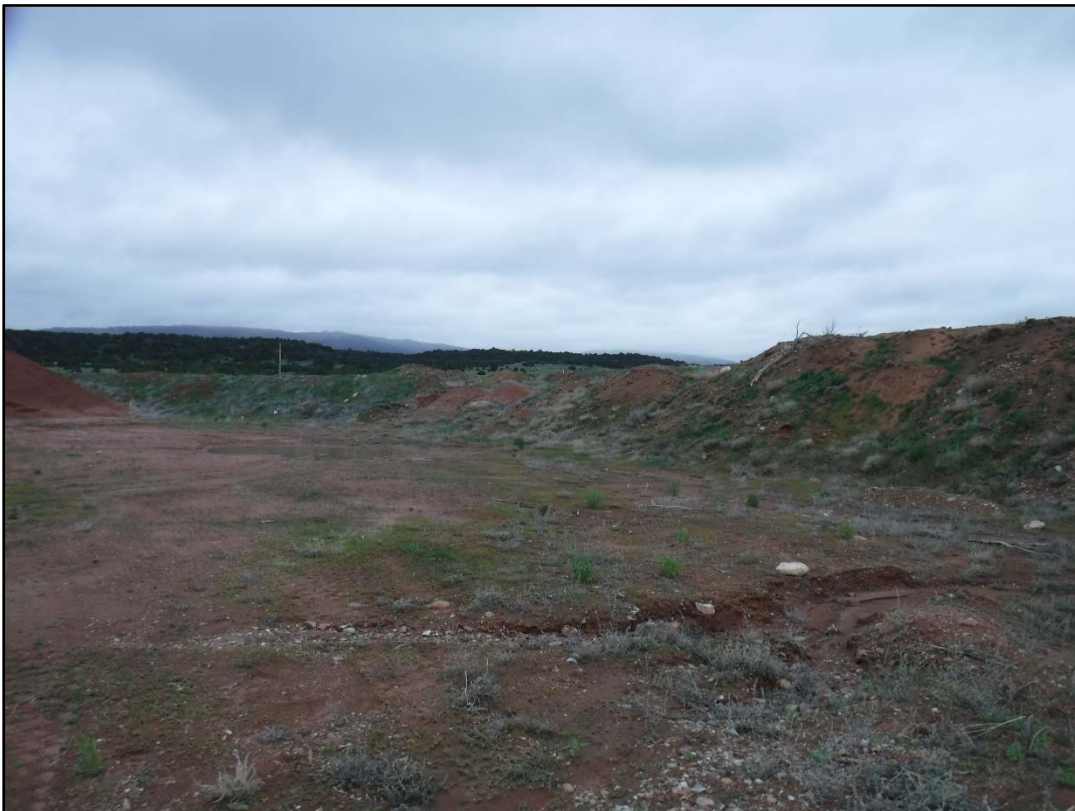
In the active portion of the mine, in the northeast, the mining faces range from near vertical to 1.5H:1V. Along these faces there are a few erosion rills that have formed. The debris from these rills are contained within the pit area. There was adequate topsoil stockpiled on site to conduct the approved reclamation plan. There was a well vegetated topsoil stockpile in the southern portion of mine area. The topsoil stockpiles have adequate vegetative cover to protect the topsoil from erosion.

Photo 4: Topsoil stockpile are in the southern portion of mine area.

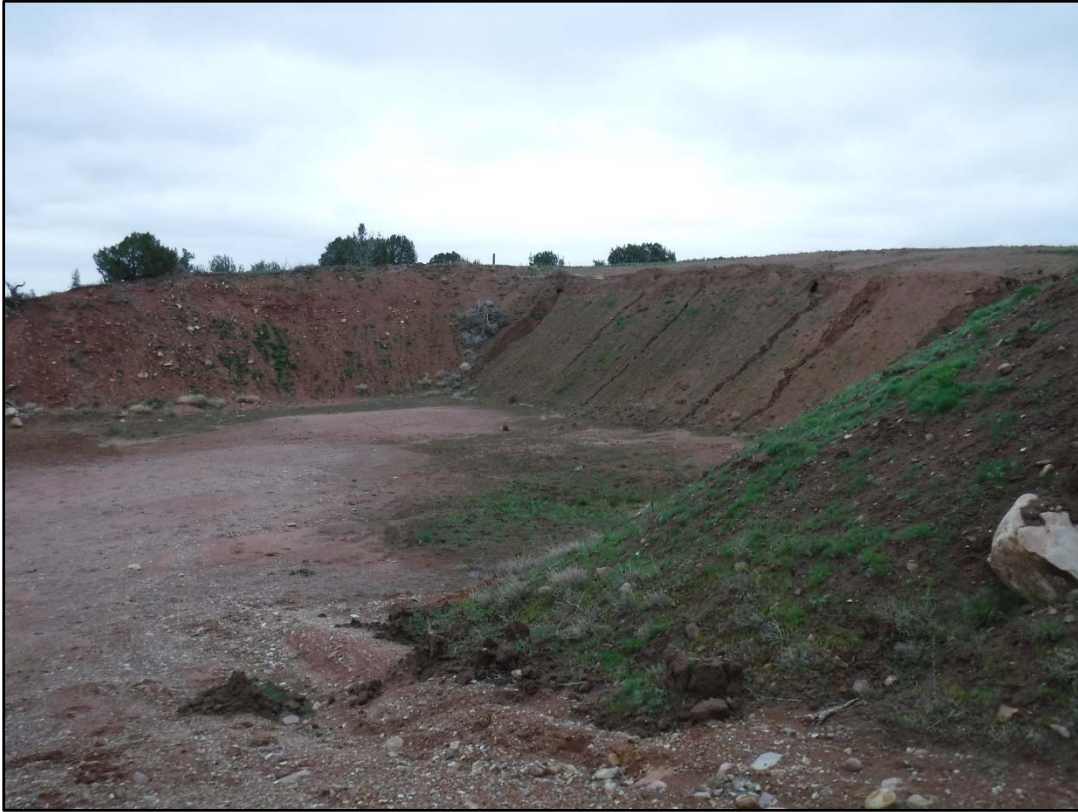
Photo 5: Recent mining face with erosion rills

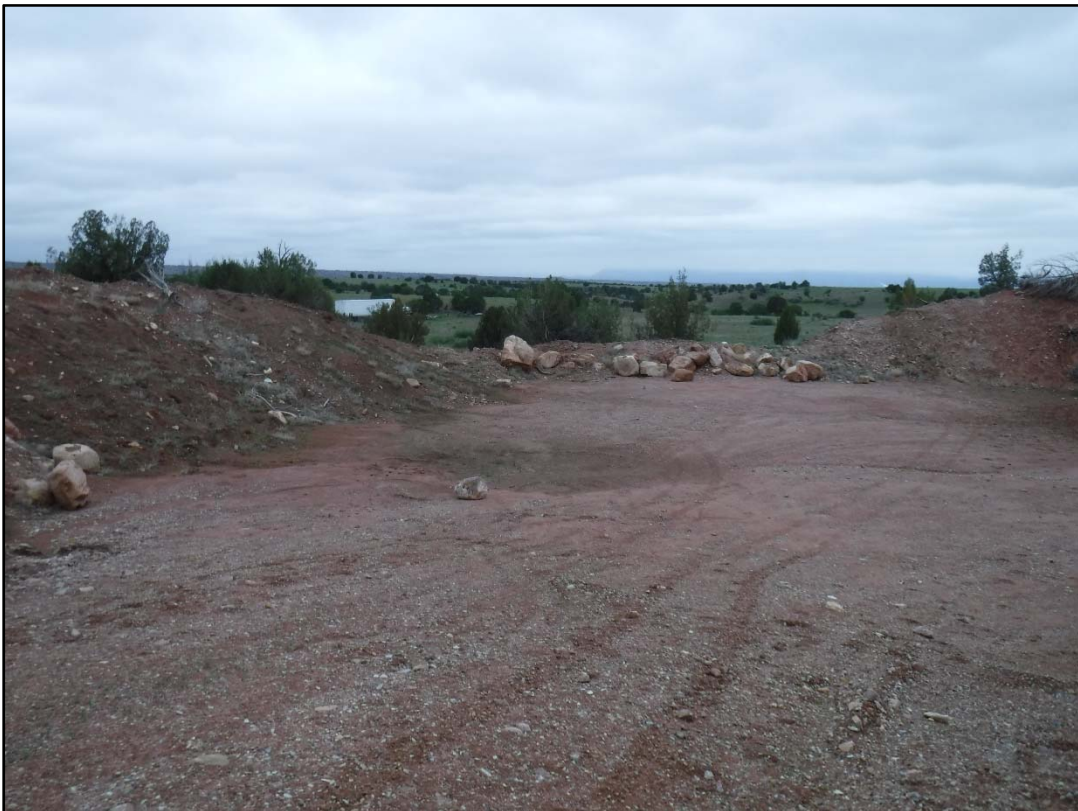
In the original permit application, the Operator agreed to keep a 150-200 foot buffer between affected land and Red Creek. During the inspection it was noted that mining had encroached to within 25 feet of the creek in the northeastern section of the currently mined area. This matter is being cited as a Problem in this report pursuant to C.R.S. 34-32.5-112 (1)(c)(VI) for failure to conduct mining as described in the mining plan.

Photo 6: Recently mined area, looking northwest, closest to Red Creek

CORRECTIVE ACTIONS: The operator will reestablish the 150-200 foot buffer along Red Creek, reclaim all affected land, and clearly identify and mark the 150-200 foot buffer zone. Proof of compliance may be in the form of detailed photographs and GPS locations.

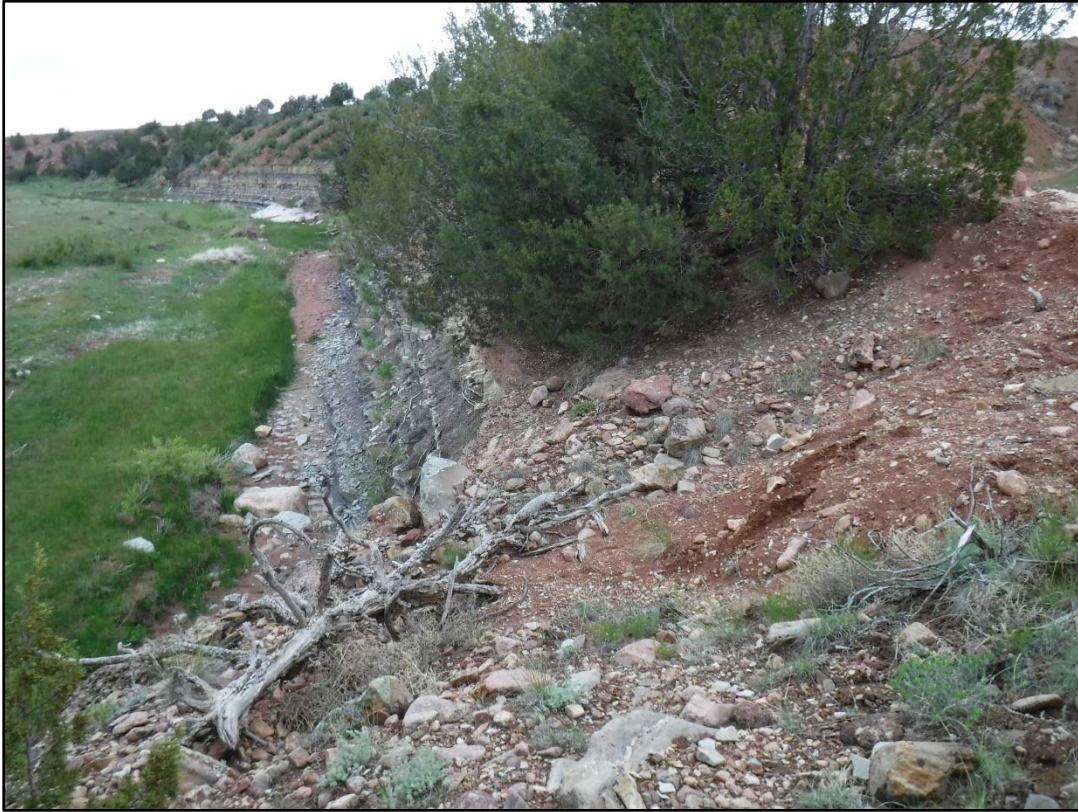
PROBLEM/POSSIBLE VIOLATION: Problem: During the inspection it was discovered that the operator allowed affected lands to come within 25 feet of Red Creek. This is a problem pursuant to C.R.S. 34-32.5-112 (1)(c)(VI) for failure to follow the approved mine plan.

Photo 7: Red Creek, left, and affected area at the right ~25 feet

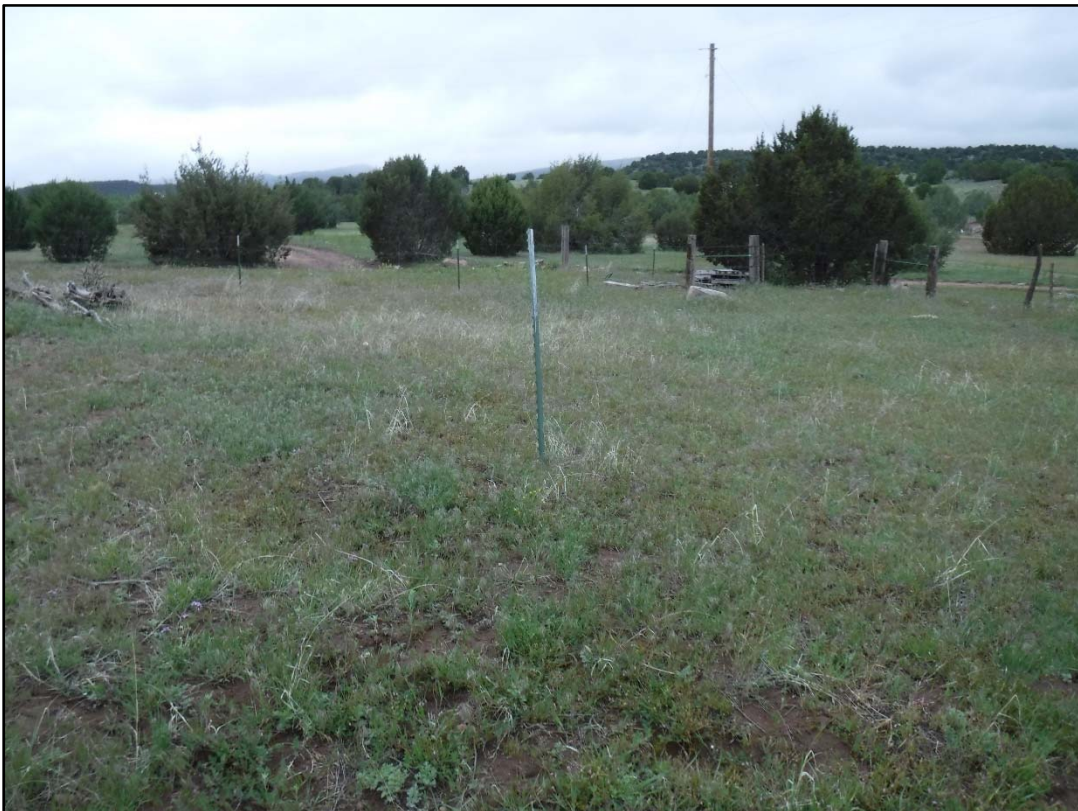
The Division was able to GPS some permit boundary markers. All current mining is within the permit boundaries.

Photo 8: Permit boundary marker.
