MINERALS PROGRAM INSPECTION REPORT
PHONE: (303) 866-3567

MINE NAME: Nahcolite Project	MINE/PROSPECTING ID#: M-1983-194	MINERAL: Carbonates	COUNTY: Rio Blanco
INSPECTION TYPE: Monitoring	INSPECTOR(S): Amy C. Yeldell	INSP. DATE: May 14, 2019	INSP. TIME: 10:00
OPERATOR: Natural Soda LLC	OPERATOR REPRESENTATIVE: Clive Beckington	TYPE OF OPERATION: 112d-3 - Designated Mining Operation	
REASON FOR INSPECTION: Normal I&E Program	BOND CALCULATION TYPE: None	BOND AMOUNT: \$4,158,340.68	
DATE OF COMPLAINT: NA	POST INSP. CONTACTS: None	JOINT INSP. AGENCY: U.S.BLM	
WEATHER: Clear	INSPECTOR'S SIGNATURE:

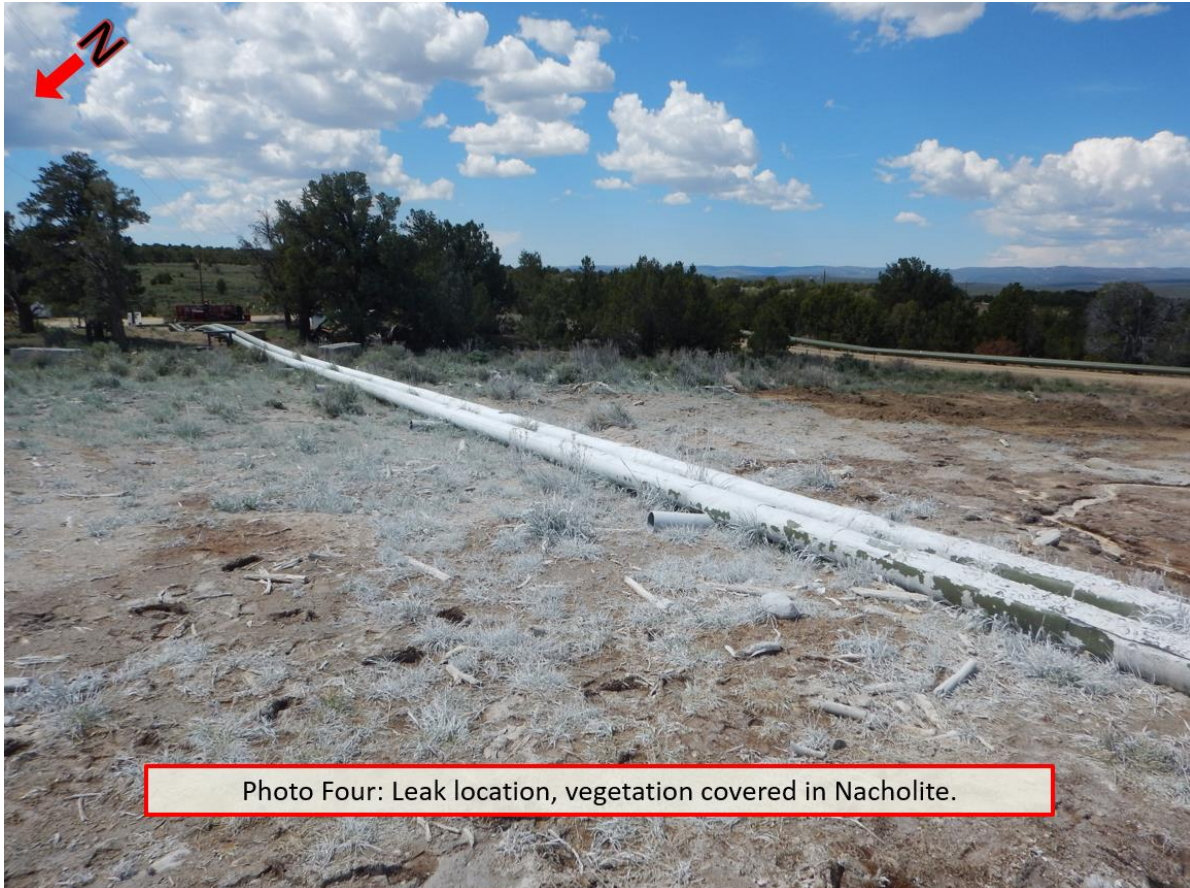
During the inspection the Division was able to observe a where the 15-16-17 wells pipeline had an undesirable event the day before (5-13-19). The Division was notified via email within 24 hours of the spill. A formal report was then submitted on May 20, 2019 (see attached). A valve on the barren liquor line developed a leak and began to spray an estimated 150 barrels of barren liquor onto the 4-3H(V) well pad. The line was isolated, repaired and brought back into service within approximately 3 hours. During the inspection the Division was able to see the areas affected by the spill. Vegetation was covered in Nacholite in approximately a 25-100 ft radius around the valve. Excess brine ran east and a dike was constructed to keep the brine within the affected areas. The brine was pumped and disposed of. Since the inspection the saturated soil has been excavated from the pad and disposed of within Pad 12's pit. Minimal remediation work remains. Specifically grading of eroded/excavated areas and soil stabilization via revegetation will be required. Please provide the Division with documentation that final remediation work has been completed as soon as practicable.

Photo Four: Leak location, vegetation covered in Nacholite.

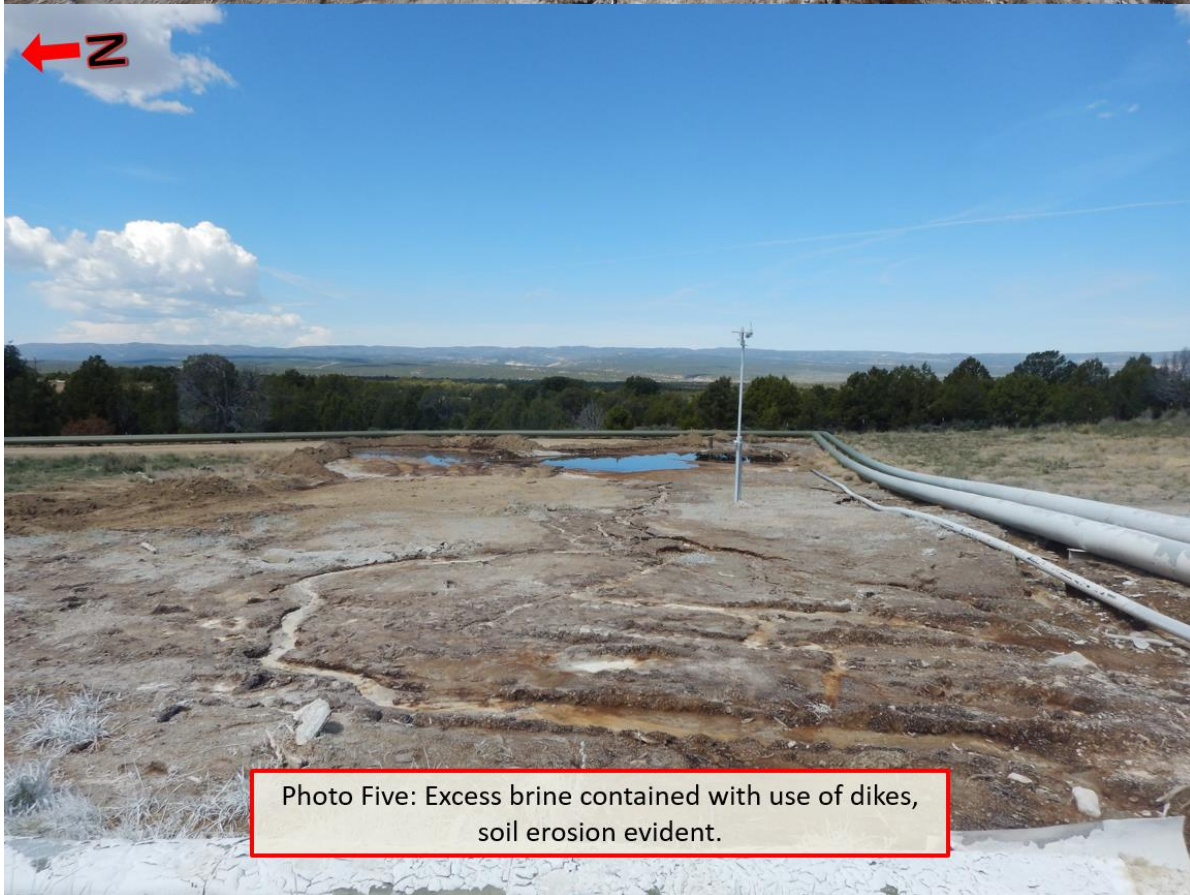
Photo Five: Excess brine contained with use of dikes, soil erosion evident.
