MINERALS PROGRAM INSPECTION REPORT
PHONE: (303) 866-3567

MINE NAME: Direzza Pit	MINE/PROSPECTING ID#: M-1984-028	MINERAL: Sand and gravel	COUNTY: Bent
INSPECTION TYPE: Monitoring	INSPECTOR(S): Amy Eschberger	INSP. DATE: March 8, 2019	INSP. TIME: 09:30
OPERATOR: Direzza Limited Family Partnership	OPERATOR REPRESENTATIVE: Dave DiRezza, Dan DiRezza	TYPE OF OPERATION: 110c - Construction Limited Impact	
REASON FOR INSPECTION: Normal I&E Program	BOND CALCULATION TYPE: Complete Bond	BOND AMOUNT: \$5,500.00	
DATE OF COMPLAINT: NA	POST INSP. CONTACTS: None	JOINT INSP. AGENCY: None	
WEATHER: Clear	INSPECTOR'S SIGNATURE:

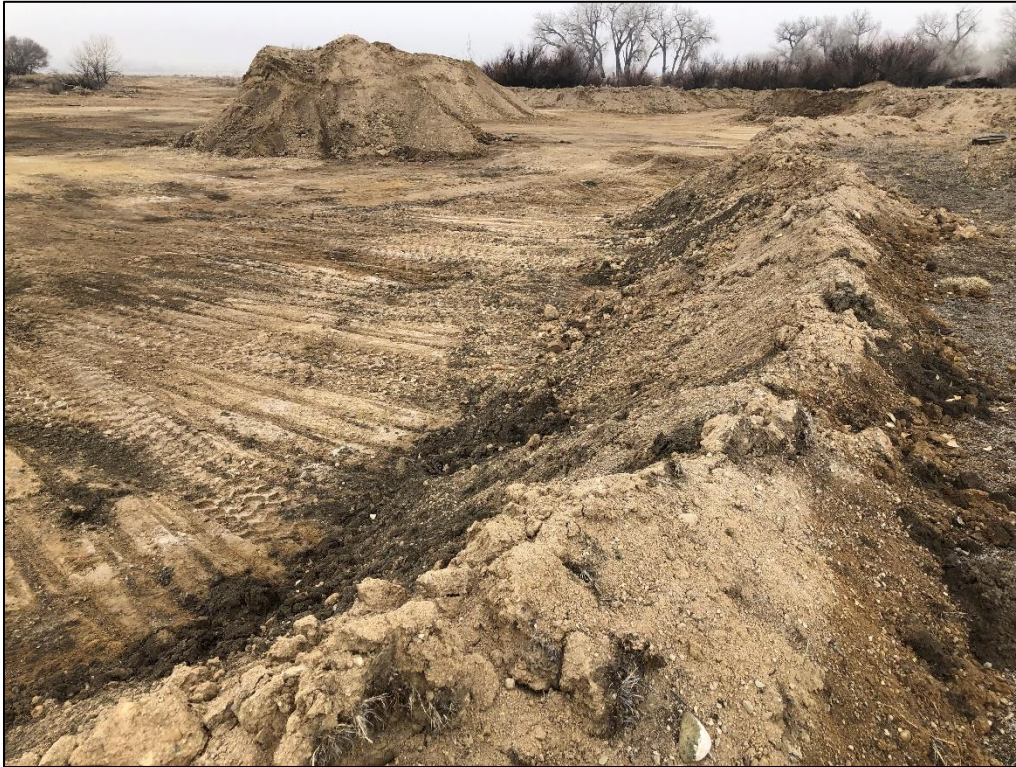
Photo 1. View looking northwest across active pit located in southwestern portion of permit area. Pit walls are no more than 5 feet in height with 1H:1V slopes.

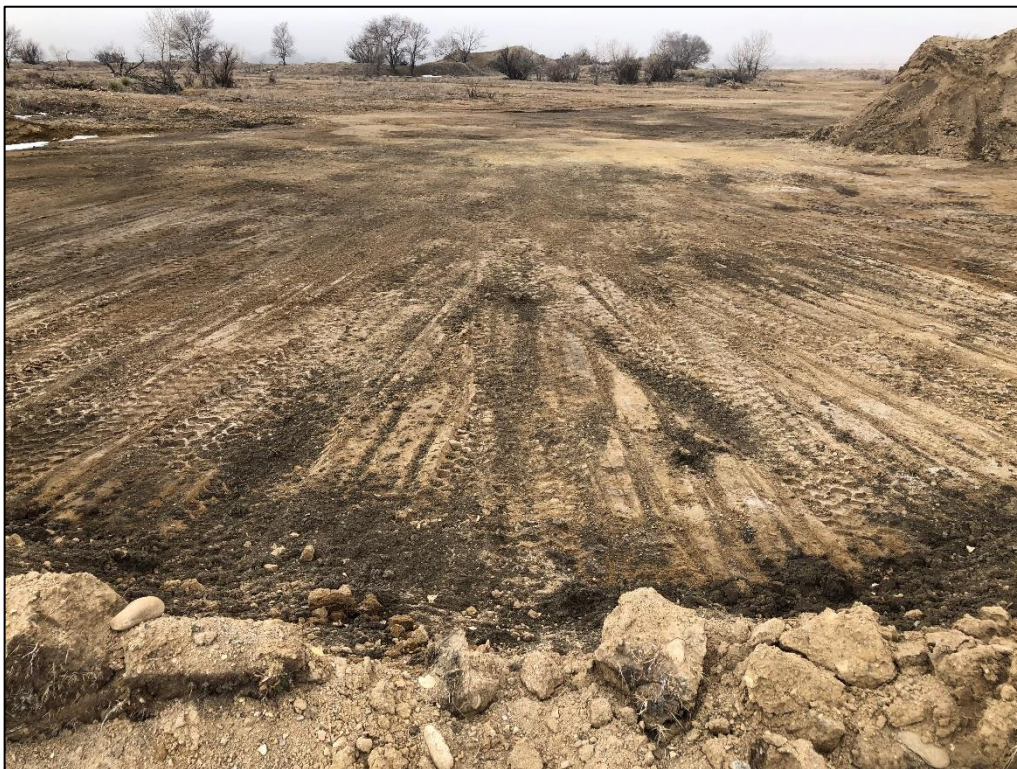
Photo 2. View looking west across active pit located in southwestern portion of permit area. Pit walls are no more than 5 feet in height with 1H:1V slopes.

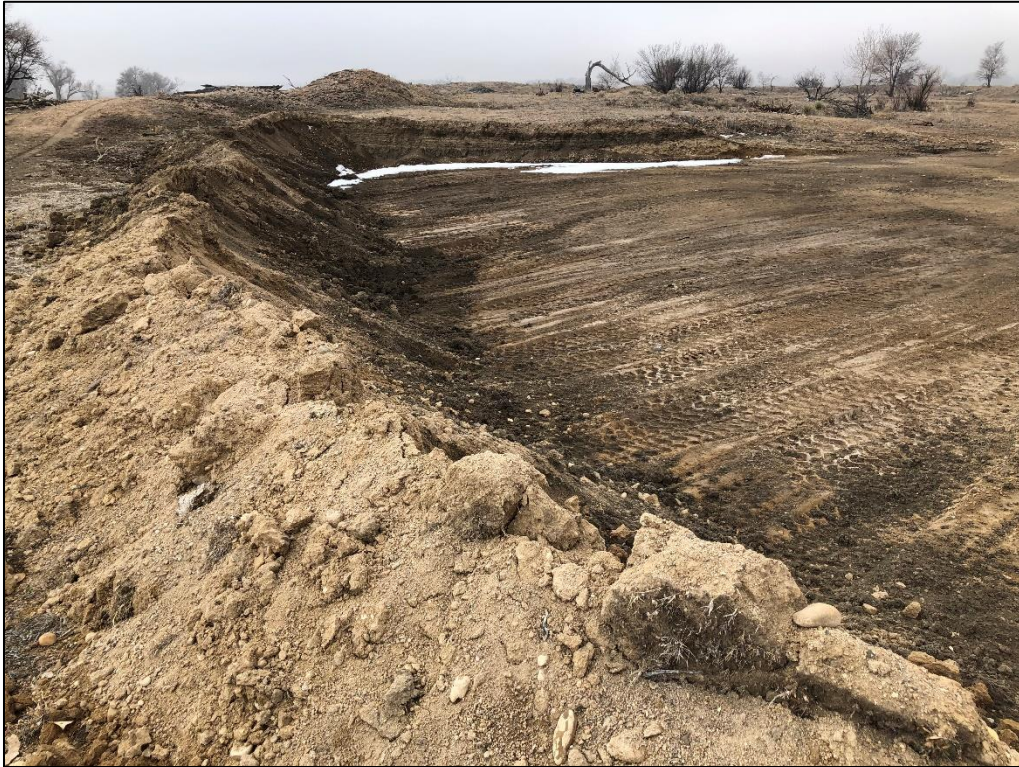
Photo 3. View looking southwest across active pit located in southwestern portion of permit area. Pit walls are no more than 5 feet in height with 1H:1V slopes.

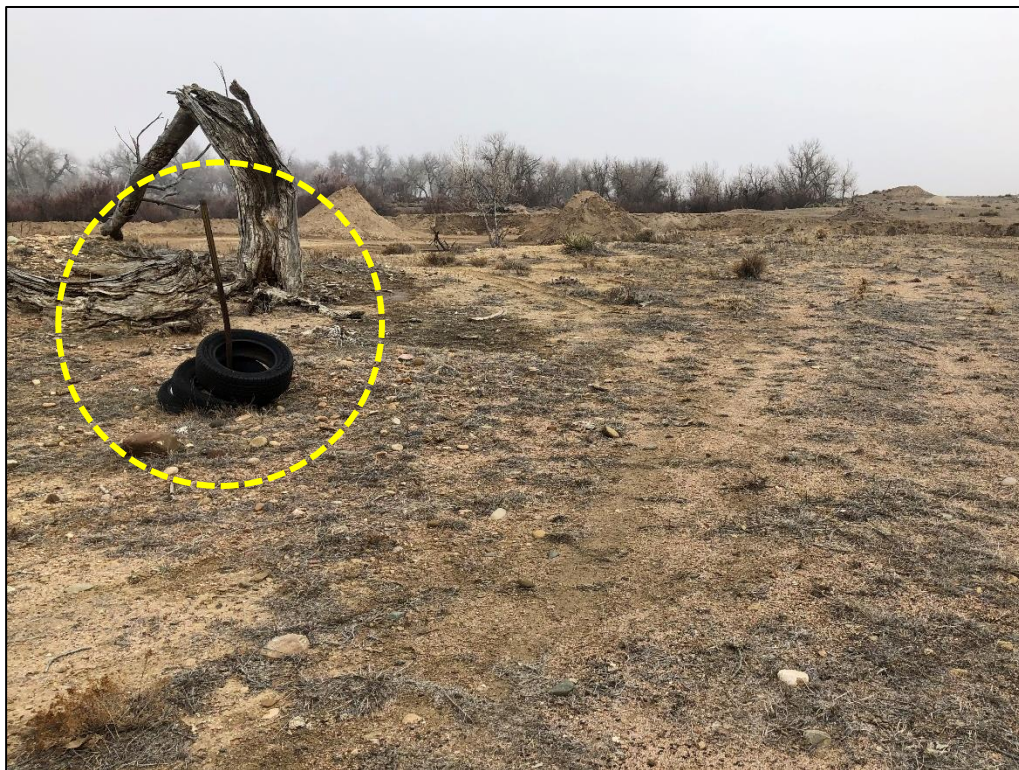
Photo 4. View looking northwest, showing southeastern permit boundary corner marked by t-post with tires around it (circled).

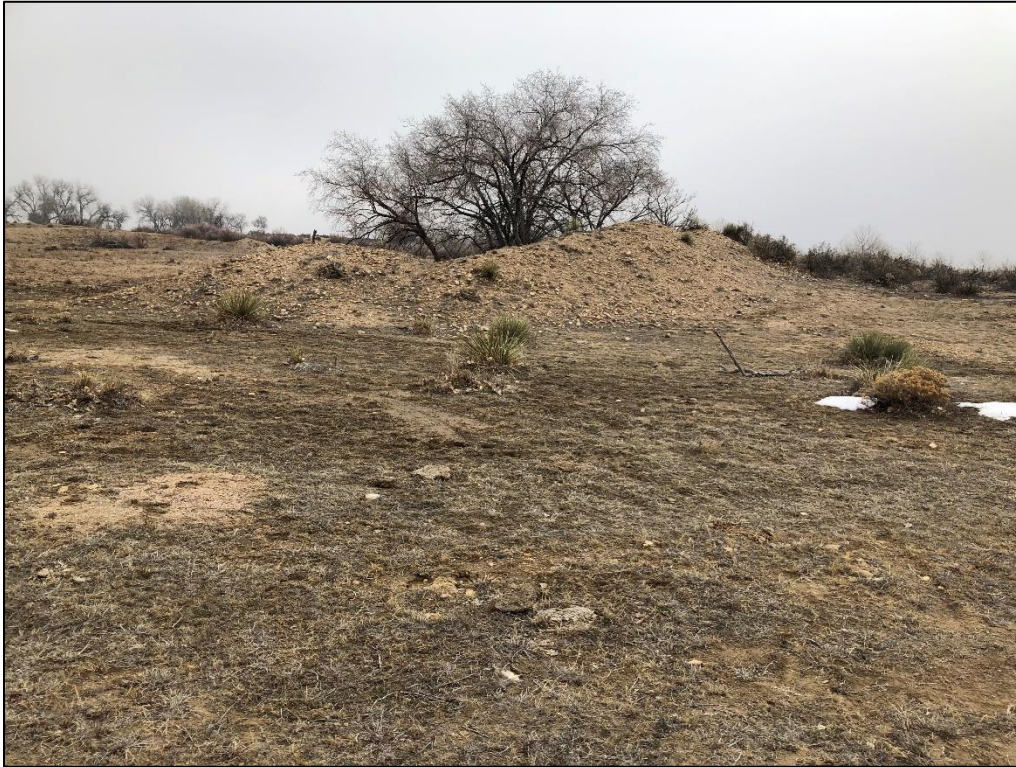
Photo 5. View looking east across permit area from its western boundary, showing one of several old waste rock stockpiles scattered across the permit area.

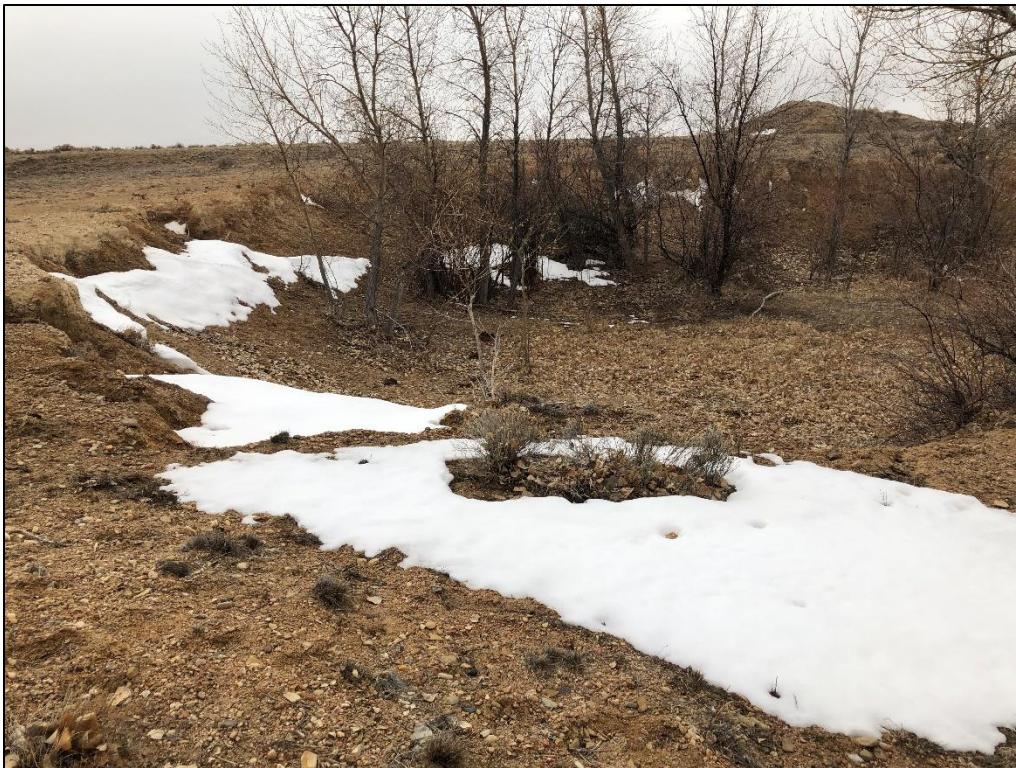
Several small stockpiles of waste rock and product are scattered across the mine site, left by pre-law mining activities. Portions of two old pits are included within the northern half of the permit area. The pit walls in these areas have slopes ranging from 1H:1V to 3H:1V, but appeared to be stable with good grass cover. As mentioned previously, the operator is not required to reclaim the steeper slopes of these old pits as long as they are not redisturbed. A topsoil stockpile is stored at the northeastern corner of the permit area, and has good grass cover. Overall, the site appeared to be stable with volunteer grasses, forbs, shrubs, and mature trees growing across the site. No significant erosion problems were observed.

Photo 6. View looking across pre-law excavation present in northern half of permit area. Note pit slopes steeper than 3H:1V but appear to be stable with some grass cover.

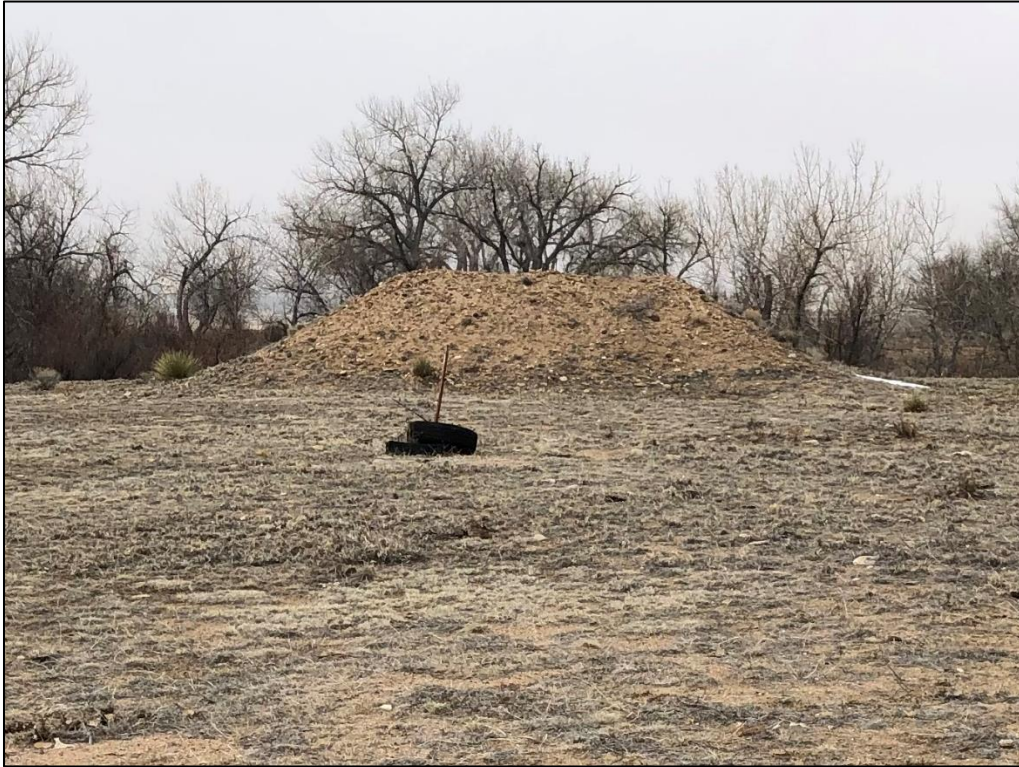
Photo 7. View looking west at topsoil stockpile stored at northeastern corner of permit area. Note t-post with tires around it marking northeastern permit boundary corner.

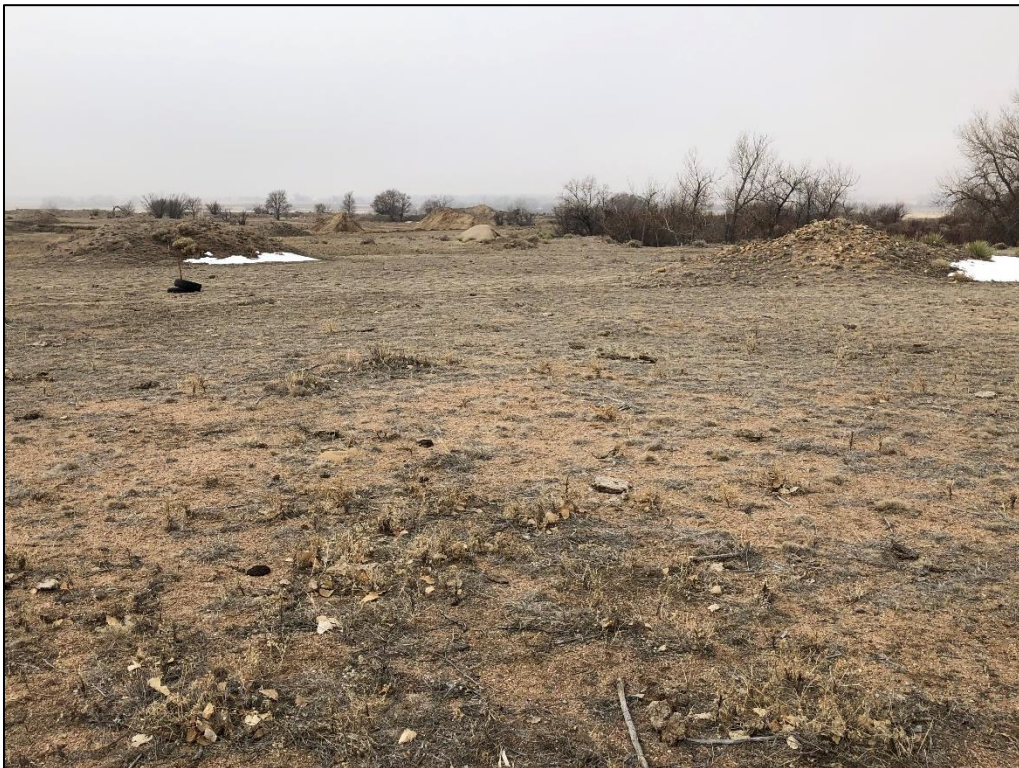
Photo 8. View looking southwest across eastern portion of permit area, showing a few of the old waste rock stockpiles (in background) scattered across the permit area.
