## Bureau of Land Management Colorado River Valley Field Office Minerals Inspection Report

General Information	
<b>Date</b>	5/23/2019
<b>Project Name</b>	Rifle Quarry
<b>Operator</b>	Colorado Lien Company
<b>Serial Number</b>	COC-077876
<b>Project Classification</b>	Plan of Operations
<b>Project Location</b>	T4S R92W Sec15, Garfield County
<b>Inspection Purpose</b>	Reclamation site inspection
<b>Time Period Onsite</b>	1 hour
<b>Attendees</b>	Jessica Lopez Pearce, BLM Geologist (report author)
	Carla DeYoung, BLM Ecologist

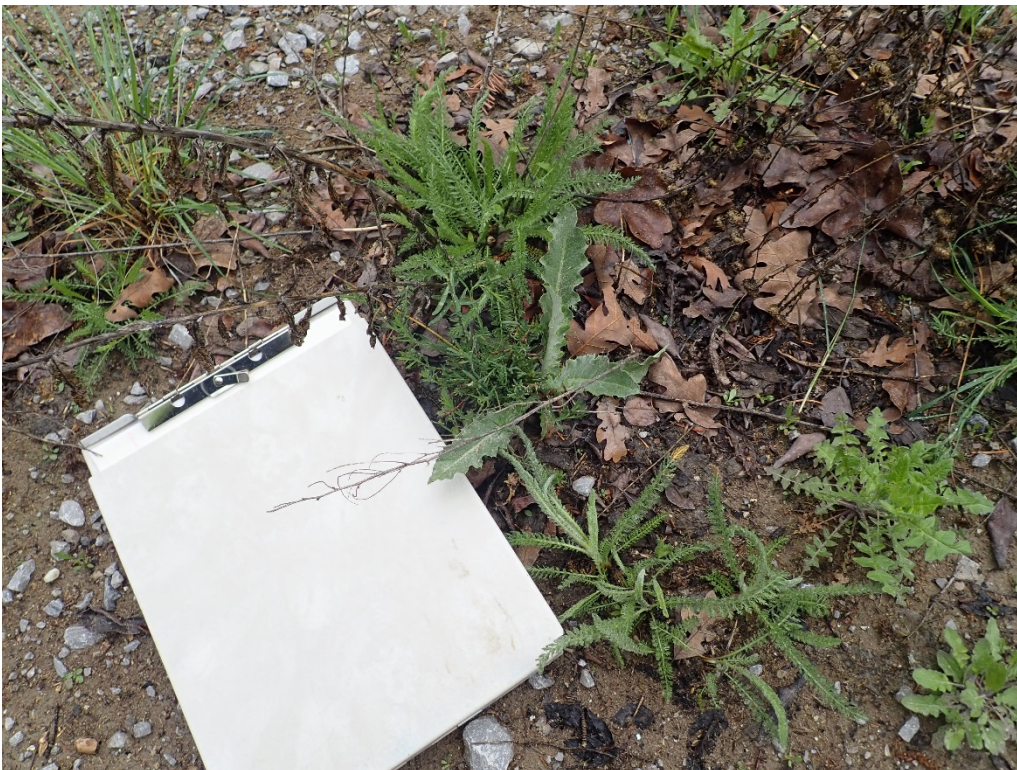
I observed the access road blocked per the Final Reclamation Plan. There was evidence of approved alternative growth media and mulching material (a combination of fish emulsion solids, spent grain solids, spent potato mash solids, mulch, and topsoil) on the surface of the road; however, it appeared to be dried out and washed away in some areas, exposing bare rock and mineral soil. There was significantly more vegetation along the sides and down the middle of the old road than in the wheel ruts. Thistle and mullein were observed growing on the access road. Signage was present at the southeast corner of the main quarry area.

Photo 1: Grasses, forbs, and Scotch thistle were observed growing in the middle and along the sides of the access road, but there was very little vegetation success within the wheel ruts. Clipboard for scale.

- BLM requires Pete Lien and Sons to perform noxious weed removal within the Rifle Quarry. In order to conduct weed spraying activities on public lands, Pete Lien and Sons will need to submit a Pesticide Use Proposal to the CRVFO. Please contact Kristy Wallner, CRVFO Weeds Coordinator, at 970-876-9023 or [kwallner@blm.gov](mailto:kwallner@blm.gov) to learn the process of submitting and receiving approval for your PUP. Processing time for a PUP may take approximately 60 days. Alternatively, Pete Lien and Sons may consider manual removal of these weeds as this would not require a PUP and at this point there were no large infestations. Within 30 days of receipt of this report, Pete Lien and Sons must either initiate the PUP process or conduct manual weed removal.

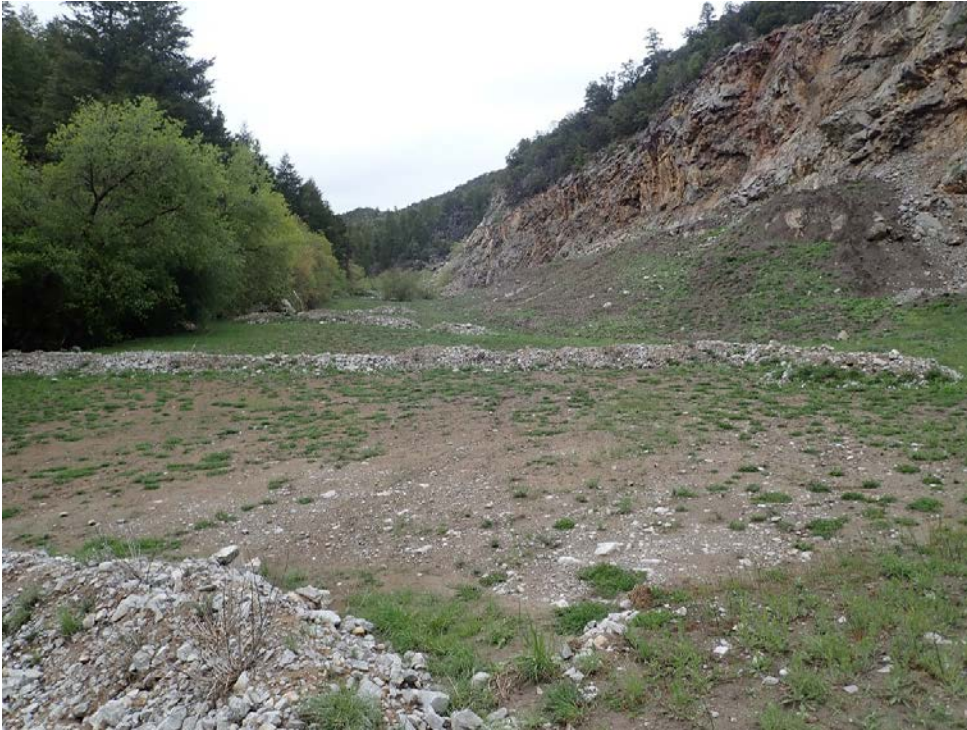
Photo 2: Looking west to the quarry floor. The heavy winter precipitation has helped revegetation efforts.

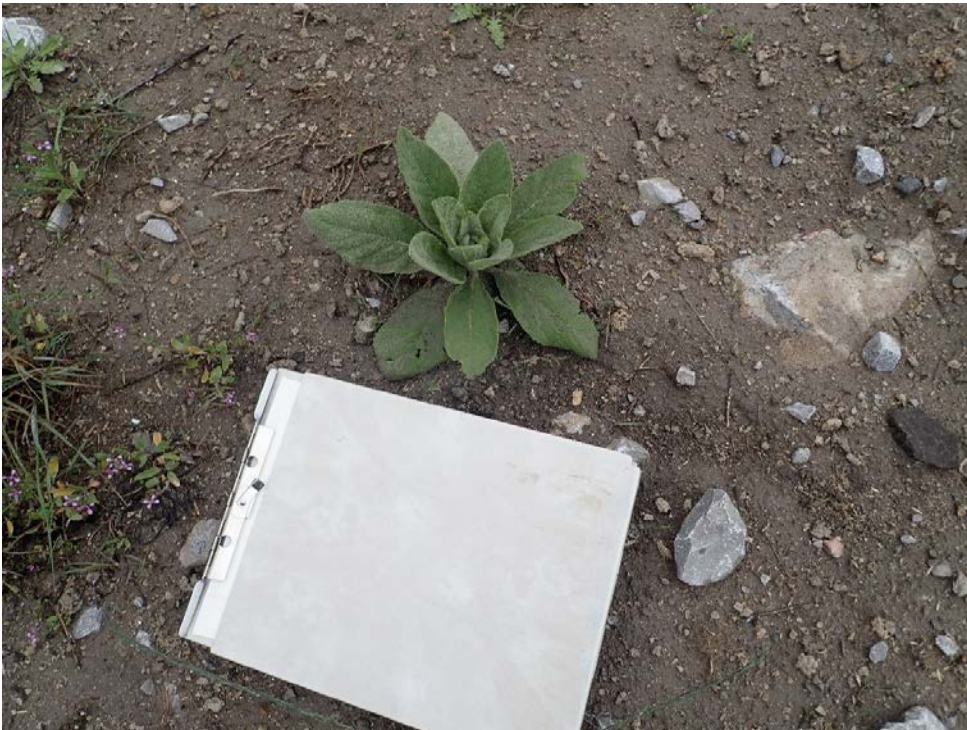
Photo 3: Mullein was observed growing on the quarry floor. Clipboard for scale.

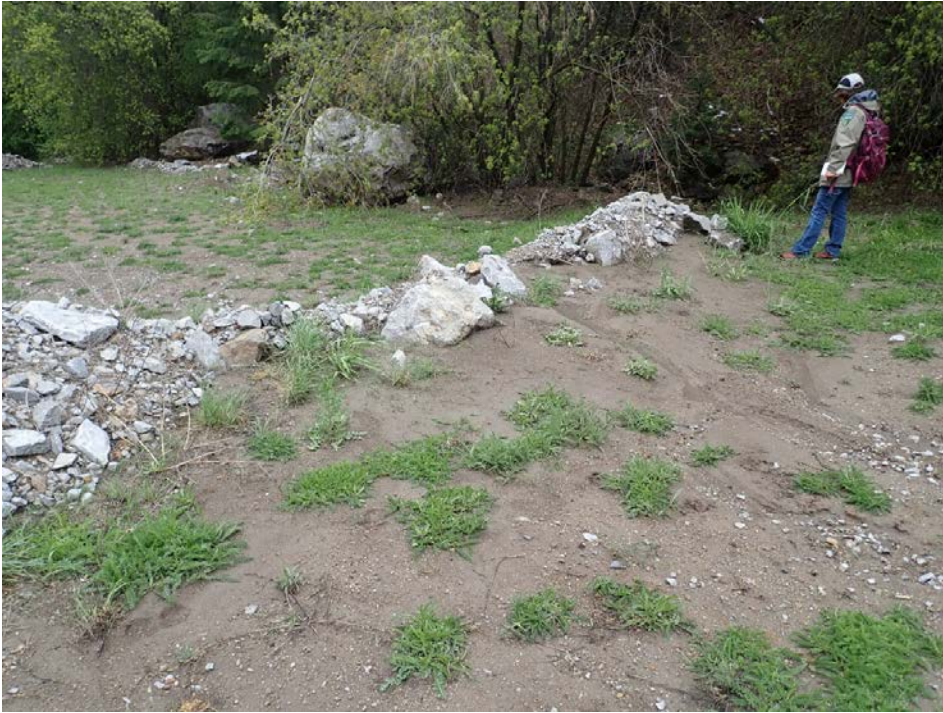
There were several 24" tall sediment control windrows running perpendicular to the west-to-east gradient on the quarry floor. These windrows were fairly effective at trapping sediment and eroded growth media. The vegetation on the quarry floor also appeared to prevent erosion. There was evidence of gullying and erosion of material in channels on the quarry floor. The channelization and erosion wasn't extensive, but additional erosion could occur if measures are not taken. The westernmost sediment berm was near failure. The operator

must ensure adequate sediment control within the site. Future inspections will continue to monitor effectiveness of sediment control.

Photo 4: Looking south to the westernmost stormwater berm. The berm showed evidence of having been overtopped recently. Additionally, sediment is accumulating upstream from the berm. This berm is in need of maintenance.

- Within 30 days of receipt, Pete Lien and Sons must take steps to prevent erosion and ensure adequate sediment control and soil stability within Rifle Quarry.

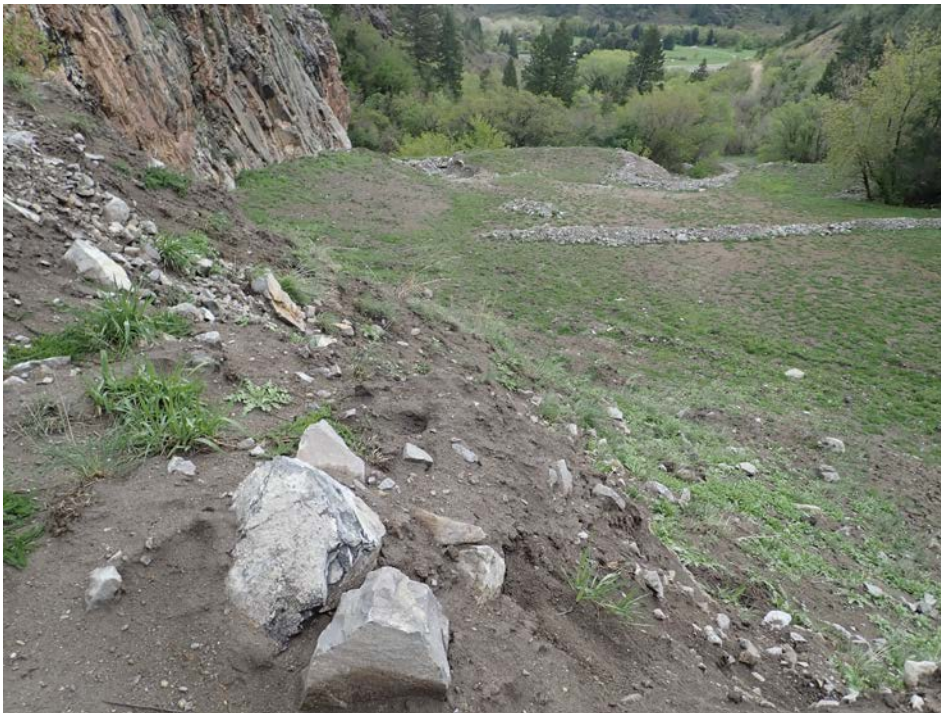
Photo 5: Looking southeast from the upper bench on the north side of the quarry. Two years ago, the grasses were abundant and green on the slope between the upper bench and lower bench. Some grasses are sprouting this year.

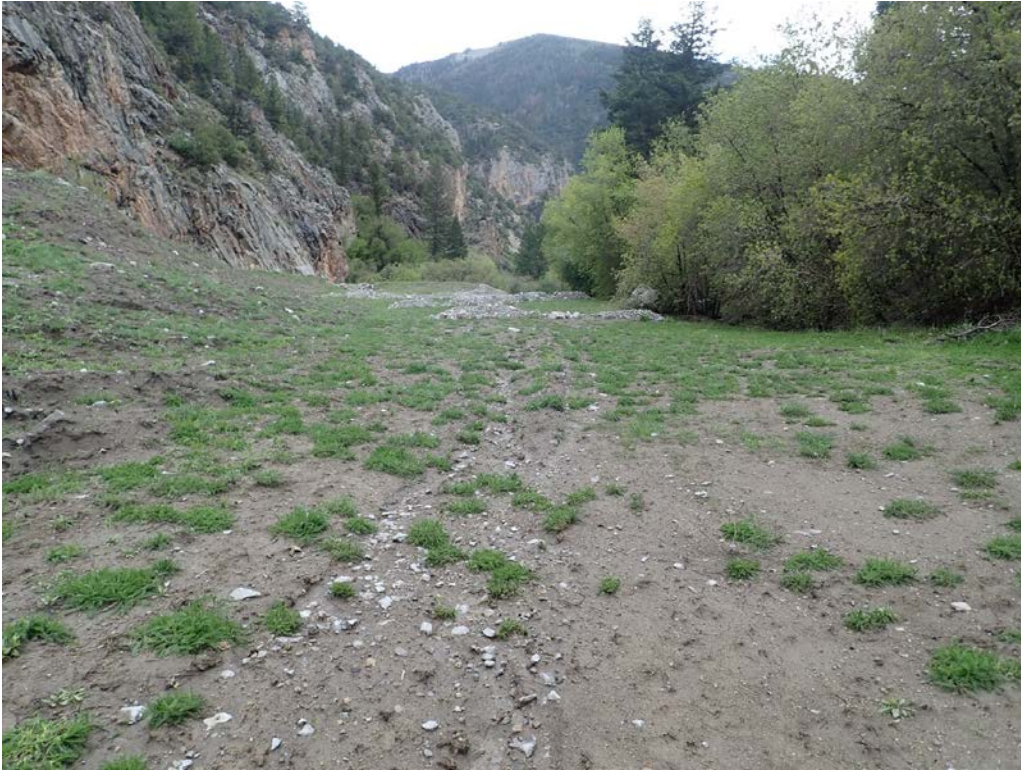
Photo 6: Looking east from the western end of the quarry floor. Gullying and erosion are beginning on this end of the site.
