## **PERMIT INFORMATION**

Permit Number: C-1996-084 Mine Name: Lorencito Canyon Mine Operator: New Elk Coal Company, LLC Operator Address: Mr. Louis Head 12250 Highway 12 Weston, CO 81091	County: Las Animas Operation Type: Surface Permit Status: Permanent Cessation Ownership: Private  Operator Representative Present:
Weston, CO 81091	Nick Mason, Vince Massarotti
Operator Representative Signature: (Field Issuance Only)	
INSPECTION INFORMATION	
Inspection Start Date: May 29, 2019 Inspection Start Time: 07:00 Inspection End Date: May 29, 2019	Inspection Type: Coal Partial Inspection Inspection Reason: Normal I&E Program Weather: Cloudy

Inspection End Date: May 29, 2019
Inspection End Time: 09:00

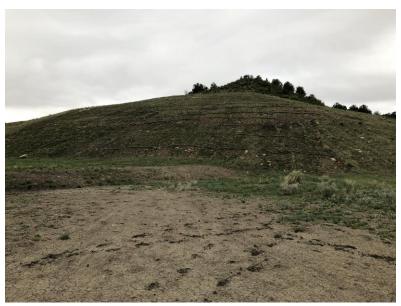
Further treatment of rills is recommended on the hillside above Pond 6. The hillside above the pond cleaning dump area is healing well, however the dump area itself has a significant amount of area that is devoid of vegetation.

Area where pond cleanings are dumped

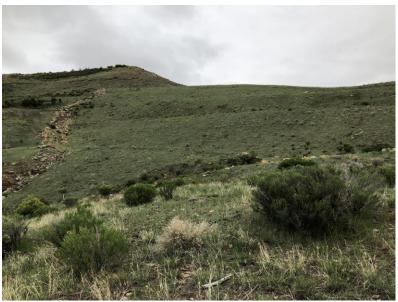
Fill 8

Fills 7, 8, and 9 were inspected. No large rills or gullies were seen. The vegetation on all three fills looks very good.

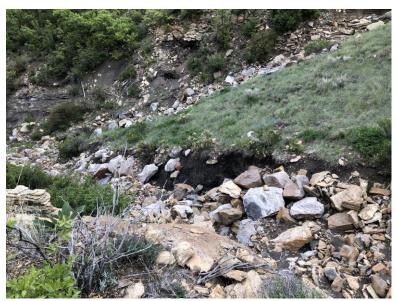
No problems were found with ditches. Ditch D84 appears to remain stable. Ditch D3 was examined closely, and the channel contained significant vegetation and no erosion.

Ditch D84 below Fill 8

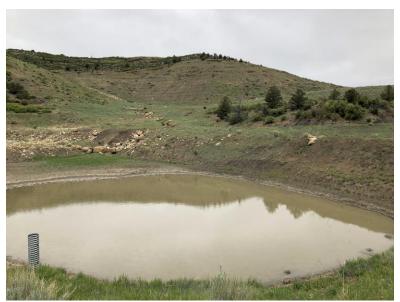
All ponds were inspected: 5, 6, 7, 8, 9, and 9a. Pond 6 contained significant water. The others were nearly dry or dry. None of them were discharging. No problems were identified with embankments, spillways, or other features of the ponds.

Pond 6 and watershed above it

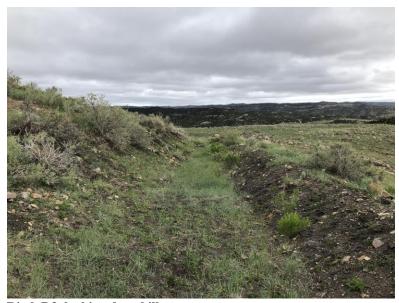
Ditch D3, looking downhill
