PERMIT INFORMATION

Permit Number: C-1981-012 Mine Name: New Elk Mine Operator: New Elk Coal Company, LLC Operator Address: Mr. Louis Head 12250 Highway 12 Weston, CO 81091	County: Las Animas Operation Type: Underground Permit Status: Active Ownership: Private
	Operator Representative Present: Nick Mason and Vince Massarotti (Jansen only)
Operator Representative Signature: (Field Issuance Only)

Inspection Start Date: May 28, 2019 Inspection Start Time: 11:00 Inspection End Date: May 29, 2019 Inspection End Time: 09:45		Inspection Type: Coal Complete Inspection Inspection Reason: Normal I&E Program Weather: Windy	
Joint Inspection Agency: None		Joint Inspection Contacts: 	
Post Inspection Agency: None		Post Inspection Contacts: 	
Inspector(s): Robert D. Zuber, P.E.	Inspector's Signature:

A complete inspection was conducted by Rob Zuber of DRMS on May 28 and 29, 2019. The inspection on the 29th entailed the Jansen Loadout only. The weather was windy and warm, and the ground was dry.

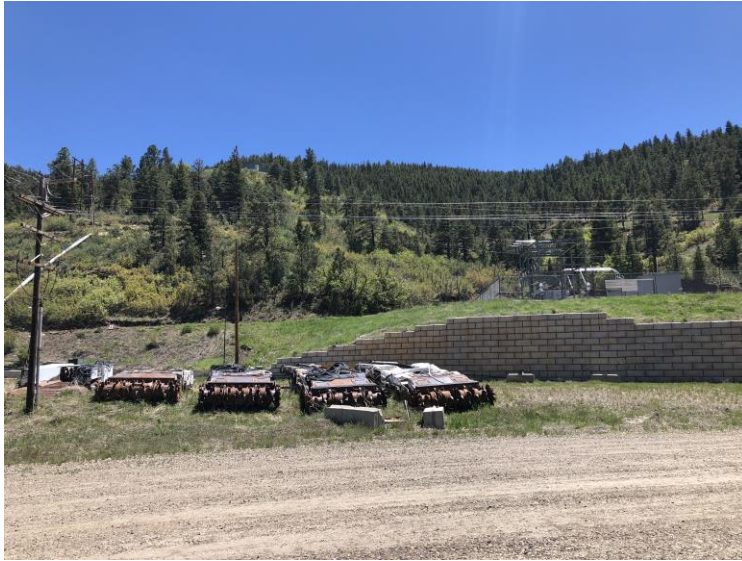
- The hill below the water tanks was observed, and no erosion or other problems were seen.
- No erosion was seen around the East Portal or East Portal substation.
- The retaining wall by the Bates Portals appears stable.
- No leaks or other problems were seen at any of the equipment storage areas.

Hill below water tanks, East Portal substation, and equipment storage next to office

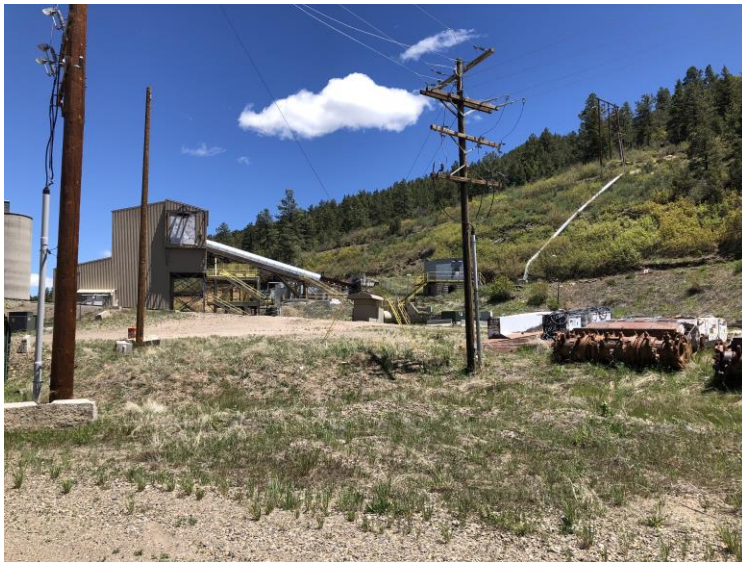
East Portal

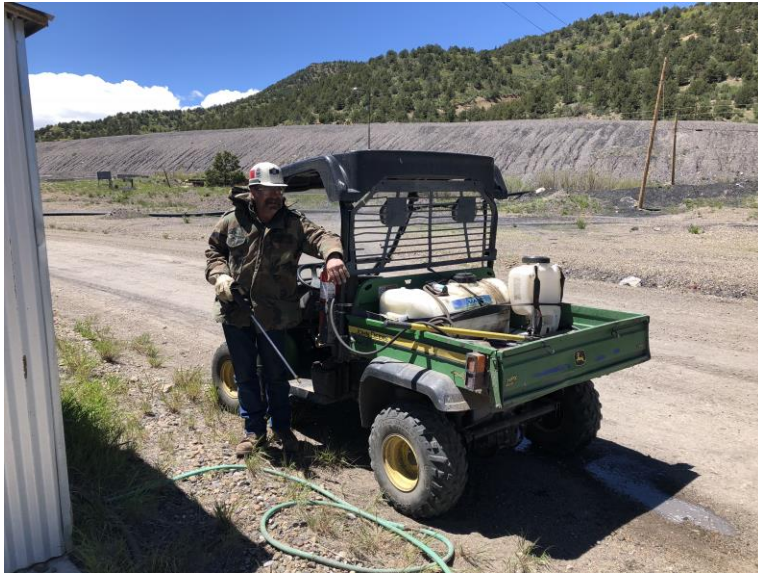
Due to significant precipitation in recent weeks, the vegetation on reclaimed areas was robust. This includes the West Portal area, the lower portion of the RDA, and the Development Waste Pile. The majority of this vegetation appeared to be desirable species, however NECC appears to be pro-active in controlling weeds. On the day of the inspection of the main mine site, Bill Massarotti was seen preparing his equipment to spray weeds around the site.

Bill Massarotti and spraying equipment

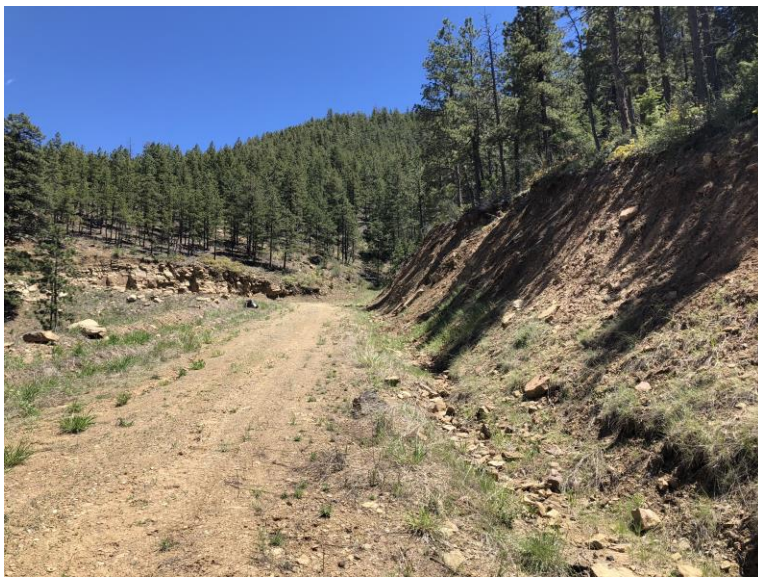
No problems were seen with any roads, including the road to the RDA and the road to the water tanks.

Road to water tanks

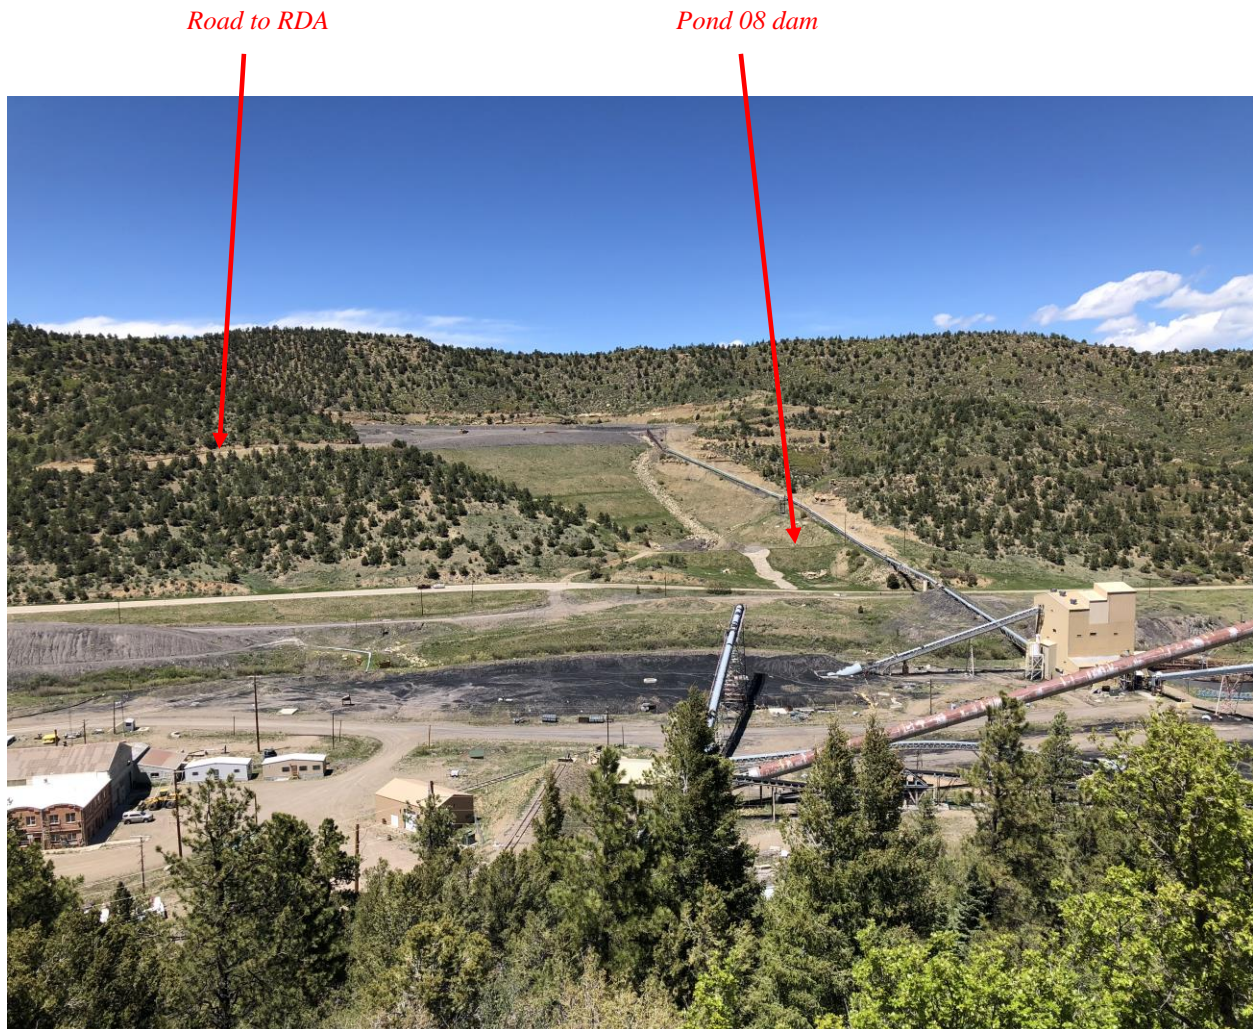
View of RDA and facilities from water tanks

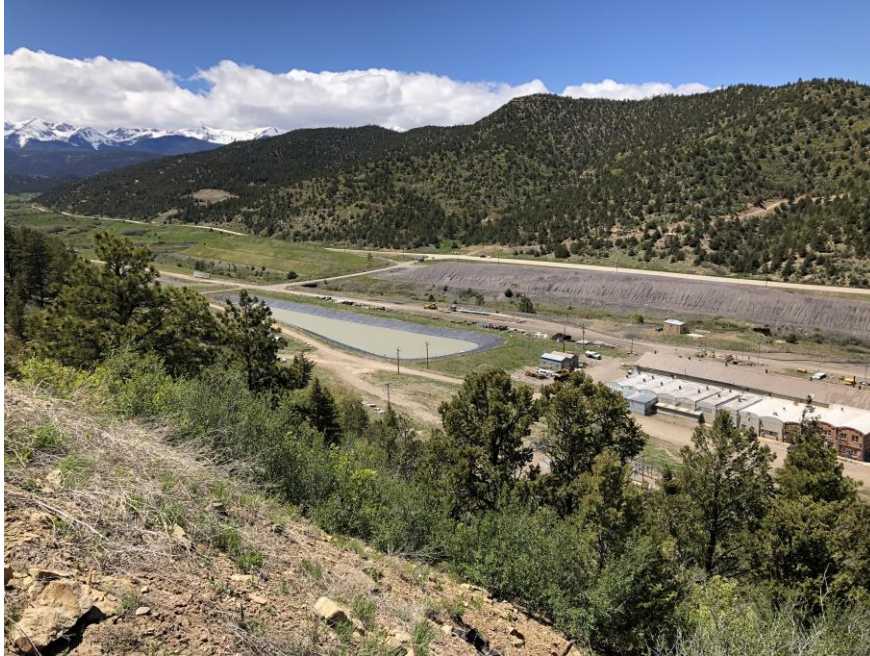
View of Pond 001A and waste piles from water tanks

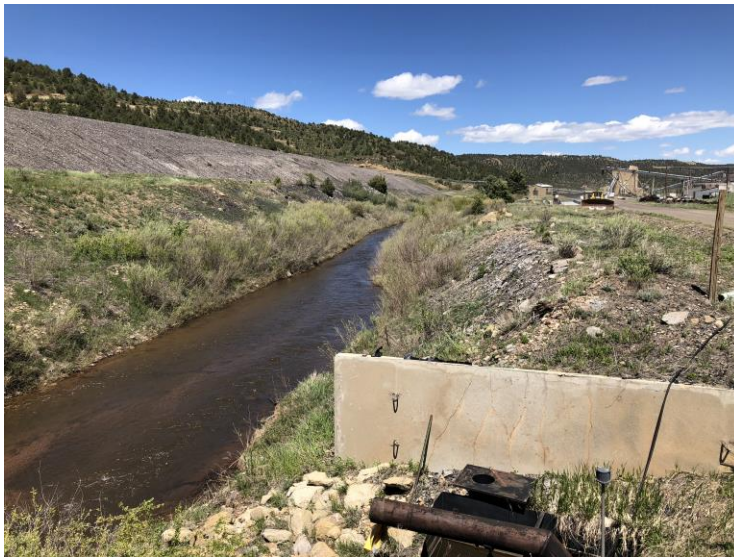
The Middle Fork of the Purgatoire River was inspected, and no eroding banks or signs of pollutant loading from the New Elk Mine were seen. Particular reaches that were inspected include the reach next to DWDA#2, near the entrance road, and beside Ponds 006A and 007A.

Middle Fork of Purgatoire River, with Pond 001A discharge structure in foreground

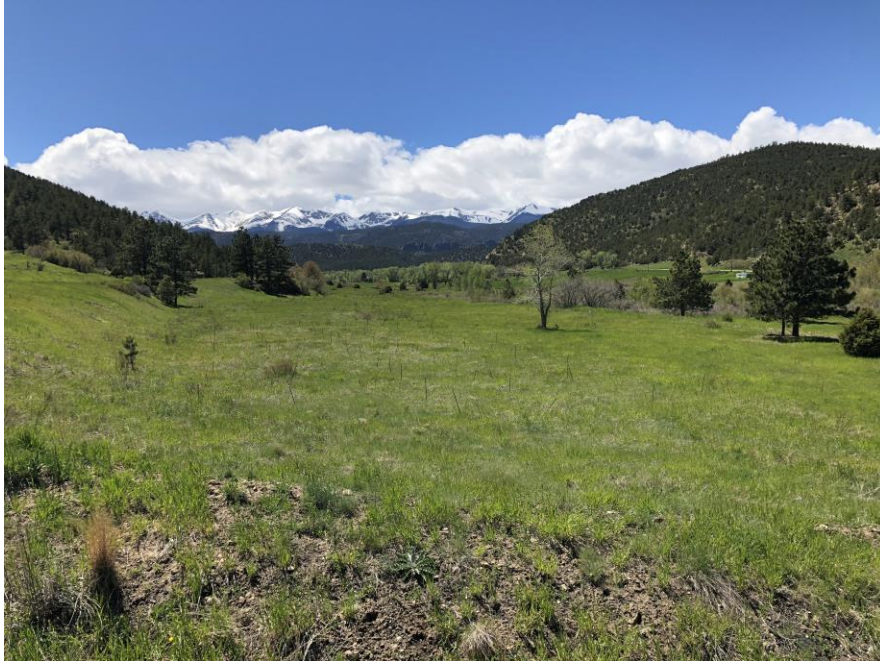
West Portal area, taken from Containment Area #2

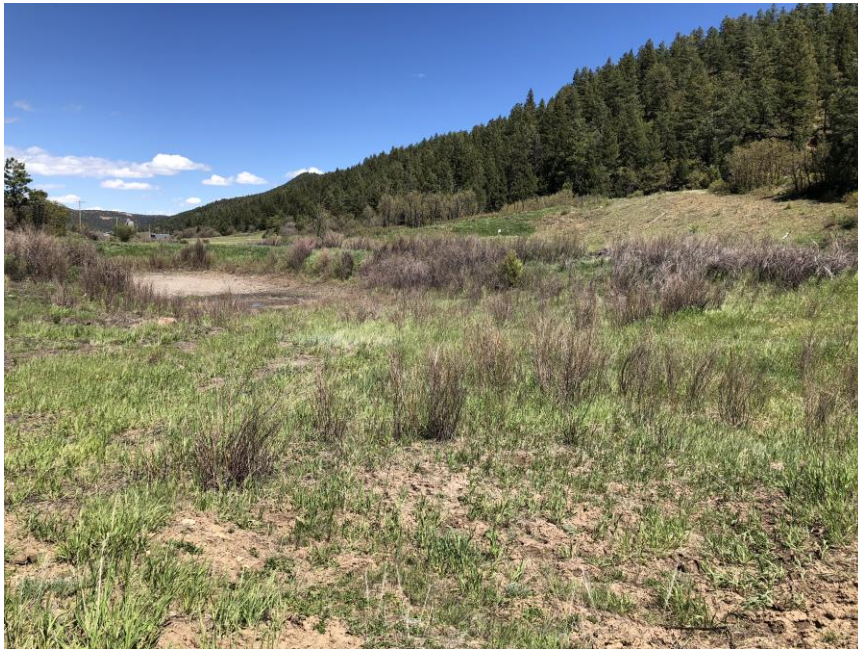
Containment Areas 1 and 2 were mostly dry; no problems were observed at these structures.

Containment Area #1

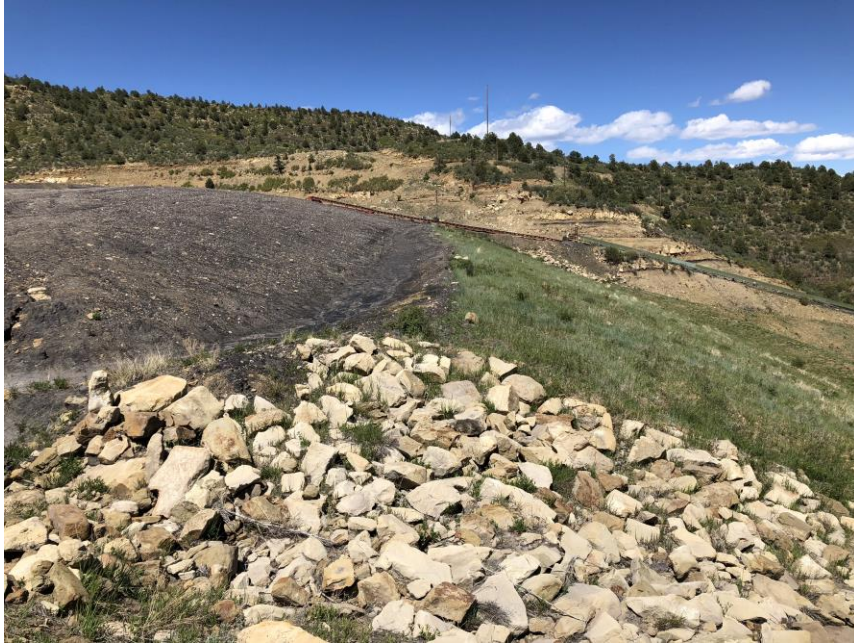
No erosion was seen on the reclaimed portion of the RDA, as viewed from beside the RDA and from the pond below. The ditches above and beside the reclaimed area are in good shape.

RDA with reclaimed portion (lower portion) to the right

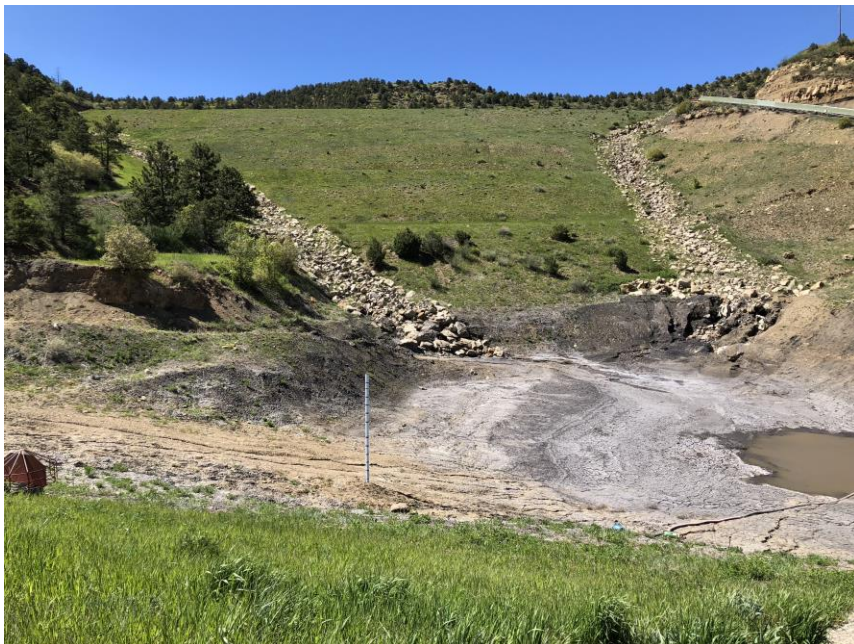
No problems were seen with the upper portion of the RDA, which still requires reclamation. Piles of material (namely sediment from ponds) have been placed in rows to limit ponding of water after rain or snow melt events.

RDA and portion of Pond 08

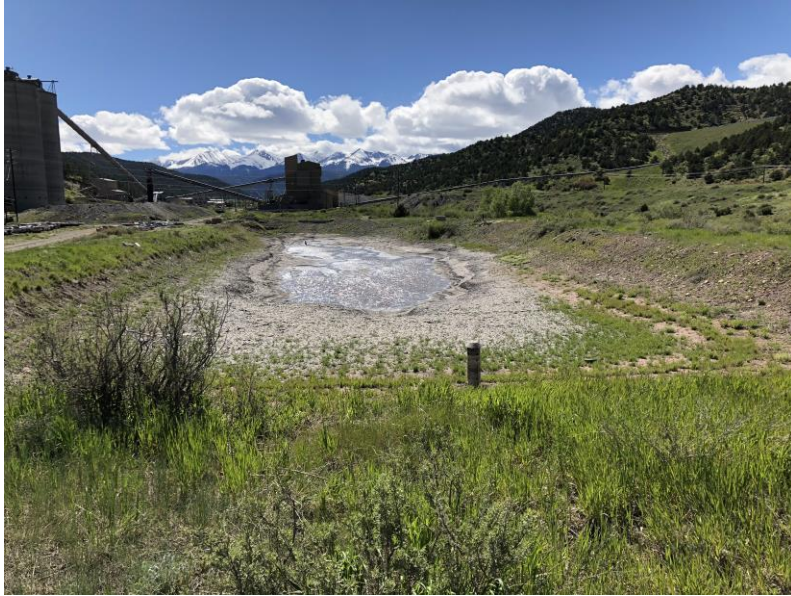
Pond 007A

Within the SAE by Pond 007A, BMPs appear to be functioning, and there was no discharge from this outfall. The SAE at the water tank pad appears to be in good shape, and BMPs appear to be functioning.

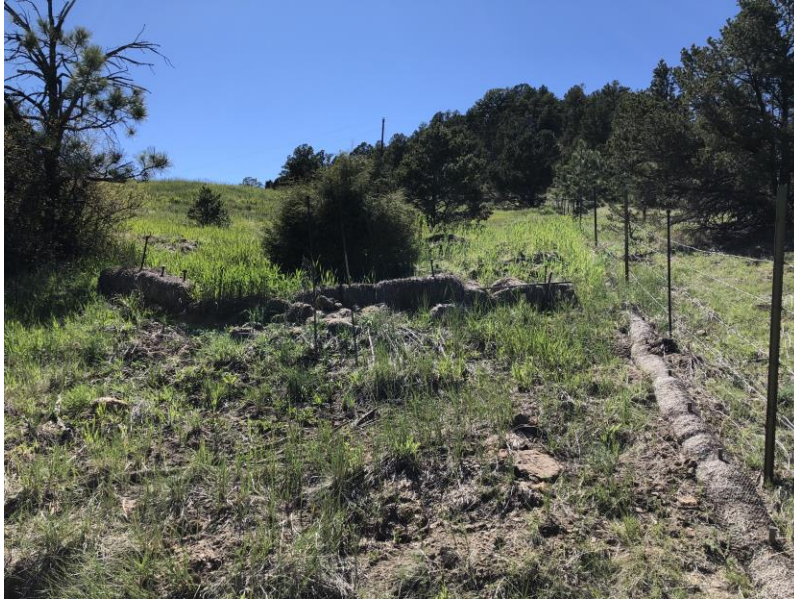
At the Northwest Fan (former Golden Eagle site), the reclamation of the pad and the areas around the pad remain in good shape. The BMPs addressing the erosion from the adjacent property (wattles and straw bales) are mostly functioning well. There is a small amount of erosion below the bales, but NECC staff have placed branches in the rills, and it is not a problem at this time.

Sediment BMPs at former Golden Eagle site

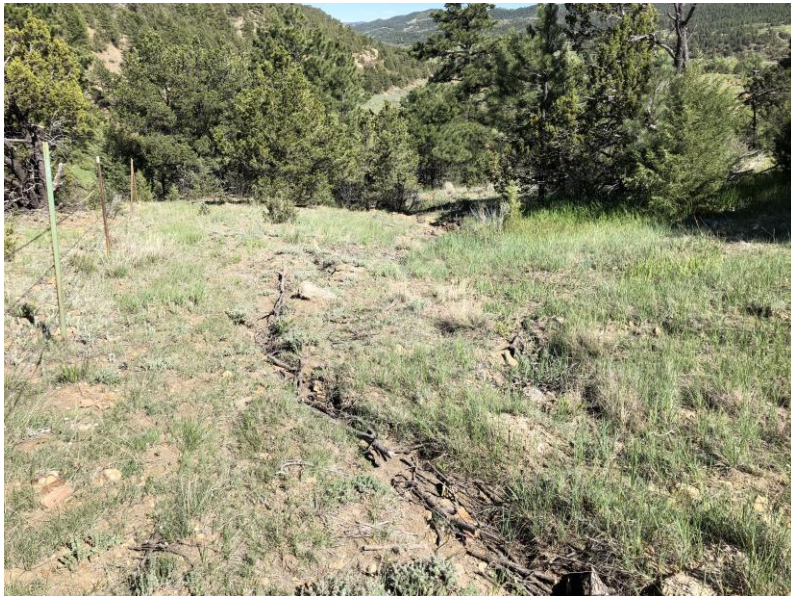
Minor erosion and branches below sediment BMPs at former Golden Eagle site
