PERMIT INFORMATION

Permit Number: C-1981-028 Mine Name: Keenesburg Strip Mine Operator: Coors Energy Company Operator Address: Mr. Danny Kipp P.O Box 467 Golden , CO 80402	County: Weld Operation Type: Surface Permit Status: Active Ownership: Private
	Operator Representative Present: None
Operator Representative Signature: (Field Issuance Only)

Inspection Start Date: December 27, 2018 Inspection Start Time: 09:30 Inspection End Date: December 27, 2018 Inspection End Time: 10:30		Inspection Type: Coal Partial Inspection Inspection Reason: Normal I&E Program Weather: Clear	
Joint Inspection Agency: None		Joint Inspection Contacts: 	
Post Inspection Agency: None		Post Inspection Contacts: 	
Inspector(s): Robert D. Zuber, P.E.	Inspector's Signature:

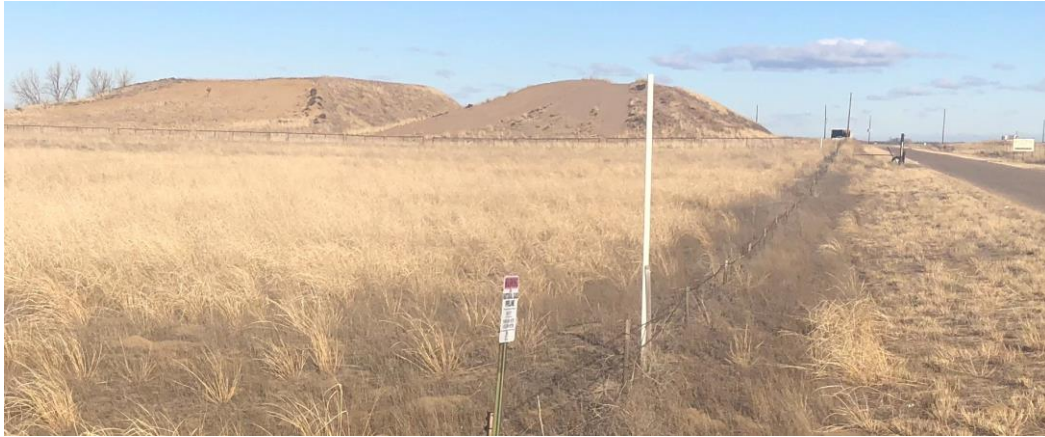
Permit Boundary markers were seen around Area 34 (white posts) and on the shop/office building (painted white stripe).

Topsand Piles A-1 and B-1 were observed from the entrance road. Topsand Pile A-3 was observed from the gate between the Dugout Pond and facilities yard. No significant erosion problems were seen at any of the topsand piles.

Southern sides of Topsand Piles B-1 and A-1 and permit boundary marker

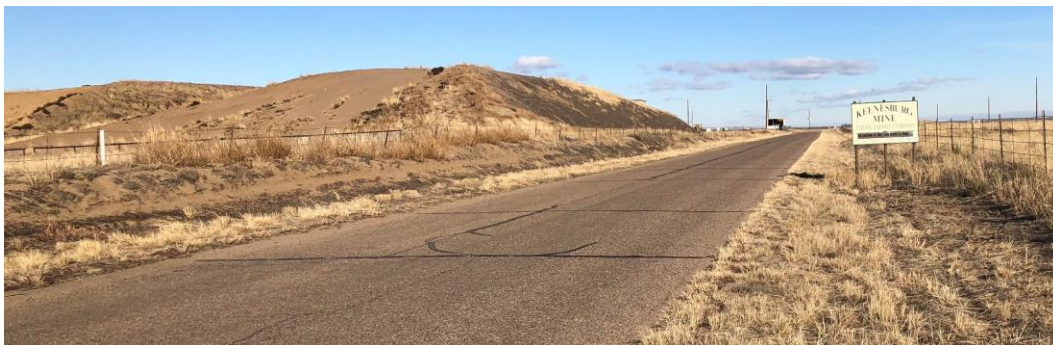
The entrance sign contained the necessary information:

- The name, address, and phone number for CEC.
- The DRMS Permit Number.

Entrance sign and Topsand Pile A-1

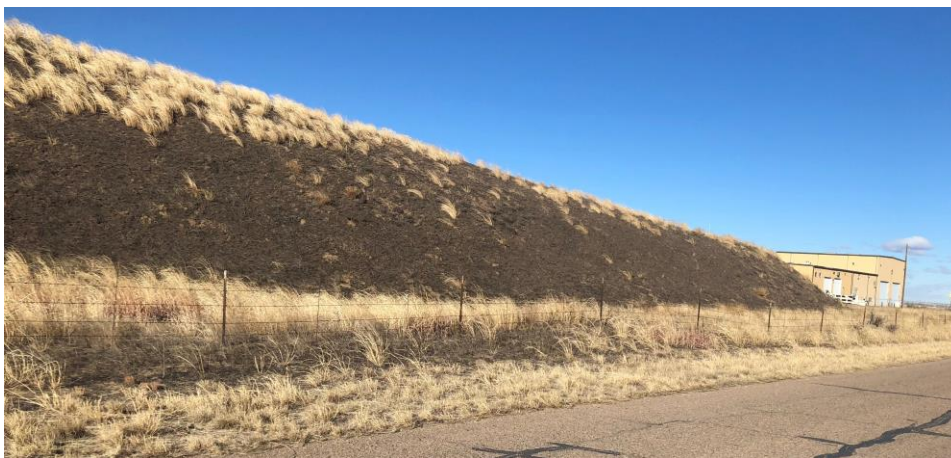
Eastern side of Topsand Pile A-1

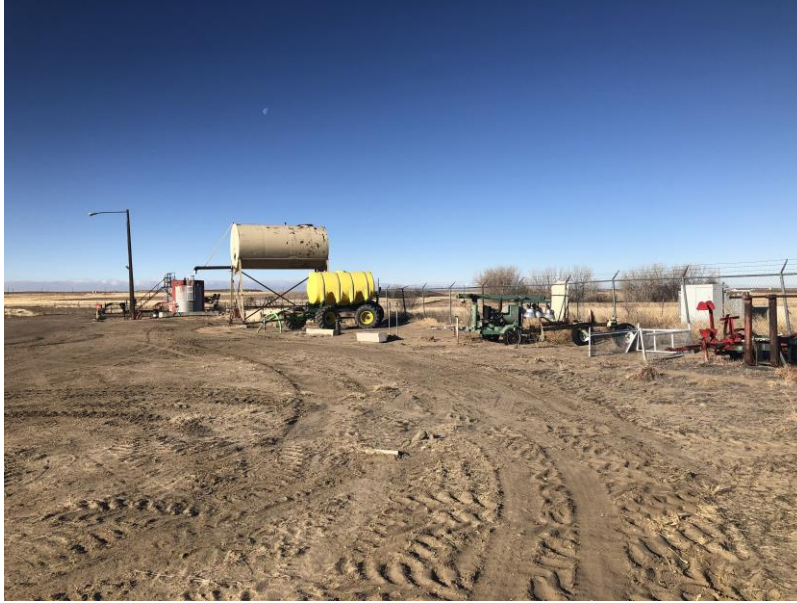
The facilities area was in tidy shape, and no problems were observed.

Facilities yard, north side

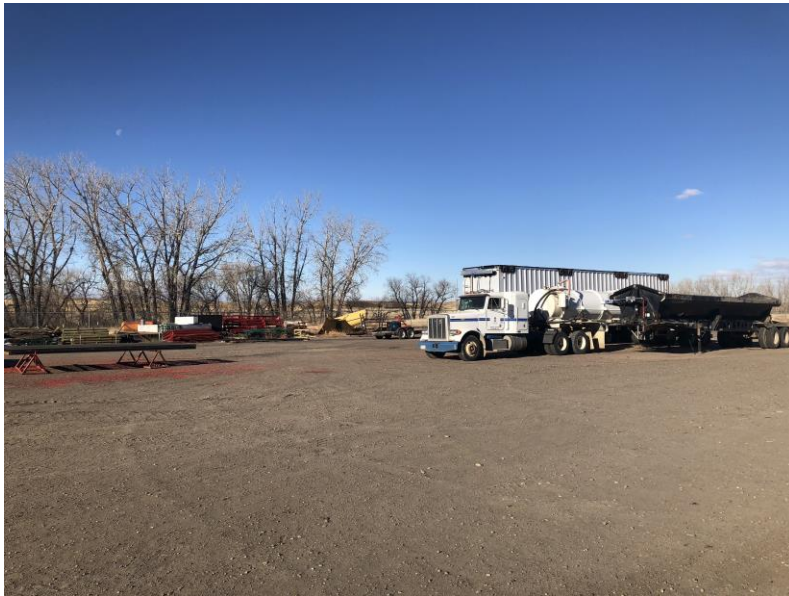
Facilities yard, west side

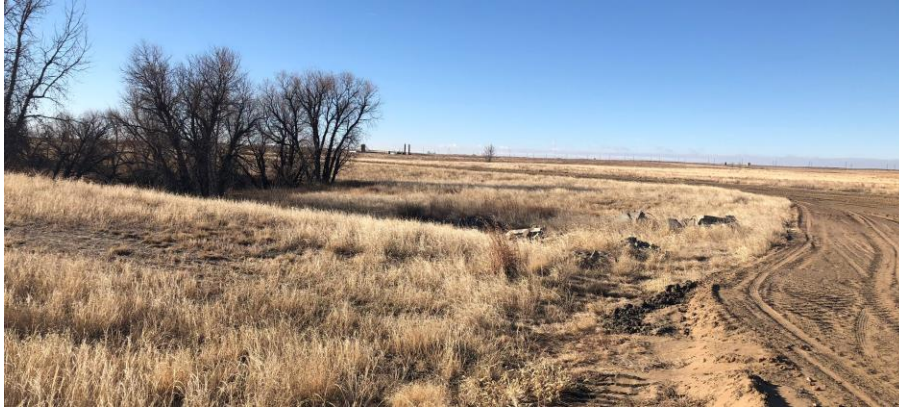
The two ponds were observed from afar. Neither Sediment Pond 2 nor the Dugout Pond appeared to be discharging during the inspection, and no problems were observed with the two ponds or the areas below the ponds, including the area below Sediment Pond 2, which is off the permit boundary.

Area below Dugout Pond

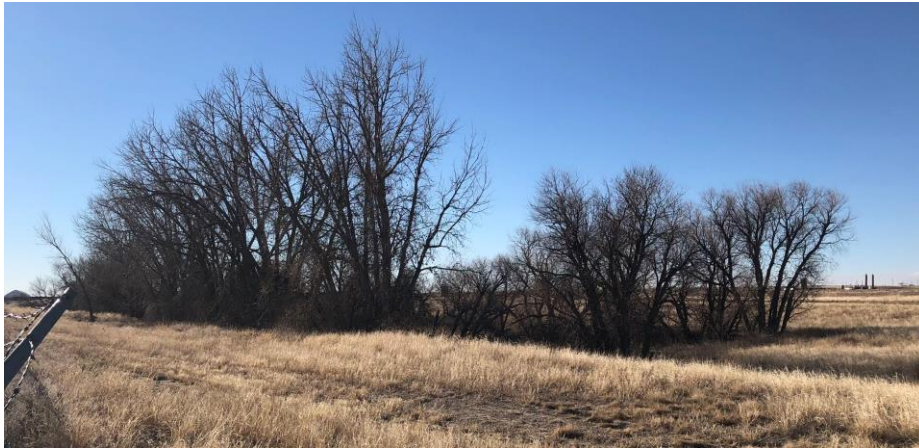
East side of Dugout Pond

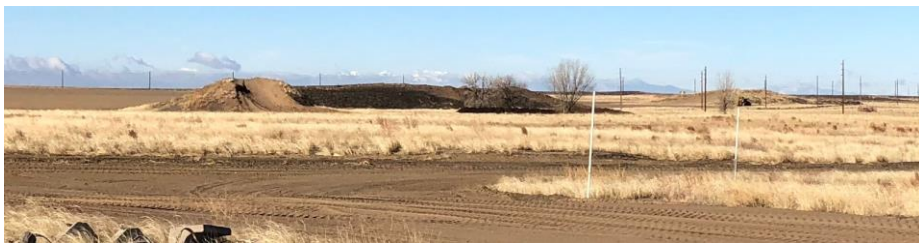
Topsand Pile A-3

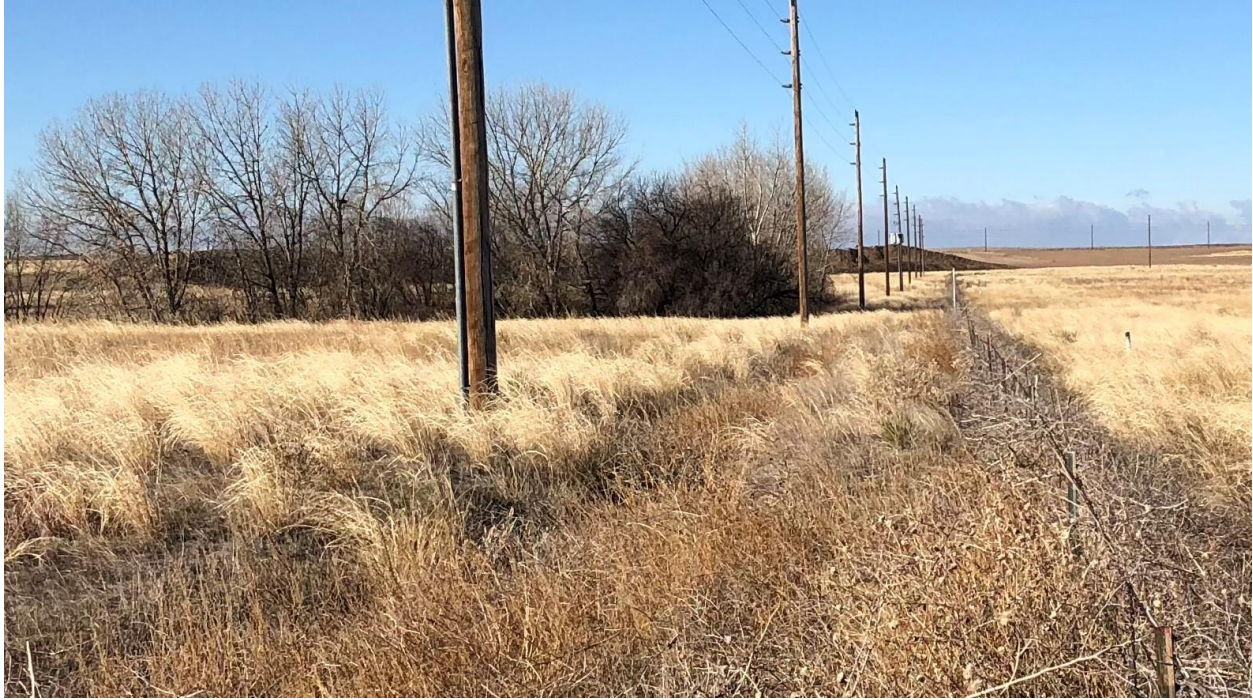
Sediment Pond 2 and area below it – the discharge point (spillway) is near the line of power poles
