MINERALS PROGRAM INSPECTION REPORT**PHONE: (303) 866-3567**

MINE NAME: Lob Lolly Pit	MINE/PROSPECTING ID#: M-2013-066	MINERAL: Borrow material for gravel and sand	COUNTY: Archuleta
INSPECTION TYPE: Monitoring	INSPECTOR(S): Lucas J. West	INSP. DATE: May 14, 2019	INSP. TIME: 15:36
OPERATOR: Arboles Sand & Stone, LLC	OPERATOR REPRESENTATIVE: Steve Wright	TYPE OF OPERATION: 112c - Construction Regular Operation

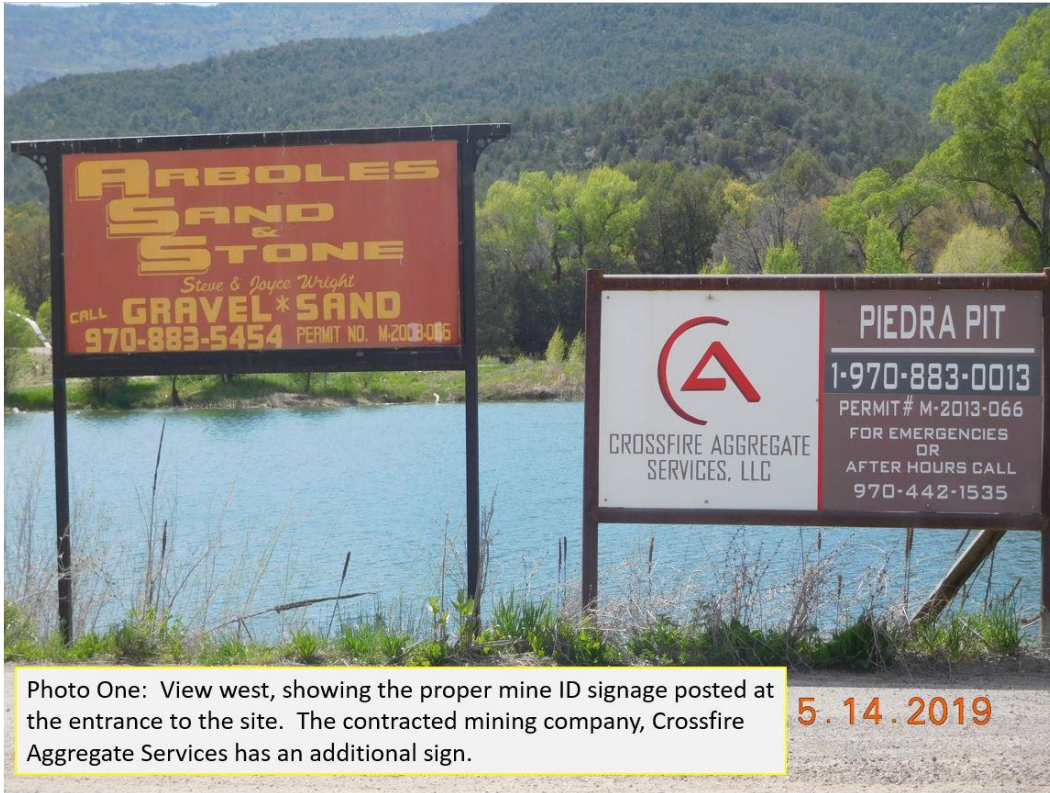
Photo One: View west, showing the proper mine ID signage posted at the entrance to the site. The contracted mining company, Crossfire Aggregate Services has an additional sign.

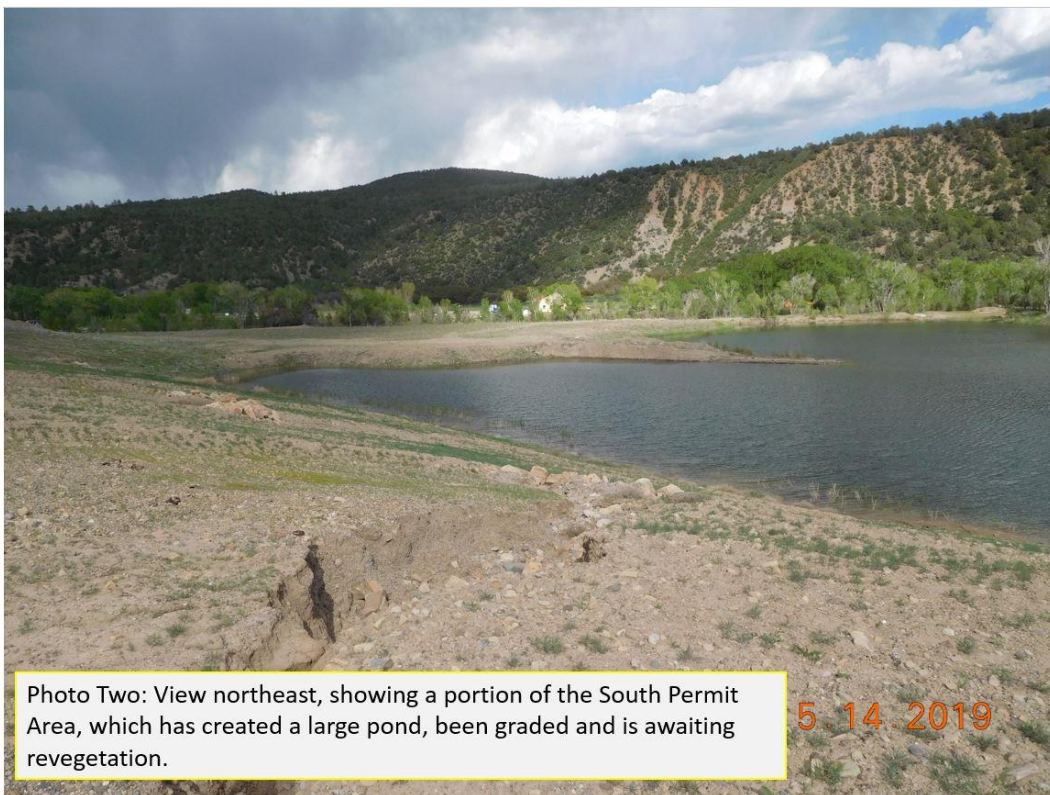
Photo Two: View northeast, showing a portion of the South Permit Area, which has created a large pond, been graded and is awaiting revegetation.

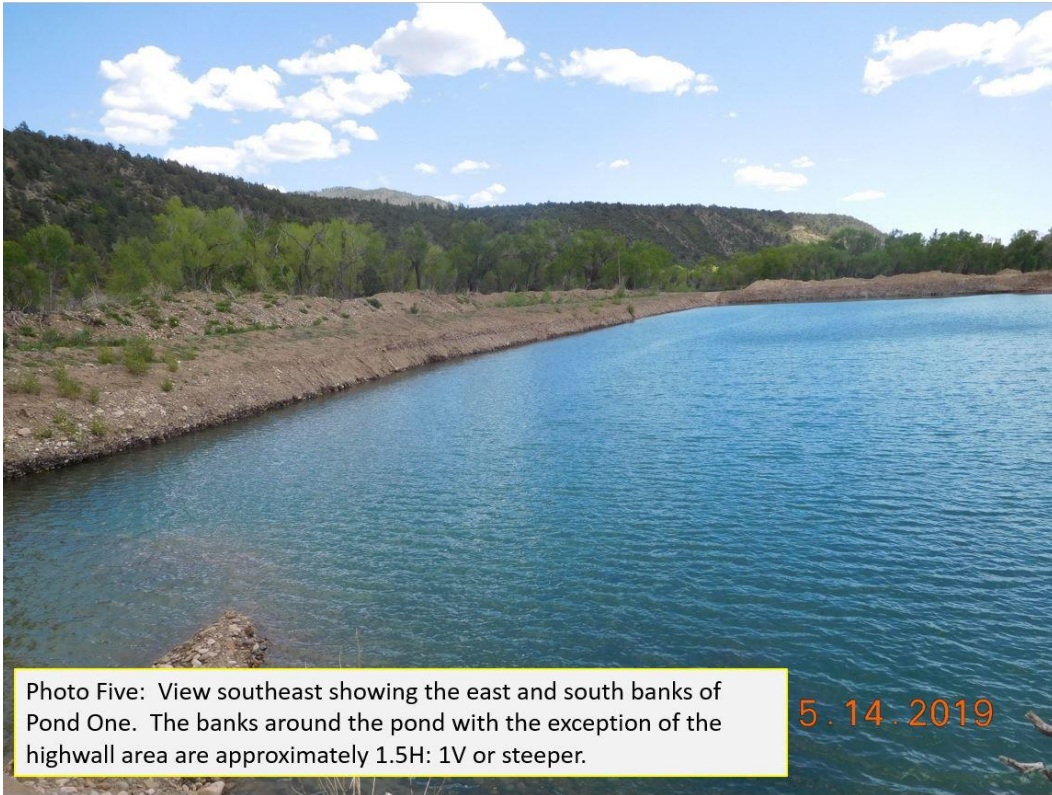
The North Permit Area is estimated to consist of approximately 26.6 disturbed acres. All mining, crushing and stockpiling activities are confined to this area. The processing areas including the washout pond, seen in Photo Four is clean and well kept, all equipment and stockpiles are in good condition. The mining operations have created two ponds. Pond One is approximately 3 acres, seen in Photos Five and Six is the current area that is being mined. It has a highwall that is approximately 15 feet above the water line, extends an unknown distance below the water line and is nearly 250 feet long. The highwall is vertical or near vertical on the western bank. The north, south and east banks are all approximately 1.5H : 1V or steeper and will need to be relaxed significantly to achieve final reclamation topography. During mining activities Pond One is dewatered into Pond Two, and vice versa to create a non-discharging facility. Pond Two is approximately 2 acres and can be seen in Photos Seven and Eight. Unlike Pond One no defined highwall exists at this pond however all banks appear to be nearly 1.5H : 1V or steeper and will also need to be relaxed significantly to achieve the final reclamation topography. No sloughing or significant erosional features were noted around either one of the ponds during this inspection.

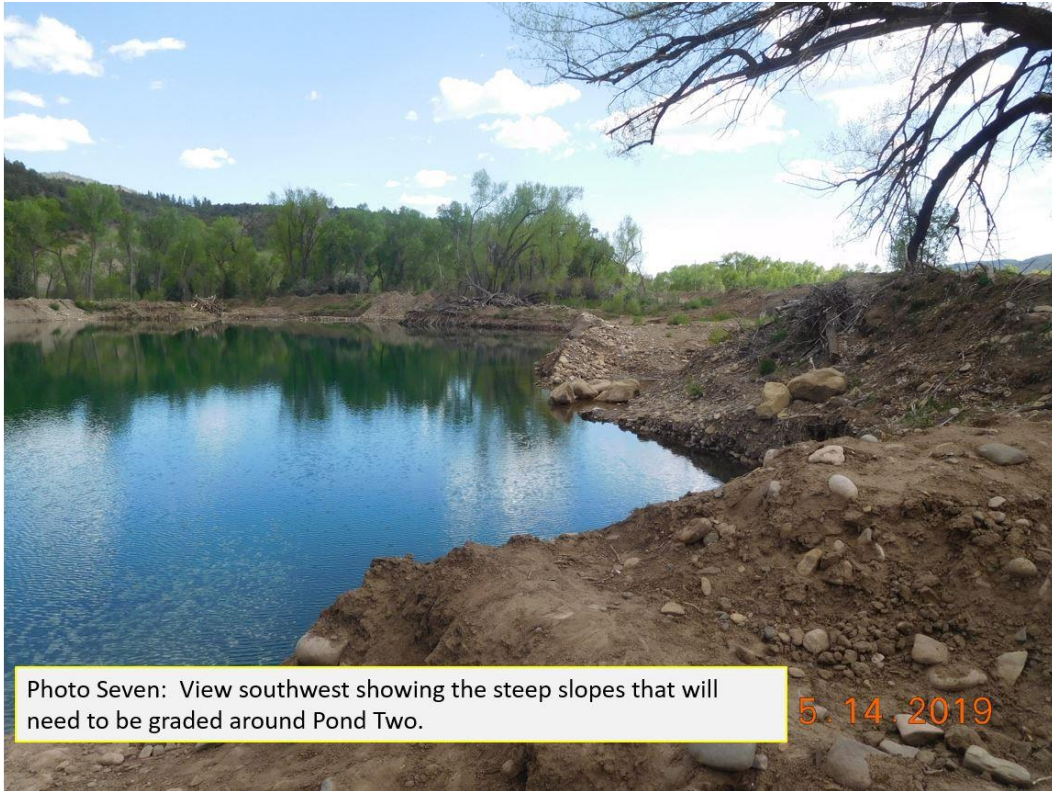
Photo Seven: View southwest showing the steep slopes that will need to be graded around Pond Two.

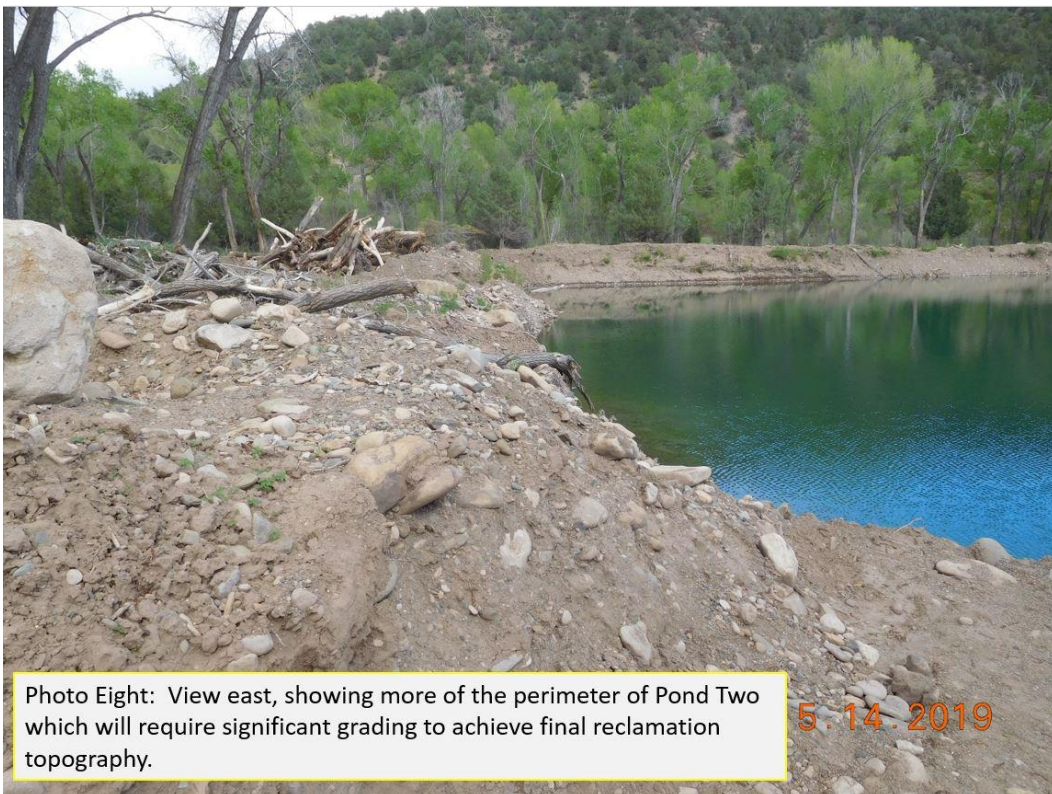
Photo Eight: View east, showing more of the perimeter of Pond Two which will require significant grading to achieve final reclamation topography.
