MINERALS PROGRAM INSPECTION REPORT
PHONE: (303) 866-3567

MINE NAME: Craig Pit	MINE/PROSPECTING ID#: M-1976-027	MINERAL: Sand and gravel	COUNTY: La Plata
INSPECTION TYPE: Monitoring	INSPECTOR(S): Lucas J. West	INSP. DATE: May 14, 2019	INSP. TIME: 18:20
OPERATOR: Skanska USA Civil West Rocky Mountain Di	OPERATOR REPRESENTATIVE: None	TYPE OF OPERATION: 112c - Construction Regular Operation	
REASON FOR INSPECTION: Normal I&E Program	BOND CALCULATION TYPE: None	BOND AMOUNT: \$158,692.74	
DATE OF COMPLAINT: NA	POST INSP. CONTACTS: None	JOINT INSP. AGENCY: None	
WEATHER: Clear	INSPECTOR'S SIGNATURE:

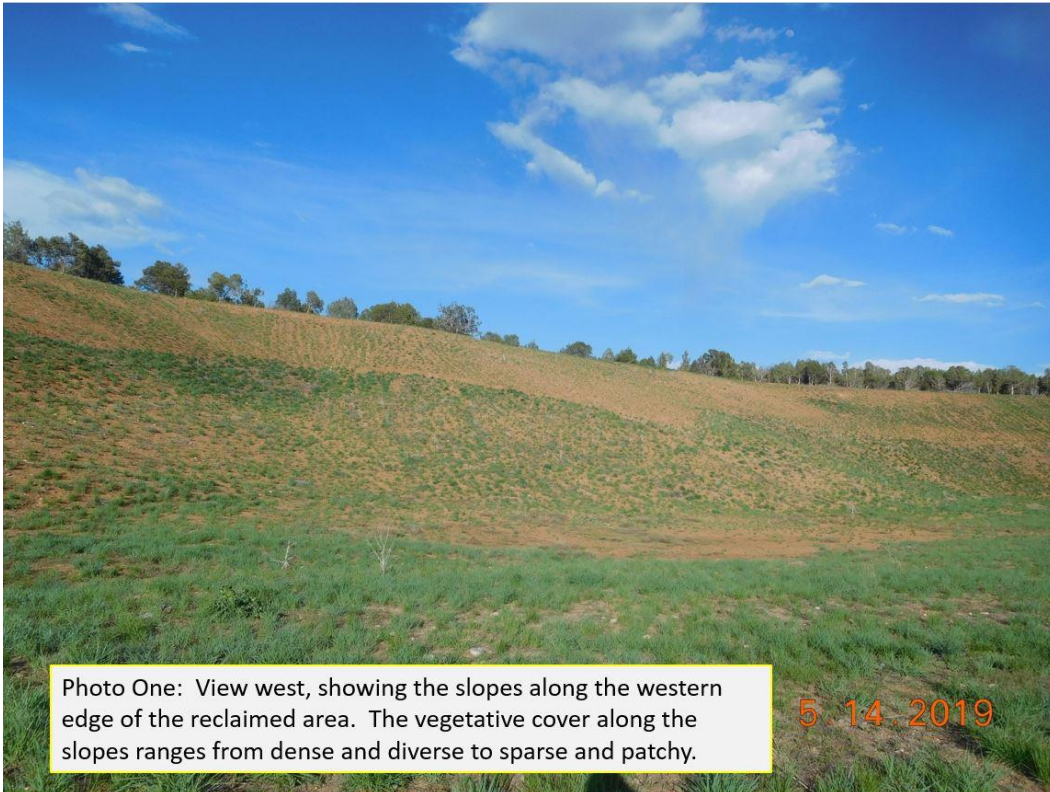
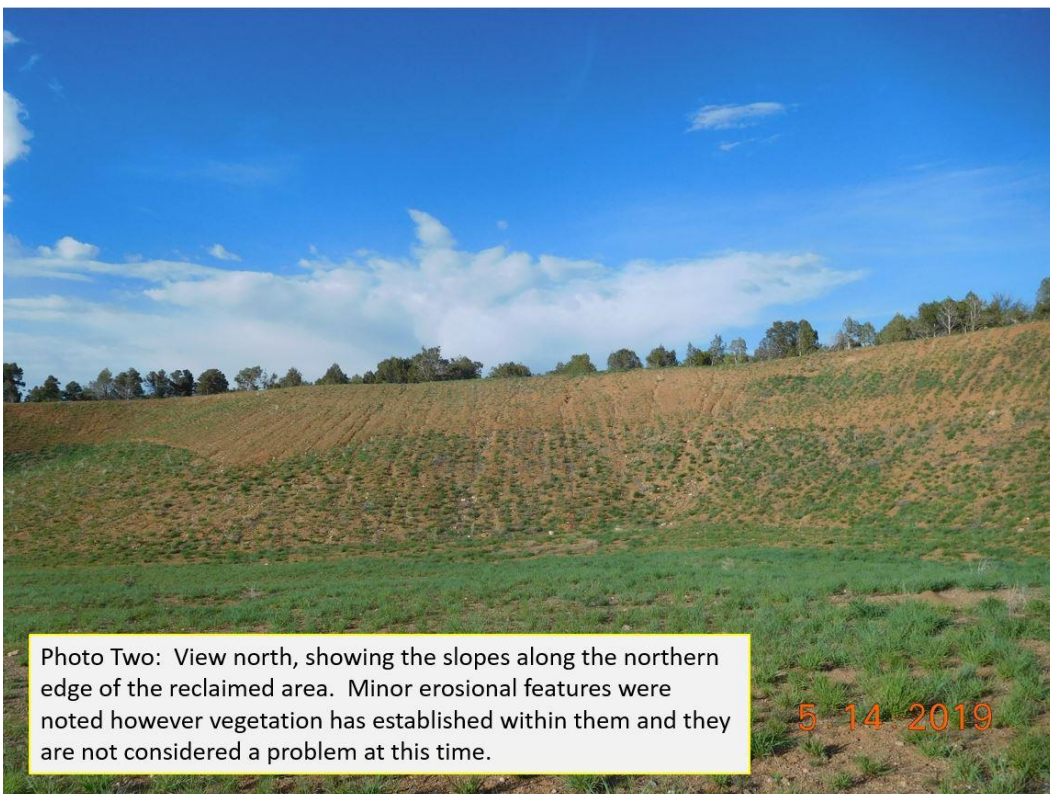
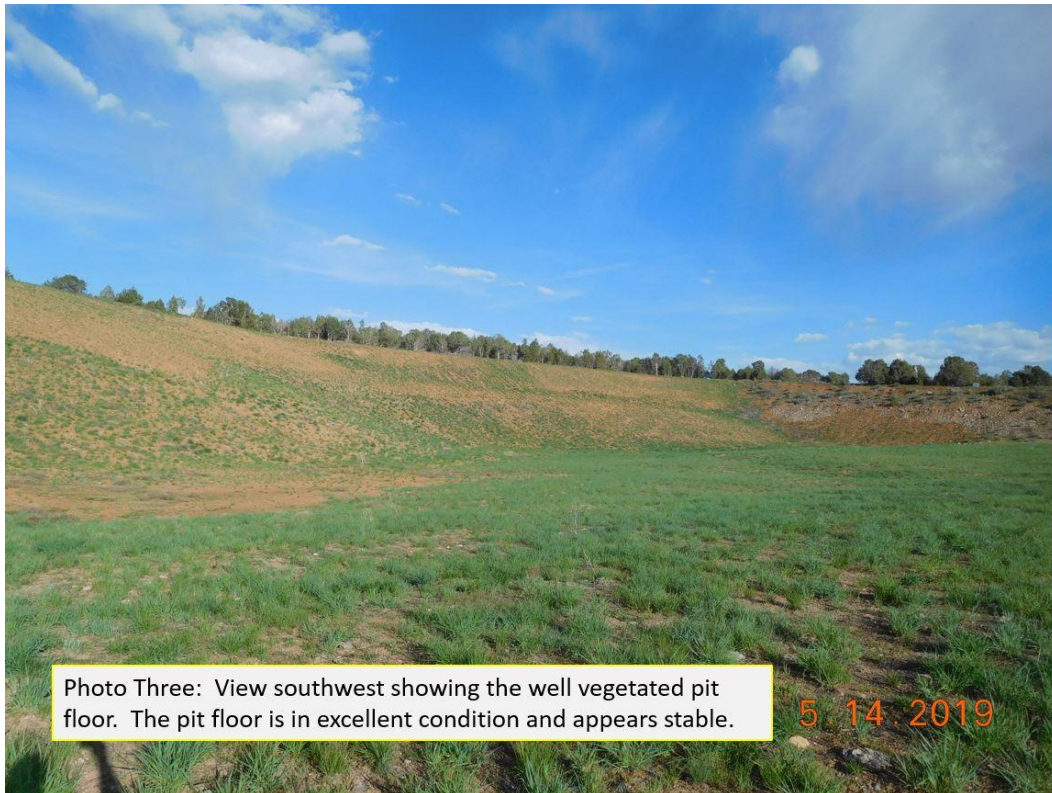
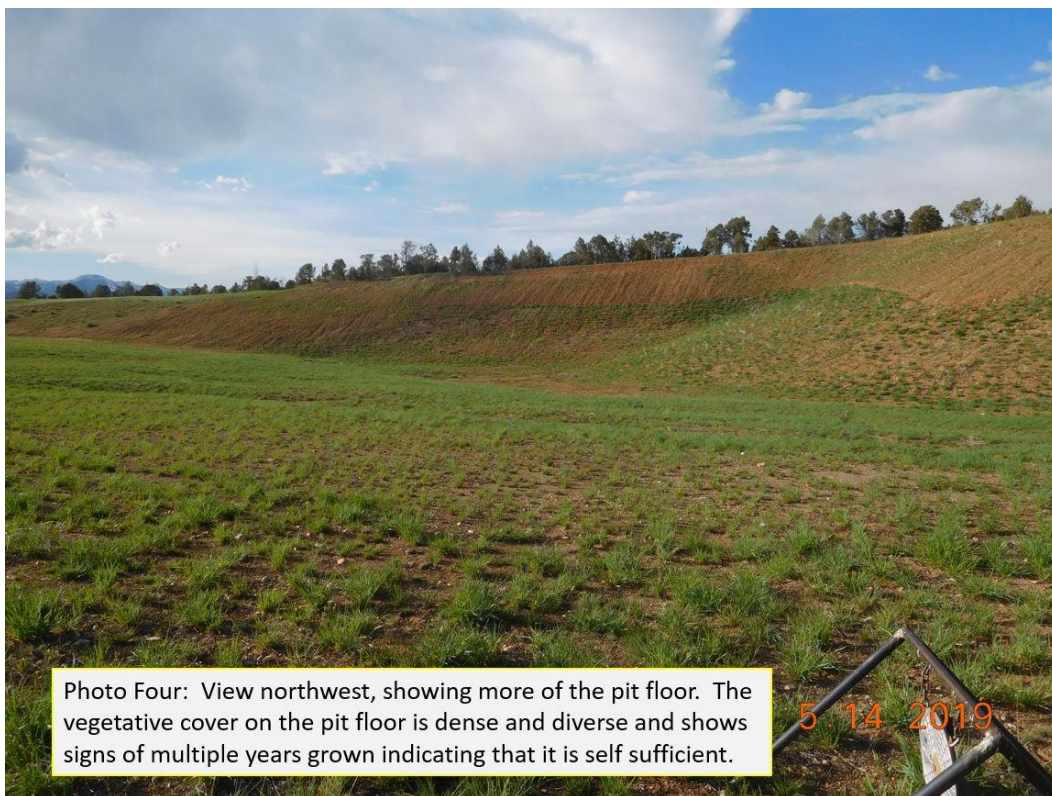
PHOTOGRAPHS

The site was not active during the inspection and reclamation of the site is nearly complete. The reclamation plan consists of a gently graded pit floor to exhibit positive drainage surrounded on three sides by stable vegetated slopes. As of the Division's previous inspection all earthwork and grading had been completed as well seeding efforts. All slopes around the perimeter of the permitted area appear to be stable and in good condition. Examples of the condition of the slopes can be seen in Photos One and Two. The vegetative cover on the sloped areas ranges from dense and diverse to sparse in some places. Given the severity of the drought conditions in the previous years the vegetative cover is being established better than expected.

The pit floor exhibits positive drainage and no impounded storm water or erosional features were observed on site. Two large stockpiles lie in the southern portion of the pit floor and have been approved to remain for landowner use, post reclamation, as a result of the approval of TR-03. The stockpiles appear to be stable and in good condition. Photos Three and Four show the remainder of the pit floor which is in excellent condition. The vegetative cover on the pit floor is dense and diverse and evidence of active weed management efforts were noted.

No problems or possible violations were noted during this inspection and no signs of settling, slumping or erosion were observed. The vegetative cover on the site varies, however if it continues on its upward trend the site may be eligible for release in the near future. All responses to this report should be directed to Lucas West at the Colorado Division of Reclamation, Mining and Safety at 1313 Sherman Street, Room 215, Denver CO, 80203, by phone at 303-866-3567 Ext. 8187 or by email at lucas.west@state.co.us.
