MINERALS PROGRAM INSPECTION REPORT
PHONE: (303) 866-3567

MINE NAME: Jones Pit East	MINE/PROSPECTING ID#: M-1987-009	MINERAL: Sand and gravel	COUNTY: Prowers
INSPECTION TYPE: Monitoring	INSPECTOR(S): Amy Eschberger	INSP. DATE: March 26, 2019	INSP. TIME: 11:40
OPERATOR: Prowers County	OPERATOR REPRESENTATIVE: Mark Dorenkamp	TYPE OF OPERATION: 112c - Construction Regular Operation	
REASON FOR INSPECTION: Normal I&E Program	BOND CALCULATION TYPE: None	BOND AMOUNT: \$0.00	
DATE OF COMPLAINT: NA	POST INSP. CONTACTS: None	JOINT INSP. AGENCY: None	
WEATHER: Clear	INSPECTOR'S SIGNATURE:

M-1987-009 / Jones Pit East / Prowers County

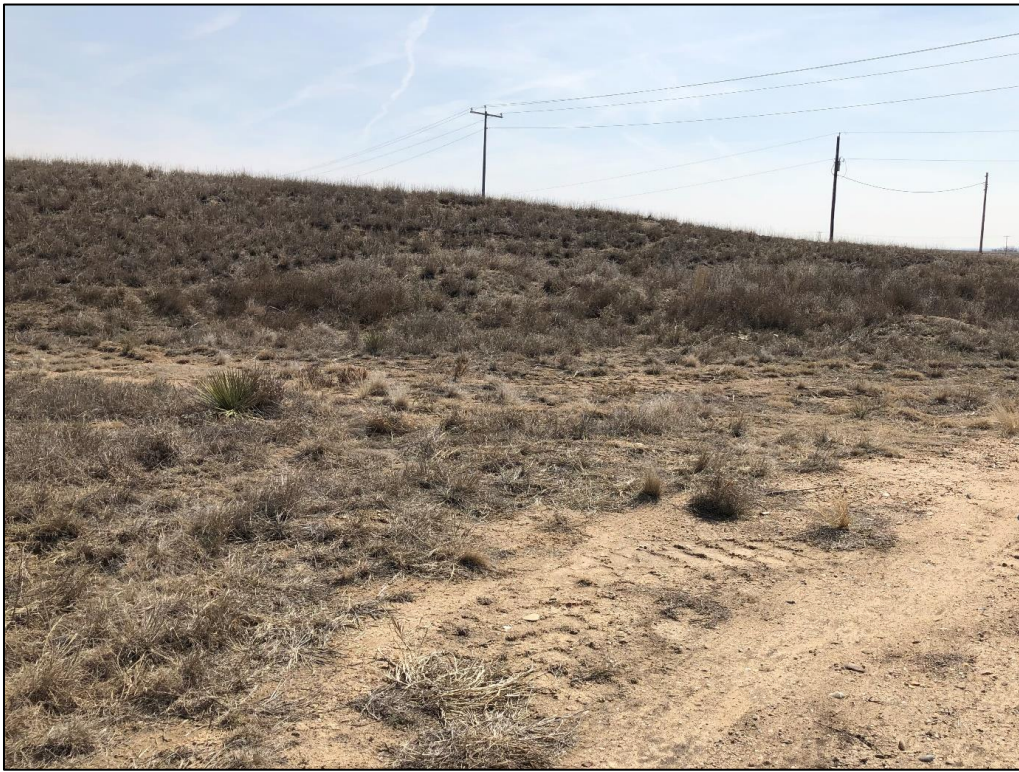
Photo 1. View looking southeast at reclaimed eastern highwall in southern half of permit area.

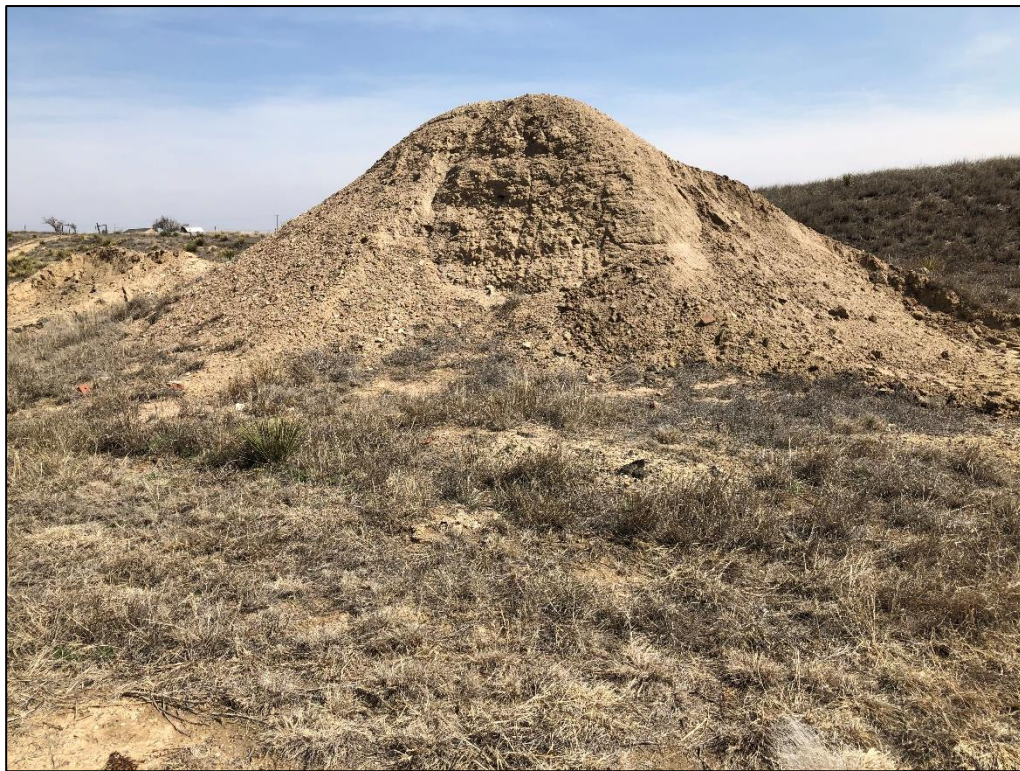
Photo 2. View of material stockpile stored on pit floor in southern half of permit area.

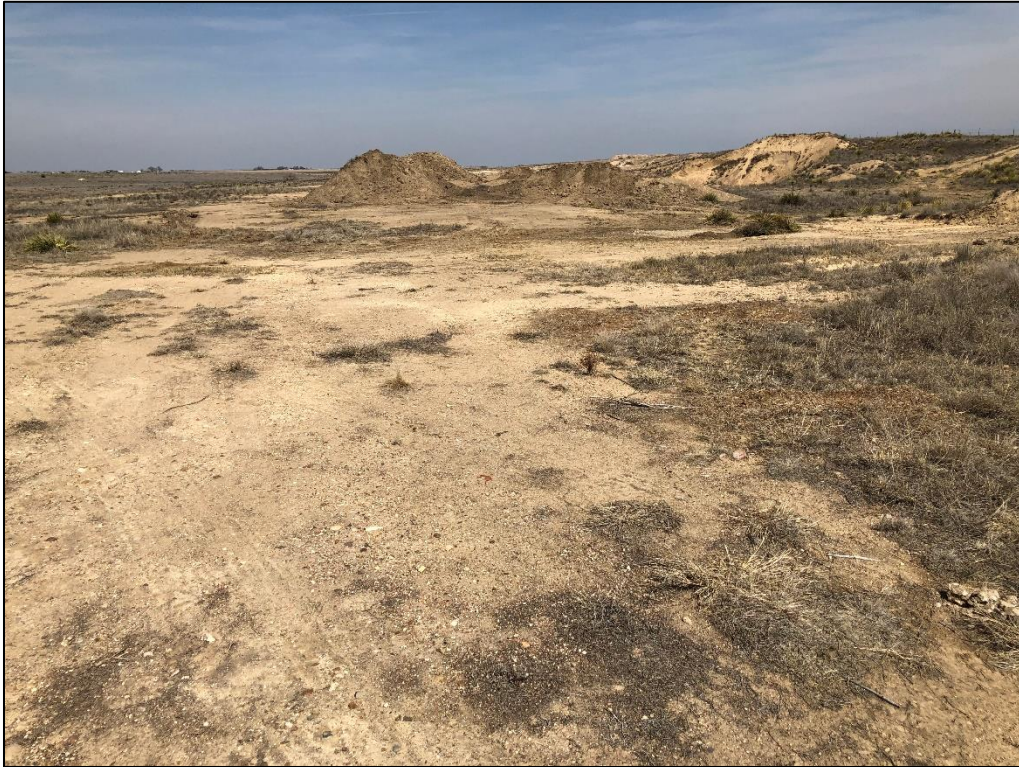
Photo 3. View looking northeast across previously mined southern half of permit area.

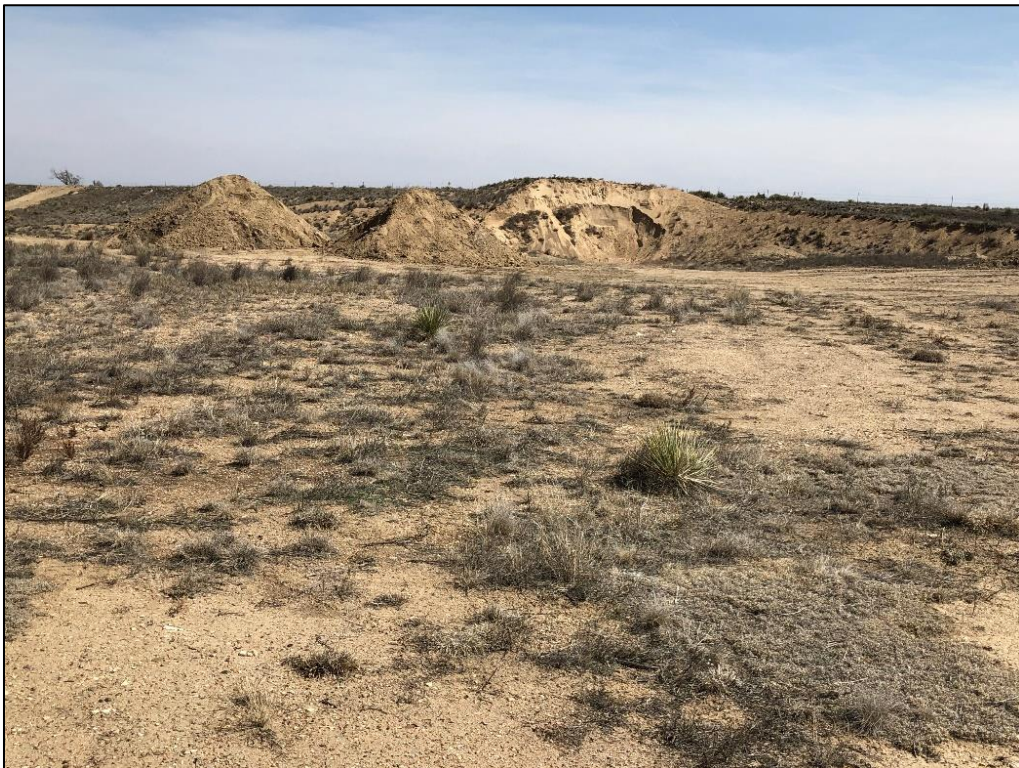
Photo 4. View looking east across previously mined southern half of permit area. Note material stockpiles stored on pit floor in this area.

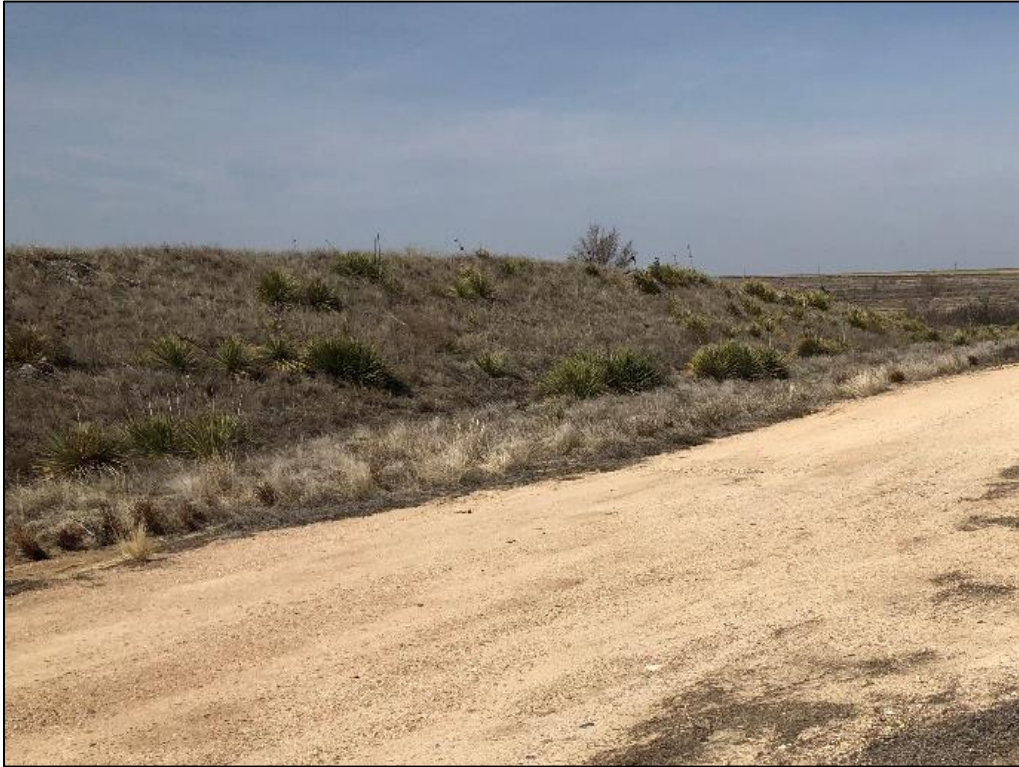
Photo 5. View looking west at large topsoil stockpile stored at southwestern edge of permit area. Note this stockpile is stable with good grass cover.

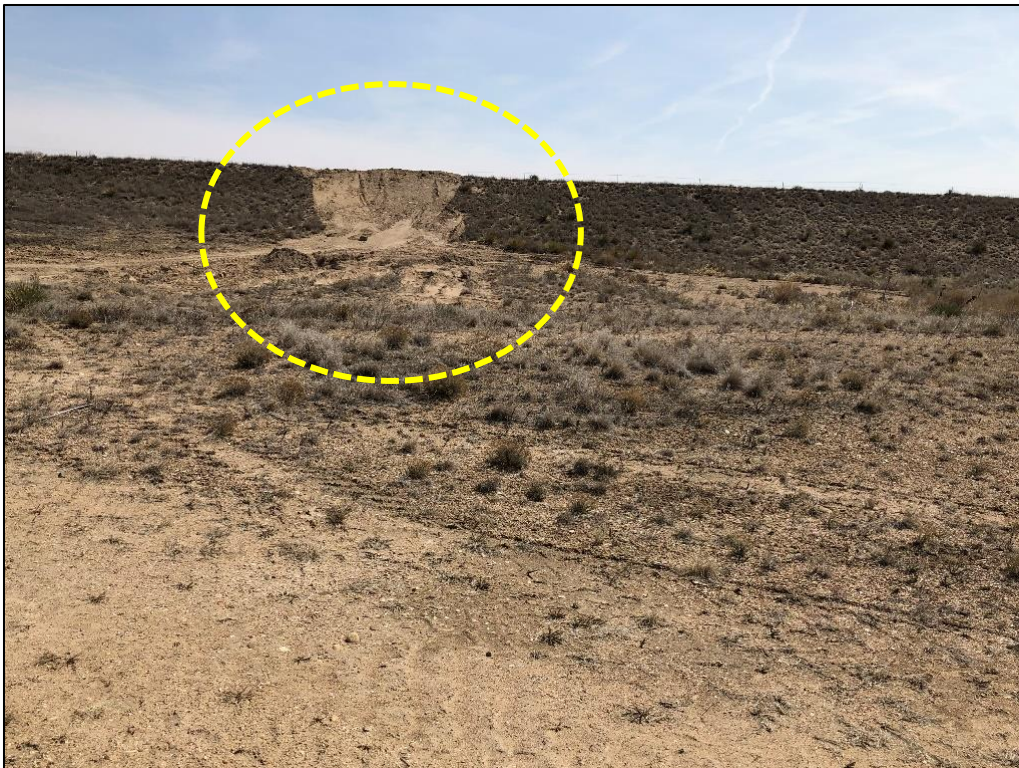
Photo 6. View looking east at reclaimed eastern highwall in southern half of permit area, showing redisturbed portion (circled) which will require regrading and revegetation for final reclamation.

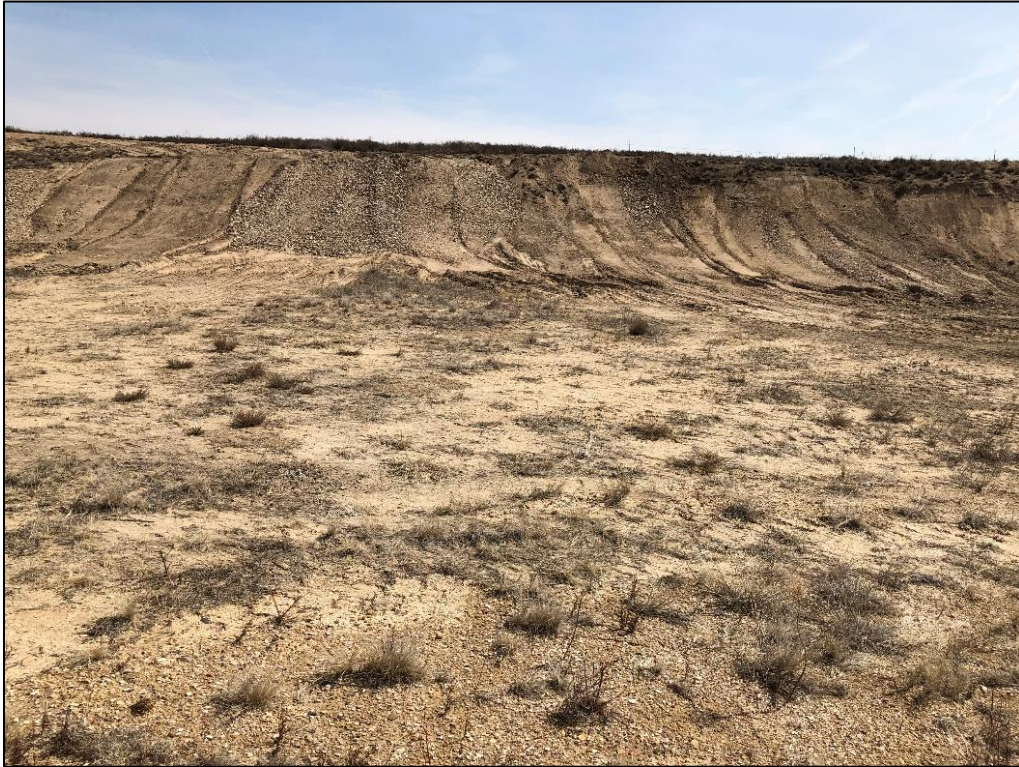
Photo 7. View looking east at portion of highwall in northern half of permit area which has been graded to 3H:1V.

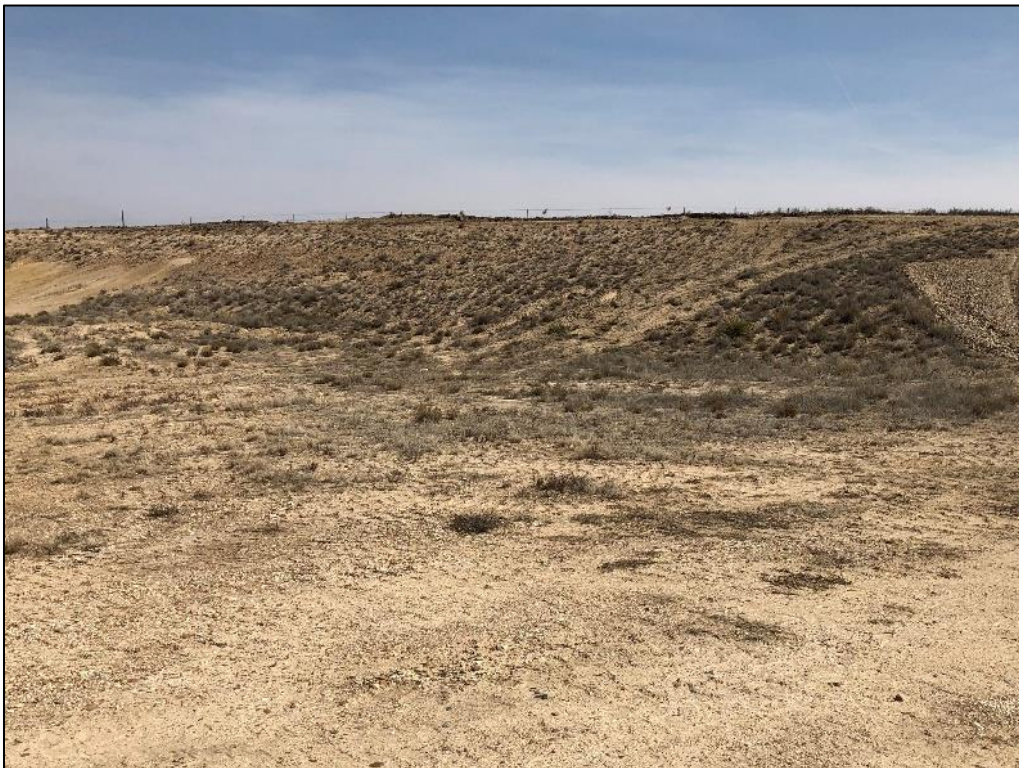
Photo 8. View looking east at portion of highwall in northern half of permit area which has been graded to 3H:1V and revegetated.

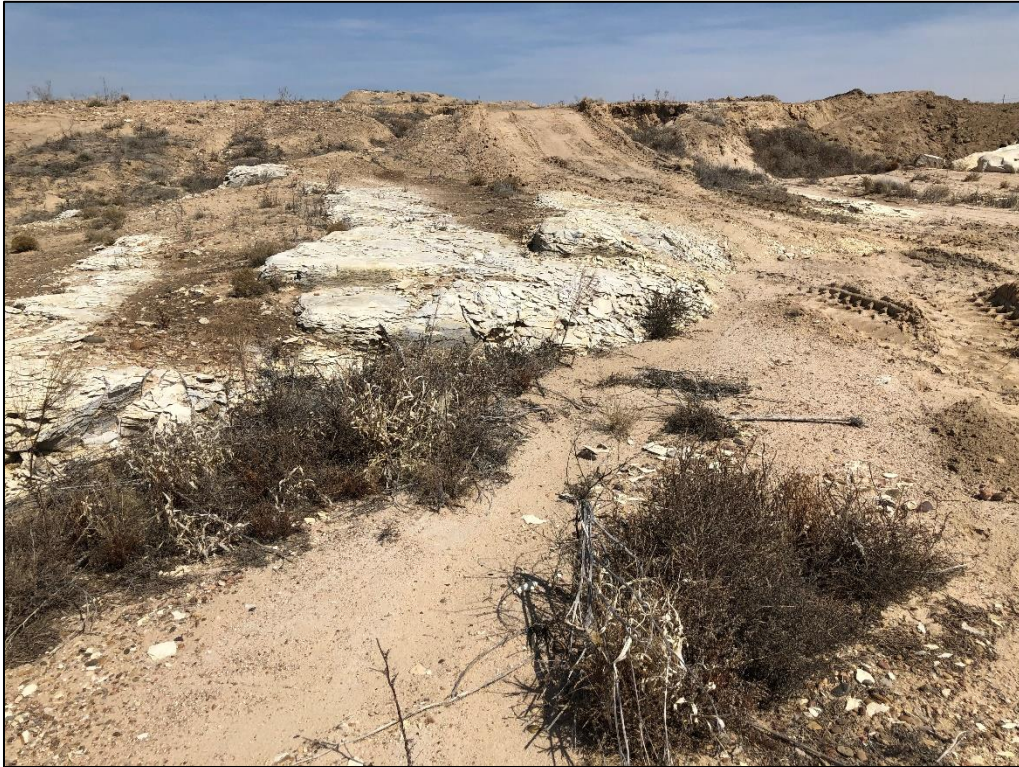
Photo 9. View looking north at eastern edge of active mine wall in northern half of permit area.

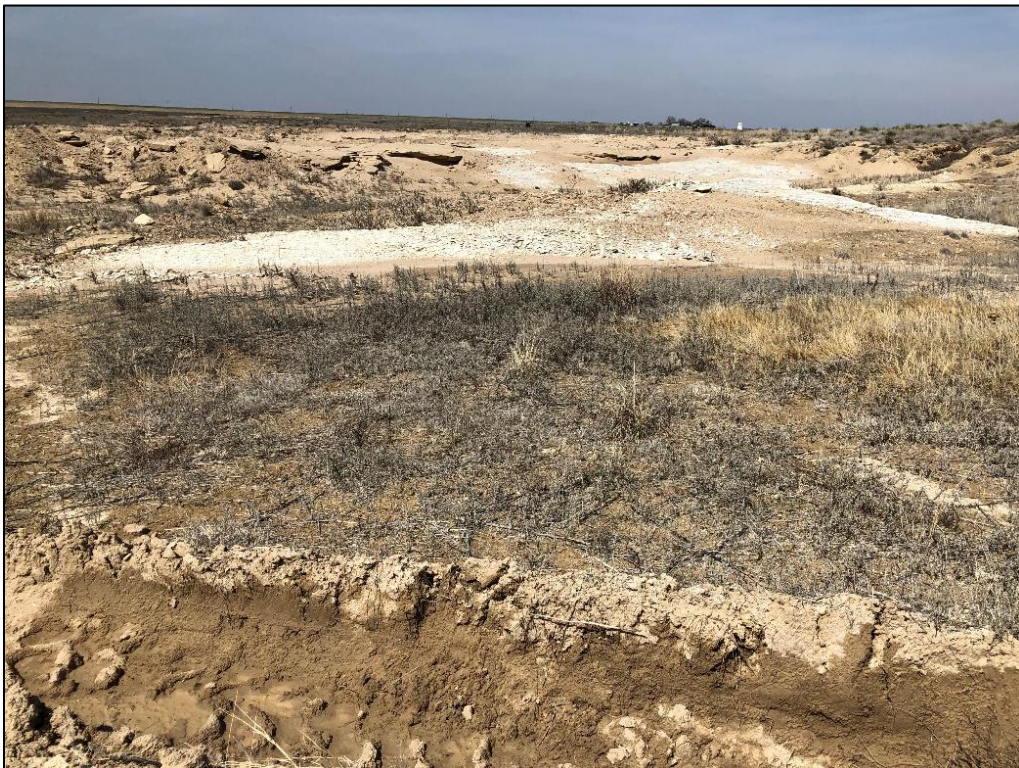
Photo 10. View looking north at western edge of active mine wall in northern half of permit area.

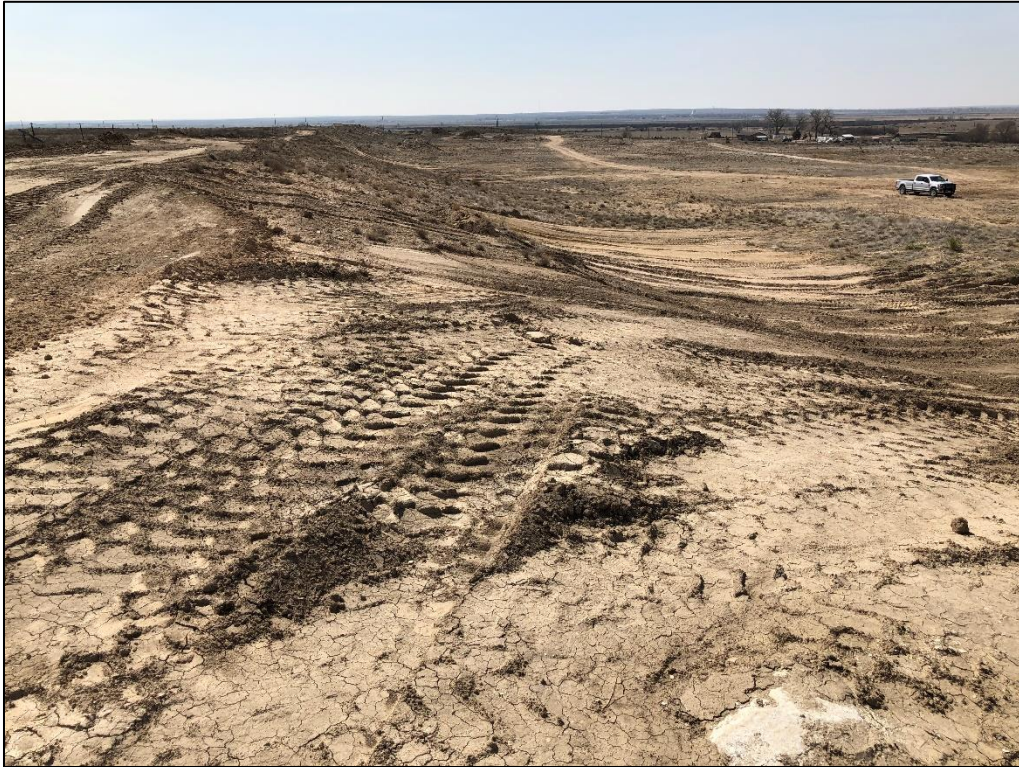
Photo 11. View looking south from top of active mine wall, showing eastern highwall graded to 3H:1V or flatter.

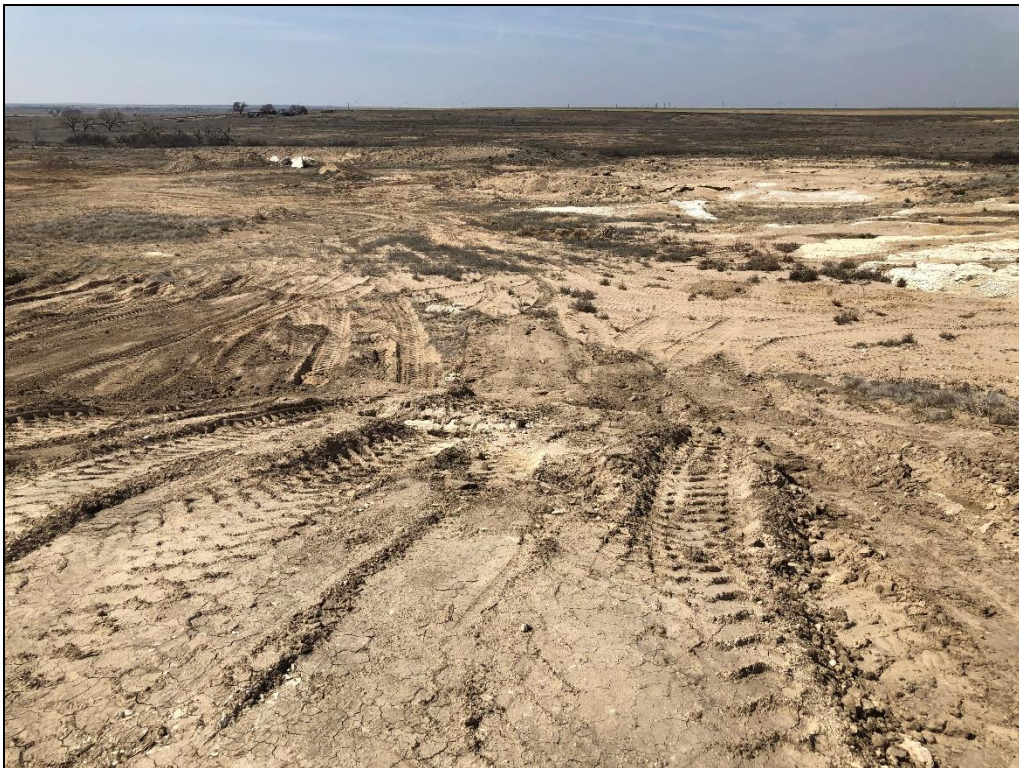
Photo 12. View looking southwest across pit from top of active mine wall.

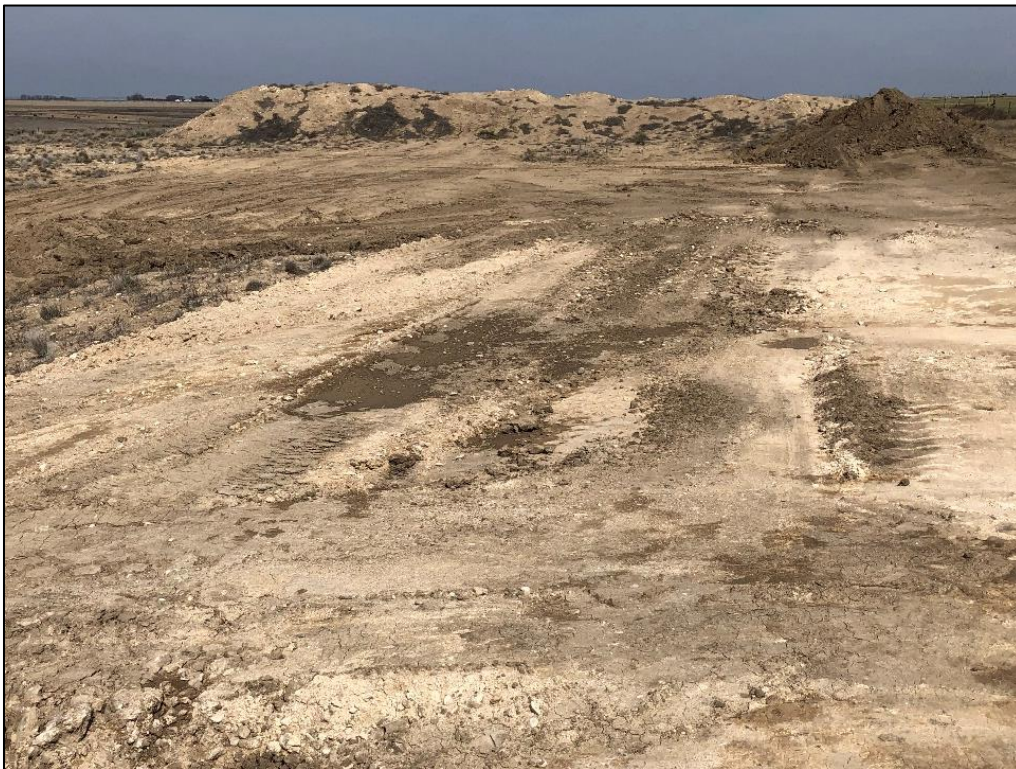
Photo 13. View looking across stripped area just north of active mine face. Note topsoil stockpile stored at northeastern edge of permit area (in background).

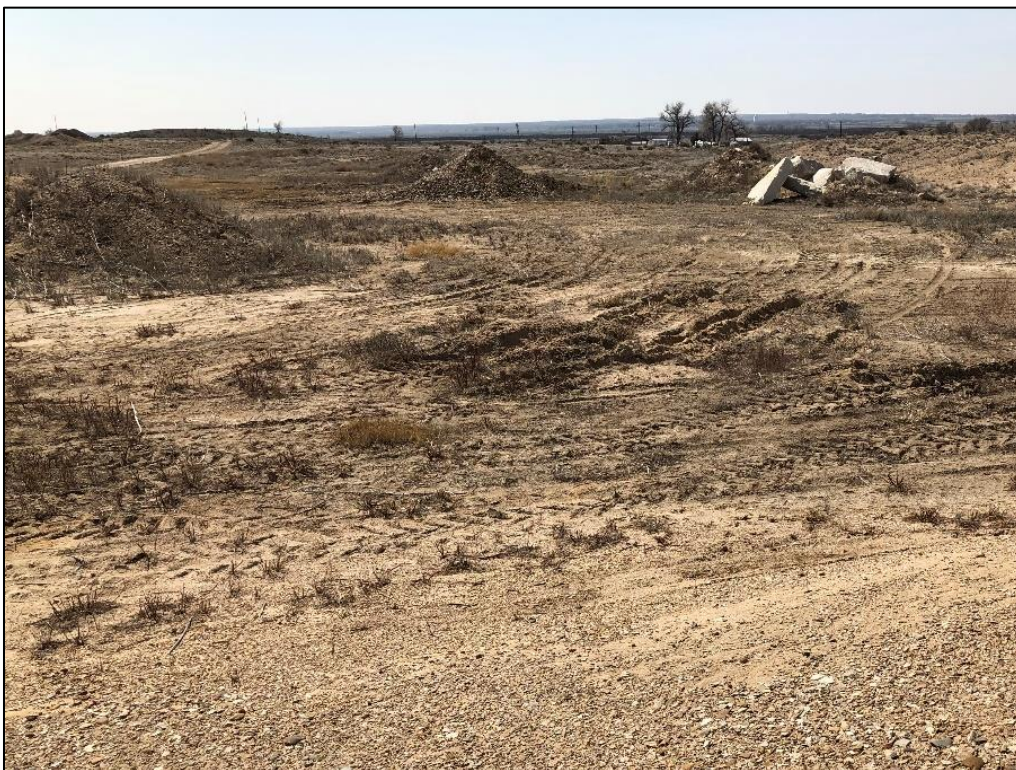
Photo 14. View looking south across western edge of pit floor in northern half of permit area. Note a few small material stockpiles stored in this area.
