MINERALS PROGRAM INSPECTION REPORT
PHONE: (303) 866-3567

MINE NAME: Riverside Parkway	MINE/PROSPECTING ID#: M-2007-005	MINERAL: Borrow material	COUNTY: Mesa
INSPECTION TYPE: Monitoring	INSPECTOR(S): Amy C. Yeldell	INSP. DATE: May 29, 2019	INSP. TIME: 08:30
OPERATOR: City of Grand Junction	OPERATOR REPRESENTATIVE: Jerod Timothy	TYPE OF OPERATION: 111 - Construction by Government Agency	
REASON FOR INSPECTION: Normal I&E Program	BOND CALCULATION TYPE: None	BOND AMOUNT: No Bond Held	
DATE OF COMPLAINT: NA	POST INSP. CONTACTS: None	JOINT INSP. AGENCY: None	
WEATHER: Clear	INSPECTOR'S SIGNATURE:

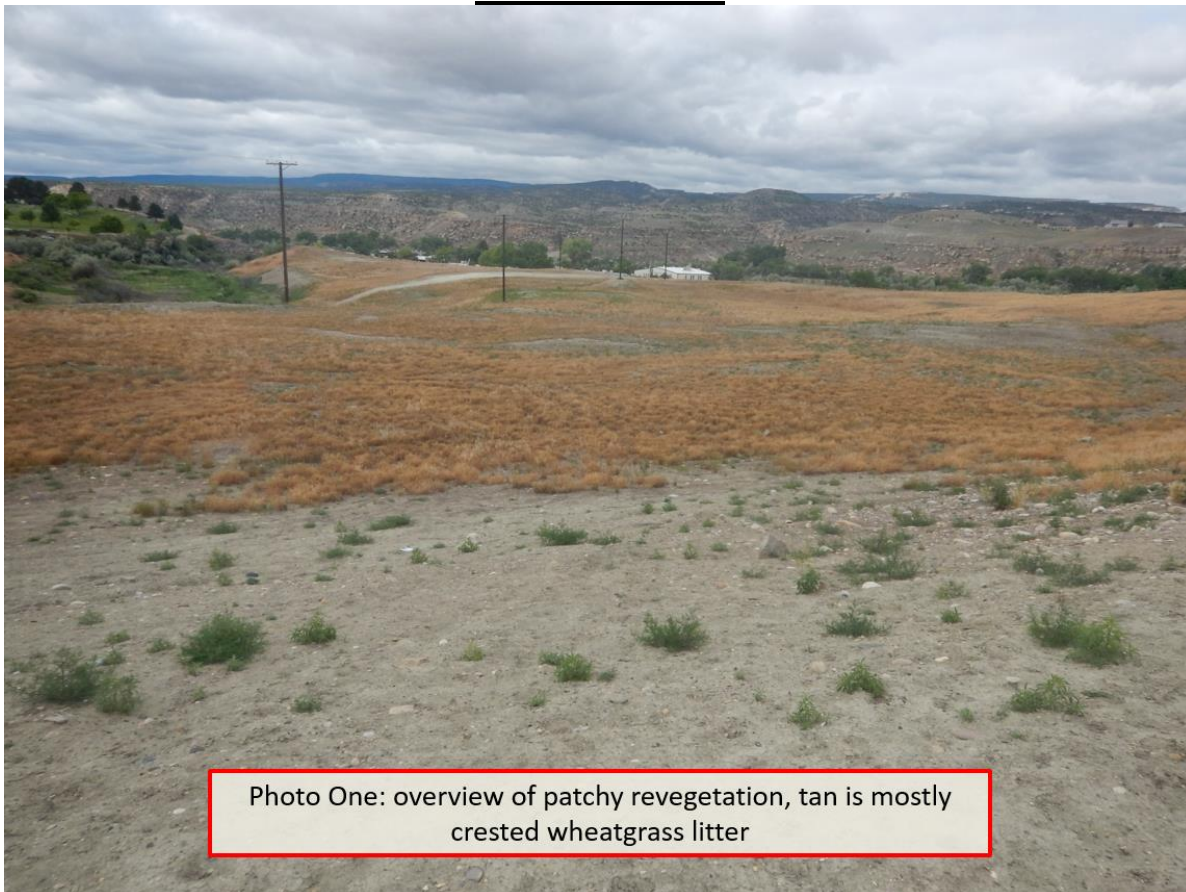
Overall staff was very pleased with the amount of vegetative cover on site. The mild winter and extremely wet spring has considerably benefited the site with regards to plant establishment. Specifically crested wheatgrass has done very well as evidenced by both the large amounts of last year's growth as litter and the abundance of new germination this year. In general despite the excessive moisture, state listed weeds and noxious species do not appear to be thriving more than in years past. During the inspection Kochia (1-4" tall) and mustard (approx. 1 ft. tall) were observed. The operator is encouraged to treat nuisance species as well as state listed weeds as necessary. As a whole the site remains stable with little to no observable erosion.

Photo One: overview of patchy revegetation, tan is mostly crested wheatgrass litter

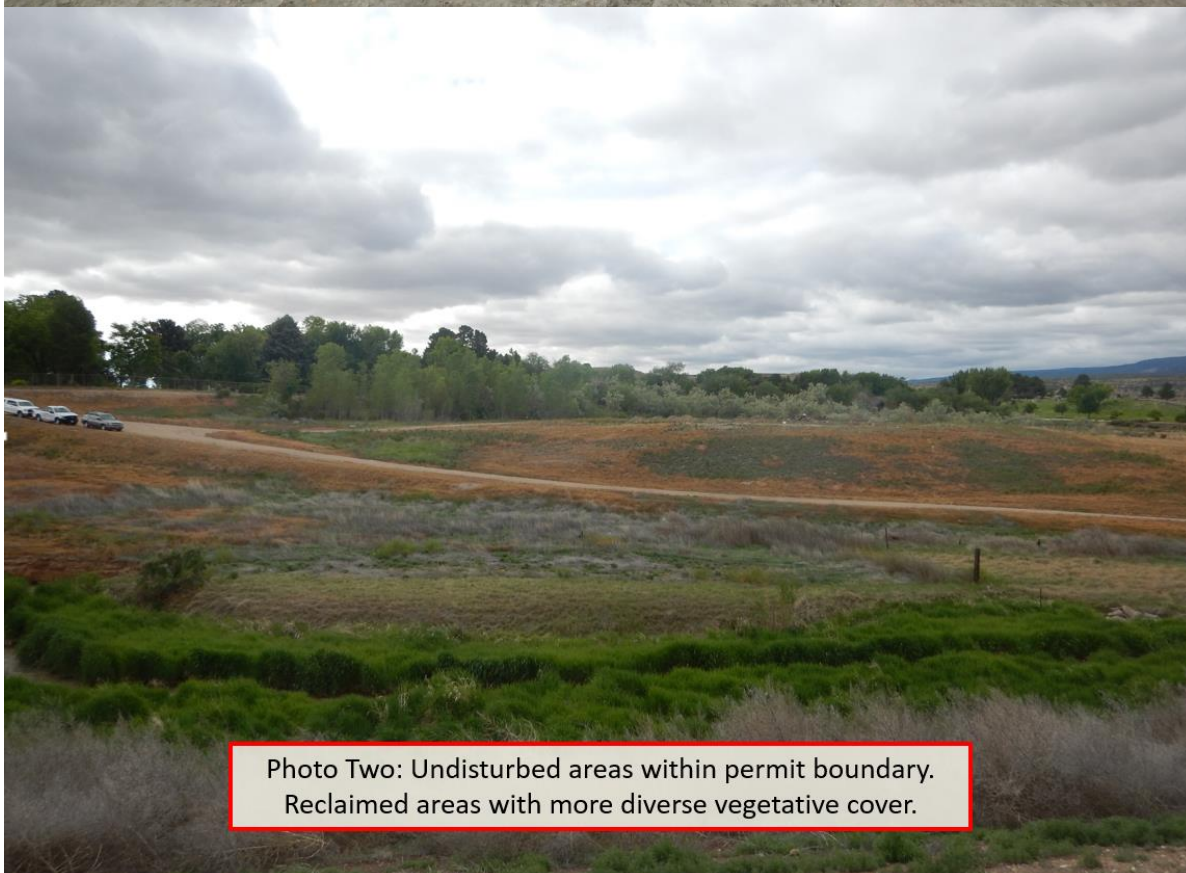
Photo Two: Undisturbed areas within permit boundary. Reclaimed areas with more diverse vegetative cover.
