**MINERALS PROGRAM INSPECTION REPORT**  
**PHONE: (303) 866-3567**

<b>MINE NAME:</b> Greer Pit	<b>MINE/PROSPECTING ID#:</b> M-1985-115	<b>MINERAL:</b> Sand and gravel	<b>COUNTY:</b> La Plata
<b>INSPECTION TYPE:</b> Monitoring	<b>INSPECTOR(S):</b> Lucas J. West	<b>INSP. DATE:</b> May 15, 2019	<b>INSP. TIME:</b> 09:12
<b>OPERATOR:</b> J Pat and Lila N Greer	<b>OPERATOR REPRESENTATIVE:</b> Jim Greer	<b>TYPE OF OPERATION:</b> 110c - Construction Limited Impact	
<b>REASON FOR INSPECTION:</b> Normal I&E Program	<b>BOND CALCULATION TYPE:</b> Complete Bond	<b>BOND AMOUNT:</b> \$9,500.00	
<b>DATE OF COMPLAINT:</b> NA	<b>POST INSP. CONTACTS:</b> None	<b>JOINT INSP. AGENCY:</b> None	
<b>WEATHER:</b> Clear	<b>INSPECTOR'S SIGNATURE:</b>

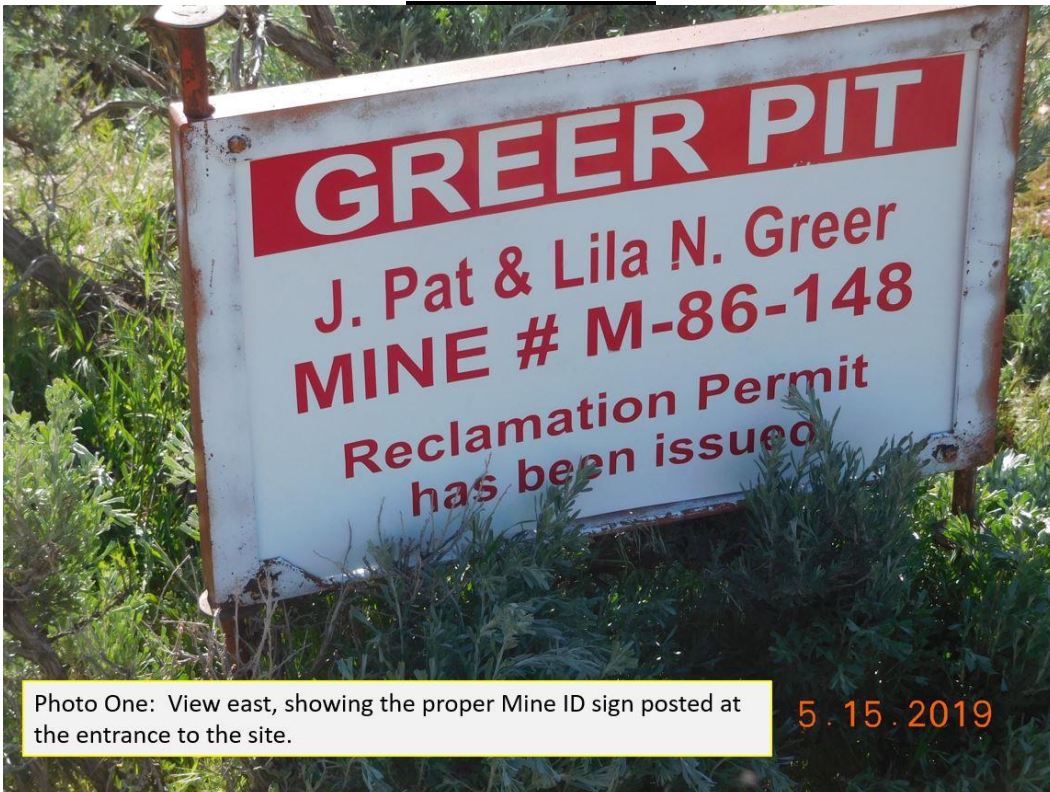
The proper mine identification signage was posted at the entrance to the site and can be seen in Photo One and the permit boundary was clearly delineated with a series of fences and berms. The site was not active during the inspection. Operations at the site occur on an intermittent basis. Large amounts of material is crushed and screened then periodically hauled from the site. A large stockpile of material is located on the pit floor. The stockpile appears to be stable and in good condition. Evidence of recent hauling activities was observed. The pit floor exhibits positive drainage and no impounded storm water was noted during the inspection. The active mine area consists of a highwall that averages 25 feet tall and is approximately 500 Linear Feet total. The highwall is a near vertical face that appears to be stable and in good condition. No evidence of sloughing or slumping was noted. The highwall can be seen in Photos Two and Three. The mining will progress to area immediately to the west of the current mining area. This area has been stripped and prepped to be mined during the 2019 construction season. The stripped area can be seen in Photo Four.

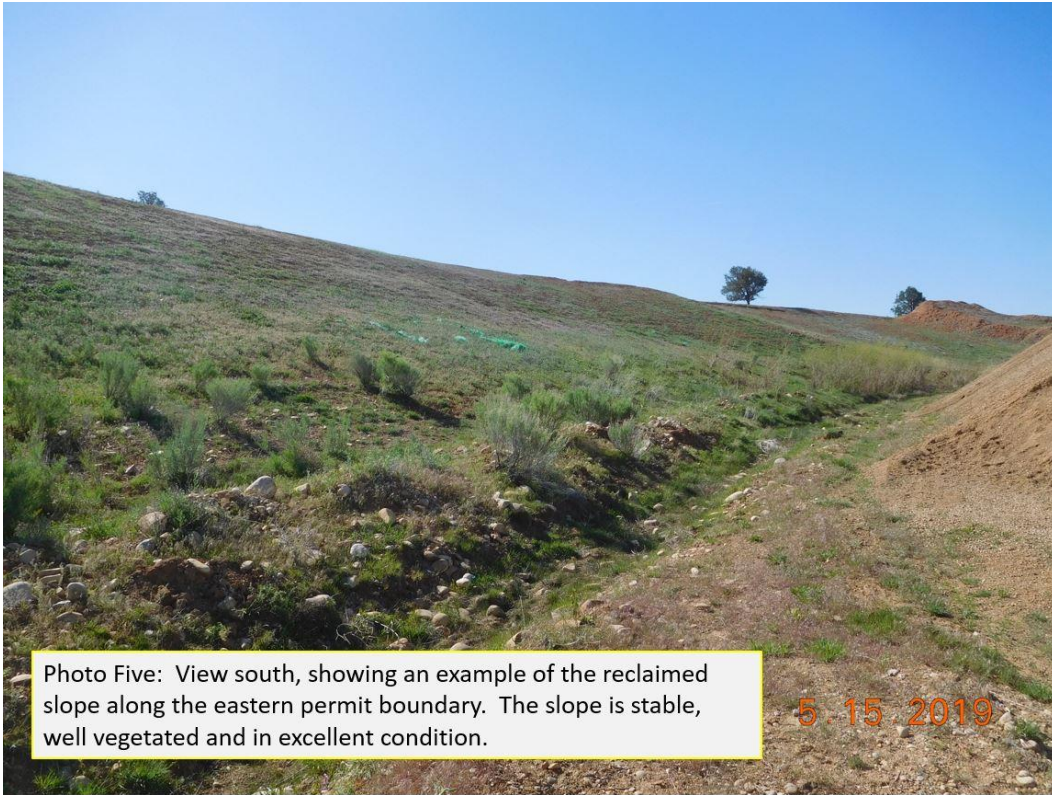
The site also undergoes contemporaneous reclamation, and the previously mined highwall along the eastern permit boundary has been sloped and revegetated and can be seen in Photo Five. The highwall has been relaxed to approximately a 2H: 1V configuration that appears to be stable and in good condition. No evidence of settling, slumping or erosion was observed. The vegetation on the slope is dense and diverse, and shows signs of multiple year's growth indicating that the vegetative cover is self-sufficient.

Photo Five: View south, showing an example of the reclaimed slope along the eastern permit boundary. The slope is stable, well vegetated and in excellent condition.
