# MINERALS PROGRAM INSPECTION REPORT PHONE: (303) 866-3567

MINE NAME:		MINE/PROSPECTING ID#:	MINERAL:	COUNTY:		
Ensminger Pit #2		M-2010-036	Clay, gravel,sand	Phillips		
INSPECTION TYPE:		<b>INSPECTOR(S):</b>	INSP. DATE:	INSP. TIME:		
Pre-Operation Inspection		Elliott R. Russell	January 16, 2019	10:00		
OPERATOR:		OPERATOR REPRESENTATIVE:	TYPE OF OPERATION:			
Rick Ensminger		Rick Ensminger	112c - Construction Regular Operation			
REASON FOR INSPECTION:		BOND CALCULATION TYPE:	BOND AMOUNT:			
Pre-Operation Inspection		None	\$47,500.00			
DATE OF COMPLAINT:		POST INSP. CONTACTS:	JOINT INSP. AGENCY:			
NA		None	None			
WEATHER:	INSPECTOR'S SIGNATURE:		SIGNATURE DATE:			
Cloudy	At Pmill		June 5, 2019

This inspection was conducted as a Pre-Operational inspection associated with Amendment AM-01, submitted to the Division on September 21, 2018. Elliott Russell, with the Division, conducted the inspection while Rick Ensminger, the Operator, accompanied the inspection.

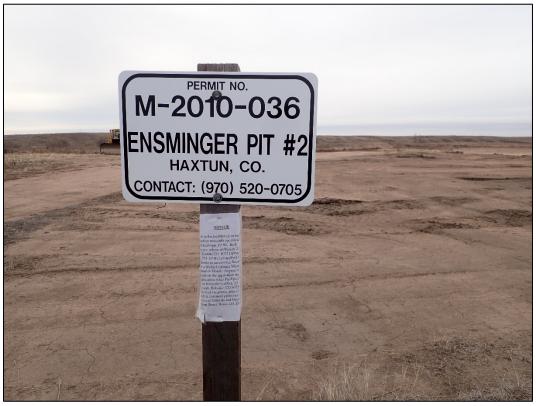
The mine site identification sign was observed at the entrance to the site and was in compliance with Rule 3.1.12(1). The boundary of the permit was delineated with t-posts. The required on-site public notice for AM-01 was also posted at the site entrance.

**Photo 1.** Mine identification sign and on-site AM-01 notice; looking south.

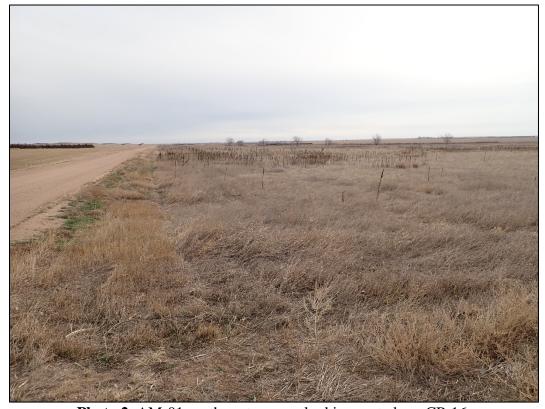
**Photo 2.** AM-01 northwest corner; looking east along CR 16.

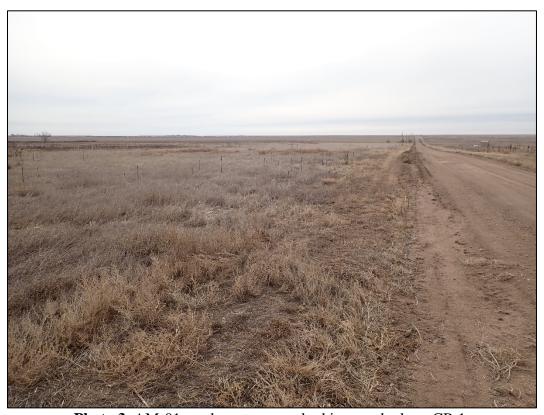
**Photo 3.** AM-01 northwest corner; looking south along CR 1.

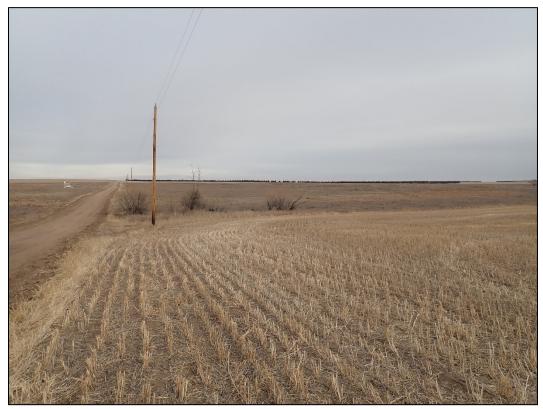
**Photo 4.** Southwest portion of the site; looking north along CR 1.

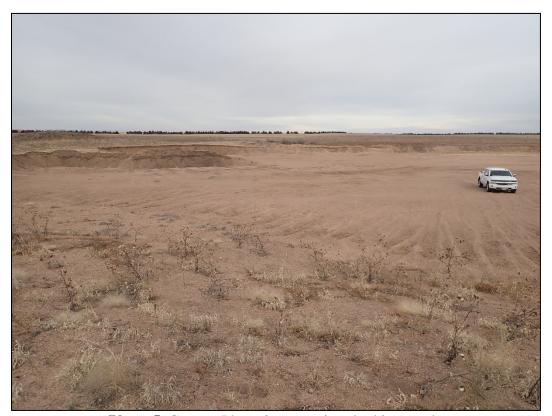
**Photo 5.** Current Phase 2 excavation; looking north.

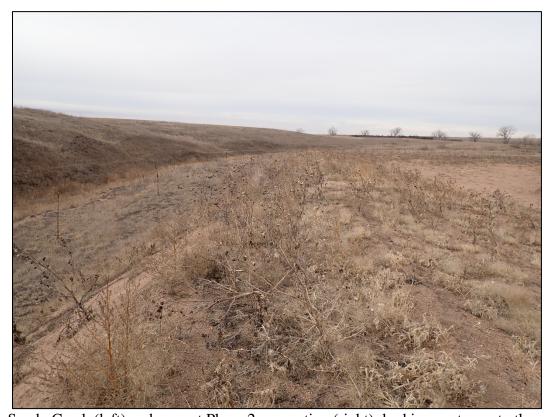
**Photo 6.** Sandy Creek (left) and current Phase 2 excavation (right); looking upstream to the southwest.

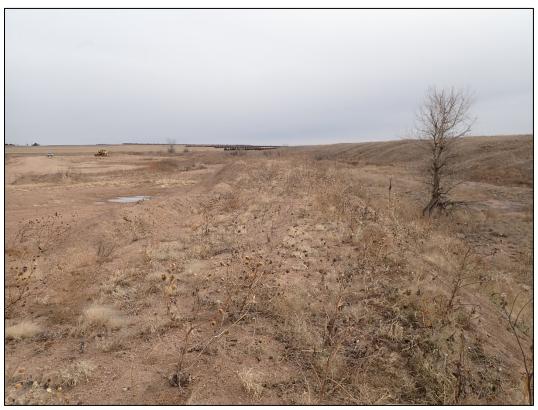
Photo 7. Sandy Creek (right) and current Phase 2 excavation (left); looking downstream to the northeast.
