MINERALS PROGRAM INSPECTION REPORT
PHONE: (303) 866-3567

MINE NAME: Kurtzer Pit	MINE/PROSPECTING ID#: M-2002-053	MINERAL: Sand and gravel	COUNTY: Phillips
INSPECTION TYPE: Monitoring	INSPECTOR(S): Elliott R. Russell	INSP. DATE: January 16, 2019	INSP. TIME: 12:30
OPERATOR: John R. Kurtzer	OPERATOR REPRESENTATIVE: Ryan Kurtzer	TYPE OF OPERATION: 110c - Construction Limited Impact	
REASON FOR INSPECTION: Normal I&E Program	BOND CALCULATION TYPE: Partial Bond	BOND AMOUNT: \$9,400.00	
DATE OF COMPLAINT: NA	POST INSP. CONTACTS: None	JOINT INSP. AGENCY: None	
WEATHER: Cloudy	INSPECTOR'S SIGNATURE:

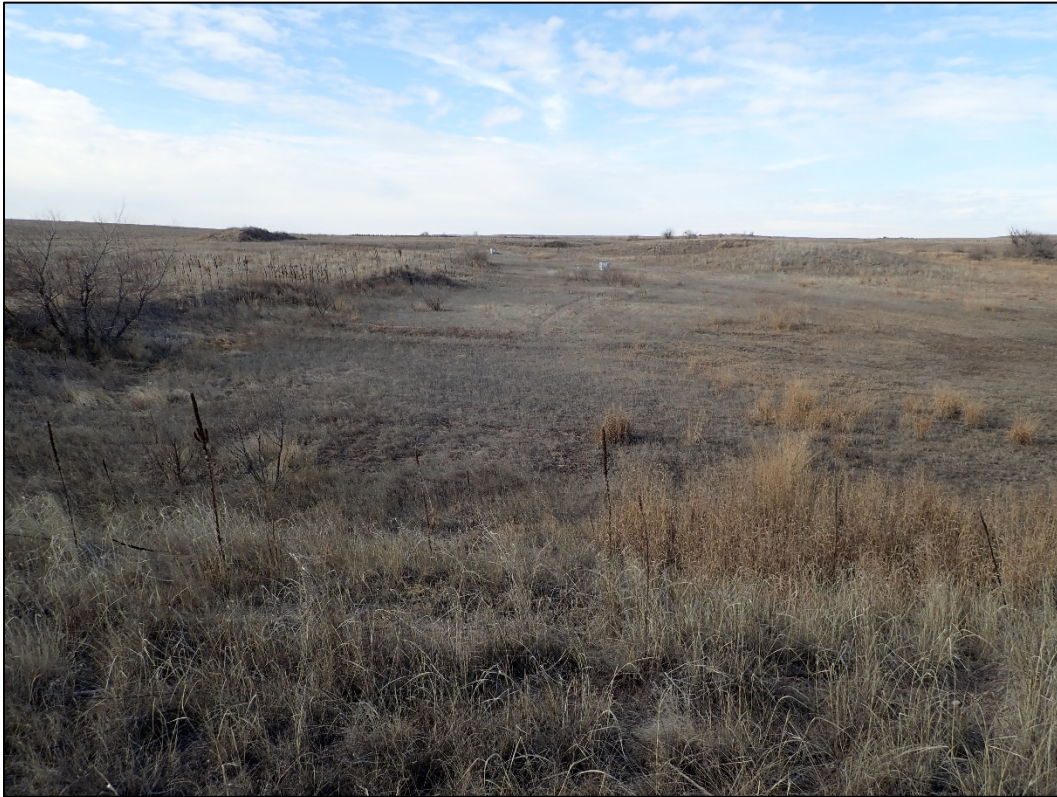
Photo 1. Site overview; looking west.

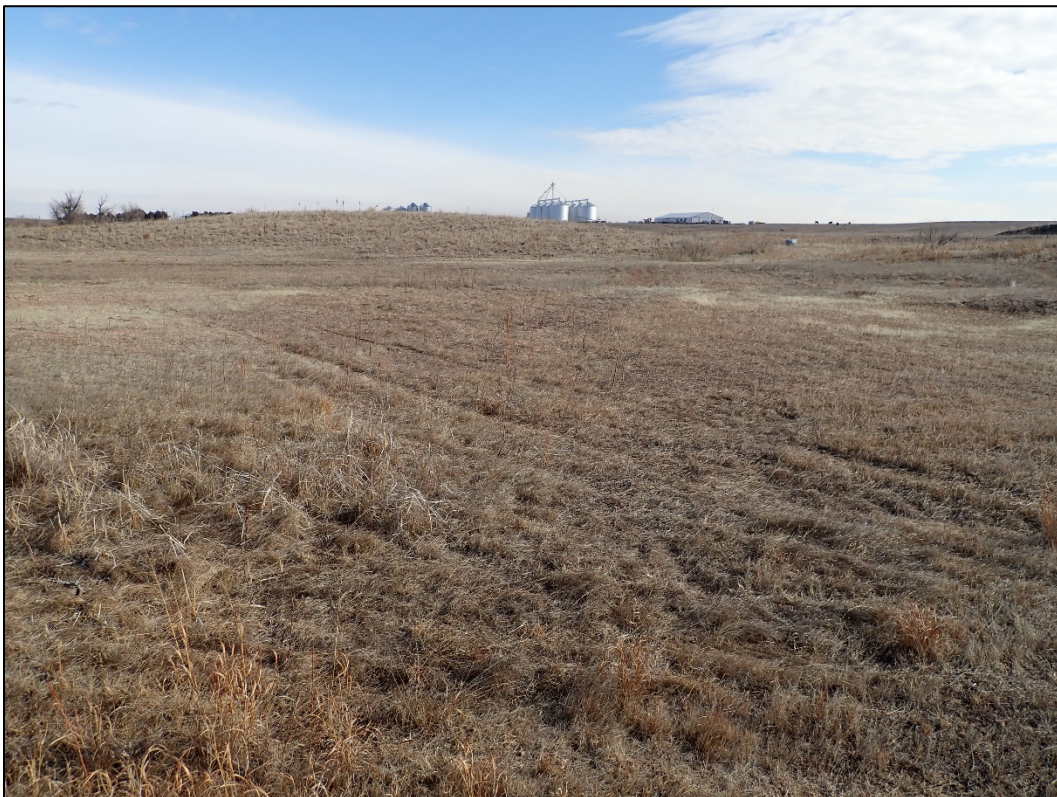
Photo 2. Site overview; looking east.

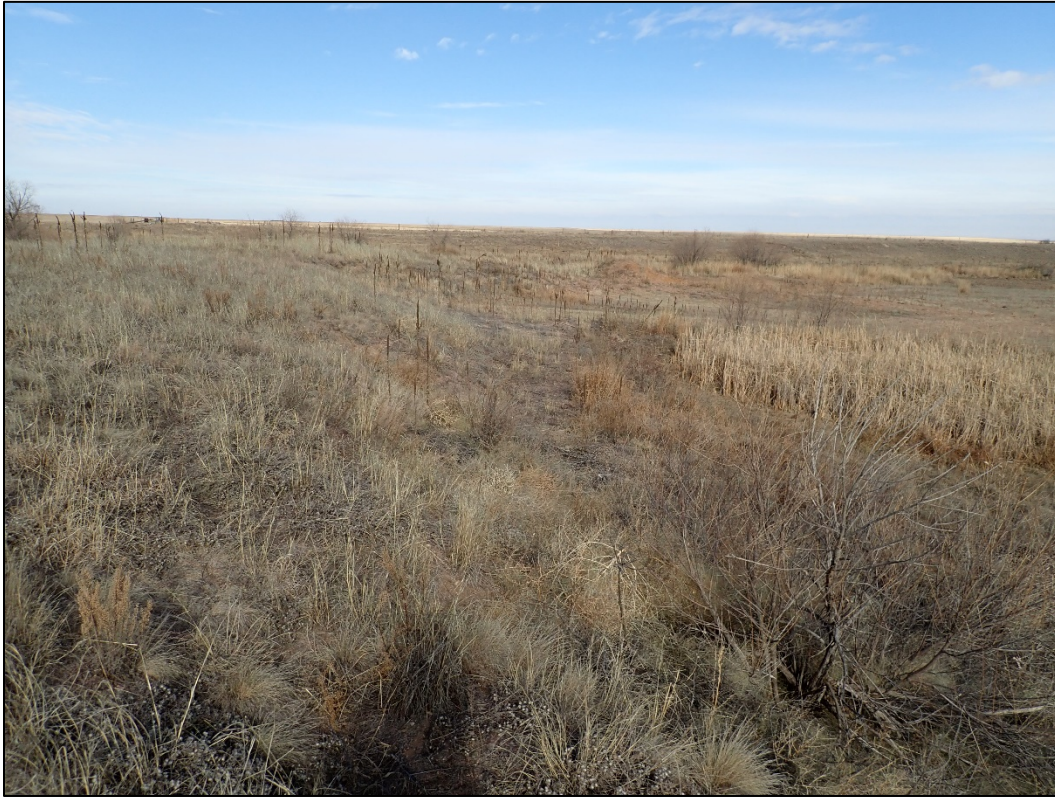
Photo 3. Far western edge of the excavation; looking north.

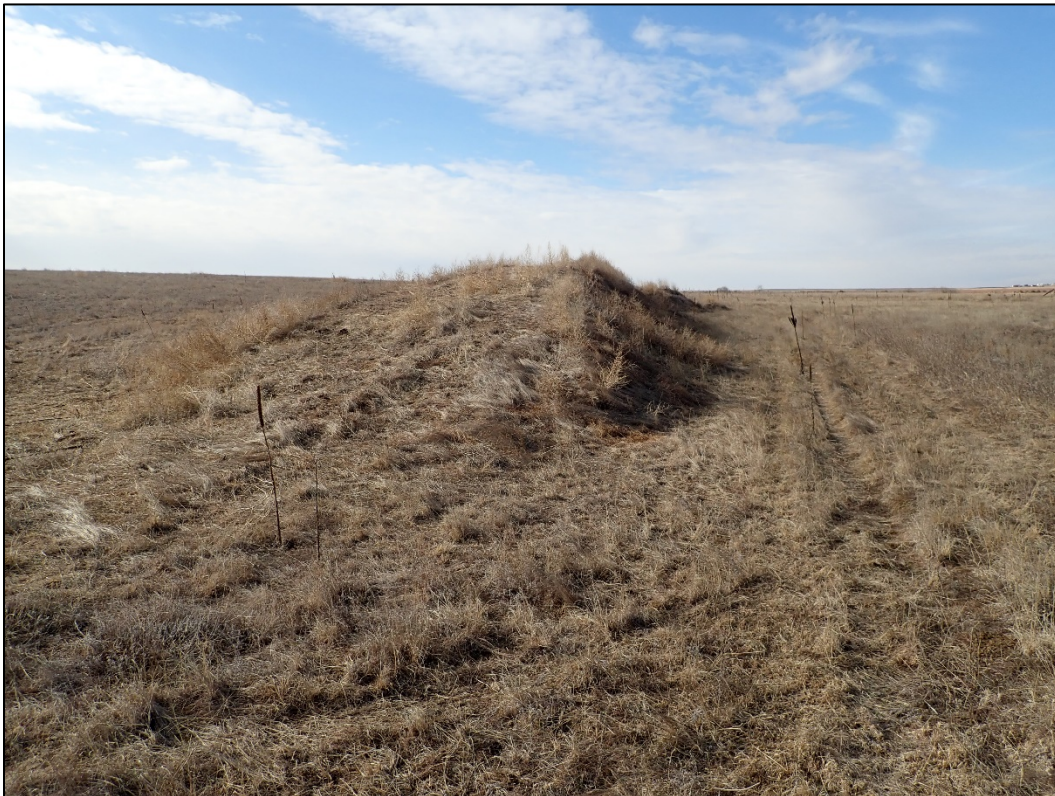
A topsoil/overburden stockpile was located south of the excavation. The Operator, who is also the landowner, expressed he would like to use this material for various projects located on their property in the future. As this stockpile is stabilized with vegetation, the Division can allow this stockpile to remain without having the Operator relocate it off-permit as this activity would create more disturbance, which would then need to be reclaimed. The Division believes this change to the Reclamation Plan is minor and does not need to be submitted as a Technical revision.

Photo 4. Topsoil stockpile to remain; looking west.

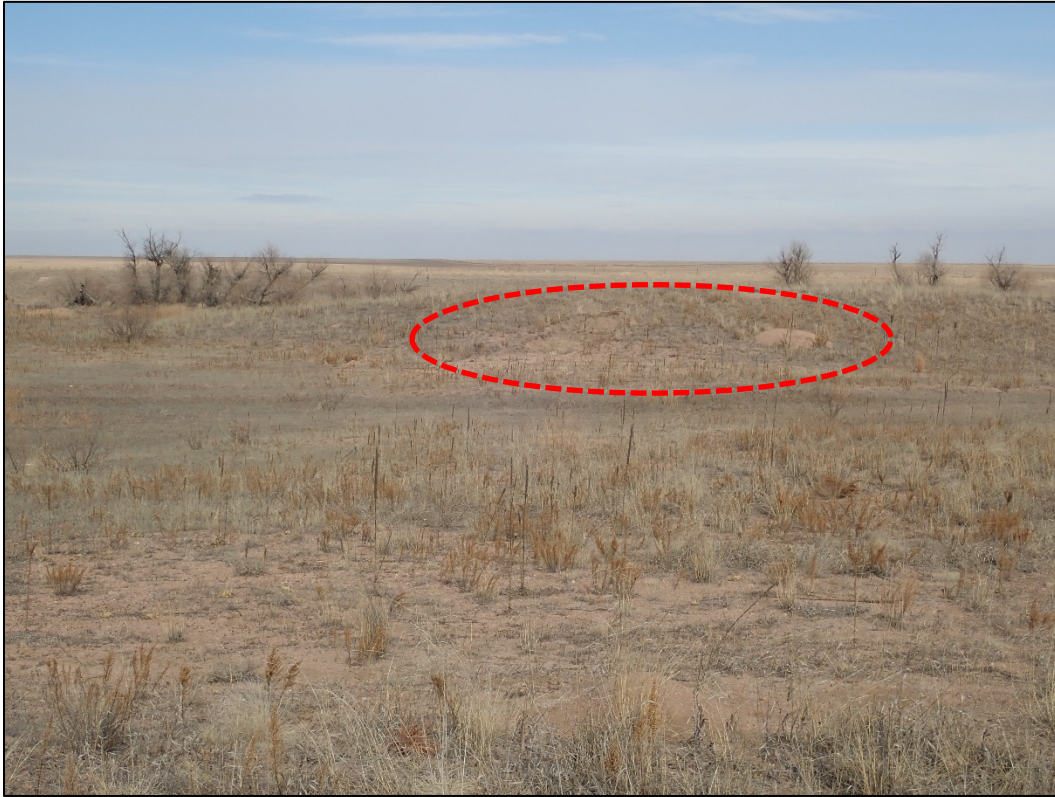
Photo 5. Recent disturbances needing additional reclamation work; looking north.

The Division observed several small recent disturbances which need to be backfilled/graded and then seeded. Since these areas are quite small, the Division believes if the Operator completes the work and the re-seeded areas begin to germinate, the Division could evaluate the site for release. The Operator will need to submit the enclosed release request form to initiate the release process, whereas the Division will inspect the site with 60 days after the request is received.
