**MINERALS PROGRAM INSPECTION REPORT**  
**PHONE: (303) 866-3567**

<b>MINE NAME:</b> River Road Pit	<b>MINE/PROSPECTING ID#:</b> M-1991-136	<b>MINERAL:</b> Sand and gravel	<b>COUNTY:</b> Mesa
<b>INSPECTION TYPE:</b> Monitoring	<b>INSPECTOR(S):</b> Amy C. Yeldell	<b>INSP. DATE:</b> May 29, 2019	<b>INSP. TIME:</b> 10:00
<b>OPERATOR:</b> Oldcastle SW Group, Inc. dba United Compai County	<b>OPERATOR REPRESENTATIVE:</b> Jason Burkey	<b>TYPE OF OPERATION:</b> 112c - Construction Regular Operation	
<b>REASON FOR INSPECTION:</b> Normal I&E Program	<b>BOND CALCULATION TYPE:</b> Complete Bond	<b>BOND AMOUNT:</b> \$18,705.00	
<b>DATE OF COMPLAINT:</b> NA	<b>POST INSP. CONTACTS:</b> None	<b>JOINT INSP. AGENCY:</b> None	
<b>WEATHER:</b> Clear	<b>INSPECTOR'S SIGNATURE:</b>

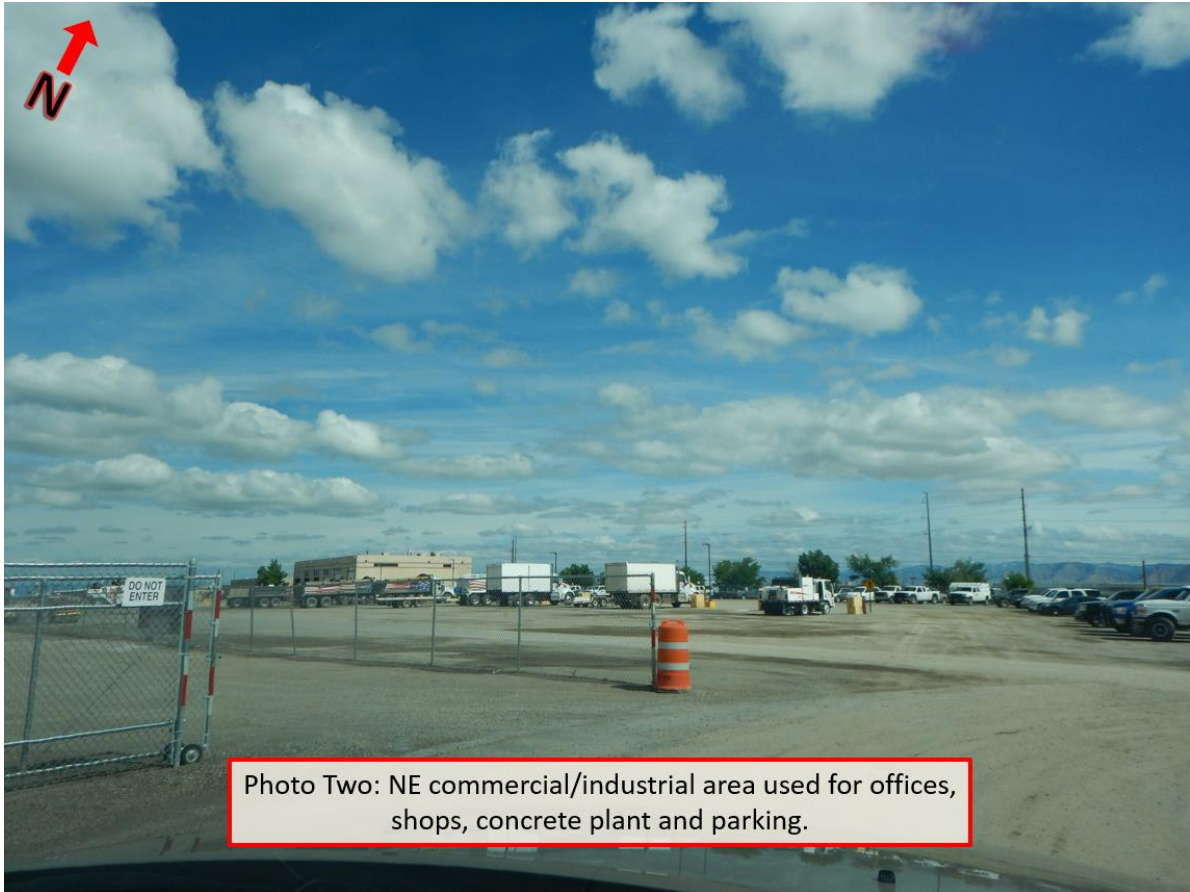
This site is mined out but is still actively being used. The post mining land use is commercial industrial. Currently the front (northeastern) 13 acres is being utilized for offices, shops, concrete plant and parking. The excavated pit area has continuing to be dewatered and used for stockpile storage and other miscellaneous material storage. In the southeastern corner of the pit on an elevated pad is the permanent asphalt batch plant with an additional scale for access to 22 ¾ Road. In general access roads and permanent processing areas appear to conform with the approved reclamation plan (AM-2).

Photo Two: NE commercial/industrial area used for offices, shops, concrete plant and parking.

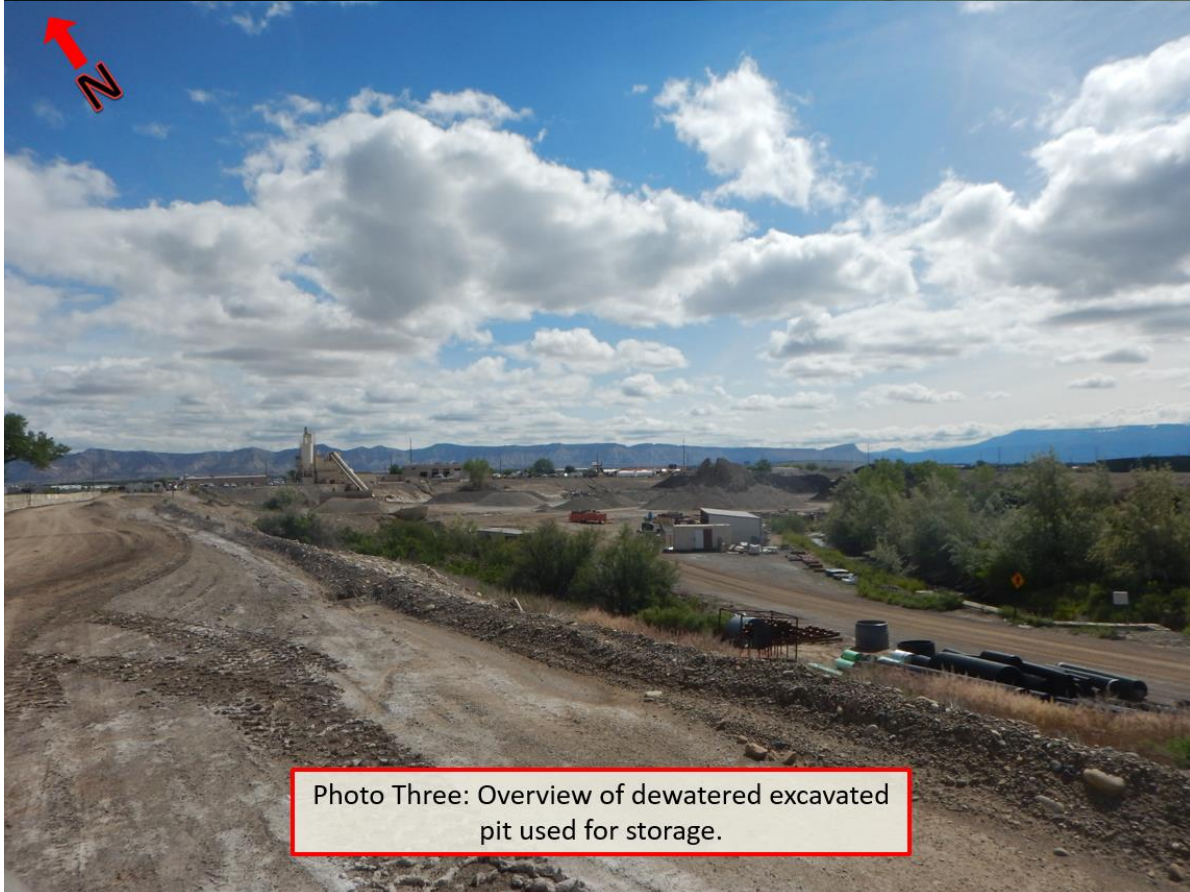
Photo Three: Overview of dewatered excavated pit used for storage.
