**COLORADO**Division of Reclamation,
Mining and Safety

MINERALS PROGRAM INSPECTION REPORT**PHONE: (303) 866-3567**

MINE NAME: Davis Pit	MINE/PROSPECTING ID#: M-2002-062	MINERAL: Sand and gravel	COUNTY: Prowers
INSPECTION TYPE: Monitoring	INSPECTOR(S): Amy Eschberger	INSP. DATE: March 26, 2019	INSP. TIME: 11:15
OPERATOR: Prowers County	OPERATOR REPRESENTATIVE: Mark Dorenkamp	TYPE OF OPERATION: 112c - Construction Regular Operation	
REASON FOR INSPECTION: Normal I&E Program	BOND CALCULATION TYPE: None	BOND AMOUNT: \$0.00	
DATE OF COMPLAINT: NA	POST INSP. CONTACTS: None	JOINT INSP. AGENCY: None	
WEATHER: Clear	INSPECTOR'S SIGNATURE:

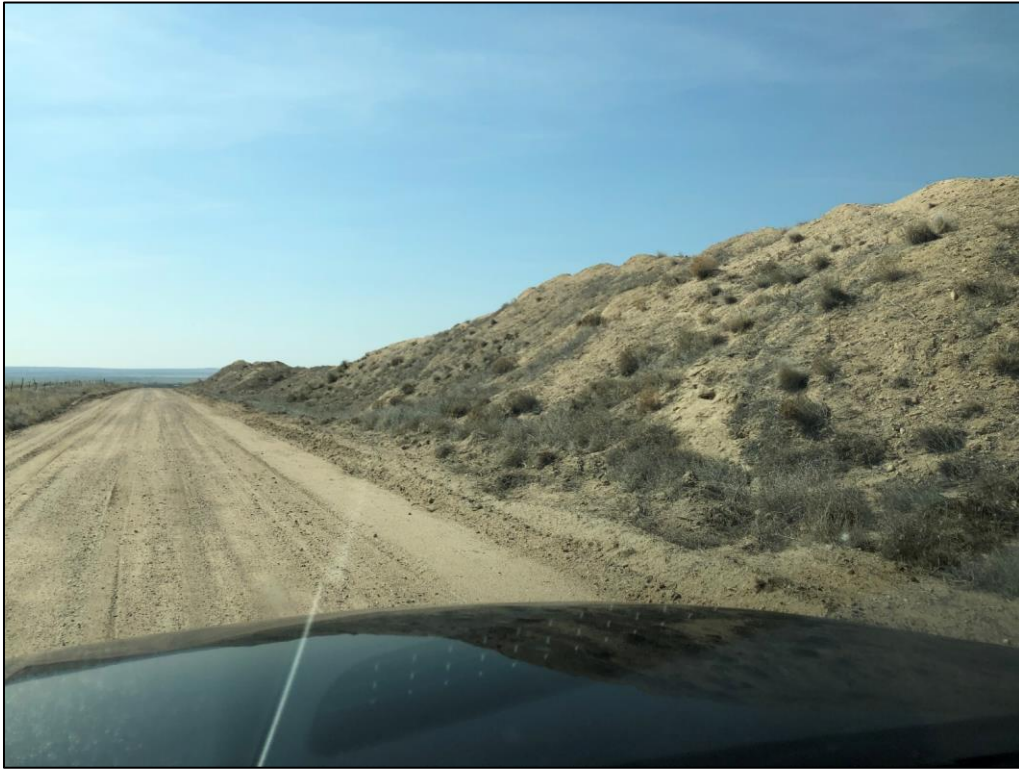
Photo 1. View looking south showing large topsoil stockpiled stored adjacent to access road.

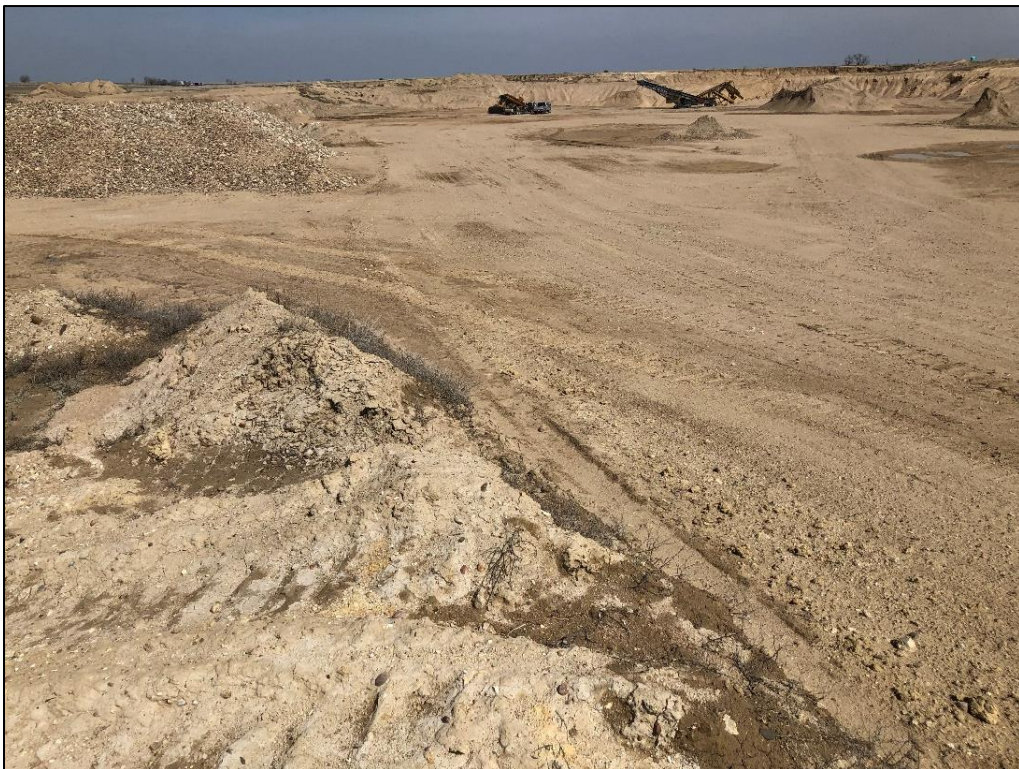
Photo 2. View looking north across pit located in south-central portion of permit area.

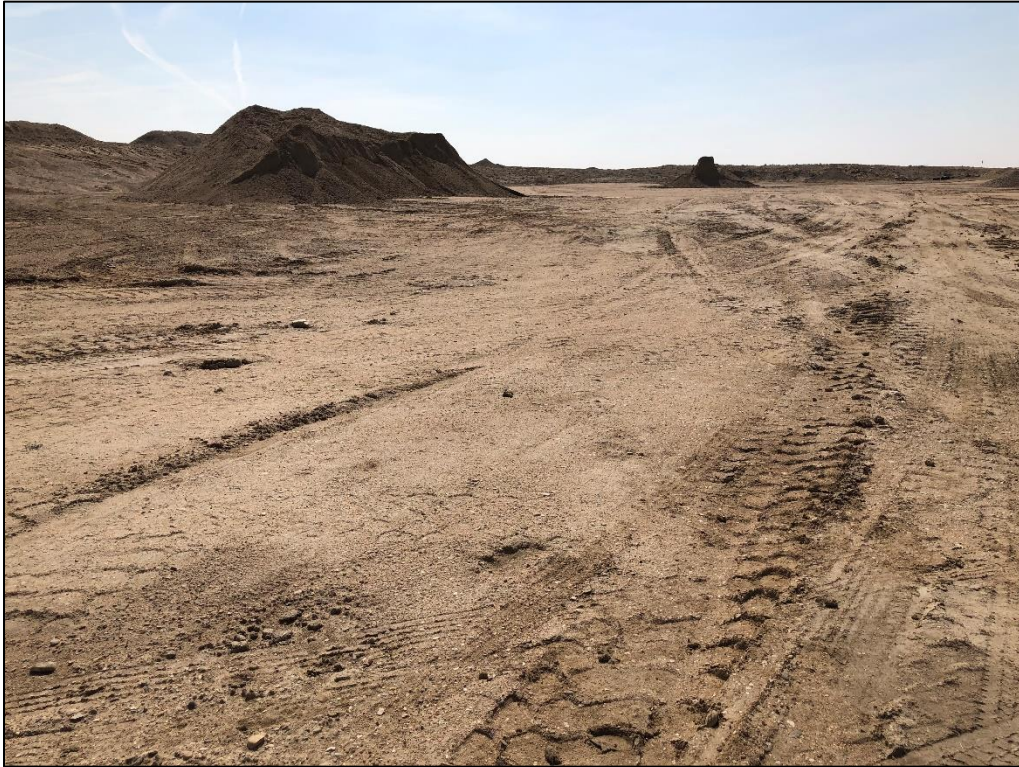
Photo 3. View looking southeast across pit showing material stockpiled on pit floor.

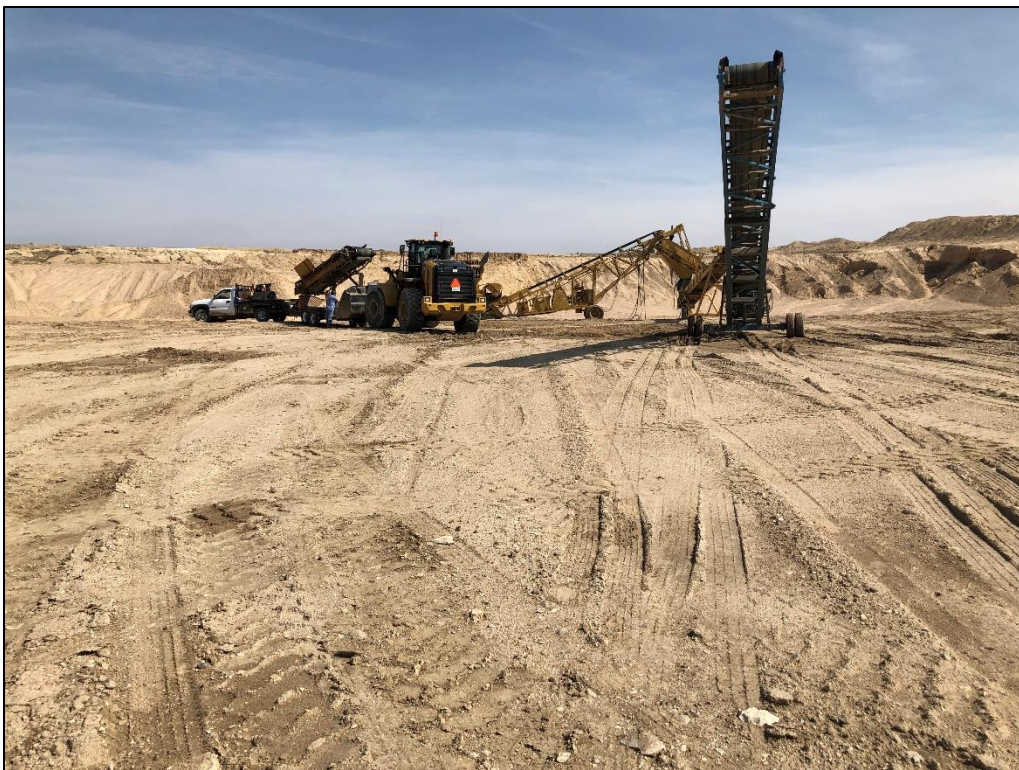
Photo 4. View looking north across pit showing mine equipment present on pit floor.

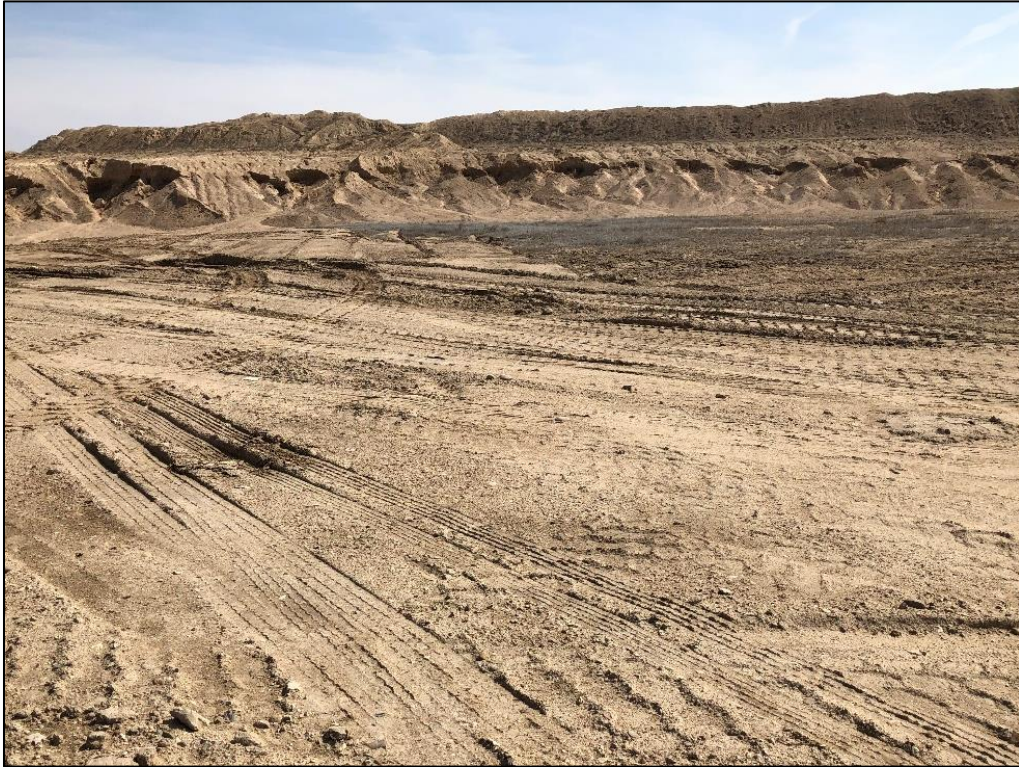
Current disturbance is located in the south-central portion of the permit area. The operation is advancing the pit generally northward at this time. The pit daylights primarily to the west and south, with a highwall that is approximately 10-12 feet in height. The Division estimates the highwall to be approximately 1,000 feet in length, with slopes ranging from 1.5H:1V to flatter than 3H:1V. The pit has reached its limits to the east. The western edge of the pit is currently 200 feet from the adjacent creek, which is greater than the 100 foot setback committed to in the permit. Several material stockpiles are stored on the pit floor. Large topsoil stockpiles are stored along the eastern edge of the pit, adjacent to the access road. Additional topsoil is stockpiled adjacent to an approximately 2 acre area just north of the pit which has been stripped in preparation for mining. A small caliche pit is located at the southwestern edge of the larger pit, and is approximately 5 feet in depth.

Photo 5. View looking east at eastern highwall approximately 10-12 feet in height with slopes ranging from 1.5H:1V to flatter than 3H:1V.

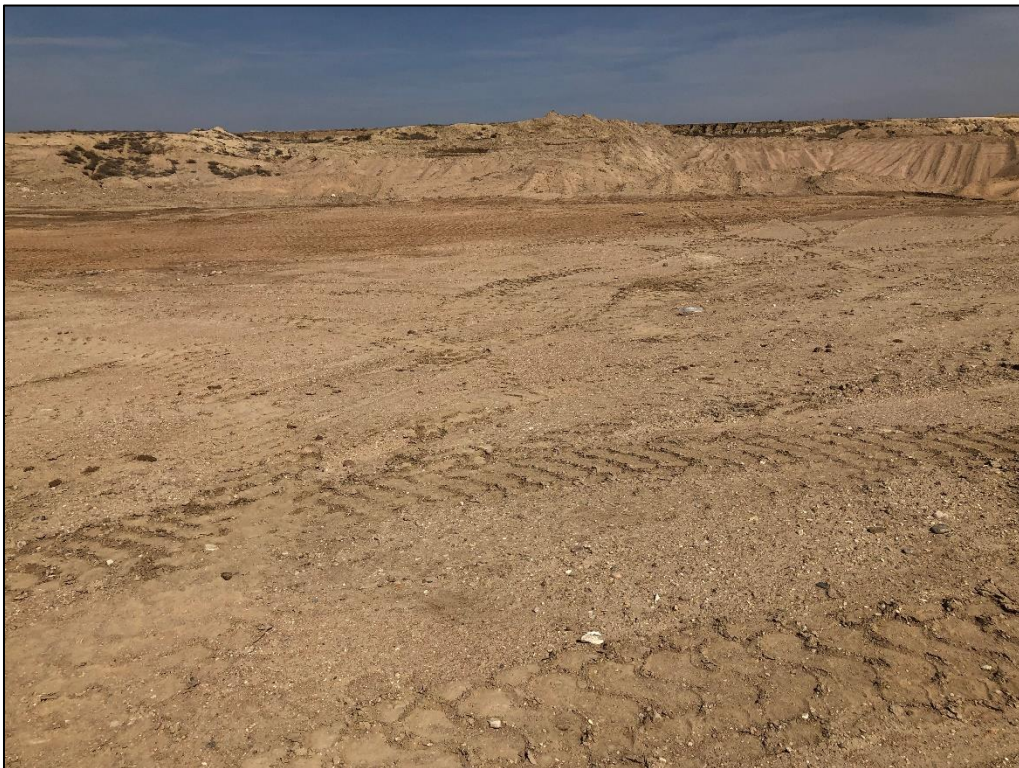
Photo 6. View looking north at northern highwall approximately 10 feet in height with slopes ranging from 2.5H:1V to flatter than 3H:1V.

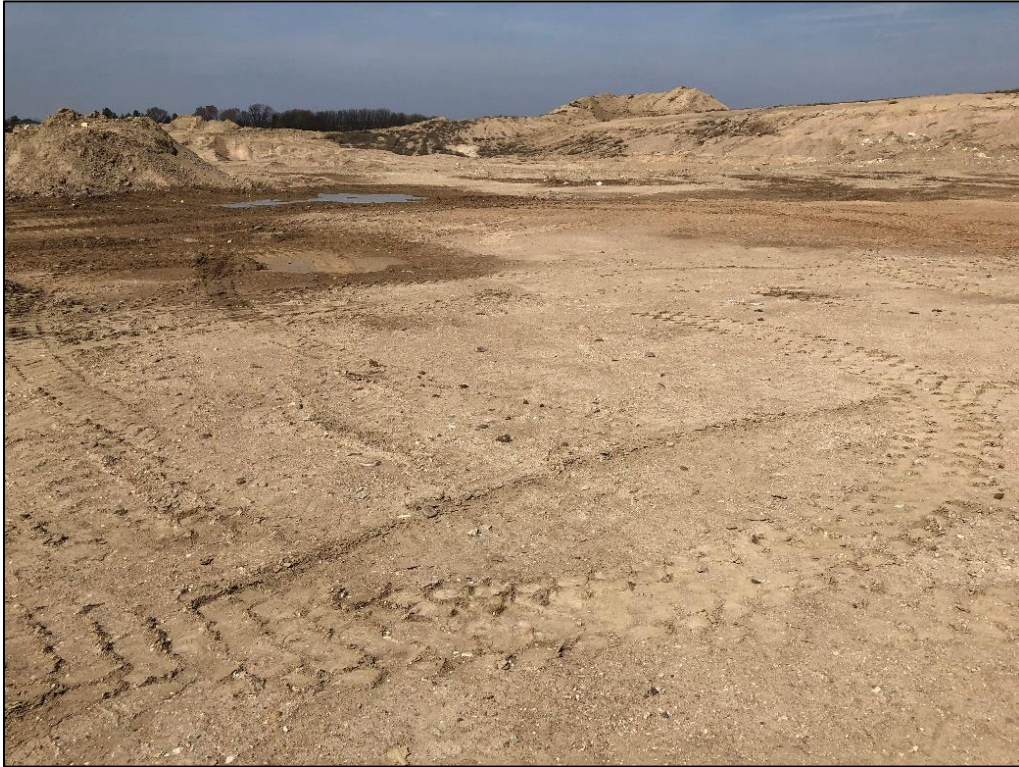
Photo 7. View looking northwest at northwestern portion of pit with highwalls graded 2.5H:1V to flatter than 3H:1V.

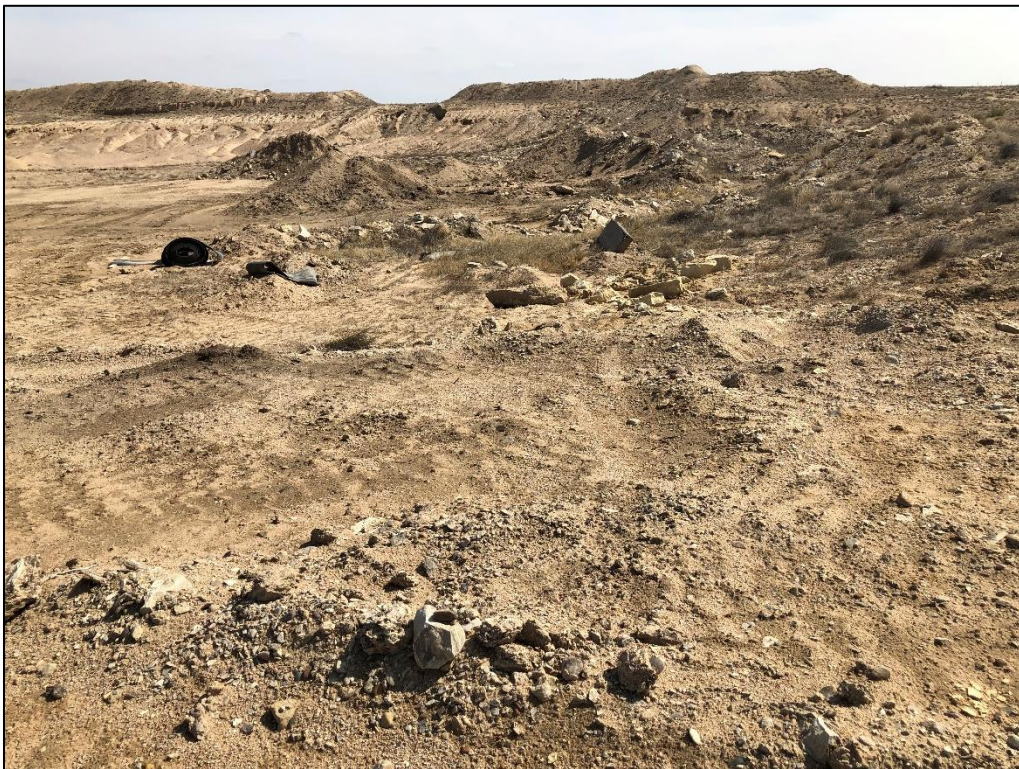
Photo 8. View looking east at southern edge of pit.

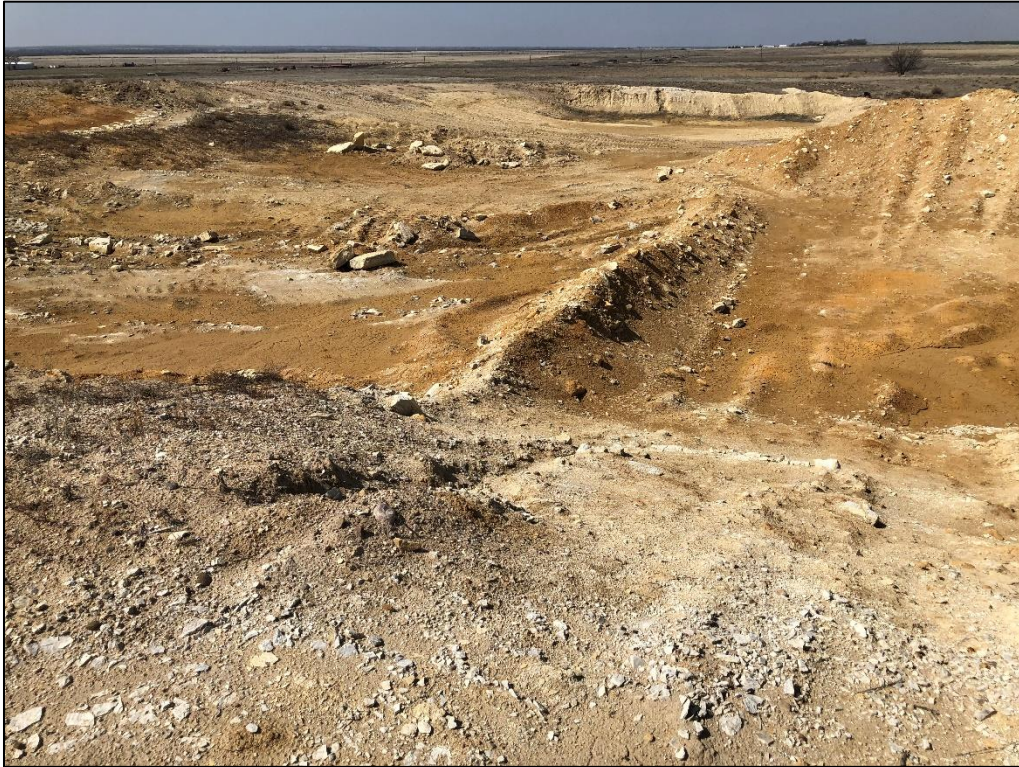
Photo 9. View looking west at small caliche pit at southwestern edge of larger pit.

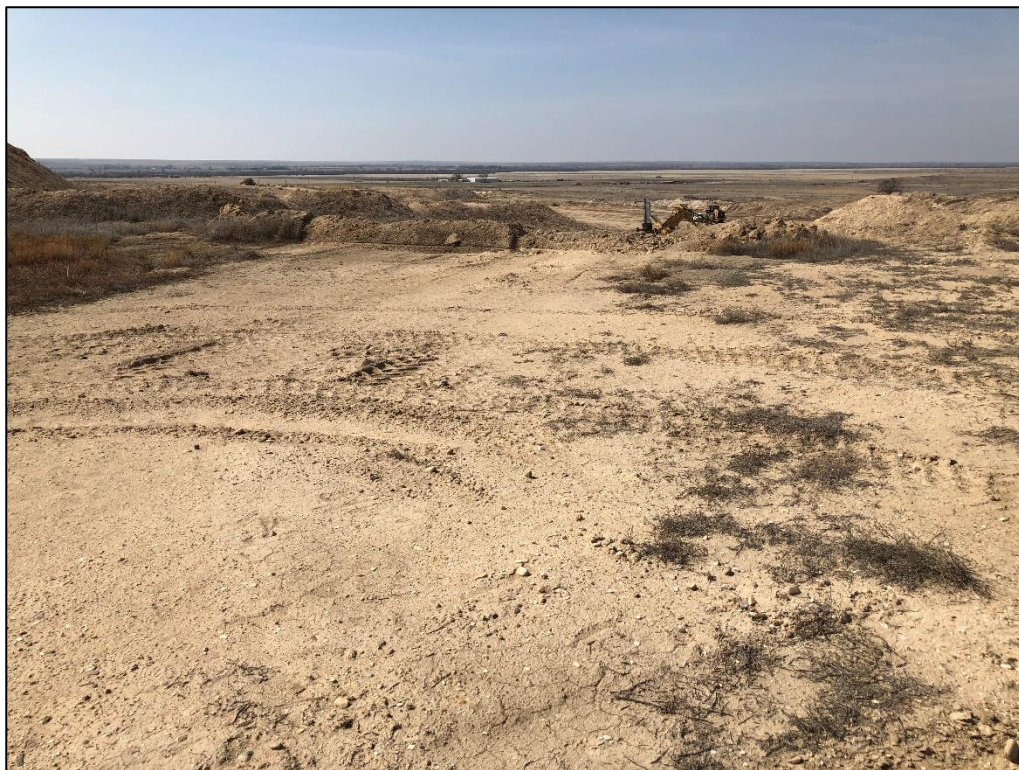
Photo 10. View looking west across area north of pit where topsoil has been stripped (and stockpiled nearby) in preparation for mining.
