Solid Minerals Inspection Report

Type of Operation	3809 Plan of Operations	Project Name	Sunday Mines Complex West Sunday, Topaz
Serial Number	COC-53227, COC-52049	Company/Org.	PINON RIDGE MINING LLC PO BOX 825 NUCLA CO 81424- 0825
Inspection Date	05/29/2019	Others Present	Lucas West, CDRMS Michael Rutter, Pinon Ridge
Inspection Time	10 AM	Inspected By	James Blair
Report Date	05/31/2019	Legal	T44N, R18W, multiple sections

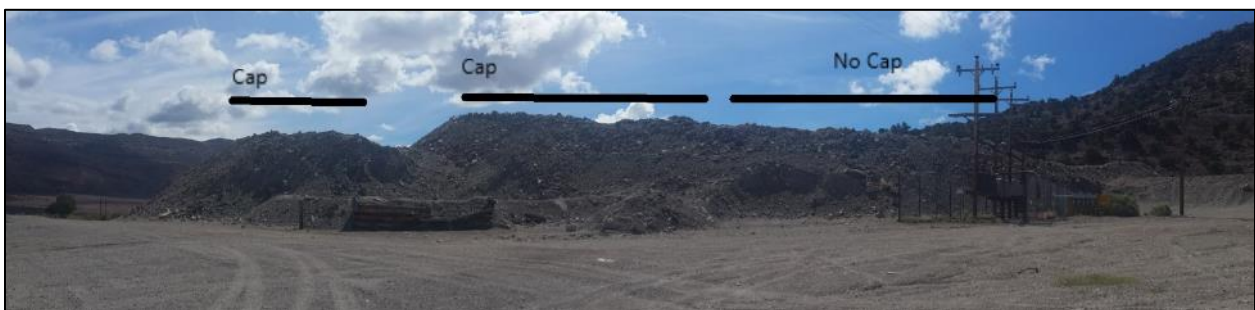
Figure 2: Panoramic photograph looking east from map 2 point 1 showing the low-grade stockpile on the east end of the Sunday's surface facilities that will be capped with barren waste rock. Also visible is de-energized transformer substation for the Sunday. There are no plans to re-energize the substation.

- Place earthen cap on low-grade stockpile on eastern end of Sunday Mine, as discussed by CDRMS.
- Fix broken windows and doors on all buildings at the Sunday Mines Complex. Consider covering windows on buildings that may be used in the near future with expanded metal. Consider boarding up broken windows and or doors on buildings that do not need to be used in the foreseeable future.

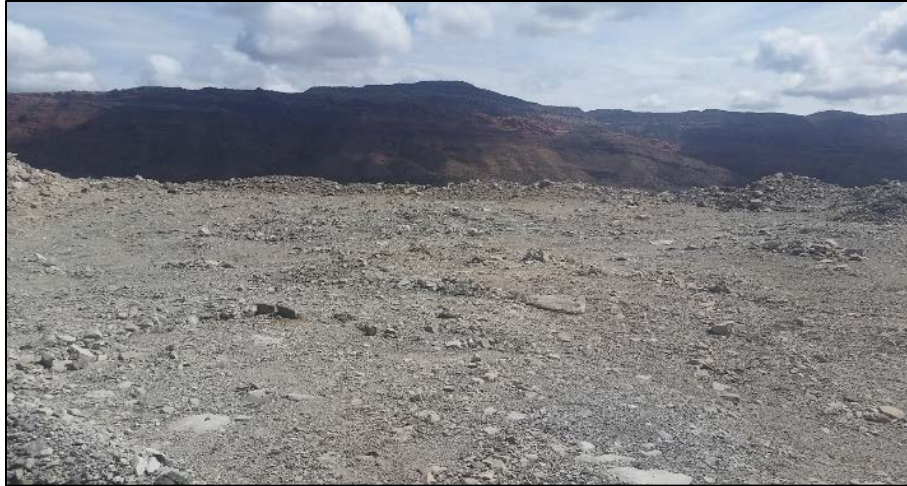
Figure 3: Looking north across the area of the low grade/waste rock stockpile that will be capped this summer.

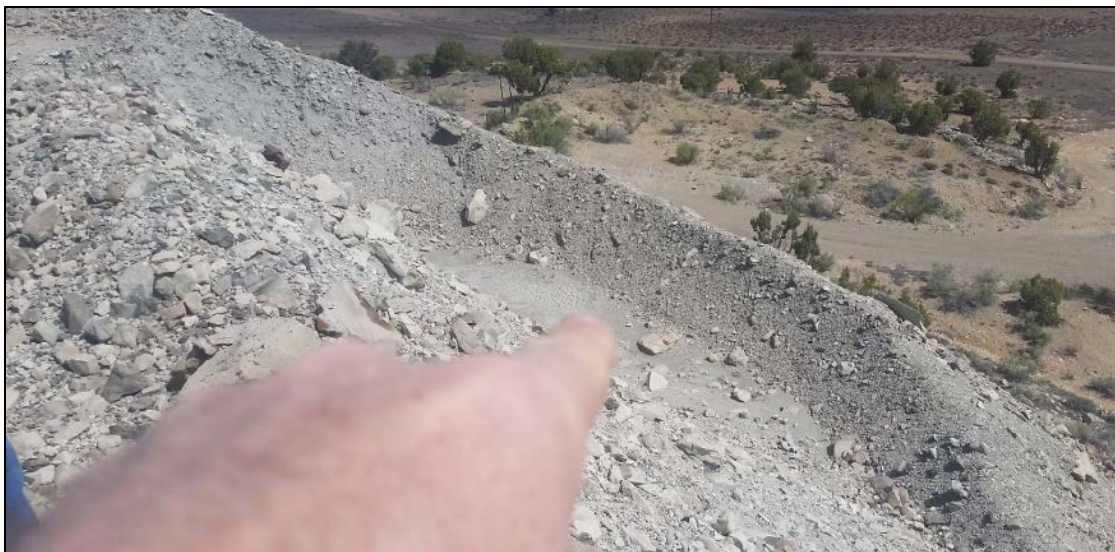
Figure 4: The northern, lower portion of the area to be capped with clean waste rock.

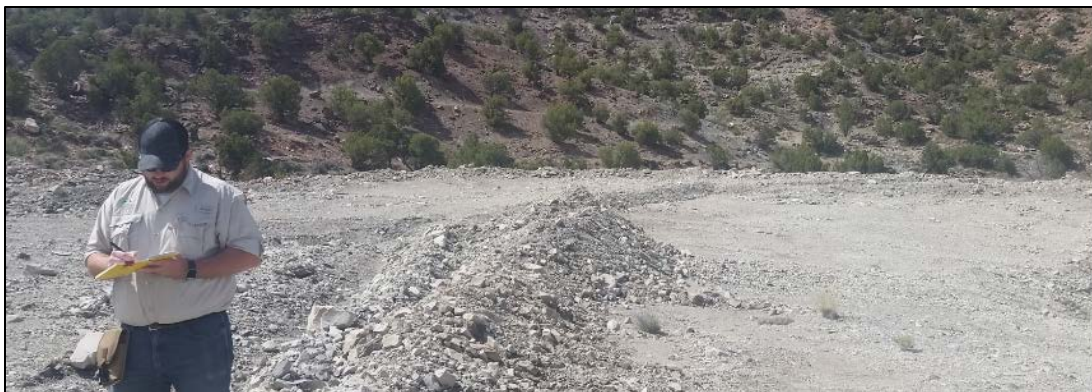
Figure 5: View looking south across the portion of the waste rock stockpile that will not be capped.

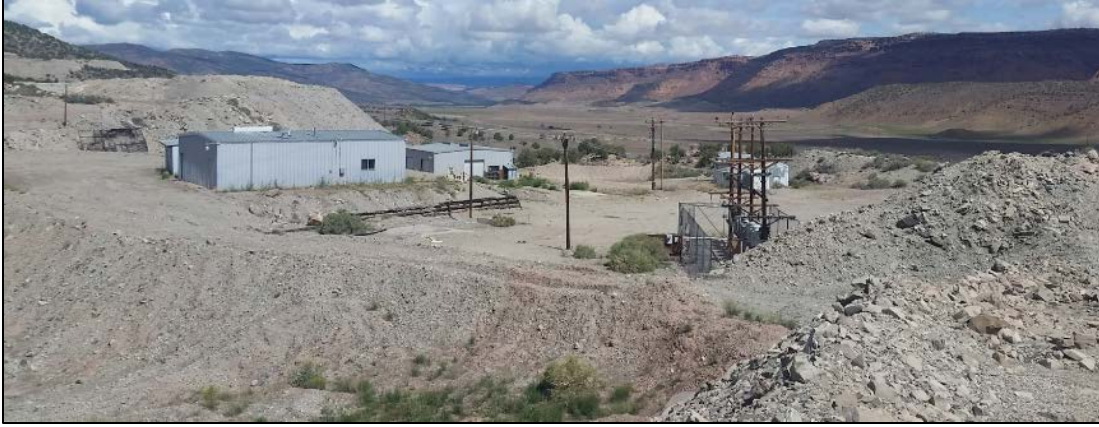
Figure 6: A view looking northwest from the waste rock pile that will be capped, across the Sunday Mine surface facilities. None of these buildings is slated to be used this year. They will be making repairs to the building. It seems that several windows and doors were vandalized over the winter. Some building appear to have also sustained some wind damage. On the left is one of the large storm water control basins. There was no standing water in. In the upper left we can see the West Sunday (farthest) and St. Jude Mines. The Carnation is very small and occupies the mid-ground between the Sunday and St. Jude. It is not visible in this photo because it is obscured by the clean waste rock dump that will be used as a source for the cap material.

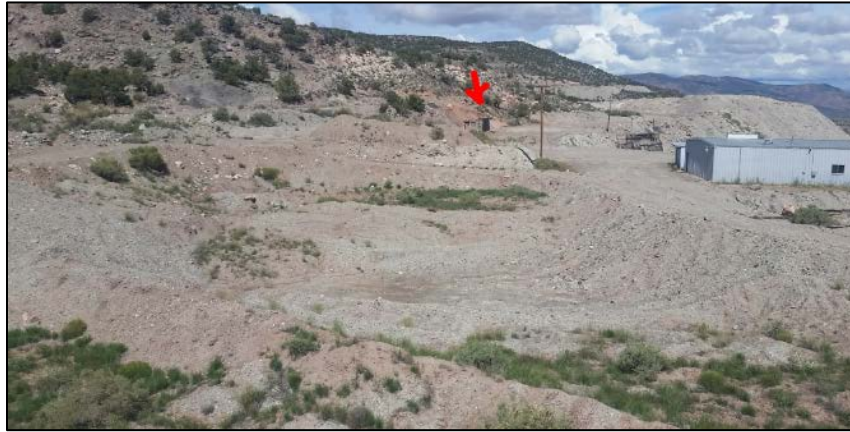
Figure 7: This is similar to the previous photo, except that it shows the Sunday Mine portal (red arrow), and gives a fuller view of the large stormwater impoundment structure (foreground).

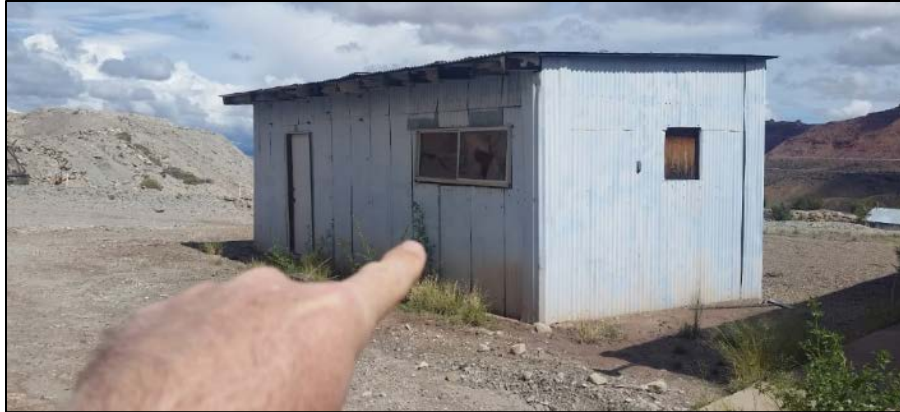
Figure 8: Broken windows and door in one of the outbuildings at the Sunday mine. I believe that this building was a scale house at one time. Will check to see if a sprung door is acceptable for an empty building in lieu of a lock, alternately consider tearing building down if not needed.

- Look into spring loaded, unlocked doors, rather than locking doors to prevent activity.
- Consider tearing down any utility buildings that are not expected to be used in the future.

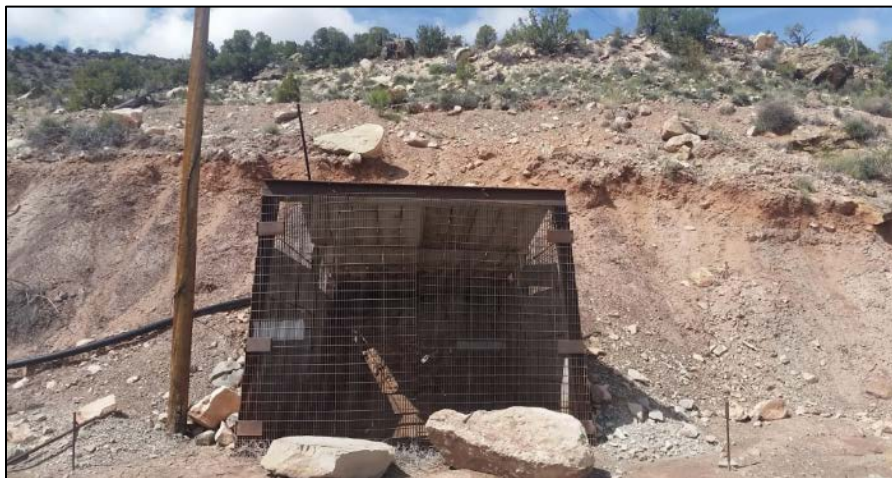
Figure 9: The Sunday Mine Portal, view looking south. The portal has been backfilled with rock for approximately 20 feet, and is also gated. This portal will be opened up this summer, but it will only be used as a secondary escape way and ventilation draw point.

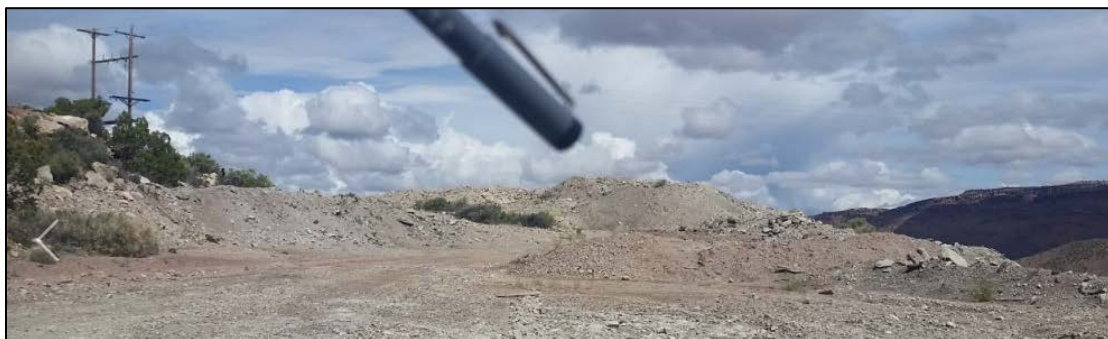
Figure 10: The pen cap in this photo shows where clean material from the NW end of the mine area will come from to build the cap on the SE corner. The view is looking towards the NW.

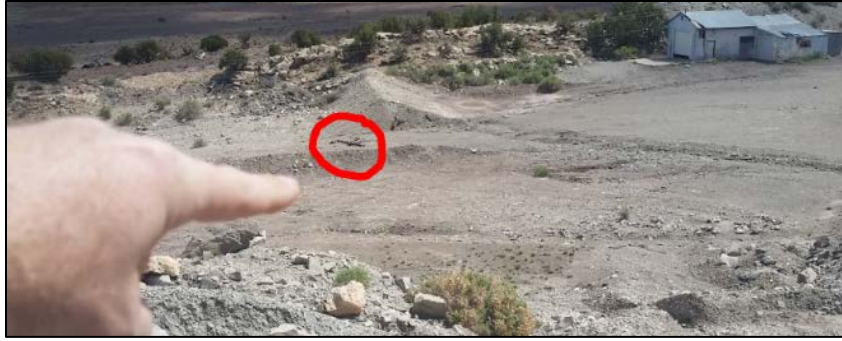
Figure 11: Looking NE across Sunday from western dump. The red circle shows some pipe that needs to be cleaned up.

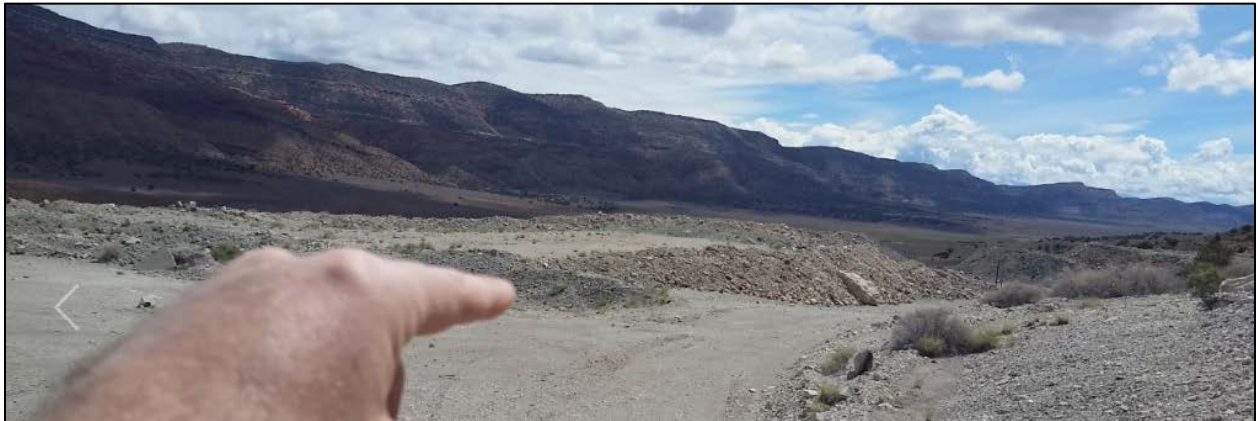
Figure 12: View of the cap material source pile looking from the NW to the SE.

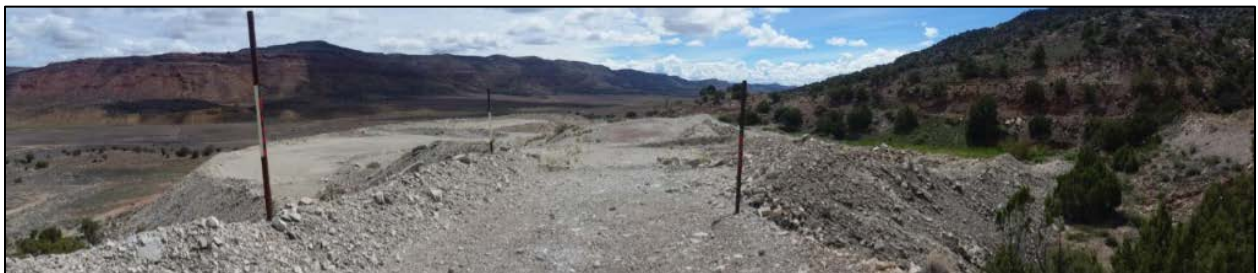
Figure 13: A panoramic view of the Sunday from the westernmost end looking NE.

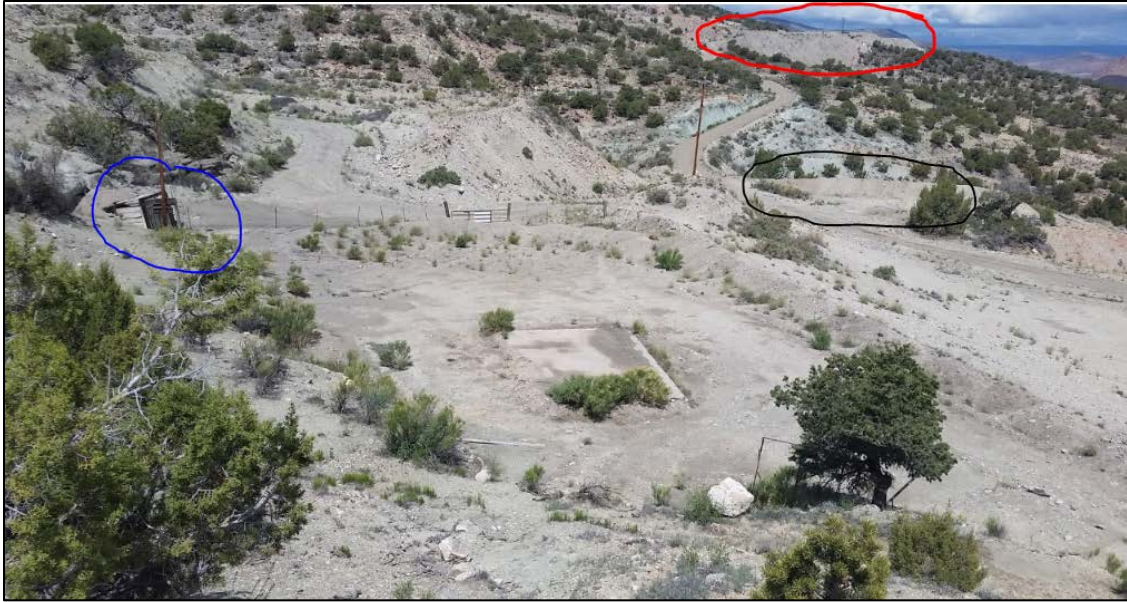
Figure 14: A view of the Carnation Mine (portal in blue circle). The only use for this is an alternate escapeway. Everything beside the portal should be reclaimed, as should the portal if they decide that they no longer need it. The pad in the foreground was probably for scales or a hopper. The black circle is a storm water pond that I have seen brim full or breached before, but today it is bone dry inside, despite it having appeared to have rained only a few days prior. The red circle is the St. Jude Mine. The county road that goes over Gyp Ridge is in the mid-ground.

- Pick up all trash and junk on mine sites, particularly those identified in the captioned photos in this report.
- Consider completing reclamation at the Carnation Mine, if no longer needed for an escape way.

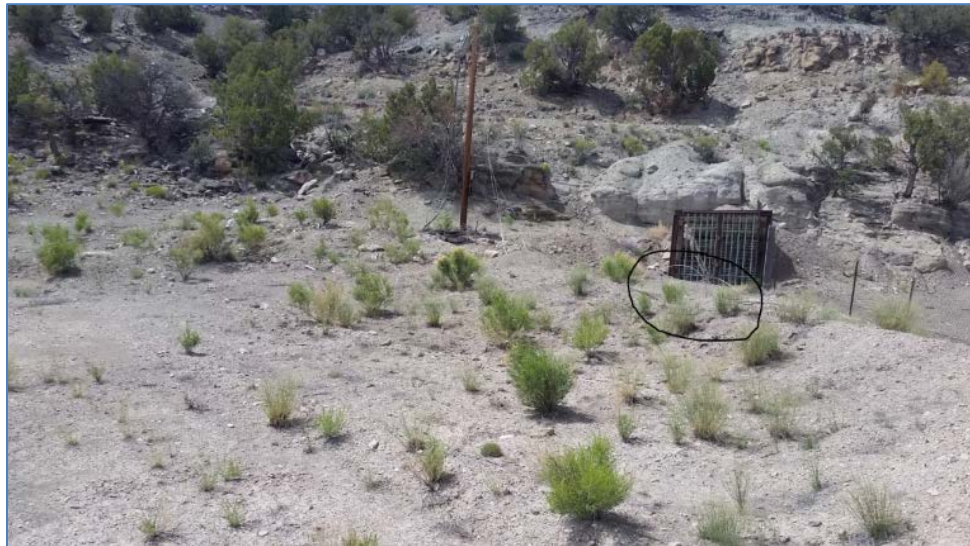
Figure 15: A view across the Carnation pad towards the portal. The Carnation mine is treated as part of the same mine BLM mine plan as the Sunday and St. Jude, but as it's own separate CDRMS plan. It has only been used as a secondary escape way for a long time, which is why there is so little development rock in front of it. Pinon Ridge should complete reclamation of the pad, if it is no longer to be used for mining purposes, and if the portal is no longer needed as an escape way, then it should be reclaimed as well. The black circle shows some old electrical transmission wire that needs to be removed from the site. There were very few weeds on site at the time of the inspection. Vegetation is relatively sparse, which is typical of these rock dumps absent any growth media or soil amendments. This site could be a good test plot for what reclamation practices can be employed at the much larger adjacent mine sites.

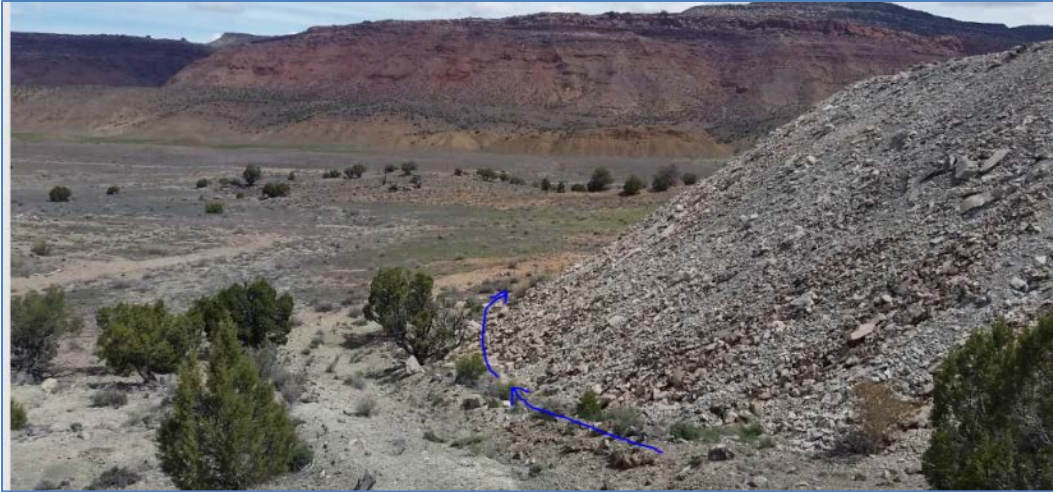
Figure 16: After inspecting the Carnation mine, we walked back along the toe of the Sunday dump. There was no sign of seeps at the toe of the dump. There was one place where there was substantial erosion that was caught by the secondary containment berm. I believe this erosion dated back to a documented storm event in 2014, caused by a breach in the berm at the top of the dump, which was subsequently fixed. I think the erosion has been arrested by repair of the berm, but will continue monitoring to see if it continues. The blue arrow shows the path we walked back to the entrance of the mines.

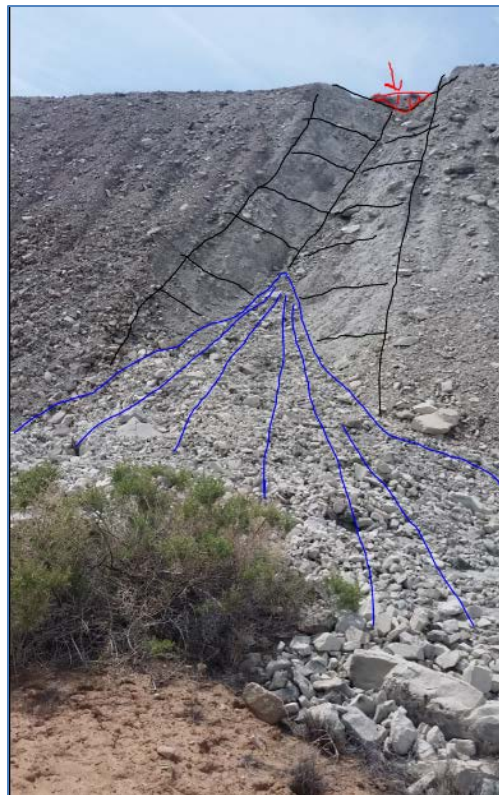
Figure 17: Erosion on the dump face caused by water flow off the top of the dump, through a breach in the top-berm during a 2014 storm water event. The black lines show the erosion excavated from the dump face. Blue lines show where the eroded material came to rest in an alluvial fan-type deposit. The red arrow at the top shows where the berm eroded and was subsequently repaired. Repairing the berm arrested any substantial subsequent erosion.

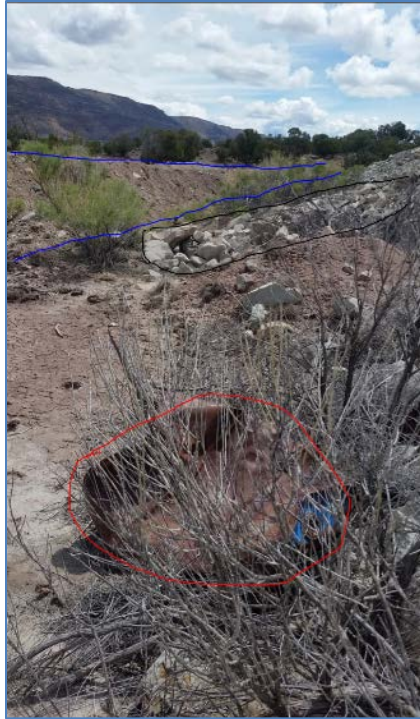
Figure 18. A view looking east along the toe of the Sunday Dump. The blue lines show the secondary containment berm at the toe. The black line circles material that eroded off the top of the dump and deposited at the bottom (see last photo). The black line shows a crushed 55 gallon drum. The drum will need to be picked up and disposed of. There was no sign of oil staining next to the drum, or indication that it contained any product.

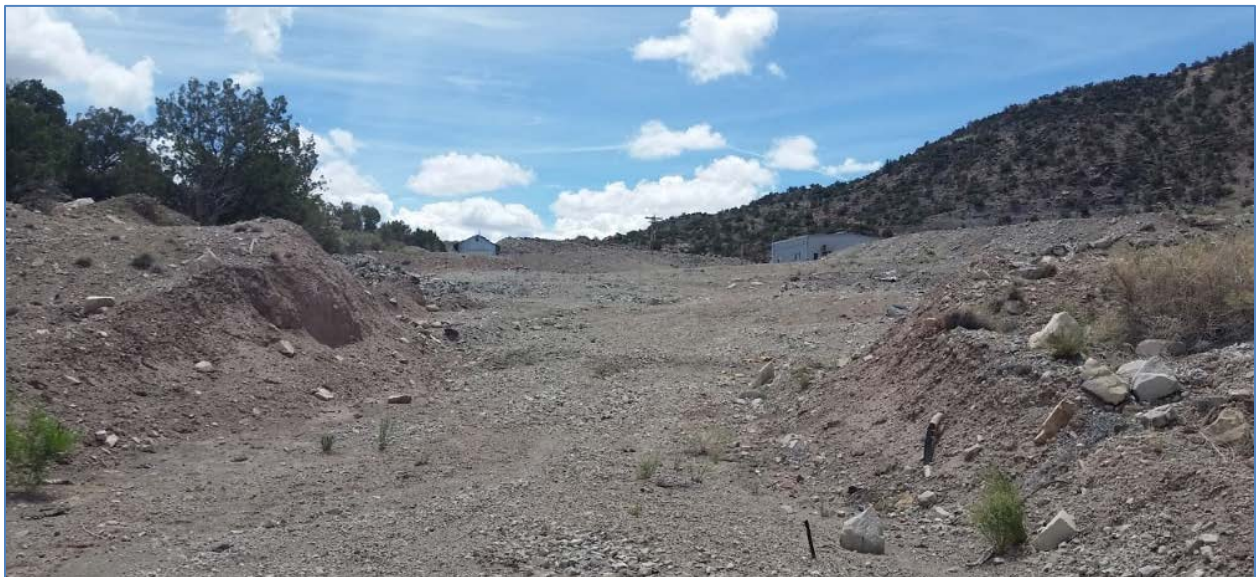
Figure 19: View looking east from the lowermost Sunday catchment basin, towards two of the Sunday Mine shop structures. Scraps of wire, drill steel and other scrap that were dumped with run of mine waste years ago now weather out to the dump, and need to be picked up on an ongoing basis.

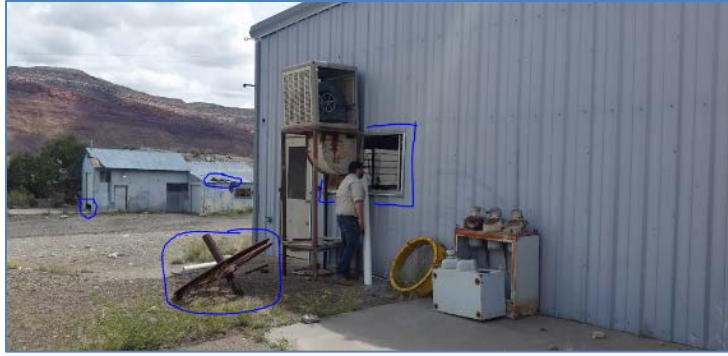
Figure 20 A view looking northeast at 2 shop buildings on the Sunday Mine. These building had been vandalized over the winter. The garage door on the far building was forced up, and the window on the close building was broken. A window was broken to gain access to the other door. Neither building contained much of value, so nothing was taken, according to Mr. Rutter. He said that he planned to put some game cameras up at the site to see if trespassers can be identified. The roof on the far building has been damaged by wind. Perhaps expanded metal guards can be put over the re-glazed windows, or the windows can be boarded shut rather than left exposed until such time as operations actually begin at the Sunday.

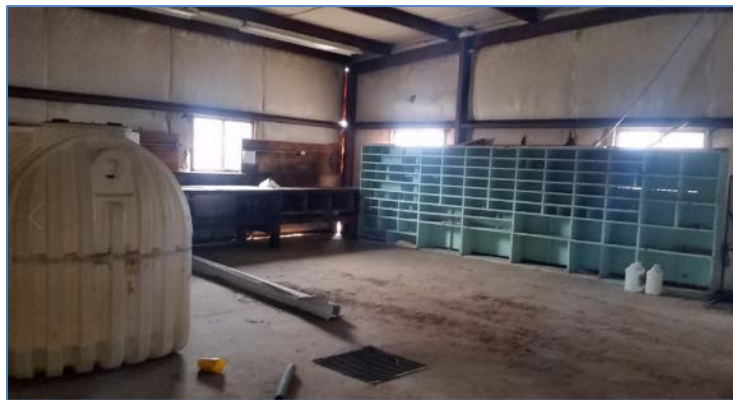
Figure 21: Inside the shop at the St. Jude Mine. This shop will be refurbished and used as the main shop/office area when the mines are reopened for sampling and characterization later this summer. The plastic tank on the left is for storing water that is hauled into the site. This will be the only source of water for upcoming sampling operations.

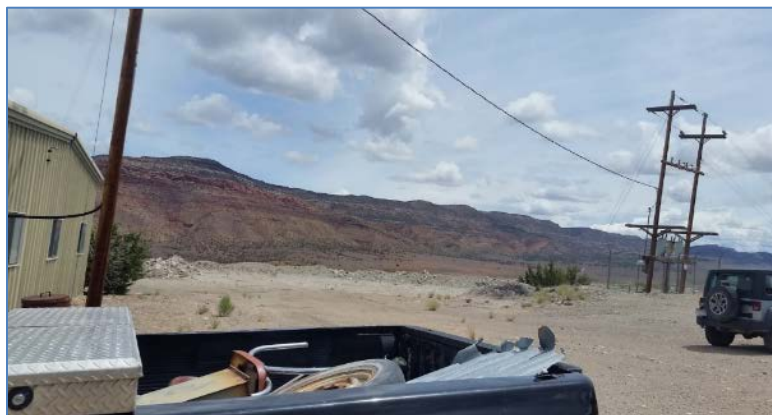
Figure 22: View looking northeast across the St. Jude dump. Power would be restored to the site, though it is not clear if the transformer bank would need to be reactivated. There are very few weeds on site despite the wet year. Visible vegetation is nearly all desirable grasses and forbs.

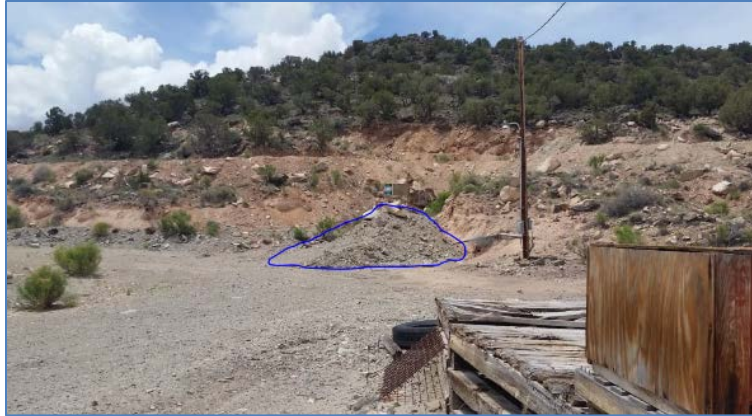
Figure 23: Looking southeast at the portal of the St. Jude Mine. Waste rock has been pushed into the portal and piled up outside of it to prevent unauthorized access inside after some theft and vandalism back in 2011. This material will be removed when the portal is opened this summer. This portal will be the main access point to the underground workings of the Sunday Mines Complex for the underground sampling and characterization activities. It will also function as a draw point for ventilation air.

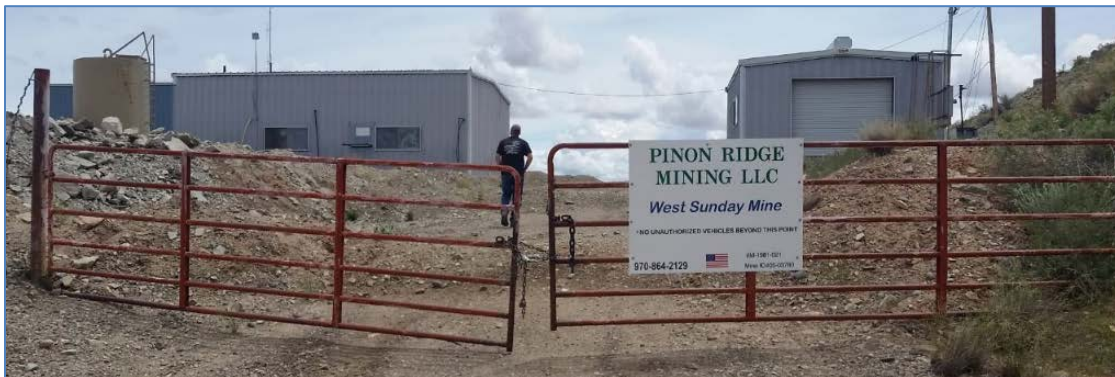
Figure 24: The West Sunday Mine (COC-52049) gate, view looking towards the east. No new activity is slated for this mine. There was no sign of tampering with any of the shop buildings at the West Sunday.

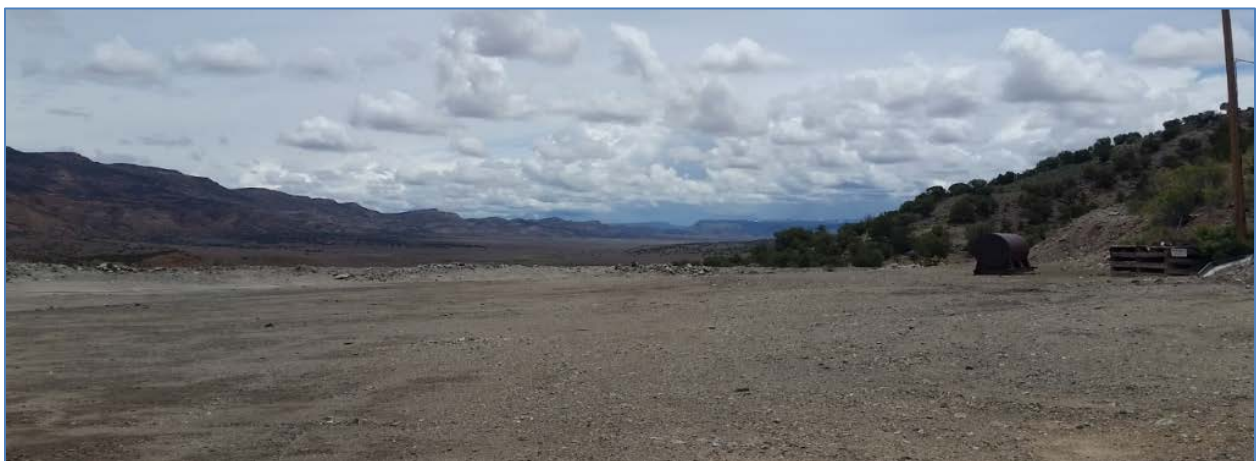
Figure 25: The West Sunday Mine waste rock dump. Virtually no weeds were on site. The mine site was fairly tidy.

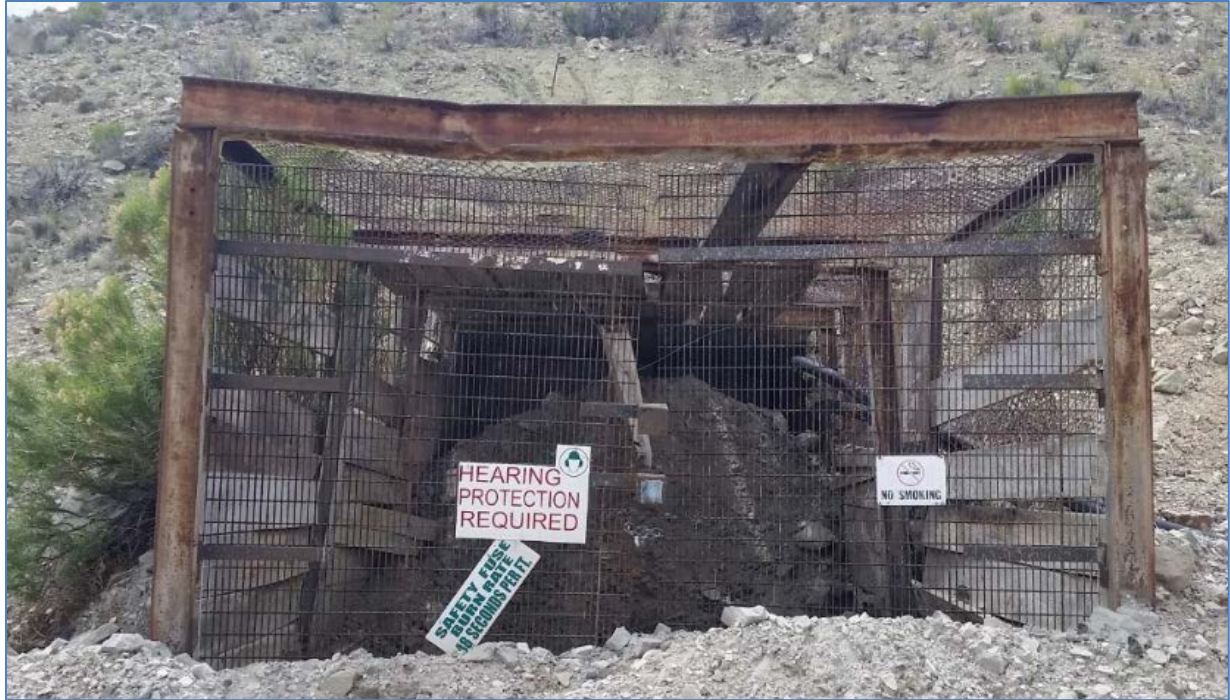
Figure 26: The portal of the West Sunday Mine. This portal has been backfilled about 20 feet back, in addition to the gate, top prevent trespassing. It is not slated to be opened up for the exploration project this year.

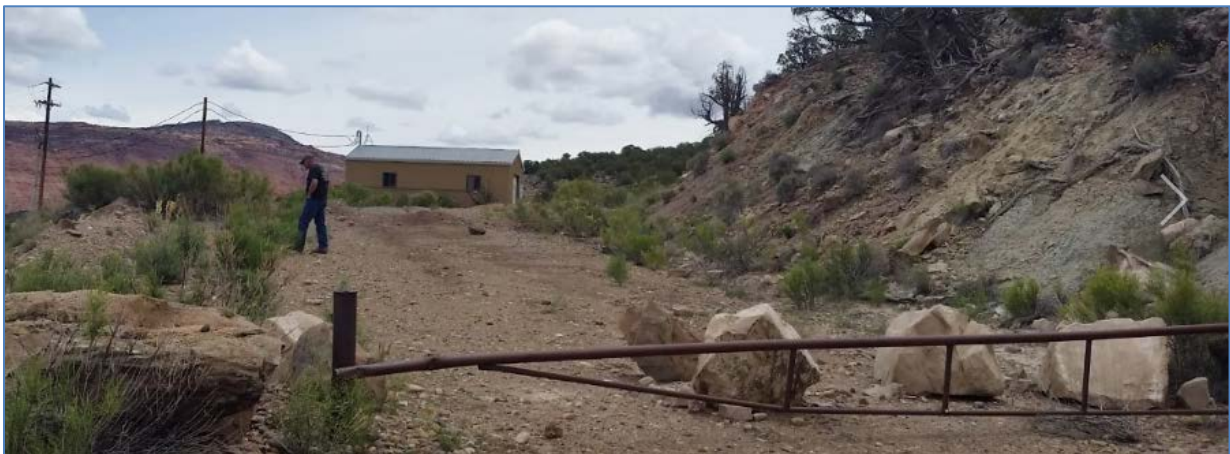
Figure 27: The entrance to the Topaz Mine, looking east. No new activity is slated for this site.

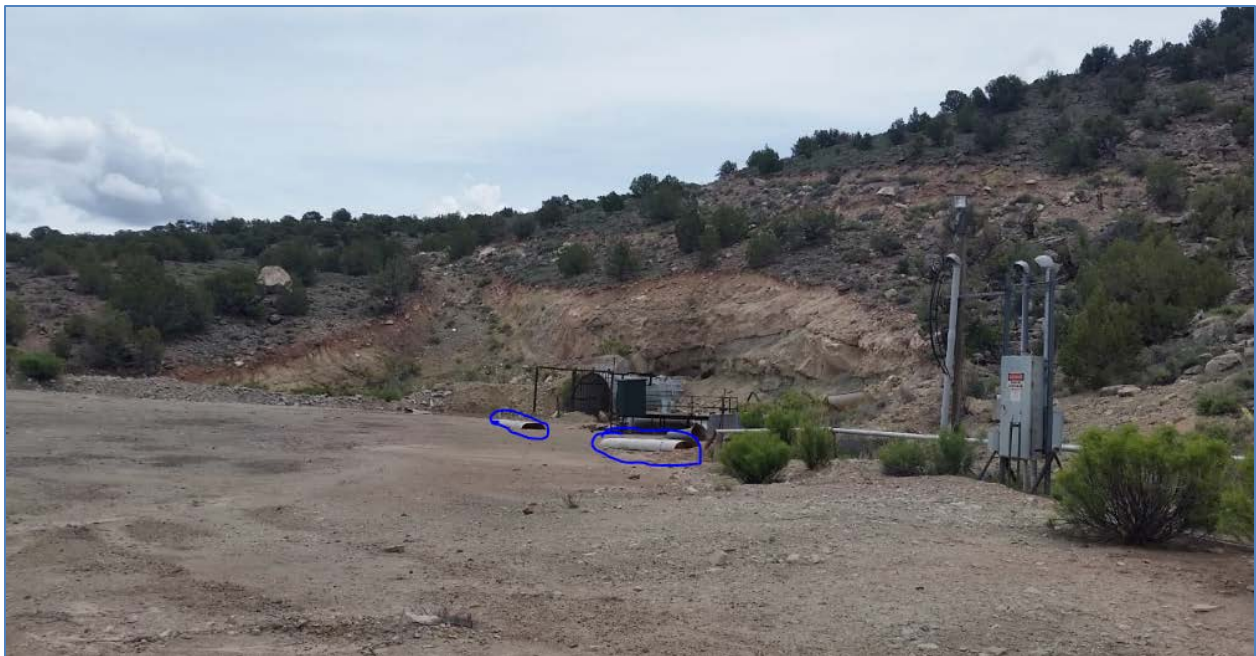
Figure 29: looking Southeast across the dump towards the portal of the Topaz mine. The site was generally tidy, with few if any weeds having emerged yet this year. The portal has been backfilled. There are some fiberglass ventilation ducts (blue circles) that have blown off of a stack. They should be disposed of if they aren't to be used soon.
