MINERALS PROGRAM INSPECTION REPORT
PHONE: (303) 866-3567

MINE NAME: Railhead Gravel Pit	MINE/PROSPECTING ID#: M-1995-036	MINERAL: Sand and gravel	COUNTY: Mesa
INSPECTION TYPE: Monitoring	INSPECTOR(S): Amy C. Yeldell	INSP. DATE: May 29, 2019	INSP. TIME: 11:00
OPERATOR: Oldcastle SW Group, Inc. dba United Compai County	OPERATOR REPRESENTATIVE: Jason Burkey	TYPE OF OPERATION: 112c - Construction Regular Operation	
REASON FOR INSPECTION: Normal I&E Program	BOND CALCULATION TYPE: Complete Bond	BOND AMOUNT: \$127,950.00	
DATE OF COMPLAINT: NA	POST INSP. CONTACTS: None	JOINT INSP. AGENCY: None	
WEATHER: Clear	INSPECTOR'S SIGNATURE:

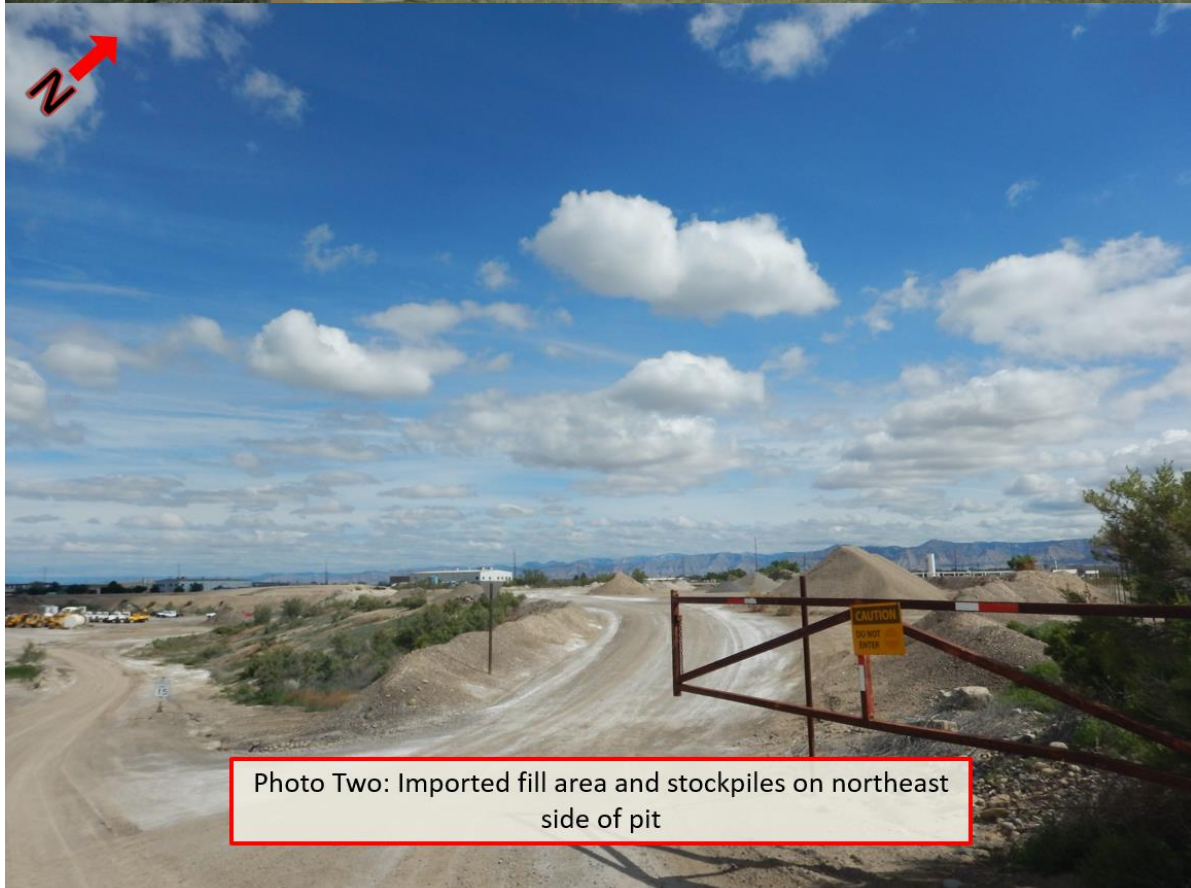
Currently the pit has several areas that appear to have been backfilled though staff was unable to determine if there was more or less than 28 acres. Within the backfilled area on the northeast side of the pit is a concrete washout pond and a few small stockpiles. The remaining backfill areas appear to be void of vegetation.

Photo Two: Imported fill area and stockpiles on northeast side of pit

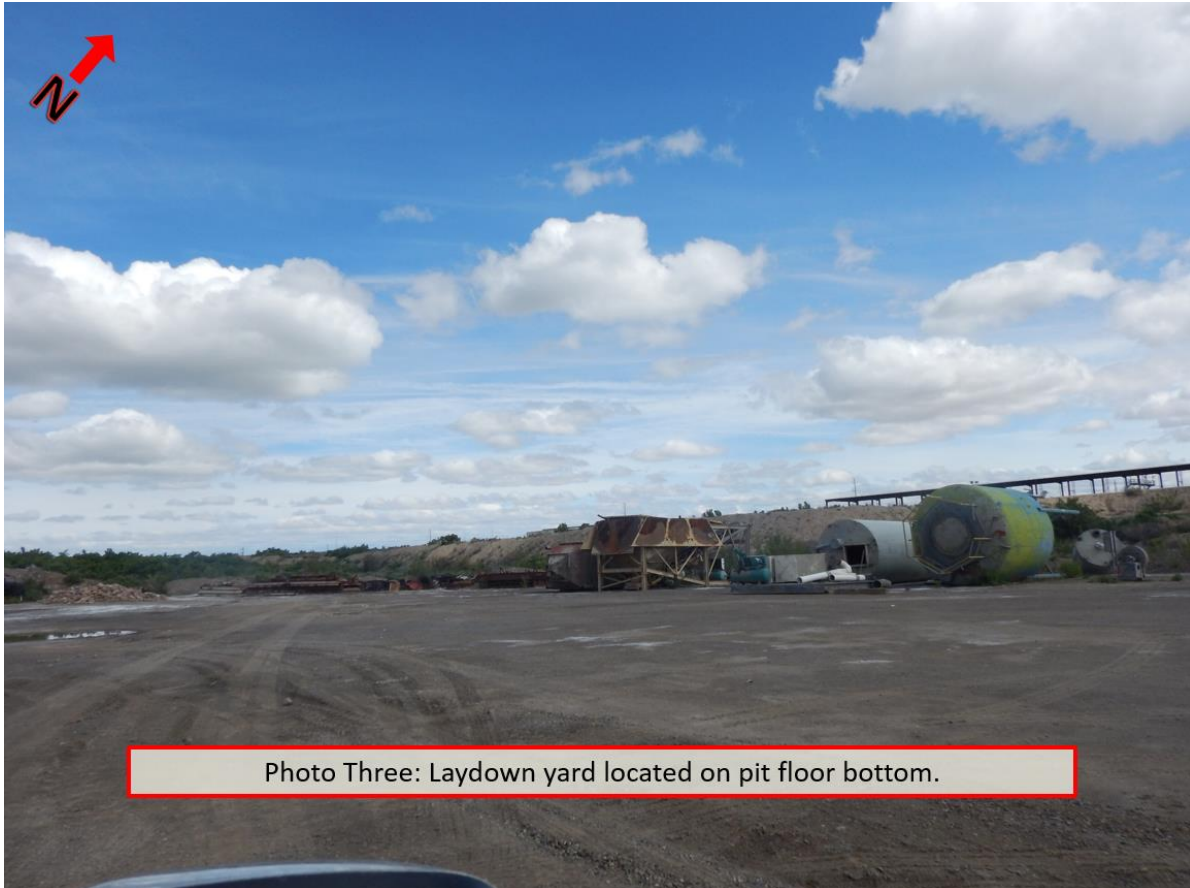
The excavated pit remains dewatered. It is being used for additional equipment storage. Within the pit floor are small wetland type areas with exposed groundwater. These areas appear to be vegetated and stable. In general the southern banks adjacent to the river seem to be mostly reclaimed with gentler slopes and vegetation. The haul road on the south side will need to be removed upon final reclamation. The northern banks are void of vegetation and have slopes that are generally a 1.5H:1V. These slopes will require slope reduction and vegetation. Once the pond is inundated the lake is anticipated to be 40 surface acres.

Photo Three: Laydown yard located on pit floor bottom.

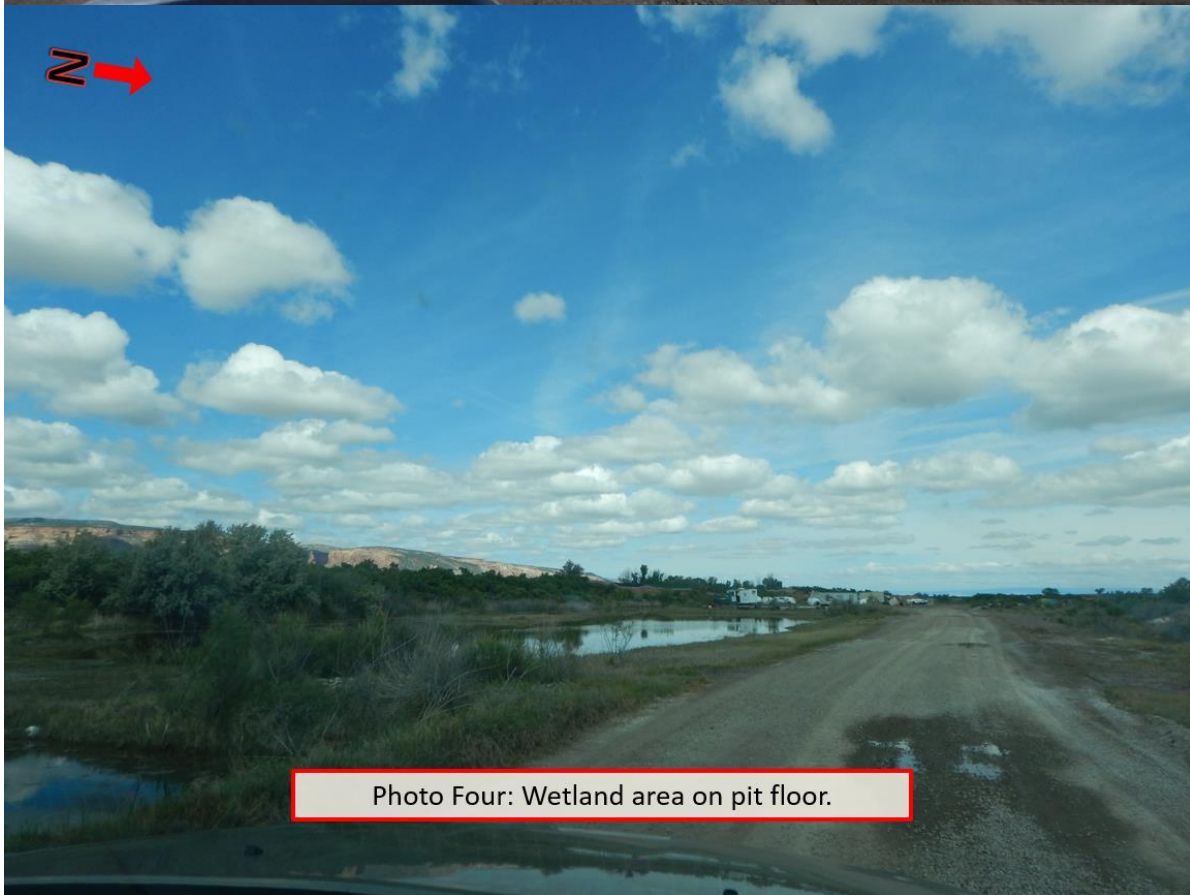
Photo Four: Wetland area on pit floor.
