MINERALS PROGRAM INSPECTION REPORT

MINE NAME: Cresson Project	MINE/PROSPECTING ID#: M-1980-244	MINERAL: Gold	COUNTY: Teller
INSPECTION TYPE: Aerial Inspection	INSPECTOR(S): Timothy A. Cazier	INSP. DATE: January 29, 2019	INSP. TIME: 13:33
OPERATOR: Cripple Creek & Victor Gold Mining Company	OPERATOR REPRESENTATIVE: None	TYPE OF OPERATION: 112d-3 - Designated Mining Operation

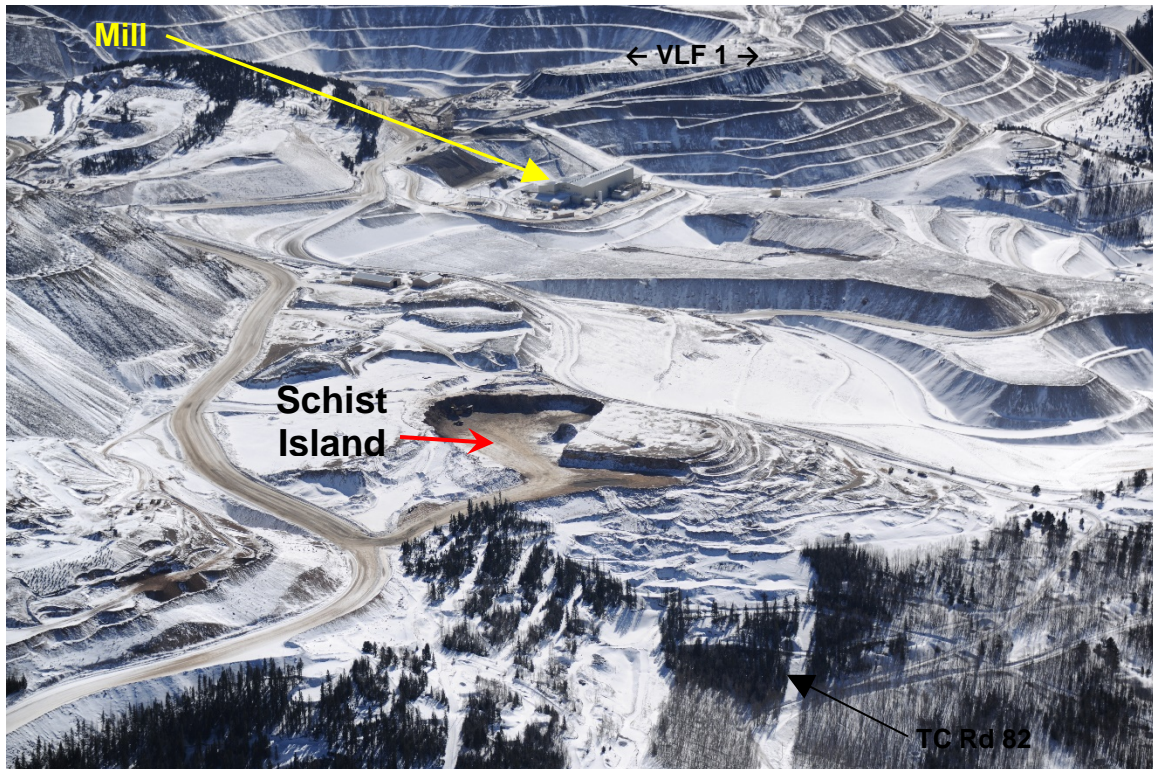
Photo 1. North Cresson pit – Schist Island Pit (Looking south).

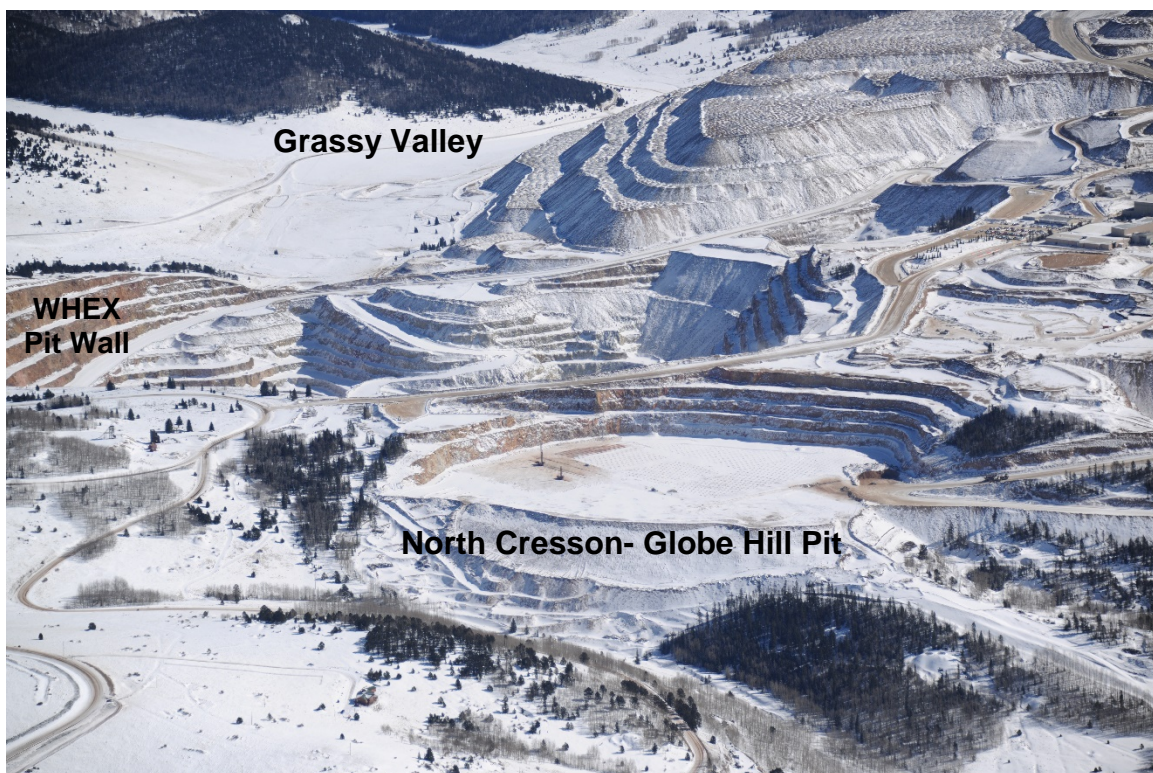
Photo 2. North Cresson (looking south).

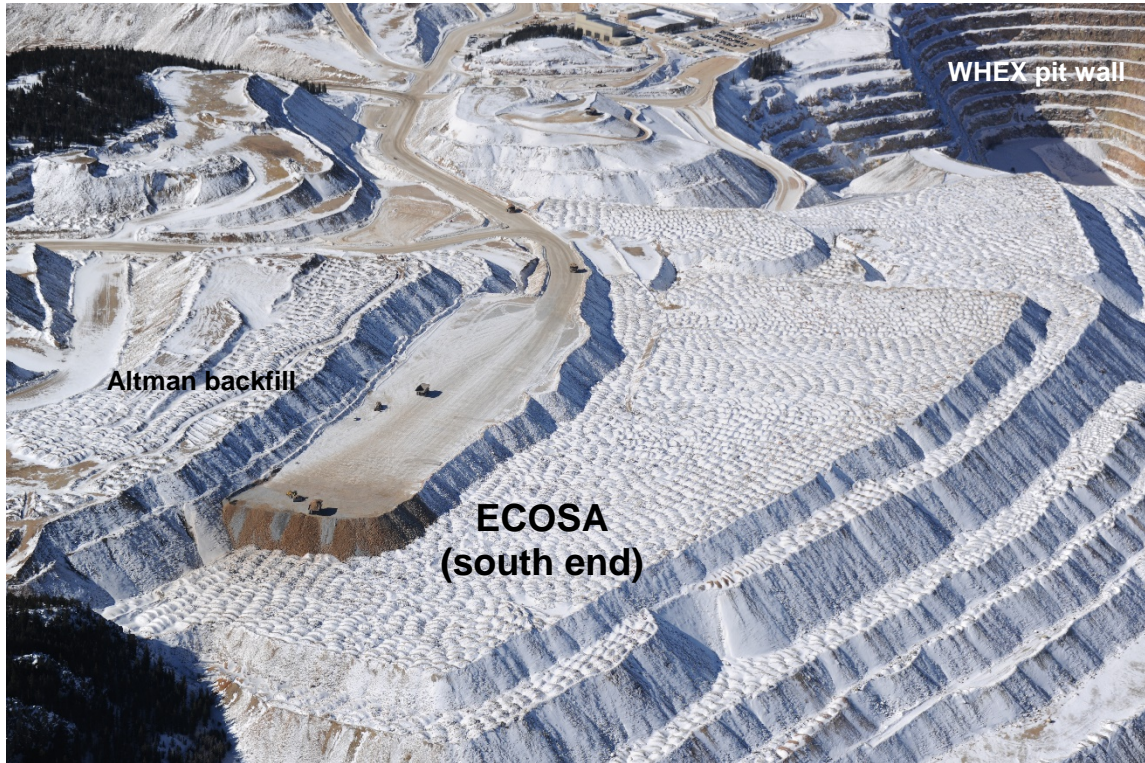
Photo 3. East Cresson OSA, south end (looking west).

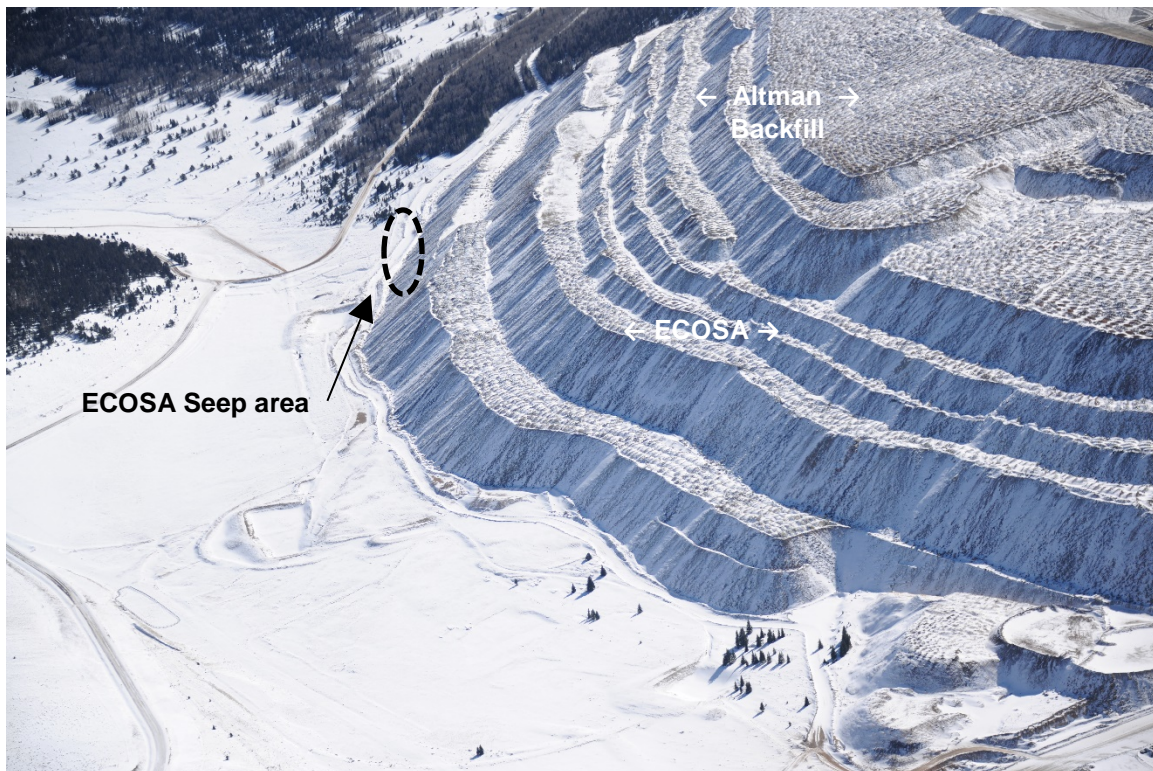
Photo 4. East Cresson OSA Toe, south end (looking south).

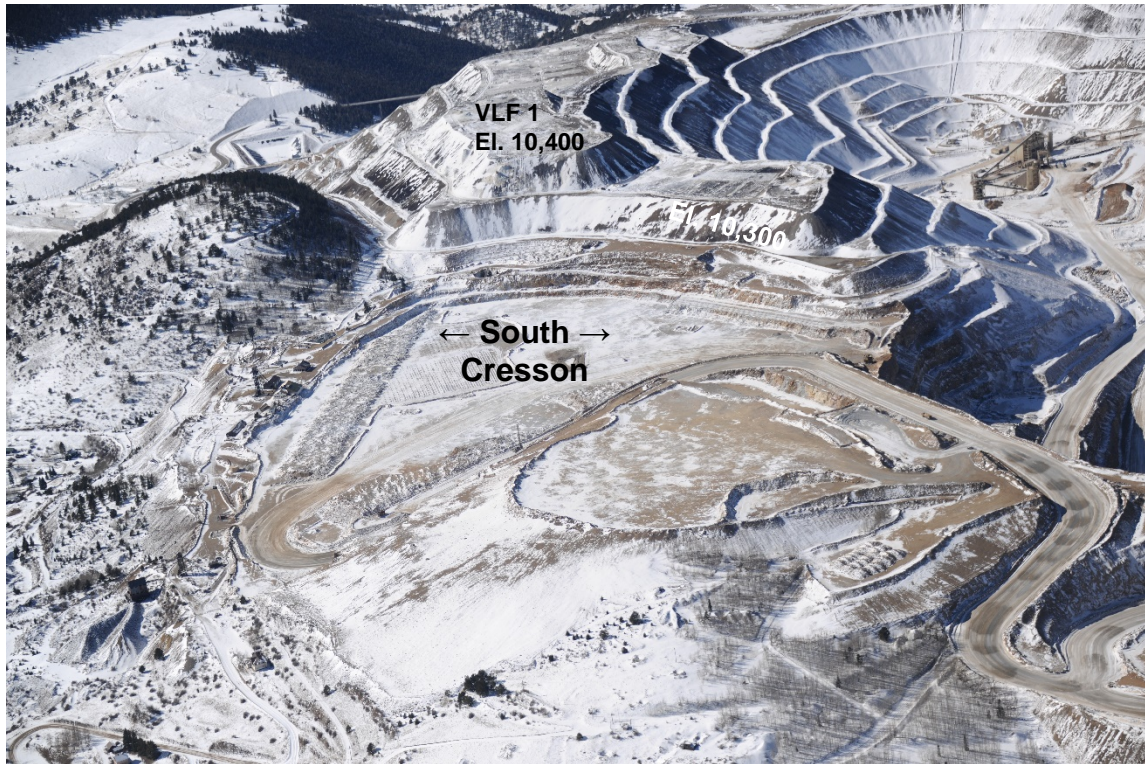
Photo 5. South Cresson Pit (looking SW).

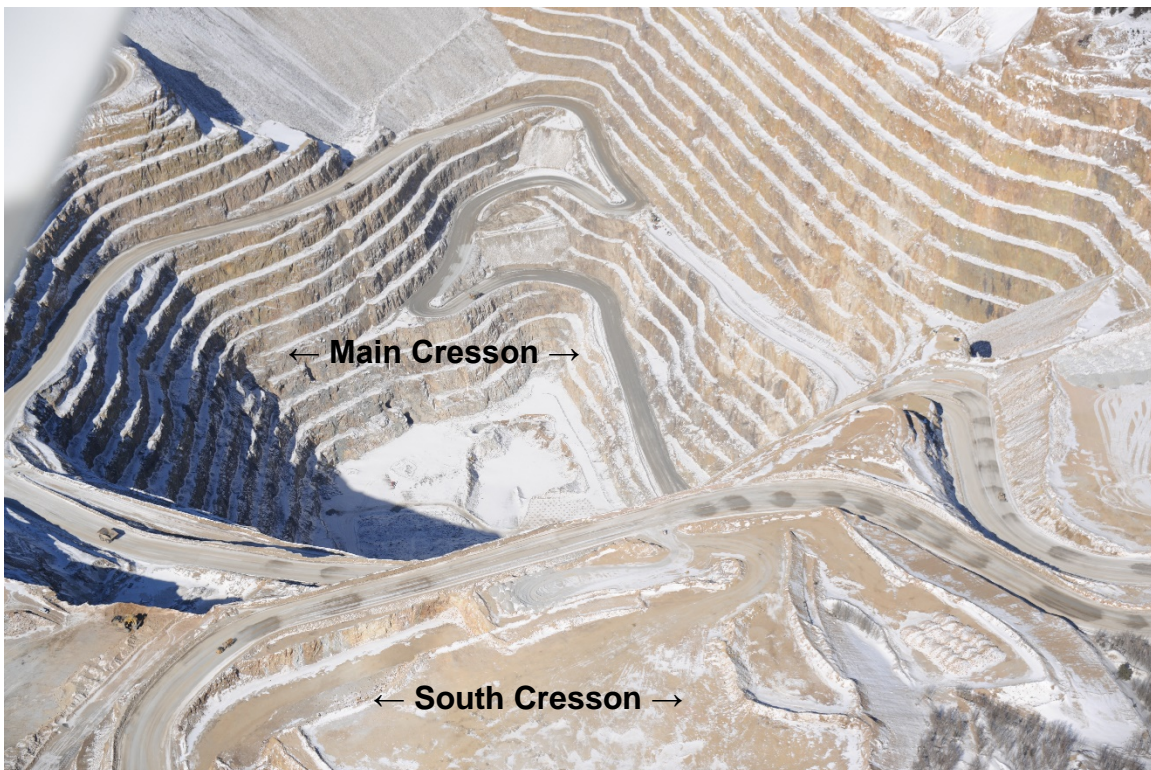
Photo 6. Main Cresson Pit (looking west)

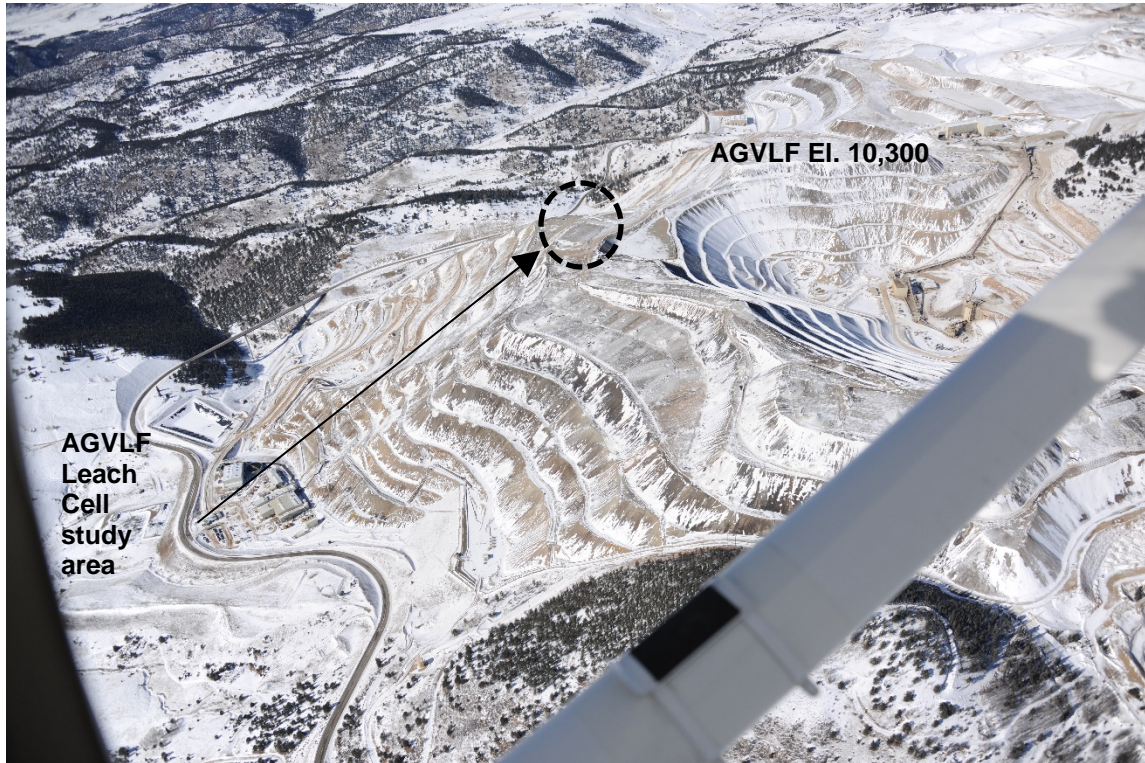
Photo 7. Arequa Gulch VLF (looking west); Note proposed Leach Cell study area.

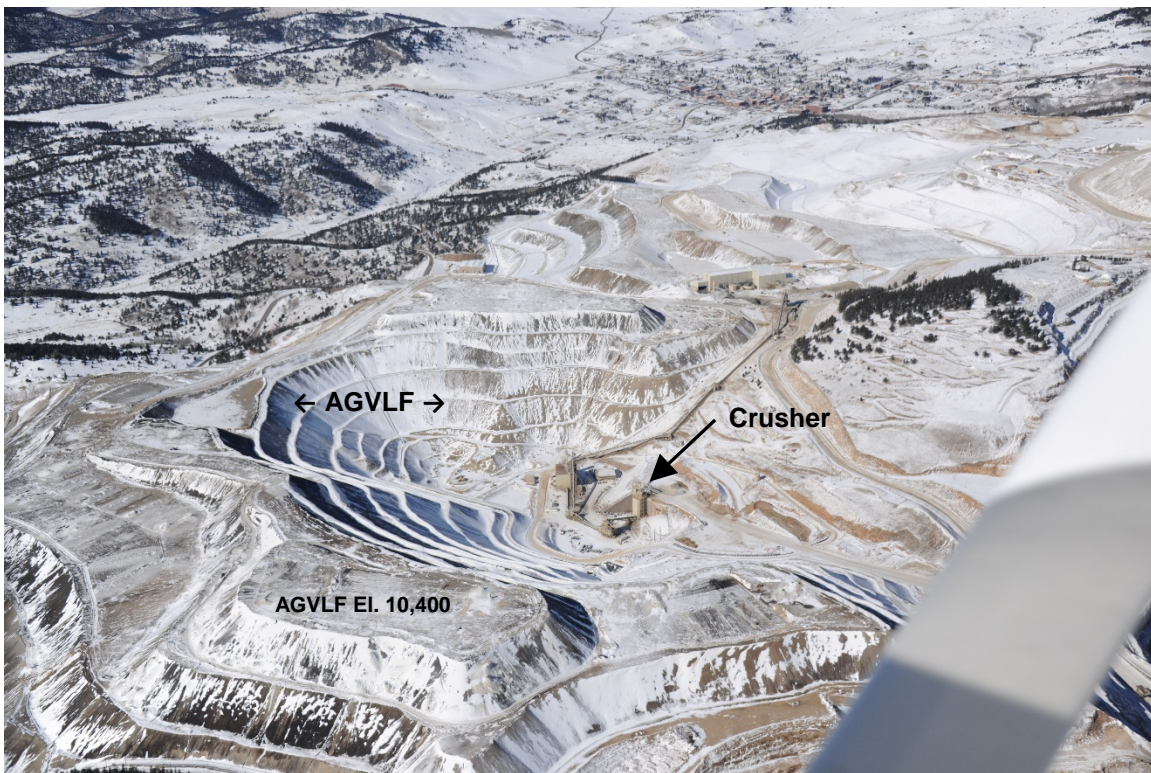
Photo 8. Arequa Gulch VLF (looking NW).

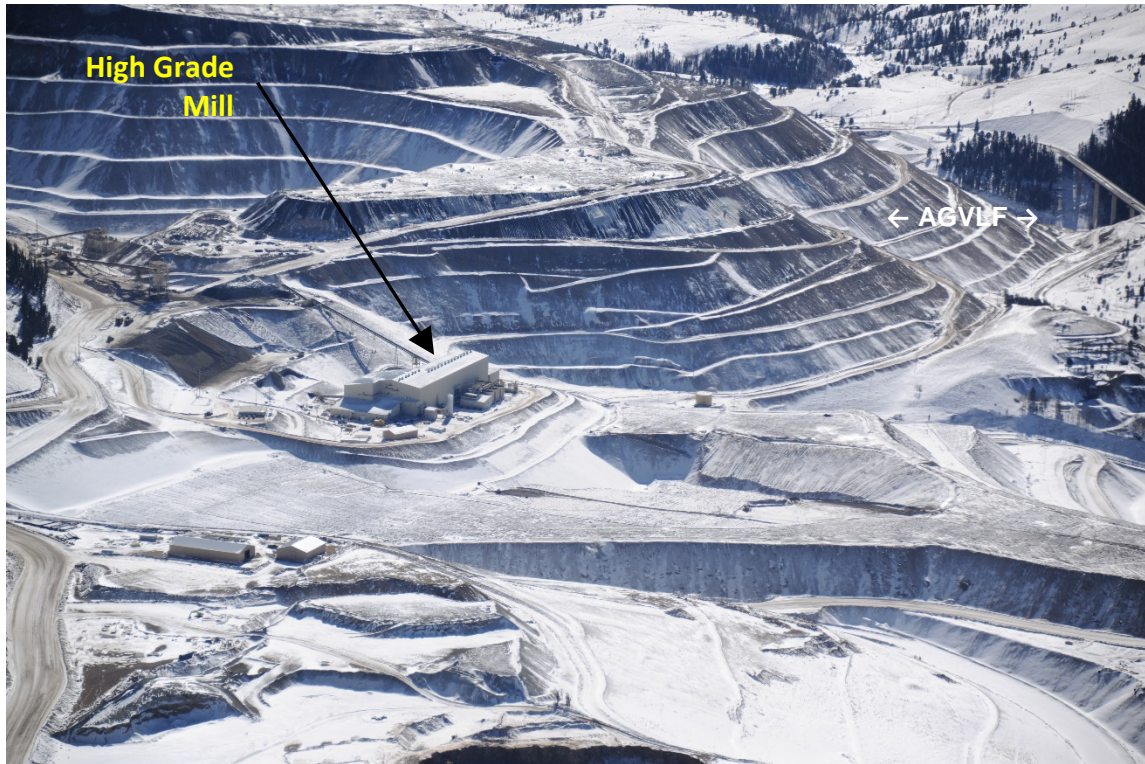
Photo 9. High Grade Mill (Looking south).

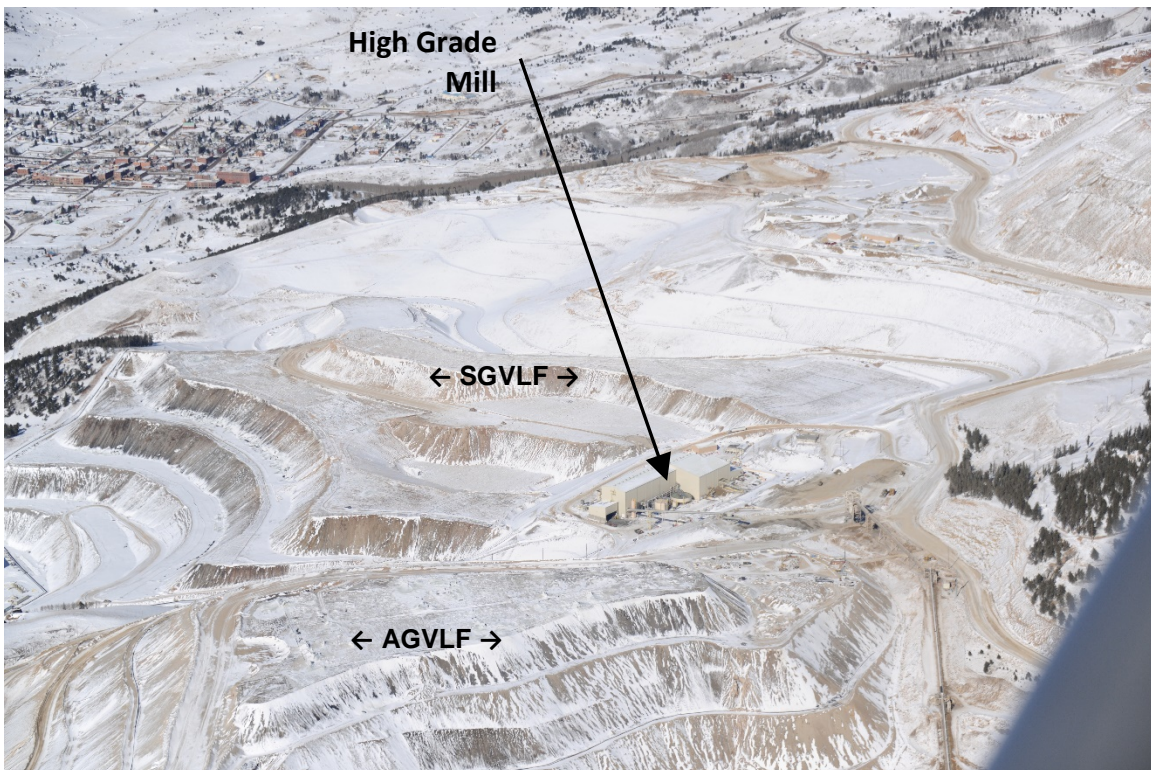
Photo 10. Squaw Gulch VLF (looking north) .

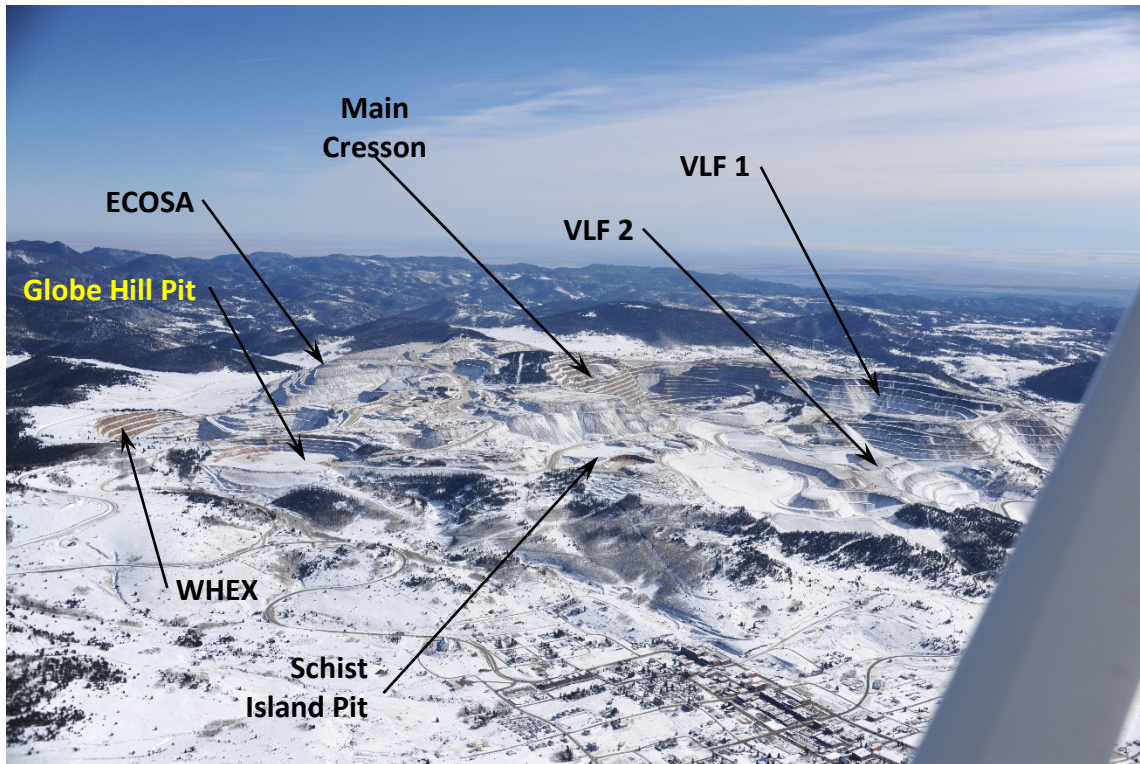
Photo 11. Site Overview (Looking SE).
