## MINERALS PROGRAM INSPECTION REPORT

<b>MINE NAME:</b> Fountain Colony Pit	<b>MINE/PROSPECTING ID#:</b> M-1987-171	<b>MINERAL:</b> Sand and gravel	<b>COUNTY:</b> El Paso
<b>INSPECTION TYPE:</b> Surety-Related Inspection	<b>INSPECTOR(S):</b> Timothy A. Cazier	<b>INSP. DATE:</b> June 11, 2019	<b>INSP. TIME:</b> 10:20
<b>OPERATOR:</b> Kiewit Western Company	<b>OPERATOR REPRESENTATIVE:</b> Misty Gothard & Jenn Bradtmueller	<b>TYPE OF OPERATION:</b> 112c - Construction Regular Operation	
<b>REASON FOR INSPECTION:</b> Surety Related	<b>BOND CALCULATION TYPE:</b> Complete Bond	<b>BOND AMOUNT:</b> \$200,000.00	
<b>DATE OF COMPLAINT:</b> NA	<b>POST INSP. CONTACTS:</b> None	<b>JOINT INSP. AGENCY:</b> None	
<b>WEATHER:</b> Clear	<b>INSPECTOR'S SIGNATURE:</b>

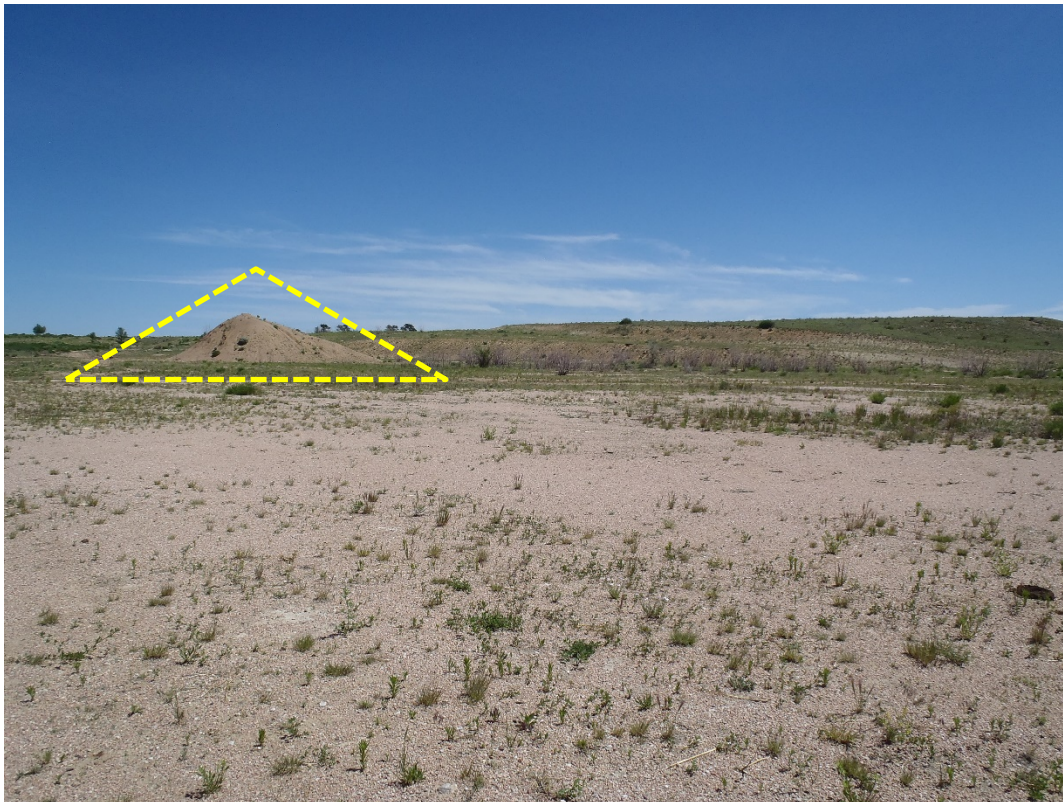
**Financial Warranty:** The \$200,000 bond held by the Division is adequate for the observed mine disturbance as the major earthwork has been accomplished. Some areas such as the current product stockpile location (see **Photo 1**), former equipment staging area (see **Photo 2**), and the current milled asphalt storage area (see **Photo 3**) will likely need disking, ripping and/or additional growth media for final reclamation. A **reclamation cost summary sheet** for the revegetation and mobilization is attached. The current surplus should be adequate for the potential additional reclamation work.

Photo 1. Current product stockpile (looking NE from access road).

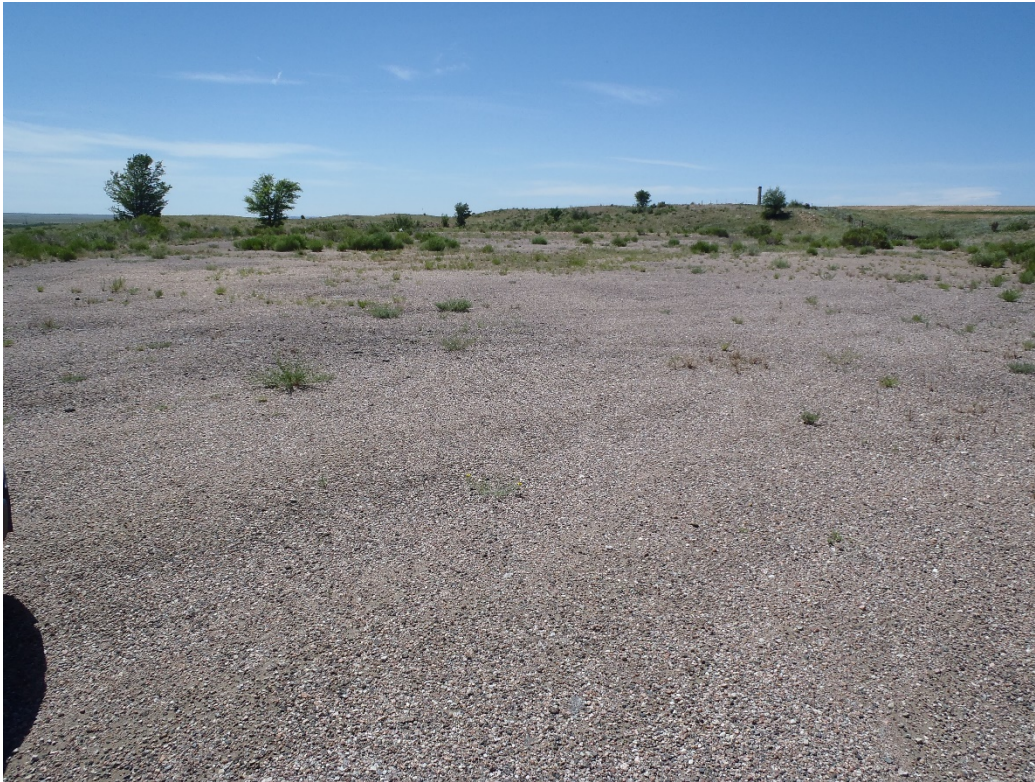
Photo 2. Former equipment staging area, likely needing growth media (looking south).

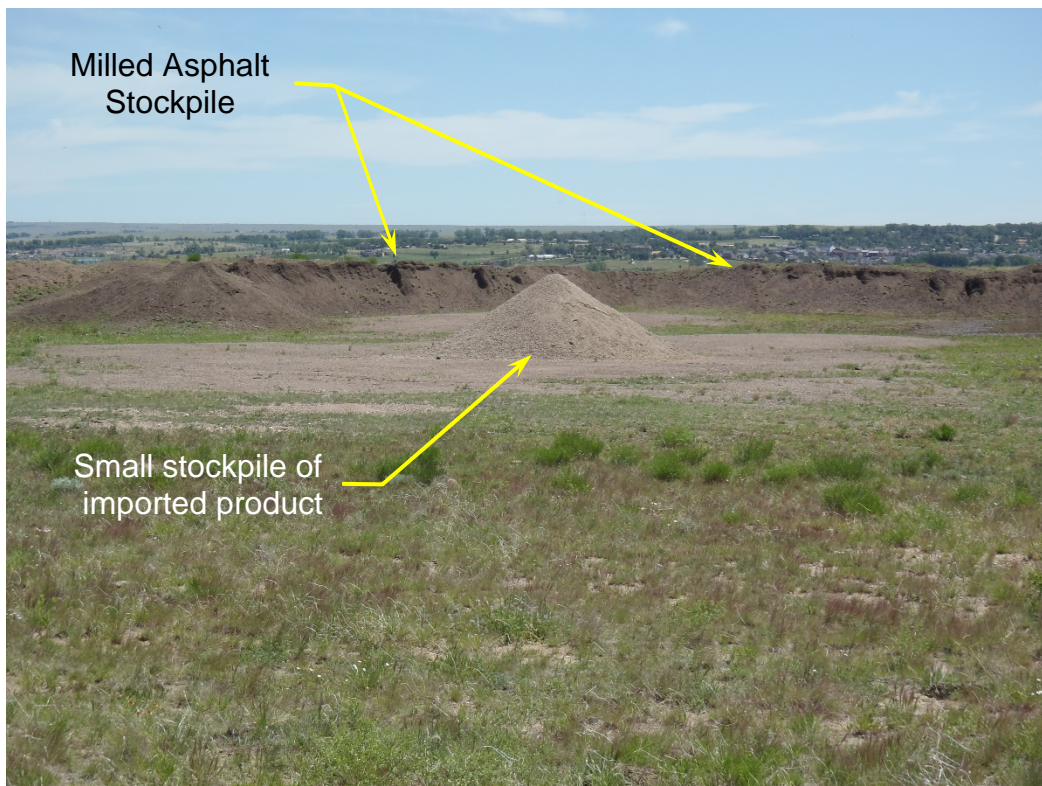
Photo 3. Milled asphalt stockpile (Looking NE from paved access road).

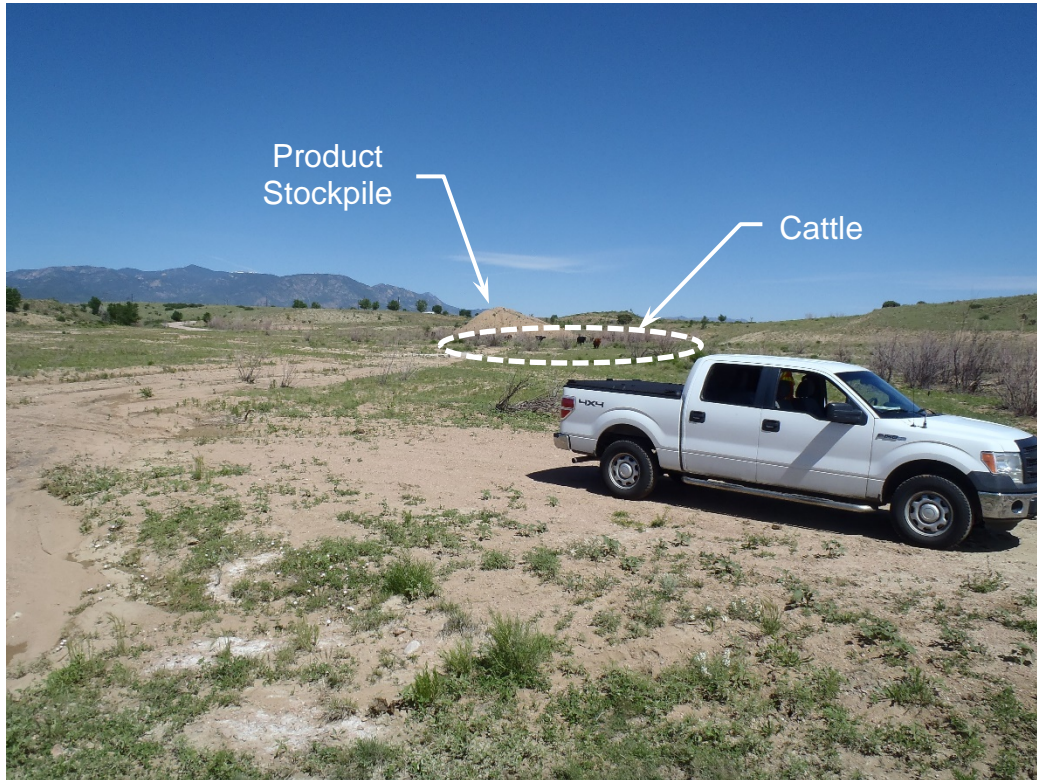
**Fish and Wildlife:** No impact to wildlife was observed. Cattle (see **Photo 4**) were observed south of the remaining product stockpile during the inspection.

Photo 4. Current product stockpile (looking NNW from north sediment pond).

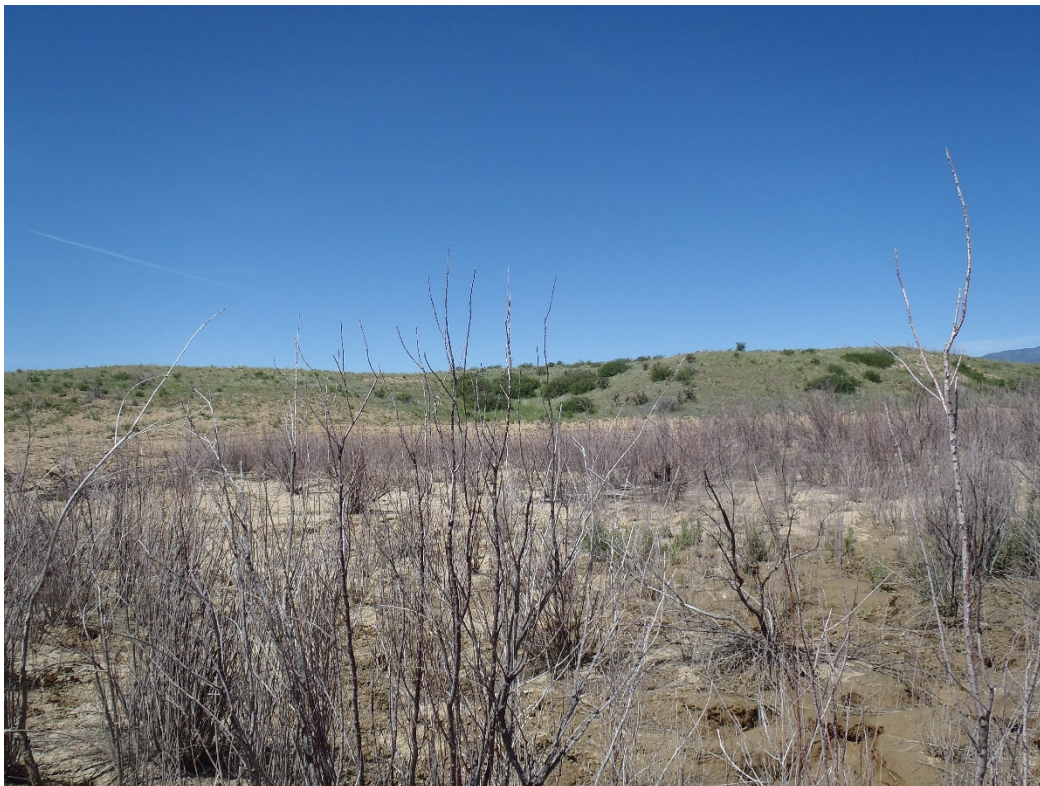
**Revegetation:** Efforts to treat the tamarisk (a.k.a. salt cedar) cited as a problem during the 2017 inspection appears to be succeeding. The plants are still present (see **Photos 5 and 6**), but very few show signs of leafing out. Site representatives stated their weed management contractor was on site about a month ago and make periodic visits to monitor the tamarisk. They also indicated the future plan is to remove the plants and mulch the areas to make it easier to spot new tamarisk growth.

Photo 5. Treated tamarisk near middle sediment pond (looking west).

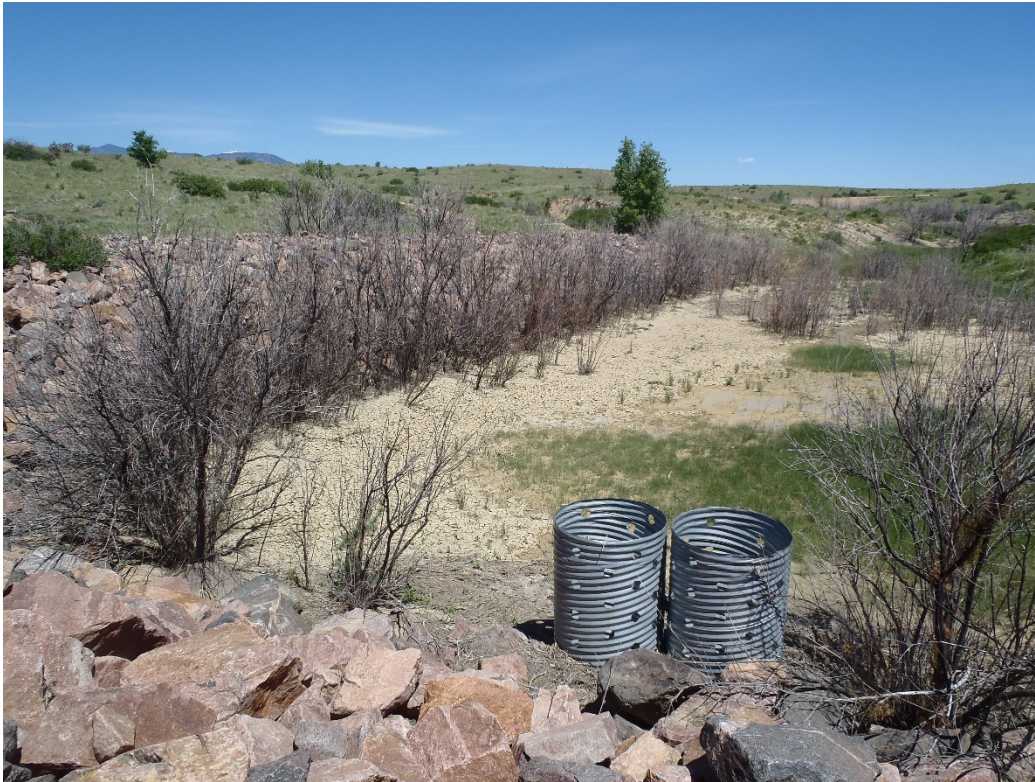
Photo 6. Treated tamarisk in south sediment pond (looking NW).

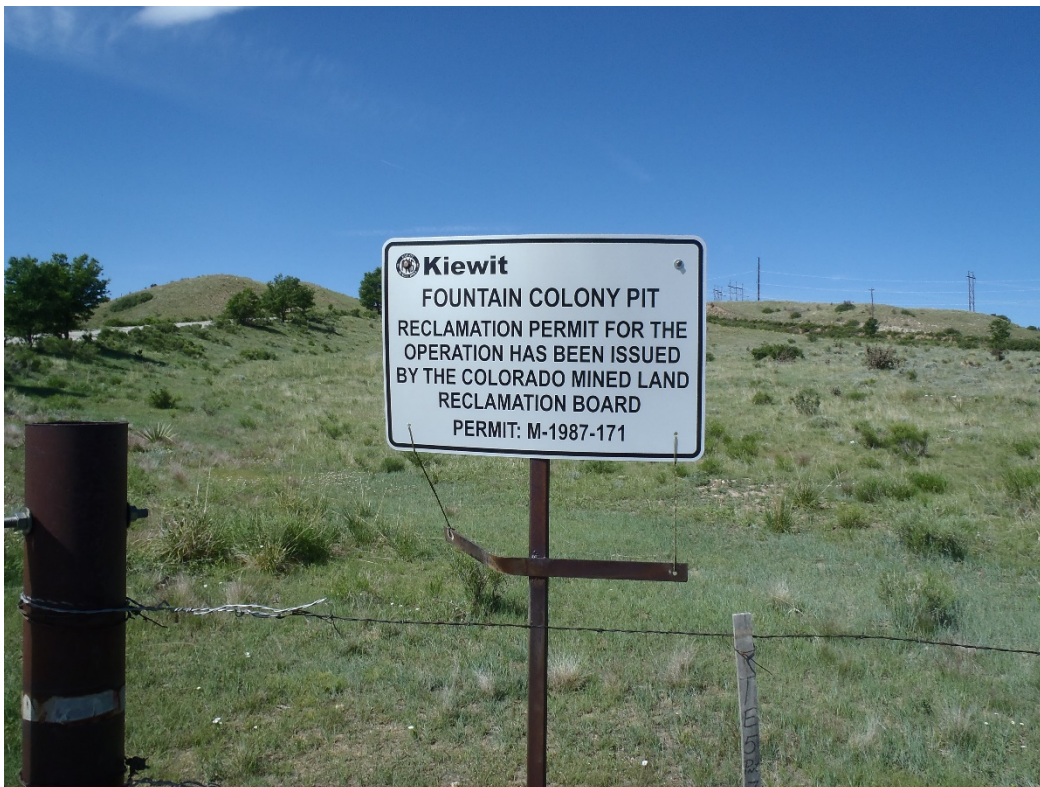
Signs and Markers: The permit sign was properly posted (see **Photo 7**). The site is fenced to delineate the permit boundary.

Photo 7. Permit sign (at entrance).

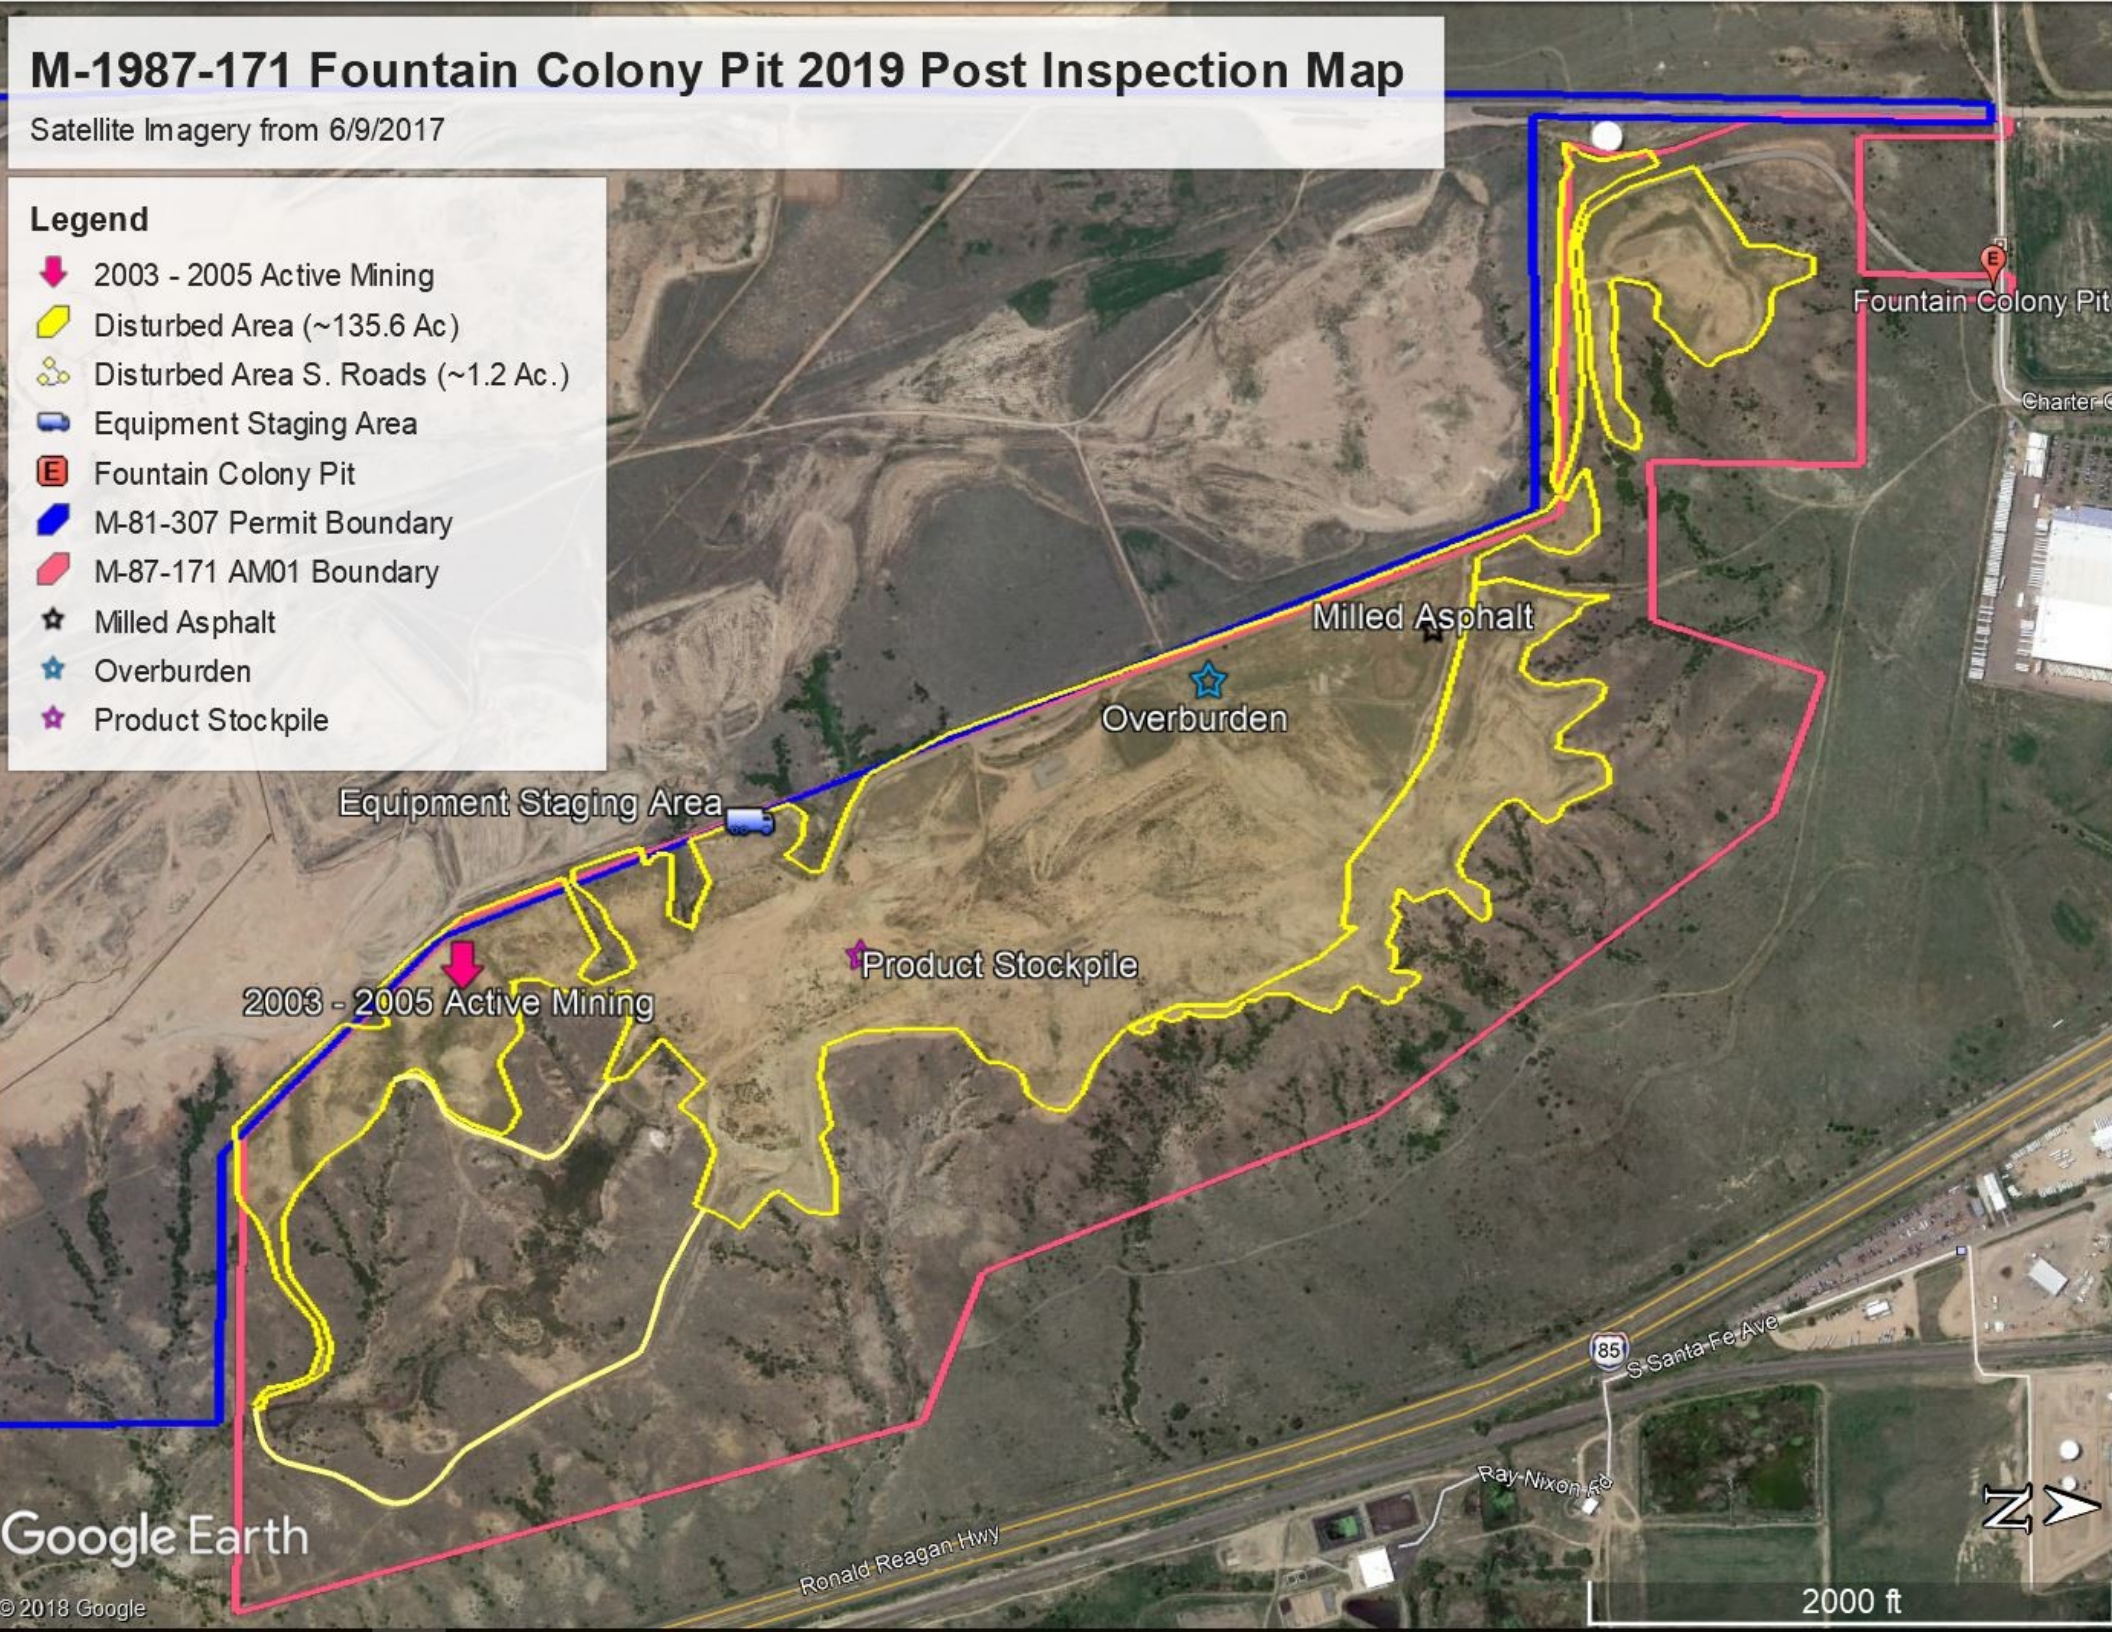
# M-1987-171 Fountain Colony Pit 2019 Post Inspection Map

**Gen. Compliance with Mine Plan:** The operation appeared to be in compliance with the approved mine plan. Google Earth was used to measure the disturbed area, which was estimated to be approximately 137 acres (including access roads on the south end of the permit area), based on June 9, 2016 satellite imagery (see attached **Post Inspection Map**).
