MINERALS PROGRAM INSPECTION REPORT
PHONE: (303) 866-3567

MINE NAME: Morgan Pit	MINE/PROSPECTING ID#: M-2006-077	MINERAL: Sand and gravel	COUNTY: Huerfano
INSPECTION TYPE: Monitoring	INSPECTOR(S): Patrick Lennberg	INSP. DATE: June 7, 2019	INSP. TIME: 11:30
OPERATOR: Paul Morgan Excavating, Inc.	OPERATOR REPRESENTATIVE: Paul Morgan	TYPE OF OPERATION: 110c - Construction Limited Impact	
REASON FOR INSPECTION: Normal I&E Program	BOND CALCULATION TYPE: Complete Bond	BOND AMOUNT: \$8,844.00	
DATE OF COMPLAINT: NA	POST INSP. CONTACTS: None	JOINT INSP. AGENCY: None	
WEATHER: Clear	INSPECTOR'S SIGNATURE:

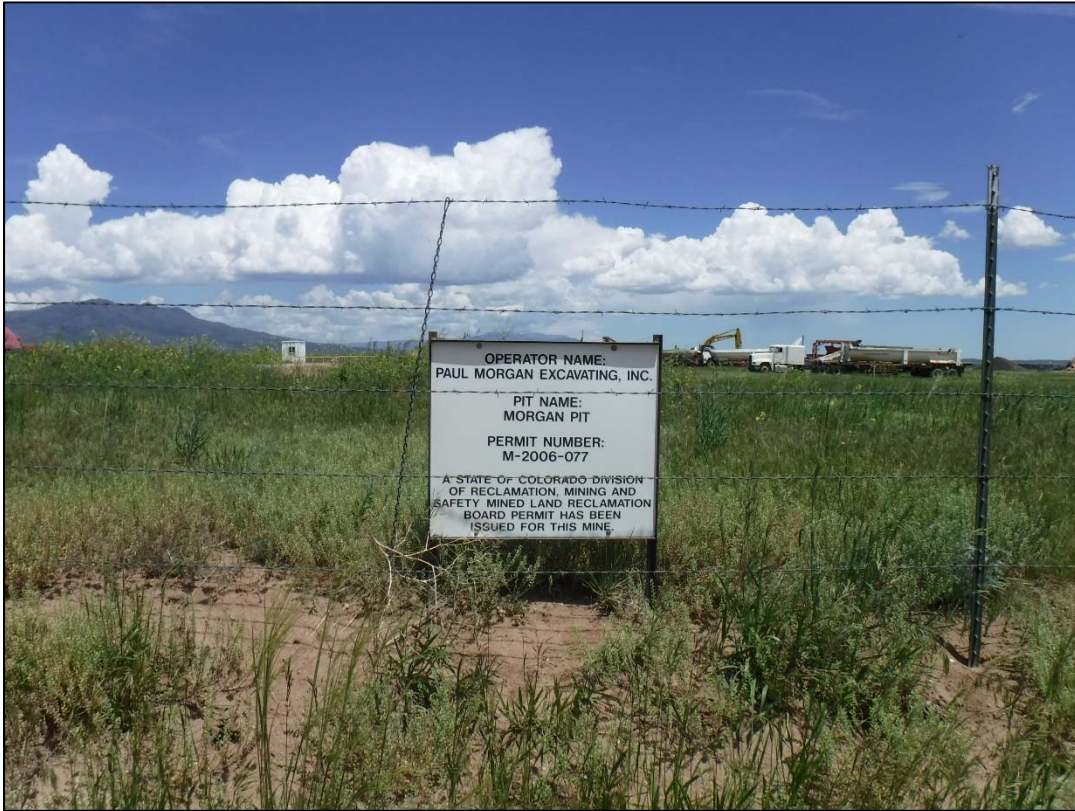
The Morgan Pit is located approximately 1 mile southwest of La Veta, Colorado. The Morgan Pit is a 110 permit for the removal of sand and gravel. The approved permit area is 9.9 acres and the approved post-mining land use is industrial/commercial. The mine site was surrounded by the following land uses: rural residential, agriculture, and rangeland. A mine sign was observed as required by Rule 3.1.12.

Photo 1: Mine sign located at entrance

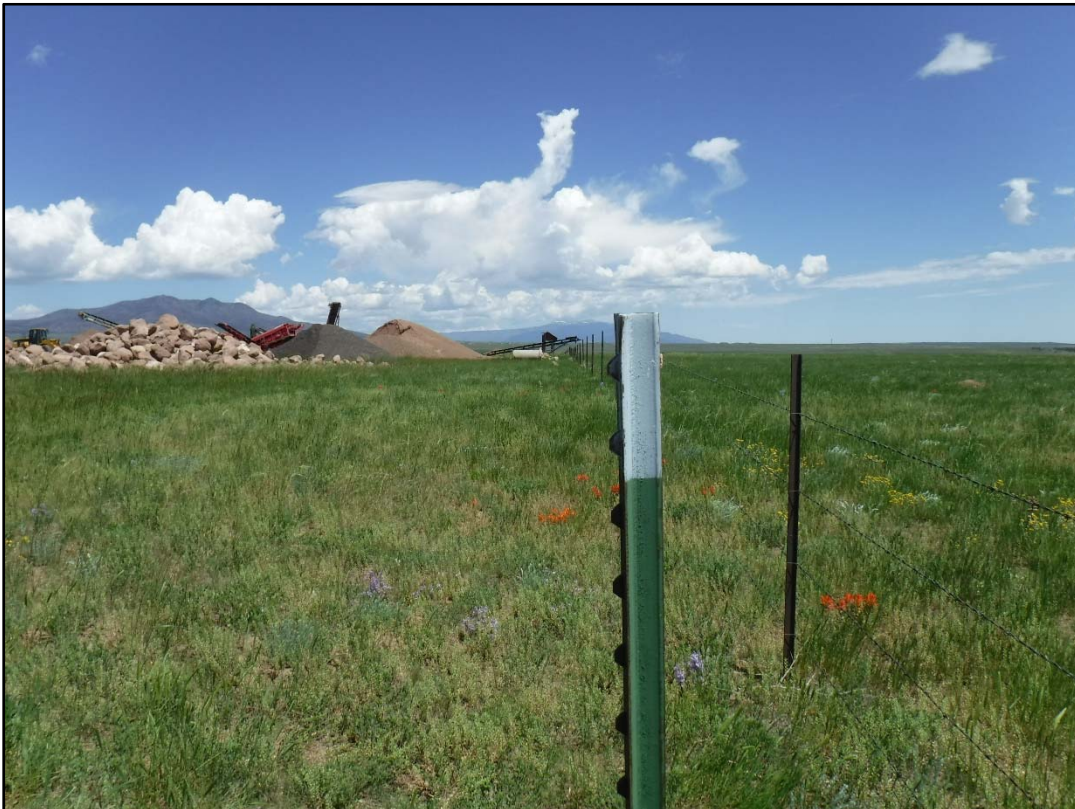
The Division was able to GPS all permit boundary markers. All current mining is within the permit boundaries.

Photo 2: Typical boundary marker

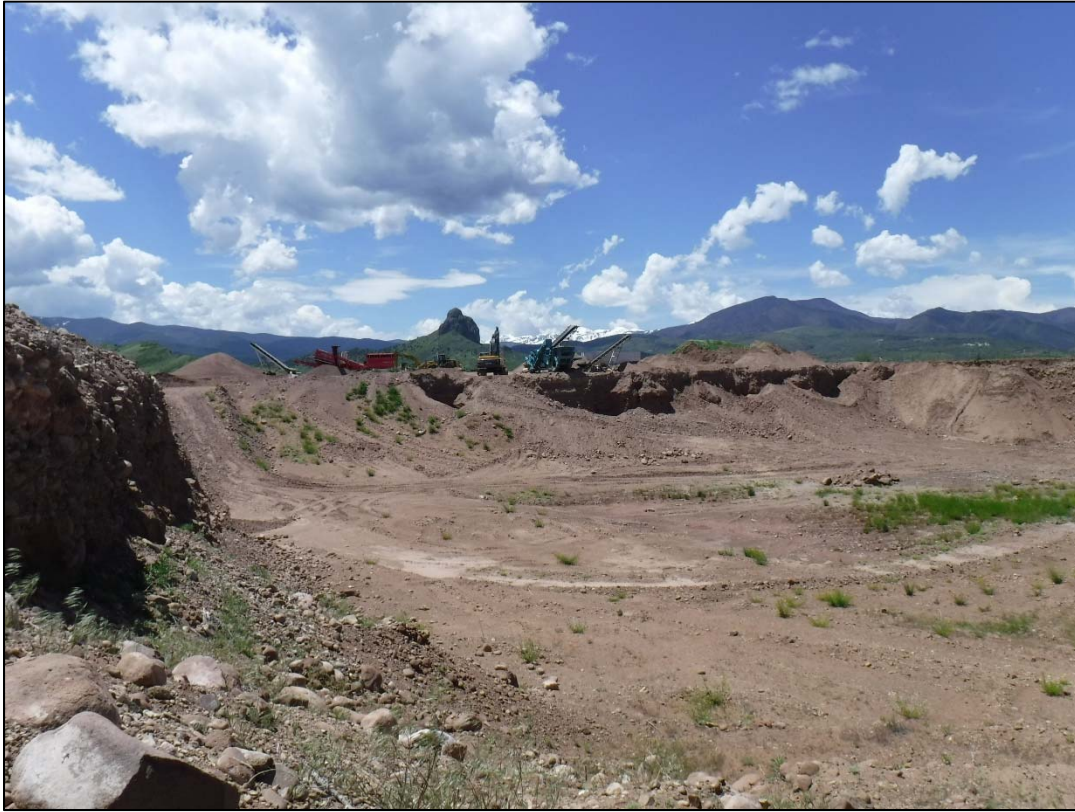
Active mining was not taking place at the time of the inspection but it was recently active. During the inspection the Operator mentioned that the quality of material was decreasing as the pit advanced south. A thick layer of silty material appears to be increasing in thickness. The Operator is currently faced with a choice, continue mining to the south in hopes that the silty material decreases or change the direction of mining from the south and move east. If the Operator elects to mine east it will require either converting the current 110 permit to a 112 permit or releasing unmined portions of the current permit and amending the permit with acreage to the east, all land to the east of the current permit boundary is owned by the Operator.

Photo 3: Looking at the south pit wall

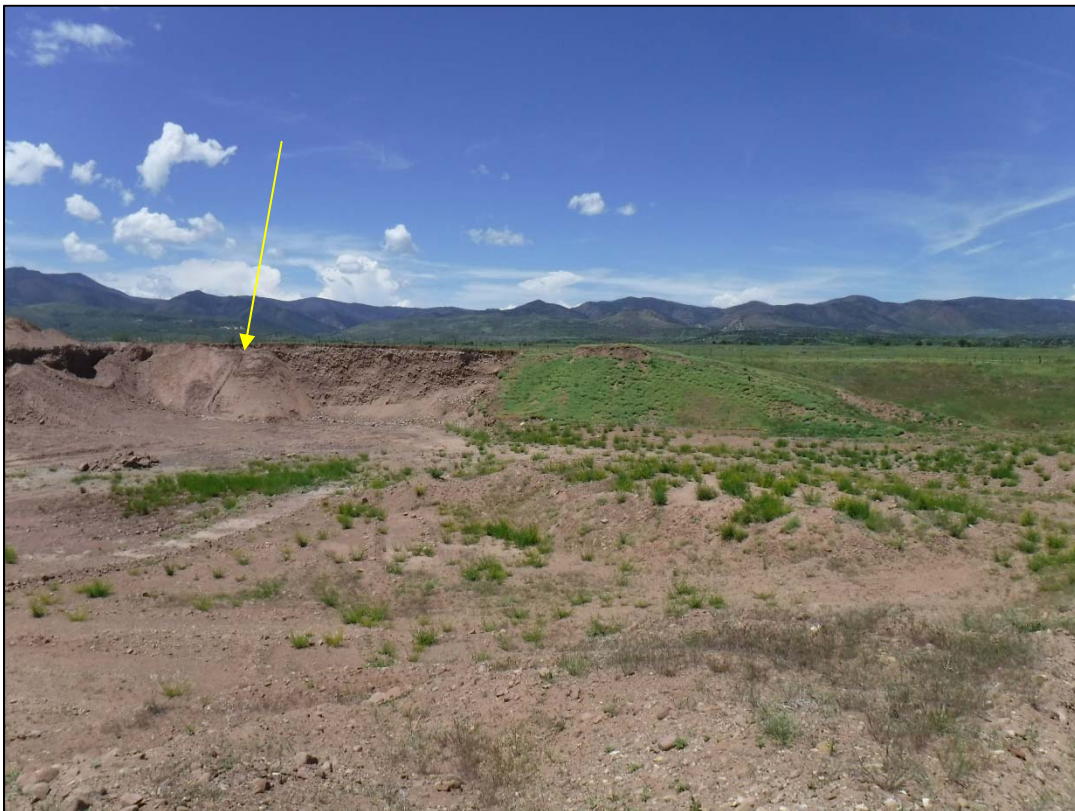
The current pit is approximately 3 acres in size, while the total disturbed area is roughly 4 acres. The northern side of the pit has been graded to a 3H:1V with some volunteer vegetation growing on the slopes. The west side of the pit has been mined to the property boundary in an effort to maximize minable material. The Operator is in the process of reclaiming this side to a 3H:1V slope using overburden material. There is a topsoil stockpile that is along the west side that will be spread once the reclaimed slope has been established. On the east side of the pit there is a highwall in the location of where potential mining may take place. The current mining face along the south wall has near vertical highwalls along with slopes that range from 2H:1V to 3H:1V. All pit walls appeared stable and no signs of erosion were seen. The pit ranges in depth from 10 to 20 feet deep. No groundwater was observed during the inspection and any stormwater that collected in the pit quickly infiltrated.

Photo 4: Looking at the west pit wall, arrow marks material being placed to reclaim highwall, topsoil pile center of picture with vegetative cover

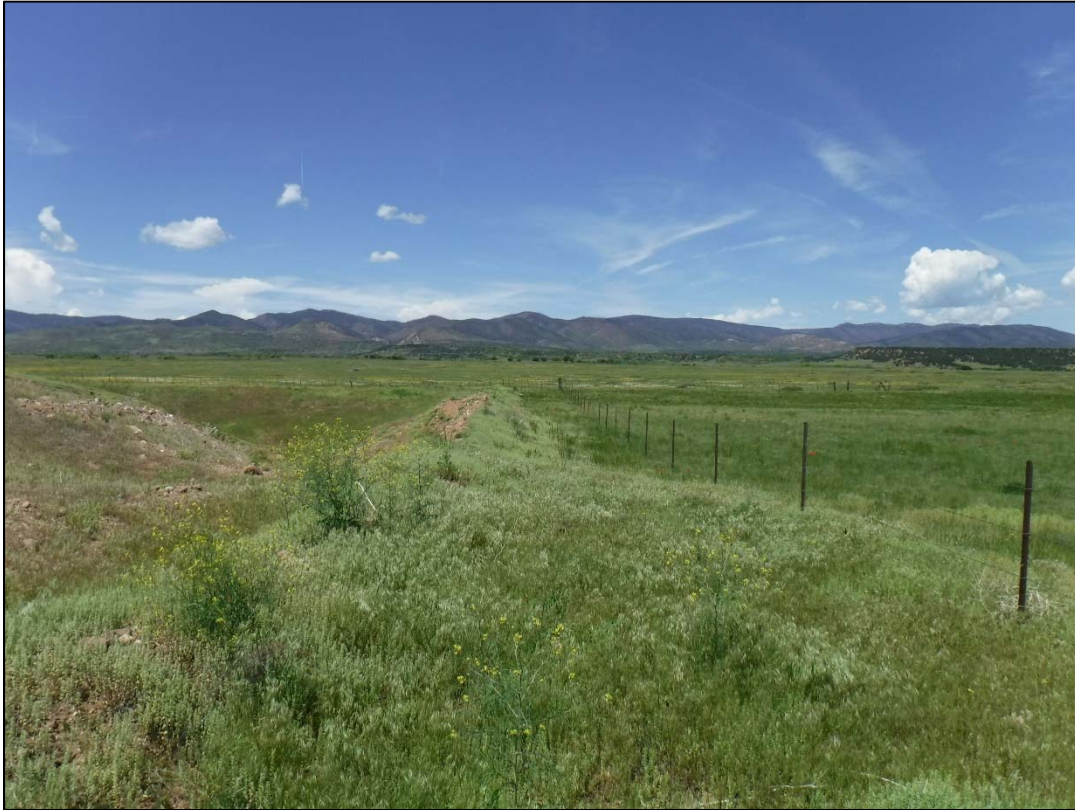
Photo 5: Looking west along the northern permit boundary

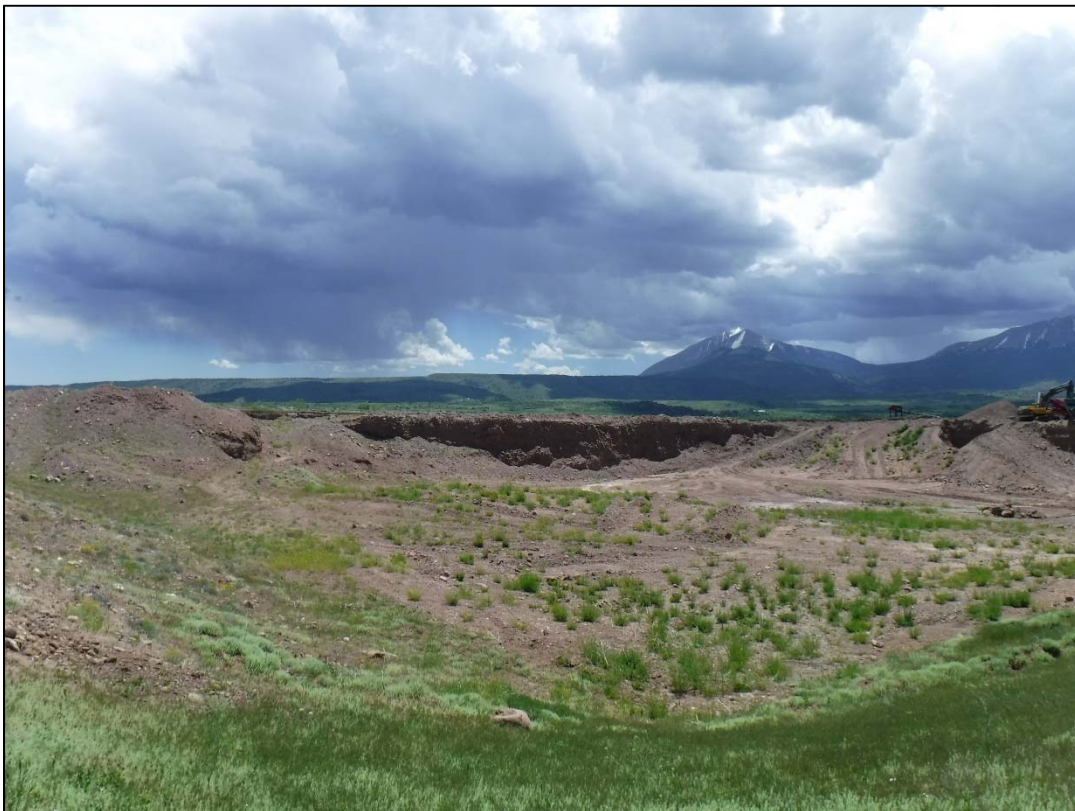
Photo 6: Looking east at the highwall of material that the Operator may opt to chase

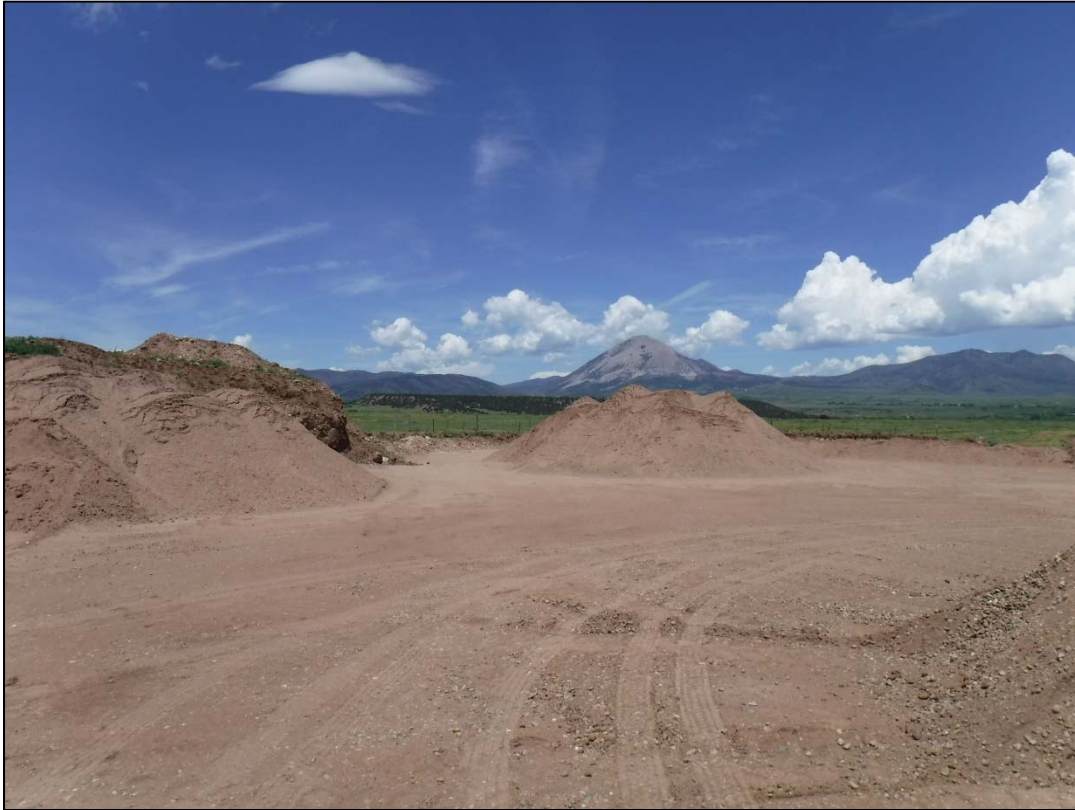
Photo 7: Stockpiled material to be used in reclaiming west wall of pit

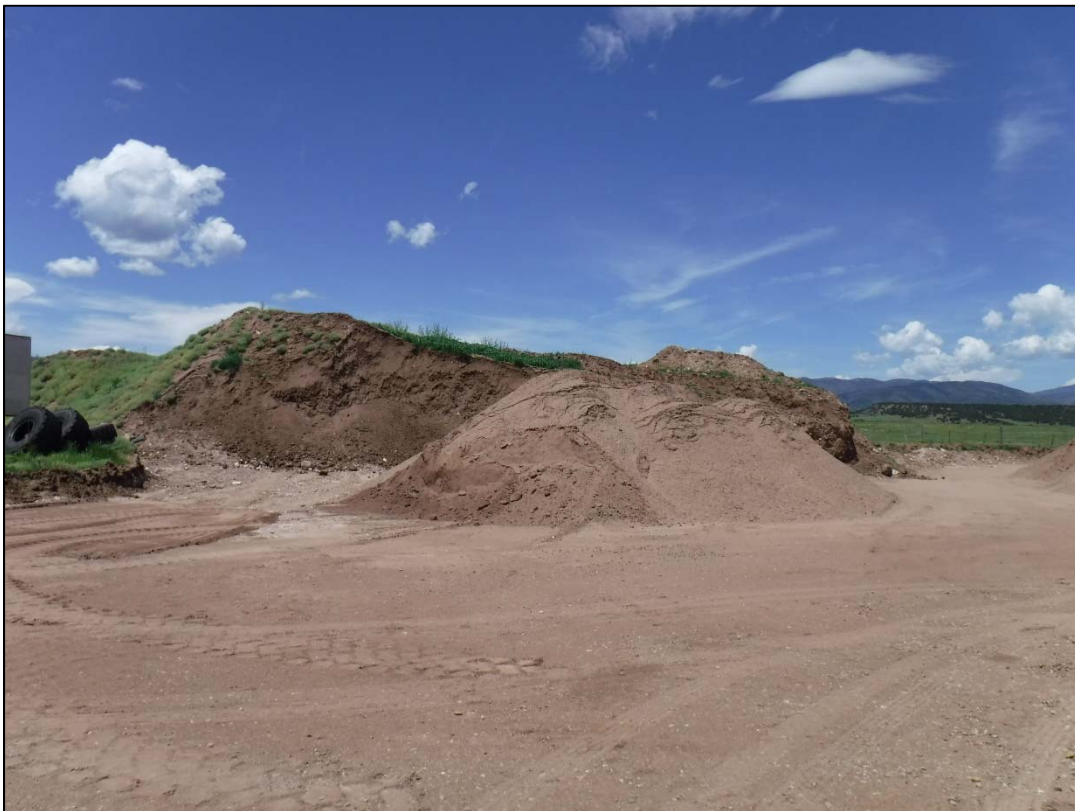
Photo 8: Stockpiled topsoil behind smaller stockpile of fines to be used in reclamation

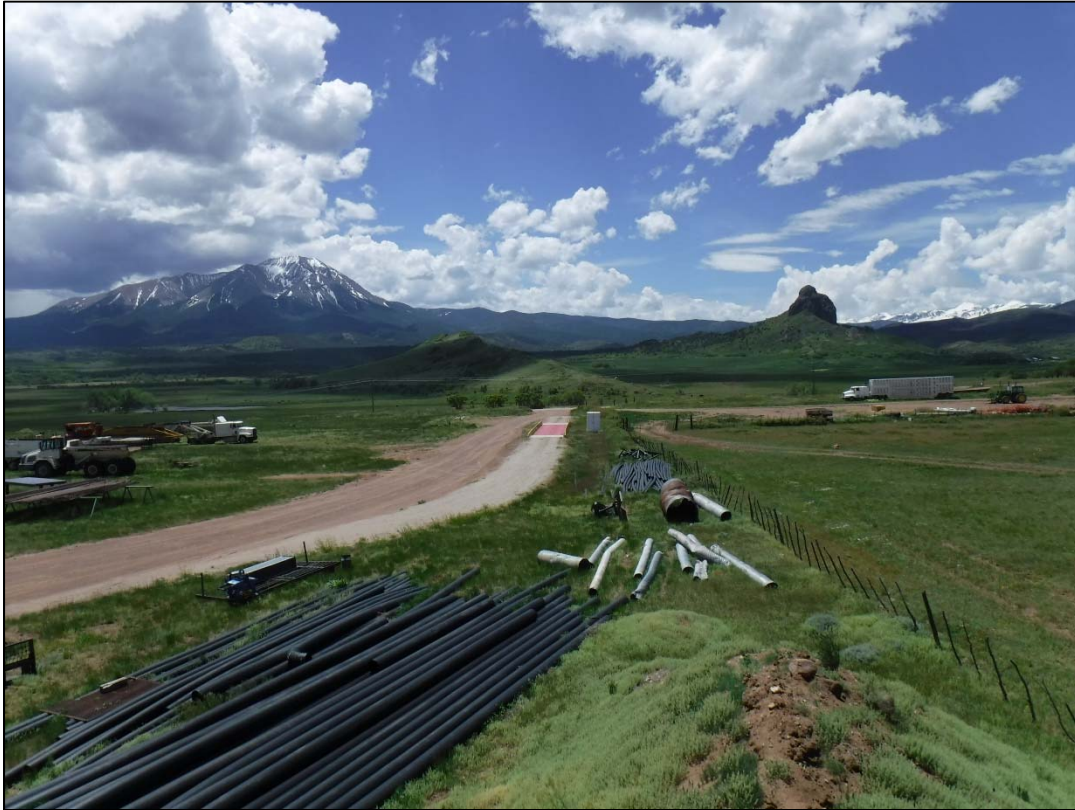
Photo 9: Mine entrance with scale house, looking south

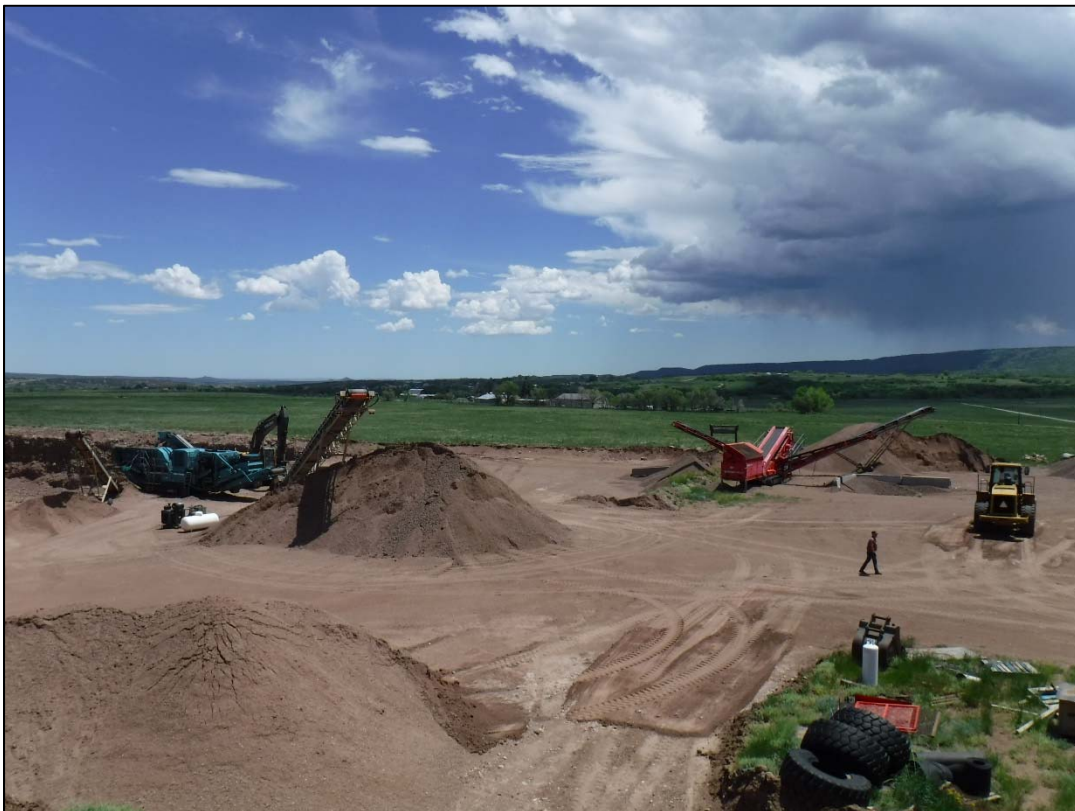
Photo 10: Additional acre of disturbance with processing equipment
