**COLORADO**Division of Reclamation,
Mining and Safety

MINERALS PROGRAM INSPECTION REPORT**PHONE: (303) 866-3567**

MINE NAME: Shaffers Crossing	MINE/PROSPECTING ID#: M-1978-208	MINERAL: Sand and gravel	COUNTY: Jefferson
INSPECTION TYPE: Monitoring	INSPECTOR(S): Michael A. Cunningham	INSP. DATE: January 19, 2018	INSP. TIME: 09:00
OPERATOR: Elk Creek Sand & Gravel, LLC	OPERATOR REPRESENTATIVE: Juliet Moores	TYPE OF OPERATION: 110c - Construction Limited Impact

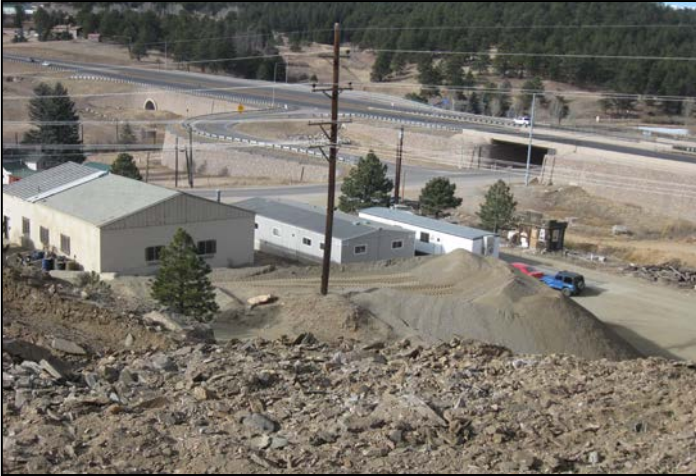
1. Overview of mine facilities.

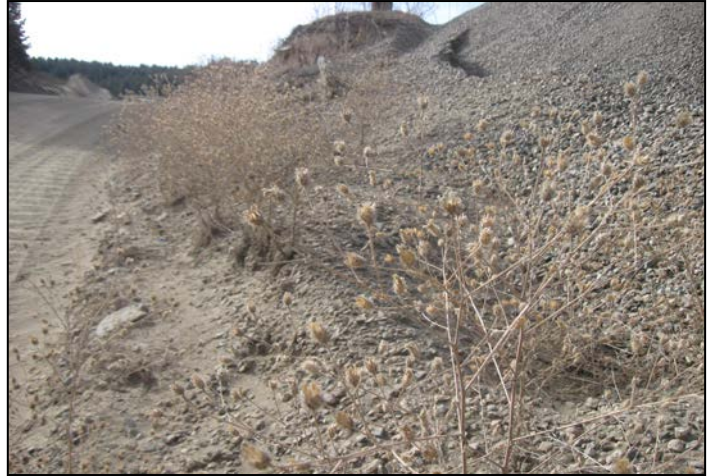
The Division observed diffuse knapweed throughout the site. Diffuse knapweed is a state listed noxious weed and must be controlled pursuant to Rule 3.1.10(6). A review of the permit file found the Shaffers Crossing operation does not have an approved Weed Control Plan. This matter has been cited as a problem and will require corrective action by the Operator; please see the first page of this report for additional information.

2. Diffuse knapweed growing along internal mine road.

control measures to be applied, a schedule for when control measures will be applied and a post-treatment monitoring plan. This weed control plan shall be submitted to the Division as a Technical Revision to the approved plan with the appropriate Technical Revision fee of \$216.00 by the corrective action date.

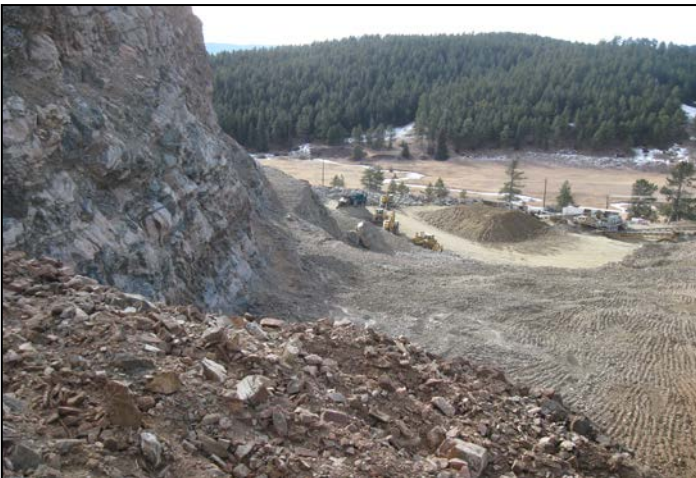
3. Overview of lower quarry. Photo taken from north end of highwall.

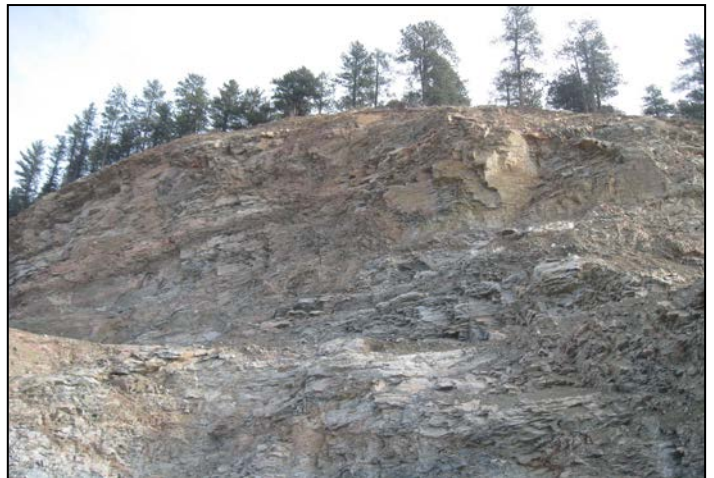
INSPECTION TOPIC: Gen. Compliance With Mine Plan**PROBLEM/POSSIBLE VIOLATION:** Problem: The benches on the highwall do not conform to the approved dimensions specified in the Mining Plan. This is a problem pursuant to C.R.S. 34-32.5-110(1)(a)(VII) for failure to follow the approved Mining Plan.**CORRECTIVE ACTIONS:** The operator shall convert the 110c Reclamation Permit to a 112c Reclamation Permit so the permit boundary may be expanded to allow the benches on the highwall to be constructed in accordance with the approved Mining Plan. The Conversion Application, with a fee of \$2,696.00 shall be submitted to the Division on or before the corrective action date.**CORRECTIVE ACTION DUE DATE:** 6/05/18**INSPECTION TOPIC:** Revegetation**PROBLEM/POSSIBLE VIOLATION:** Problem: There are state-listed noxious weeds present on site. This is a problem for failure to employ weed control methods for state listed noxious weed species within the permitted area, and to reduce the spread of weeds to nearby areas as required by Section 3.1.10 (6) of the rule.**CORRECTIVE ACTIONS:** Implement approved weed control plan and provide proof to the Division that this has been done. If a weed control plan is not already in place, the operator shall develop a weed control and management plan in accordance with Section 3.1.10 (6) of the Rule. This plan should be developed in consultation with the county extension agency, or weed control district office and should include specific

Measurements of the highwall were taken along the northernmost section and the highwall was determined to be 60 ft. in height (a map showing the location of the highwall measurements has been attached for reference). There is a working platform at the base of the highwall, which when removed will increase the overall height of the highwall. A small bench has been established approximately 30' from the top of the highwall. The Mining Plan calls for creating benches which are 12 ft. wide and 35 ft. in height. The Division could not access the bench to measure the width. However, visual observations were made from the side of the highwall and it was determined the bench was 1 - 2 ft. in width. As previously noted, the top of the highwall is in line with the permit boundary. As a result, the Operator will not be able to create a 12 ft. wide bench along this portion of the highwall. This matter has been cited as a problem and will require corrective action by the Operator; please see the first page of this report for additional information.

4. Northern section of the highwall. Photo taken facing east.

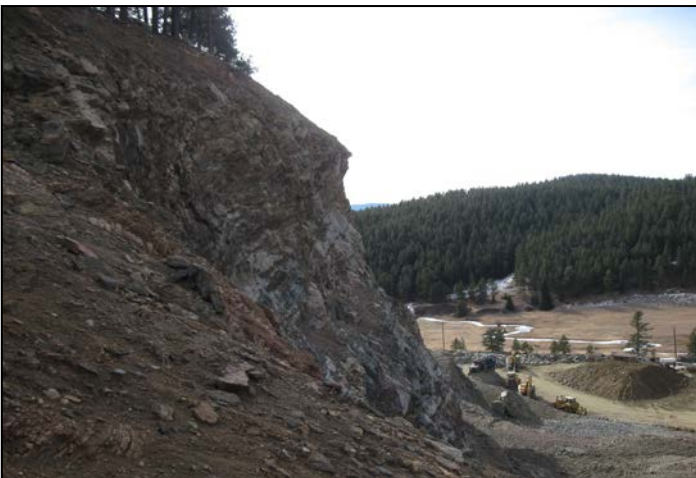
5. Overview of upper section of highwall.

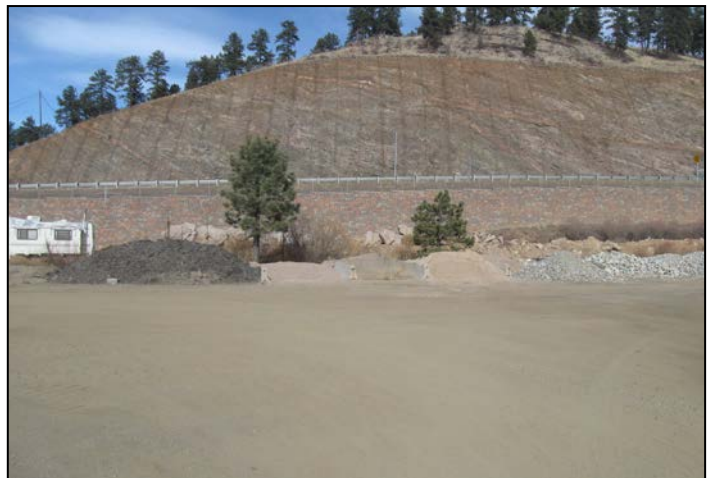
6. Quarry floor and product stockpiles.
