MINERALS PROGRAM INSPECTION REPORT
PHONE: (303) 866-3567

MINE NAME: Orchard Mesa Aggr	MINE/PROSPECTING ID#: M-1995-005	MINERAL: Gravel	COUNTY: Mesa
INSPECTION TYPE: Monitoring	INSPECTOR(S): Amy C. Yeldell	INSP. DATE: June 7, 2019	INSP. TIME: 14:00
OPERATOR: Mountain Region Corporation	OPERATOR REPRESENTATIVE: Sandra DuCray	TYPE OF OPERATION: 112c - Construction Regular Operation	
REASON FOR INSPECTION: Normal I&E Program	BOND CALCULATION TYPE: Complete Bond	BOND AMOUNT: \$56,400.43	
DATE OF COMPLAINT: NA	POST INSP. CONTACTS: None	JOINT INSP. AGENCY: None	
WEATHER: Windy	INSPECTOR'S SIGNATURE:

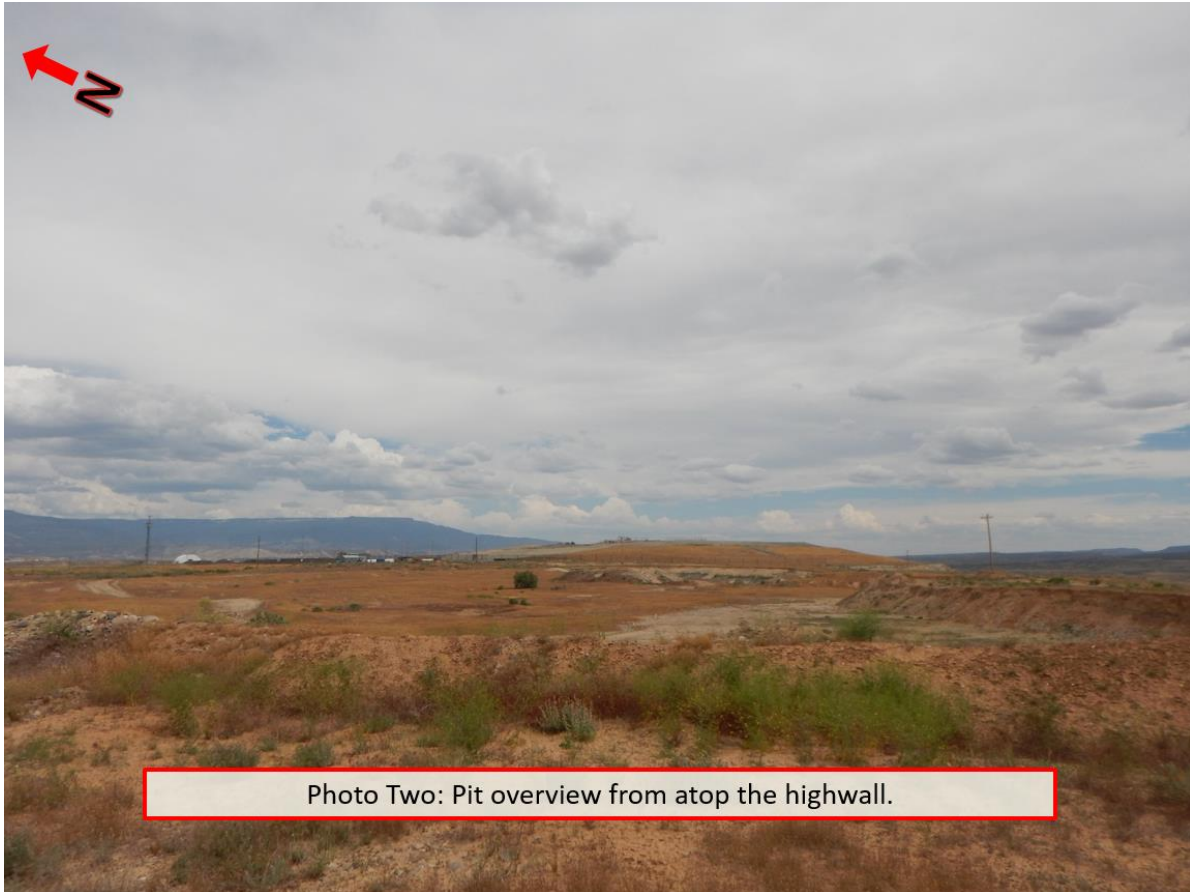
Photo Two: Pit overview from atop the highwall.

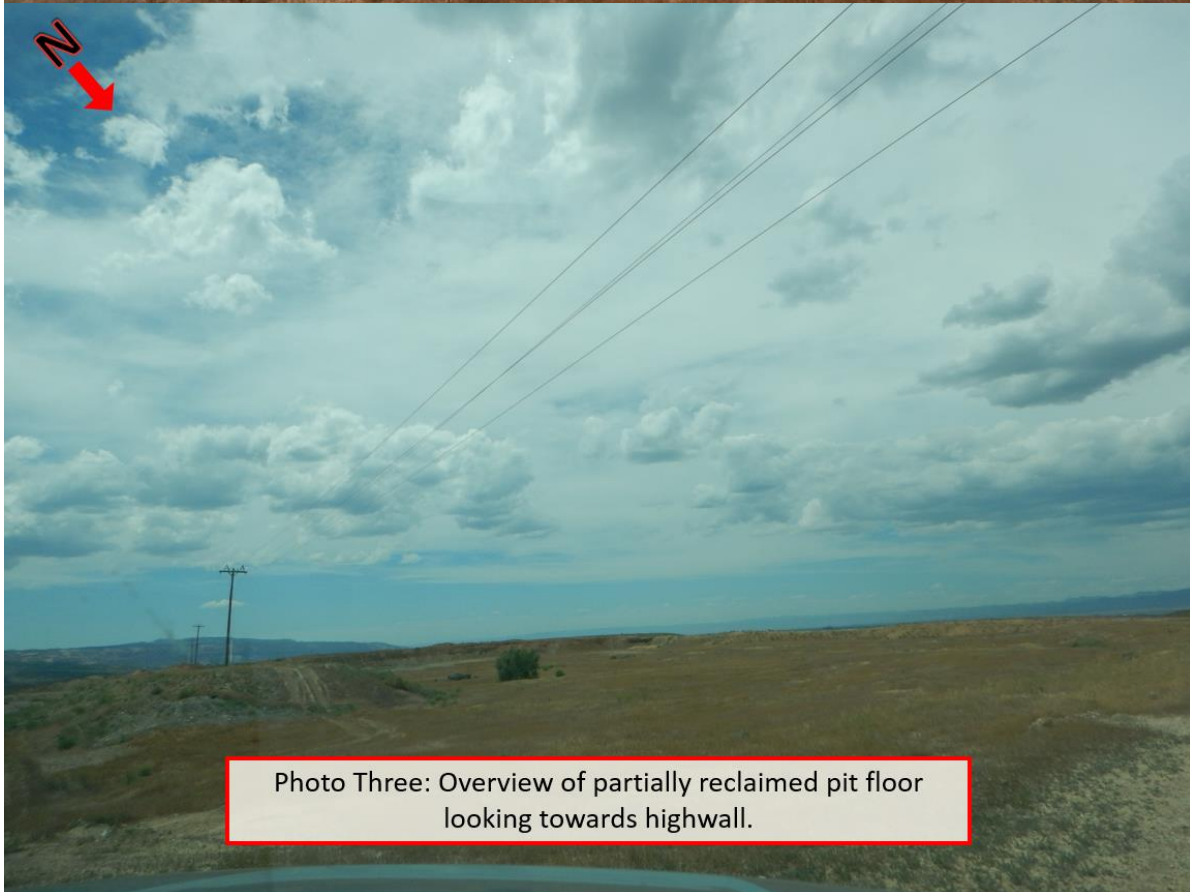
The eastern side of the excavated pit appears to have been reclaimed. Slopes are graded no steeper than a 3H: 1V. Vegetation has been established in most areas though its diversity and density were not evaluated at this time. In general vegetation in this area will likely be very sparse due to the arid conditions. The operator is encouraged to aggressively manage noxious weeds and undesirable species to avoid delays in reclamation success.

Photo Three: Overview of partially reclaimed pit floor looking towards highwall.
