Minerals 3600 Mine and Reclamation Inspection
U.S. Department of the Interior
Bureau of Land Management
Royal Gorge Field Office

Date: Oct 27, 2018 Time: 11:37 Weather: Sunny	Operation Name: CO-Quarries: Red Jasper Case Number: COC-074241 CDRMS #: M-1982-200
Attendees BLM: Amber Sanderson Operator(s): Contacted, but not present (CO-Quarries) Other(s): None	General Operation(s) are in compliance with documentation on file <input checked="" type="checkbox"/> Yes <input type="checkbox"/> No <input type="checkbox"/> N/A Operation(s) and disturbance on-site coincide with the operations and access on file <input checked="" type="checkbox"/> Yes <input type="checkbox"/> No <input type="checkbox"/> N/A

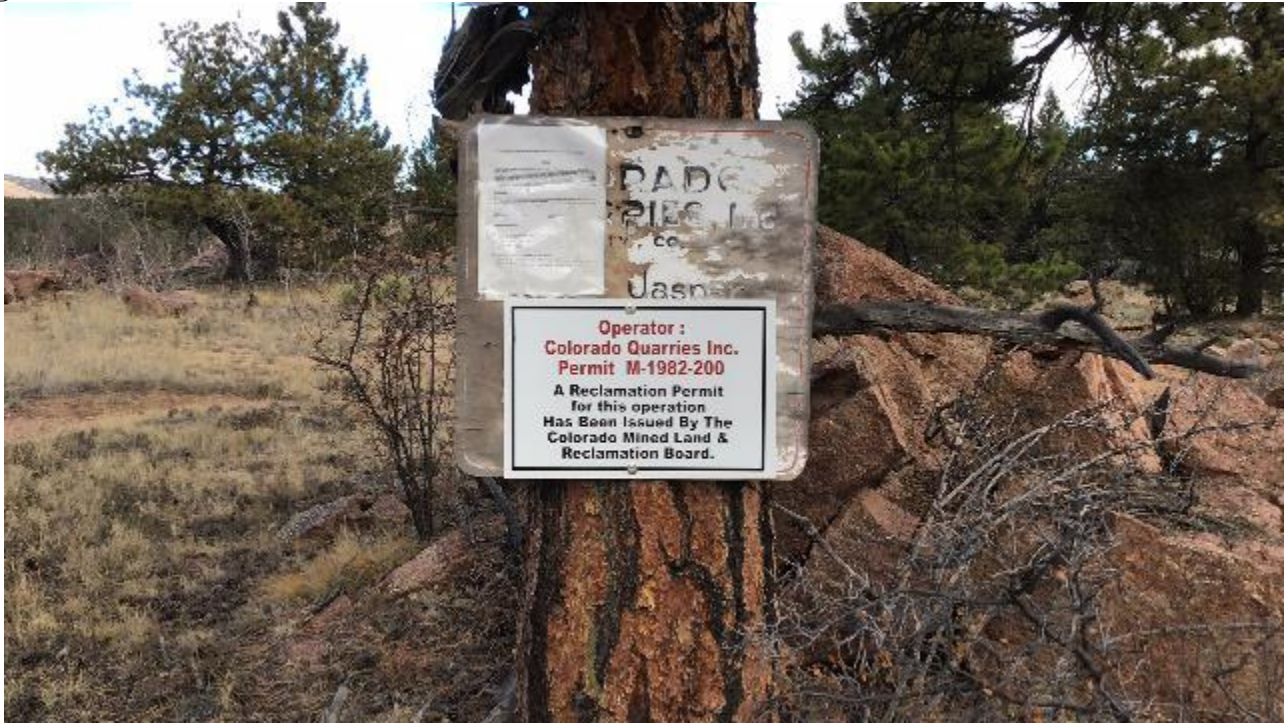
Image 1:

Comment: Sign upon southern entrance of mine site through private ranch 2 track road.

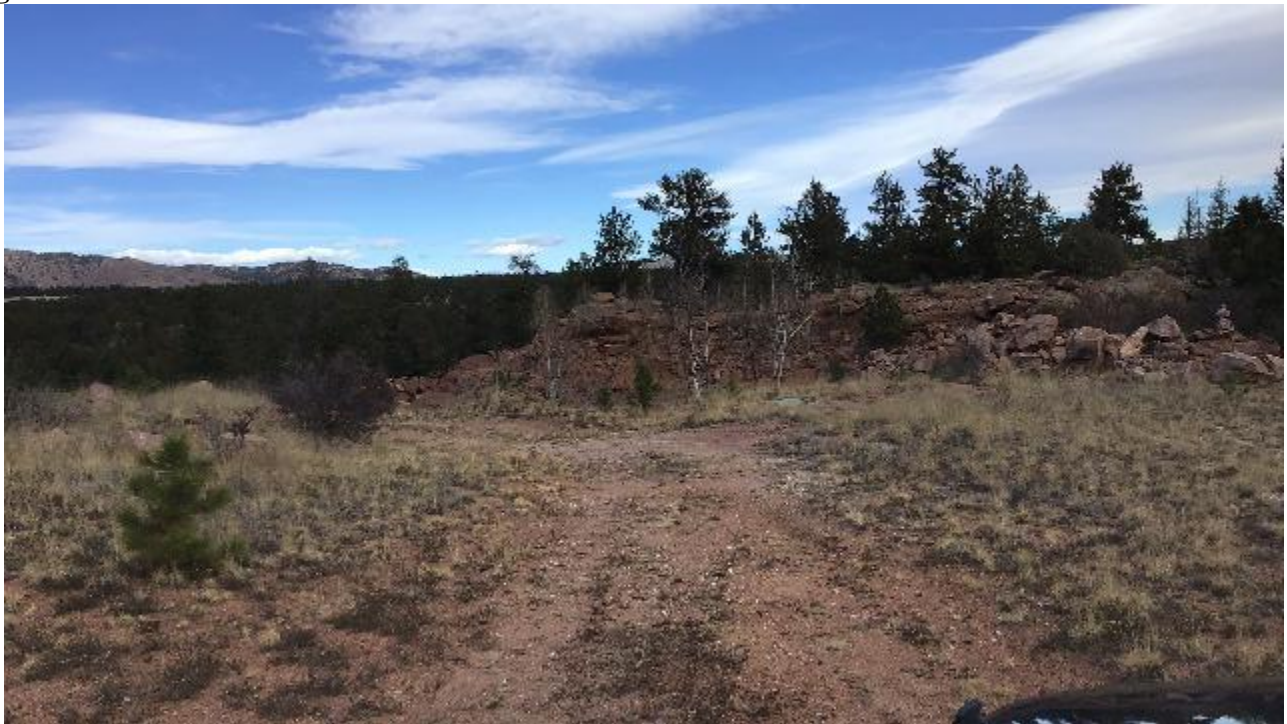
Image 2:

Comment: Entrance with stockpiles to the NE and old eastern highwall

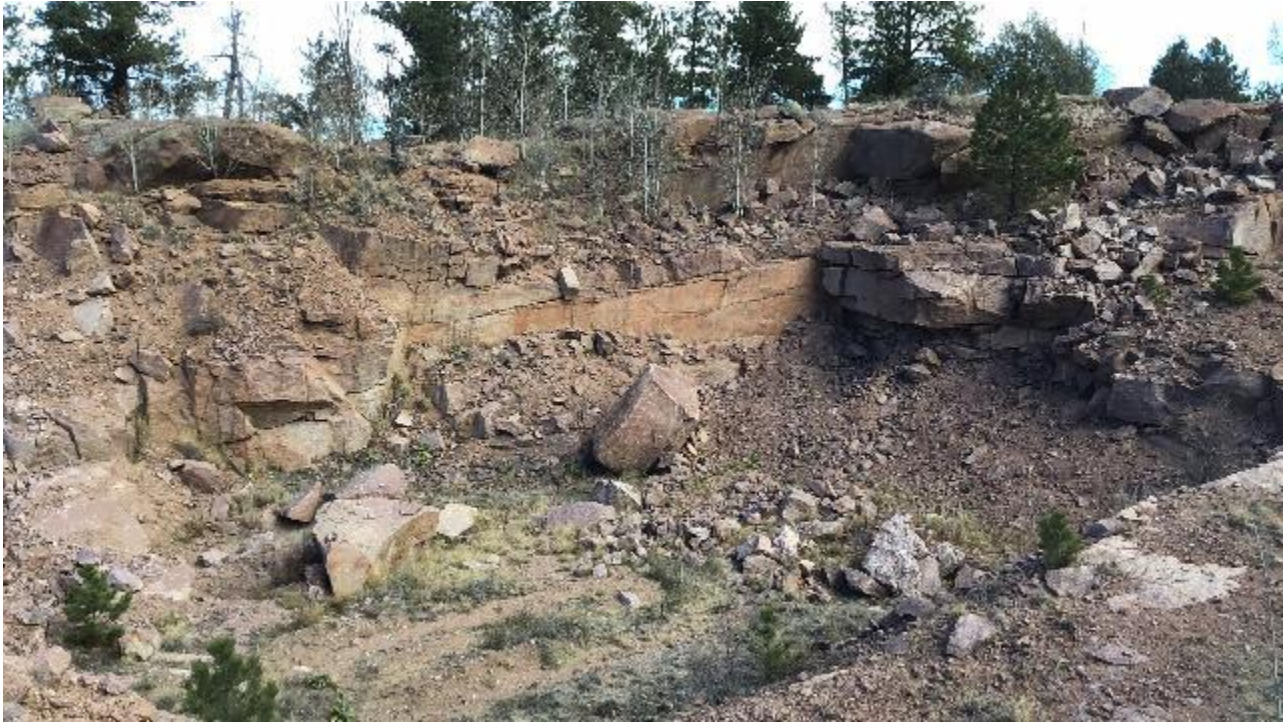
Image 3:

Comment: Northern view of old eastern highwall

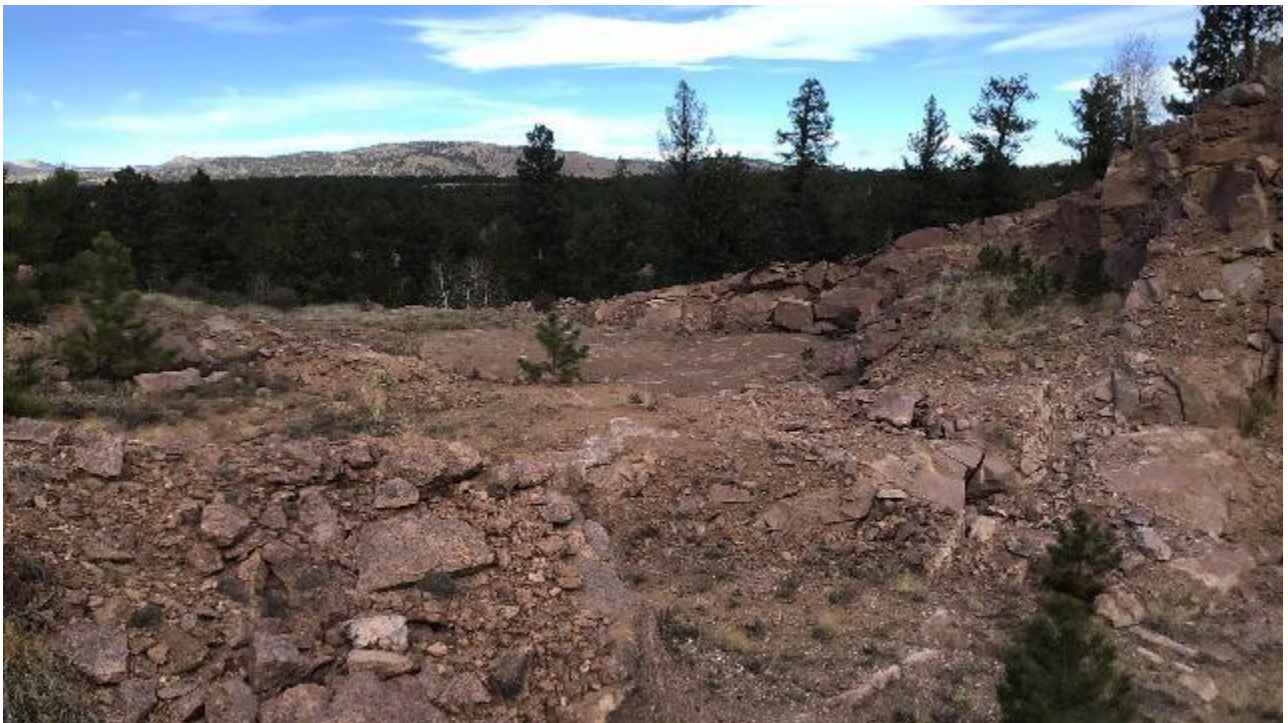
Image 4:

Comment: View NW of the active western highwall.

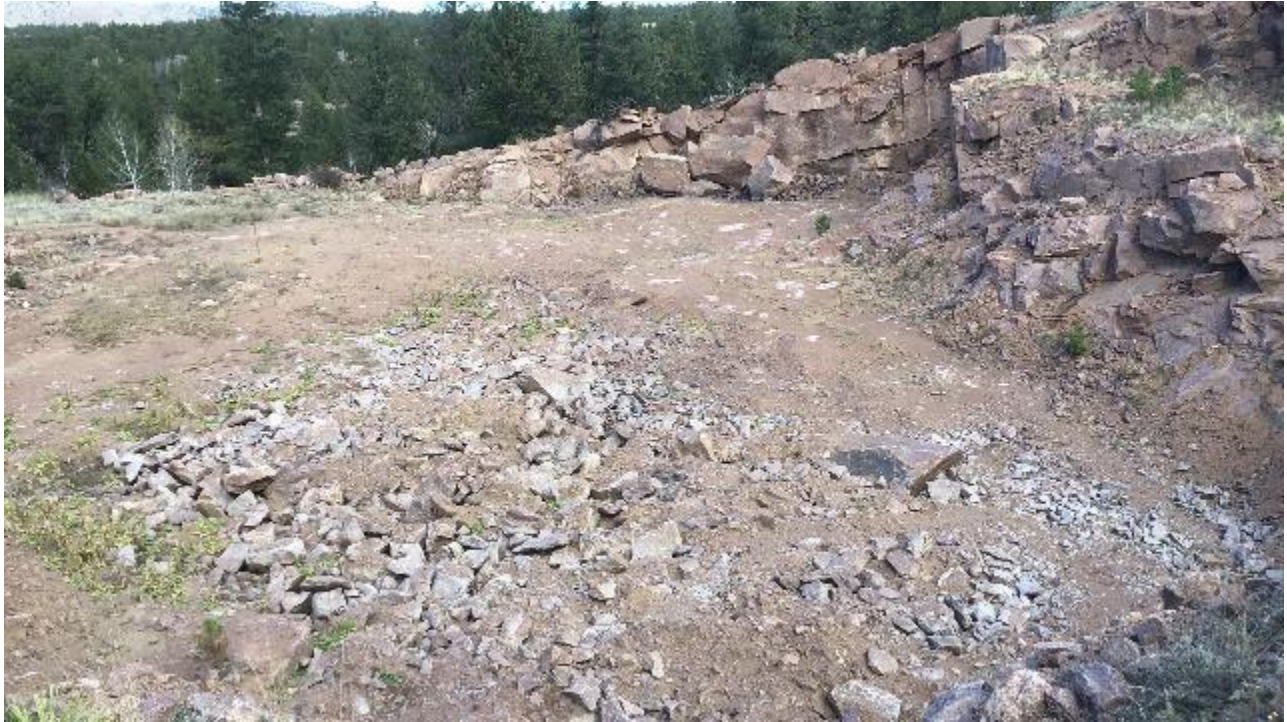
Image 5:

Comment: Inactive working floor and highwall. Working floor has been filled with riprap material to eliminate standing stormwater longer than 72 hours. No operations for the past 2 years.

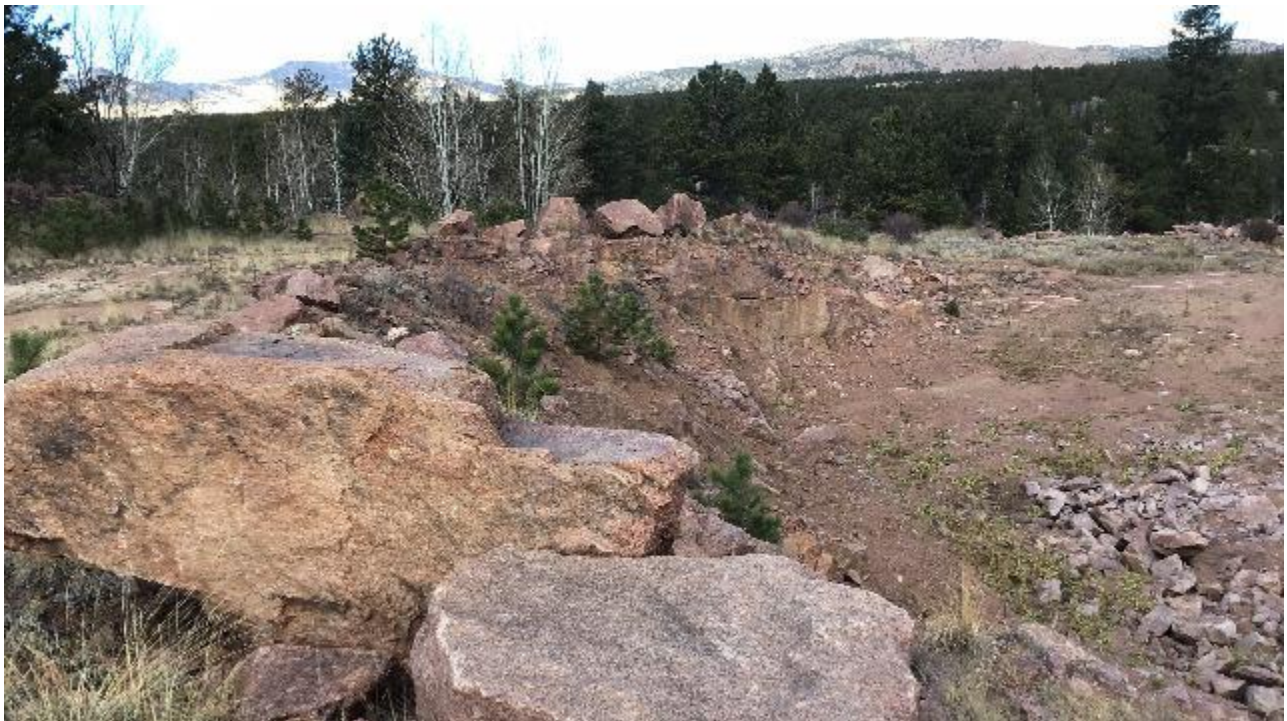
Image 6:

Comment: Berms (large boulders) along haul/access road

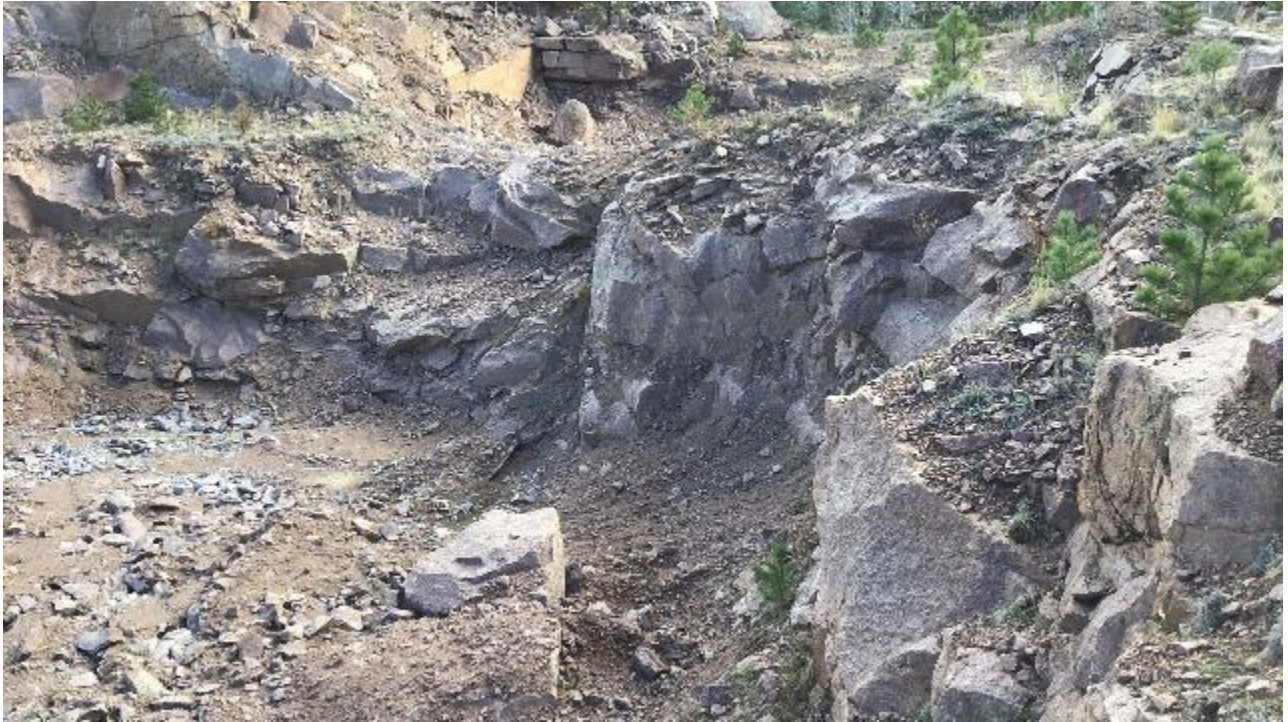
Image 7:

Comment: Eastern view of far western pit

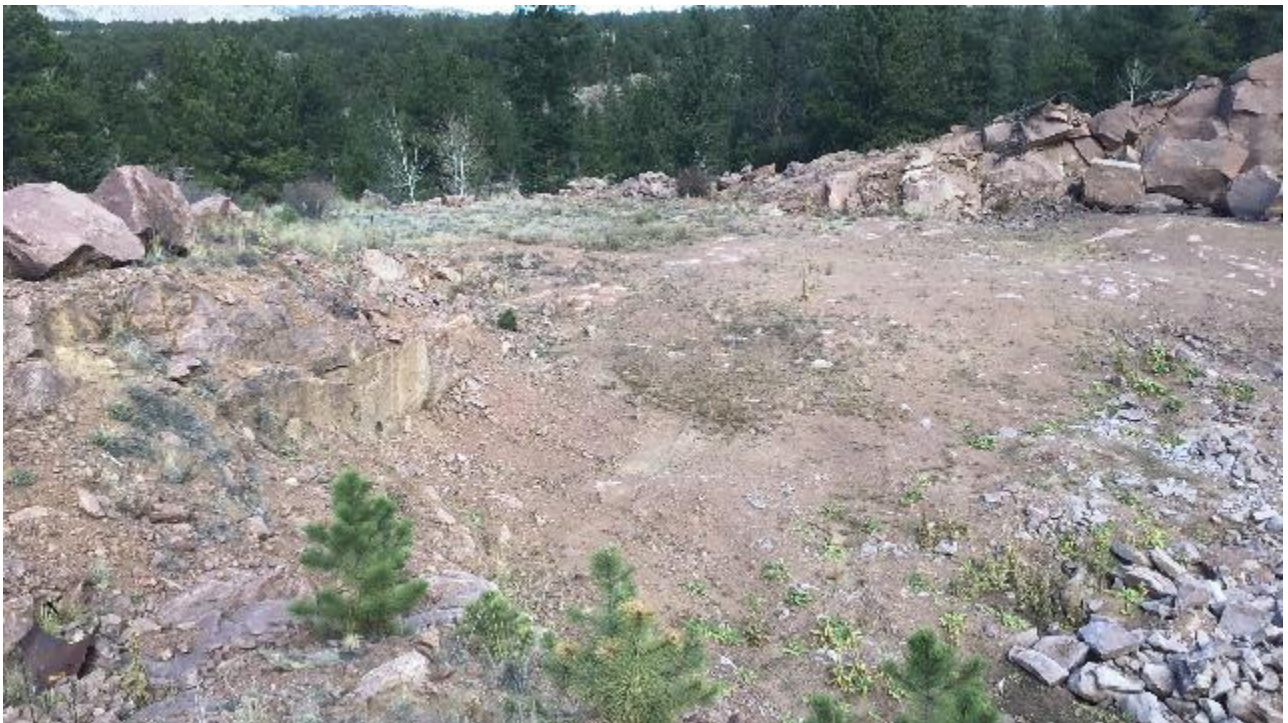
Image 8:

Comment: Western view inactive working floor

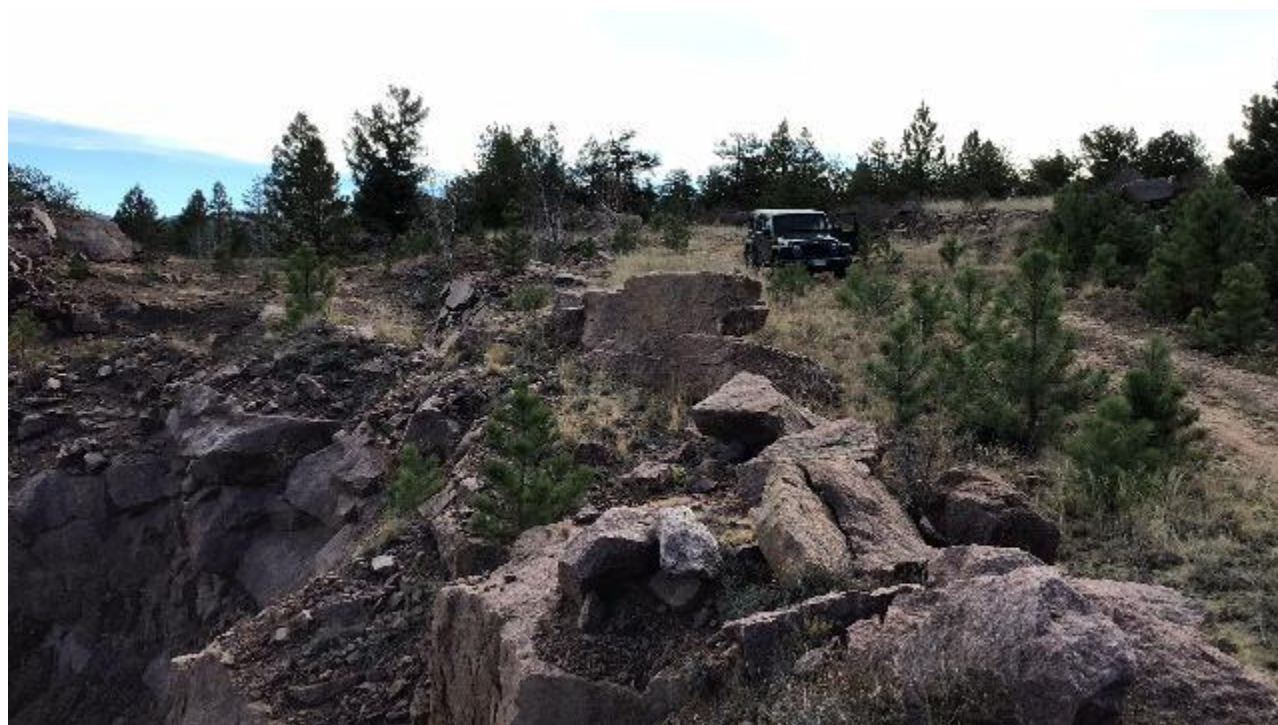
Image 9:

Comment: S/SE view of mine and access road

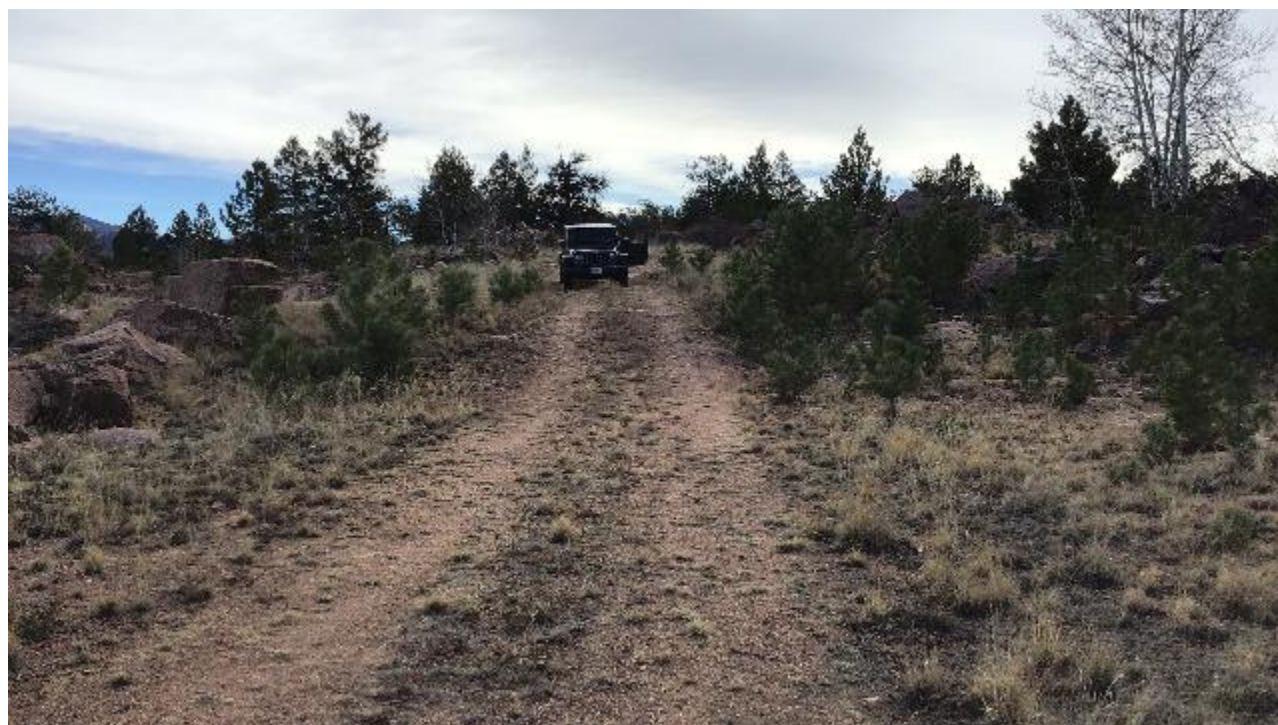
Image 10:

Comment: S/SE view of two track access road
