MINERALS PROGRAM INSPECTION REPORT PHONE: (303) 866-3567

| MINE NAME: | MINE/PROSPECTING ID#: | MINERAL: | COUNTY: |
|---|---|---|---|
| Limestone Pit No. 10 | M-2011-036 | Limestone, clay and | Moffat |
| Monitoring | Amy C. Yeldell | June 11, 2019 | 10:45 |

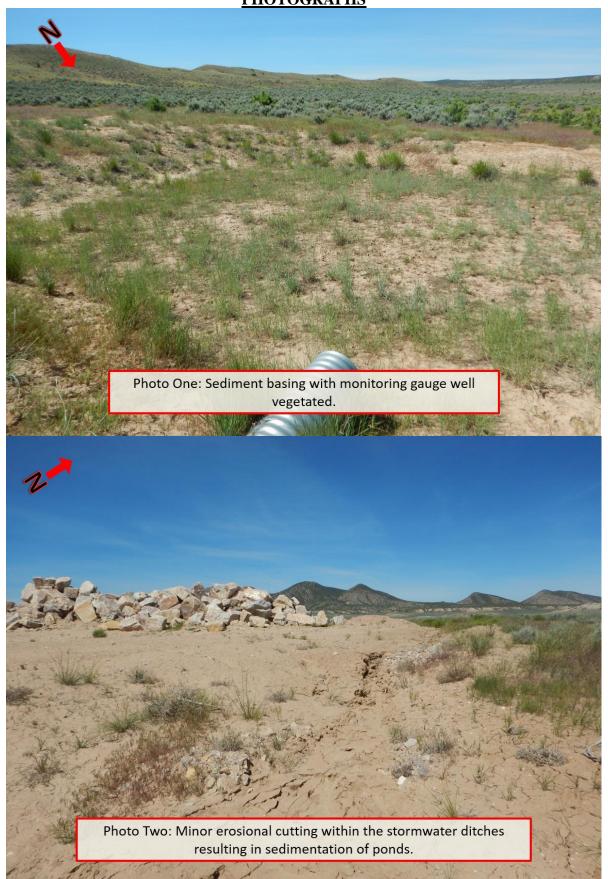
The mine identification sign and affected area boundary markers are in place and in compliance with Rule 3.1.12. Little to no additional disturbances has occurred since the previous inspections. The site was inactive at the time of the inspection. No equipment or fuel was observed on site. There are several large stockpiles of processed materials on site. All of which are stable with no erosion.

All excavated slopes are no steeper than 3H:1V with a stormwater berm at the base of the slope. The topsoil and overburden piles are clearly marked with signage to prevent accidental loss. The piles have excellent vegetative cover.

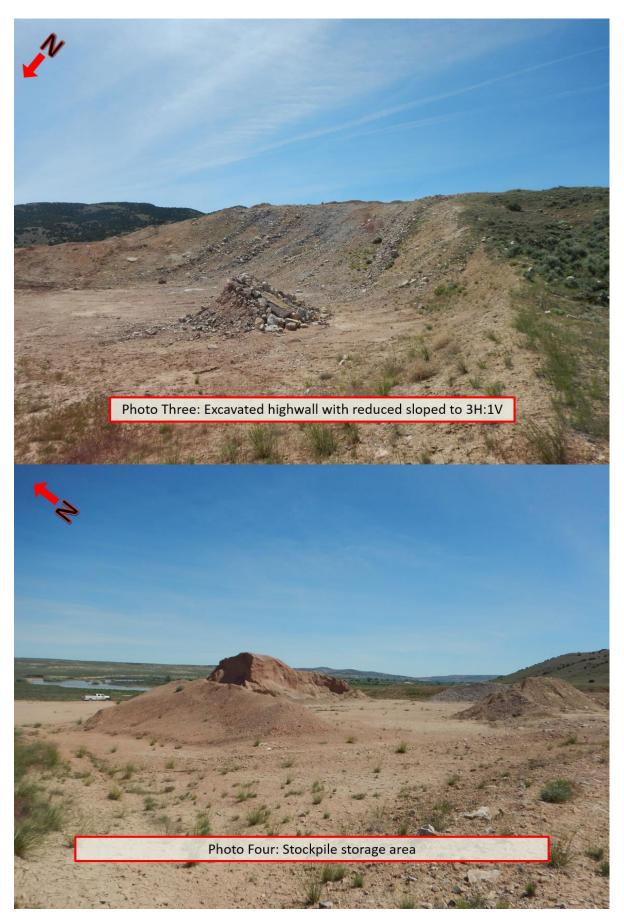
There is some minor riling and erosion however it is all contained on-site within stormwater BMP's. The erosion may result in additional sediment loading of ponds prior to stormwater events. Berms were employed around the disturbed areas to prevent run-on or run-off from the site. The Division recommends that armoring or regrading occur if/when equipment is in the area to prevent future further damage. Several stormwater BMP's were observed in addition to two hydrologic discharge monitoring gauges. The two sediment basins remain well vegetated.
