**MINERALS PROGRAM INSPECTION REPORT**  
**PHONE: (303) 866-3567**

| <b>MINE NAME:</b><br>Refuge Pit #1 | <b>MINE/PROSPECTING ID#:</b><br>M-1989-112 | <b>MINERAL:</b><br>Sand and gravel | <b>COUNTY:</b><br>Moffat |
| <b>INSPECTION TYPE:</b><br>Monitoring | <b>INSPECTOR(S):</b><br>Amy C. Yeldell | <b>INSP. DATE:</b><br>June 11, 2019 | <b>INSP. TIME:</b><br>12:45 |

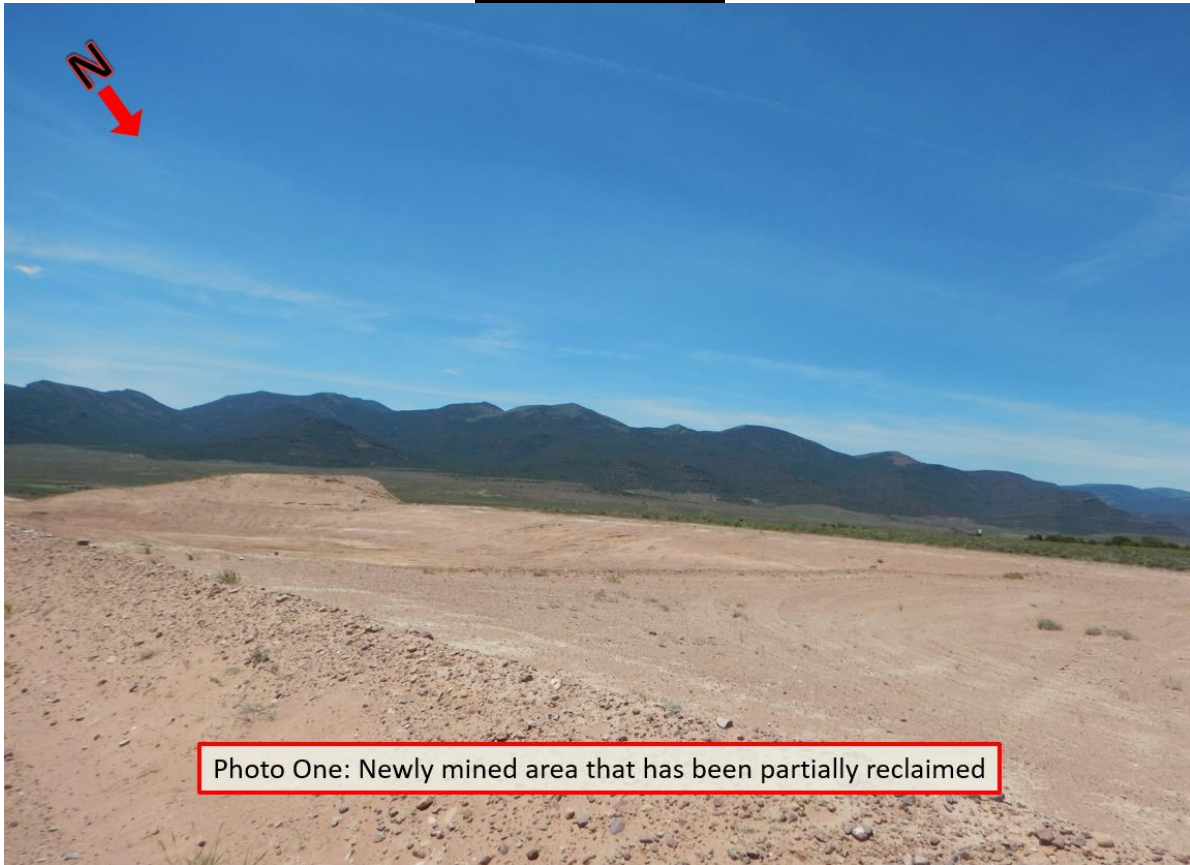
The site was inactive at the time of inspection but has recently had a large crushing operation. All of the slopes in the newly mined area have been regraded to a 3H: 1V or less. The recently processed material is stockpiled neatly on the existing pit floor.

Photo One: Newly mined area that has been partially reclaimed

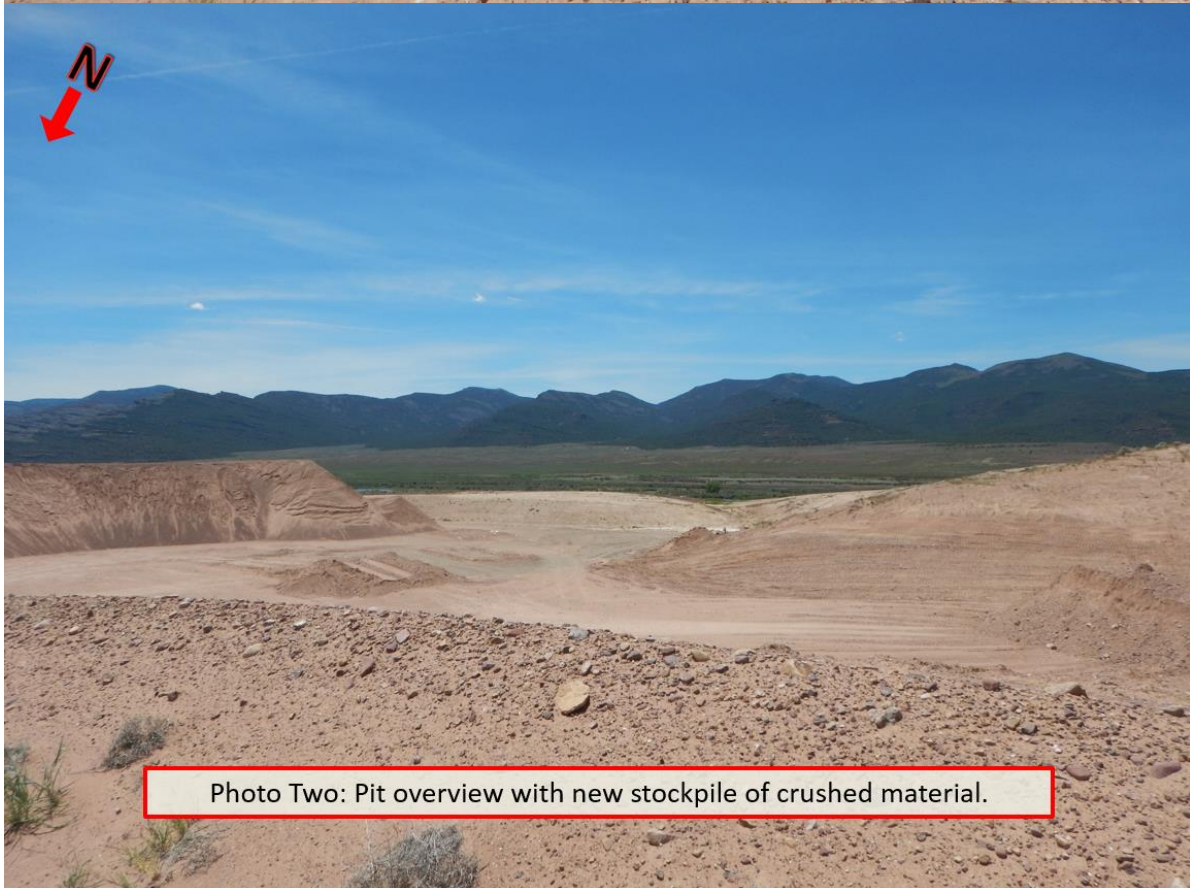
Photo Two: Pit overview with new stockpile of crushed material.
