**MINERALS PROGRAM INSPECTION REPORT**  
**PHONE: (303) 866-3567**

<b>MINE NAME:</b> N of Douglas Pass	<b>MINE/PROSPECTING ID#:</b> M-1981-043	<b>MINERAL:</b> Shale	<b>COUNTY:</b> Rio Blanco
<b>INSPECTION TYPE:</b> Monitoring	<b>INSPECTOR(S):</b> Dustin M. Czaplá	<b>INSP. DATE:</b> June 11, 2019	<b>INSP. TIME:</b> 15:00
<b>OPERATOR:</b> Colorado Department of Transportation	<b>OPERATOR REPRESENTATIVE:</b> None	<b>TYPE OF OPERATION:</b> 110c - Construction Limited Impact	
<b>REASON FOR INSPECTION:</b> Normal I&E Program	<b>BOND CALCULATION TYPE:</b> None	<b>BOND AMOUNT:</b> No Bond Held	
<b>DATE OF COMPLAINT:</b> NA	<b>POST INSP. CONTACTS:</b> None	<b>JOINT INSP. AGENCY:</b> None	
<b>WEATHER:</b> Clear	<b>INSPECTOR'S SIGNATURE:</b>

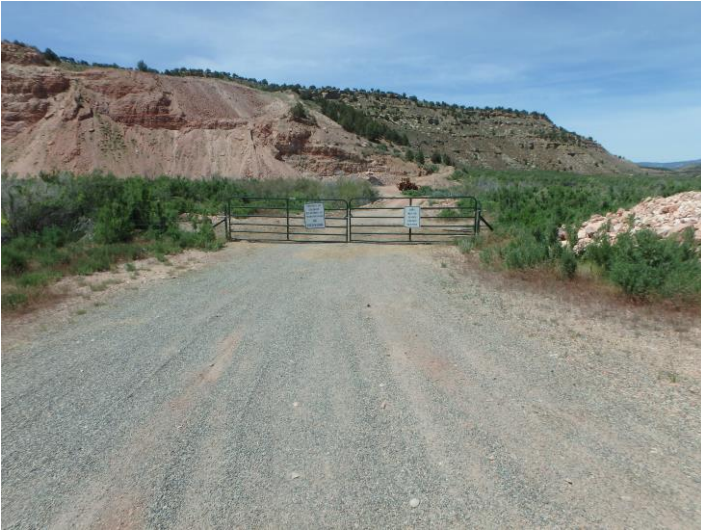
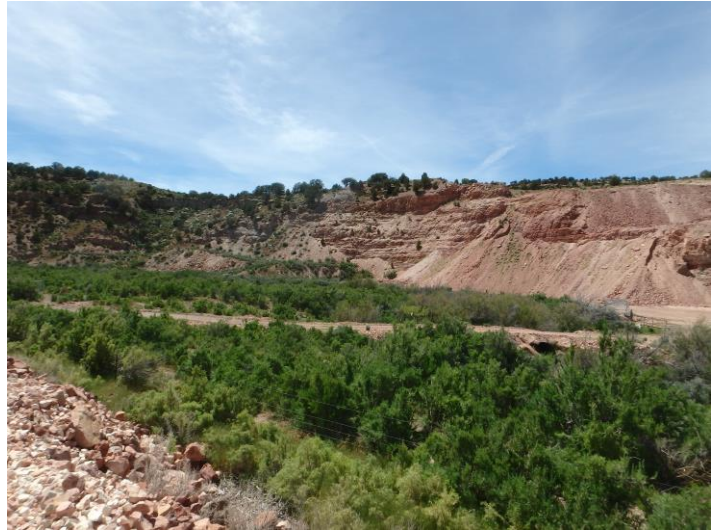
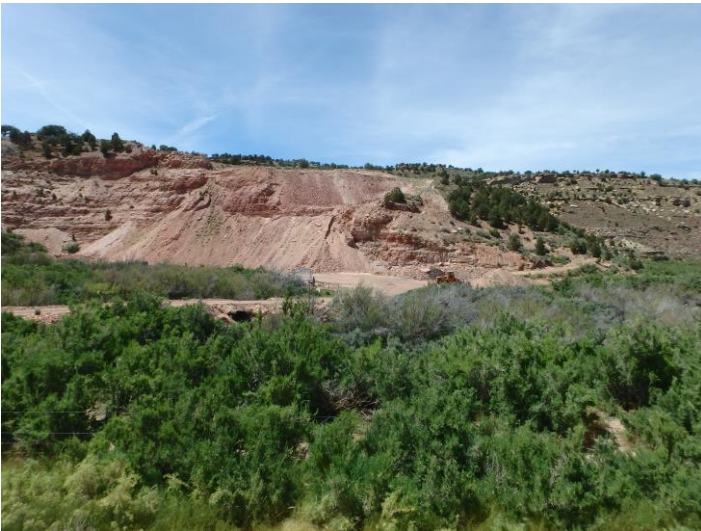
Mining was not occurring during this inspection. A small gravel stockpile, loader and screen were located on site. The highwall is located on the west end of the permit area and will advance to the west as mining progresses. Currently the highwall ranges from near vertical to 1H:1V. No stability or erosion concerns were noted.
