MINERALS PROGRAM INSPECTION REPORT
PHONE: (303) 866-3567

| MINE NAME: Stout - Amick Pit | MINE/PROSPECTING ID#: M-1981-275 | MINERAL: Sand and gravel | COUNTY: Rio Blanco |
| INSPECTION TYPE: Monitoring | INSPECTOR(S): Dustin M. Czaplá | INSP. DATE: June 5, 2019 | INSP. TIME: 11:30 |

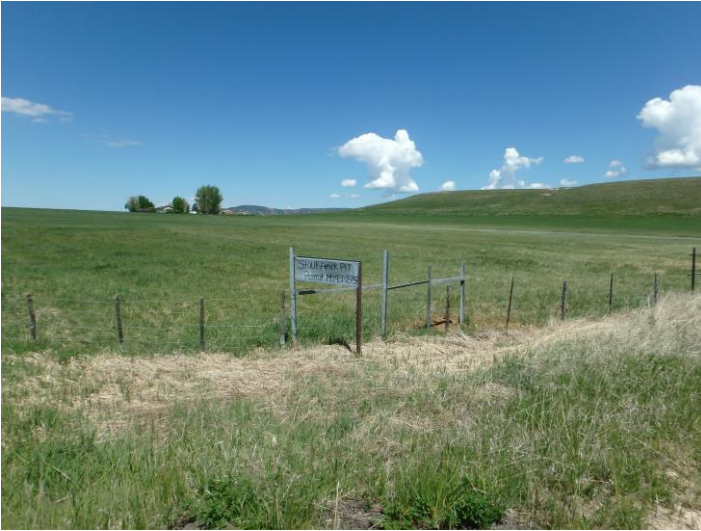
Adequate mine identification signage was noted at the entrance to the site.

Mining operations have not yet commenced at this site. The site is currently a hay field.
