MINERALS PROGRAM INSPECTION REPORT

MINE NAME: Russell Ranch Pit	MINE/PROSPECTING ID#: M-2006-008	MINERAL: Sand and gravel	COUNTY: Rio Blanco
INSPECTION TYPE: Monitoring	INSPECTOR(S): Dustin M. Czapla	INSP. DATE: June 5, 2019	INSP. TIME: 10:30
OPERATOR: Russell Ranch General Partnership dba WR A	OPERATOR REPRESENTATIVE: None	TYPE OF OPERATION: 110c - Construction Limited Impact

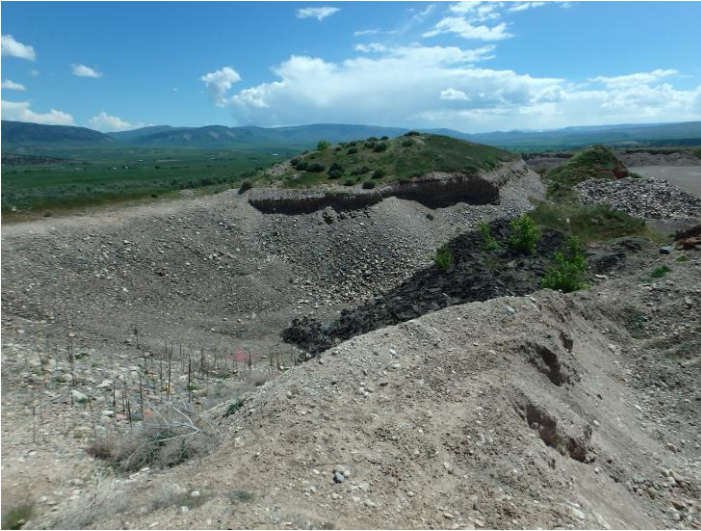
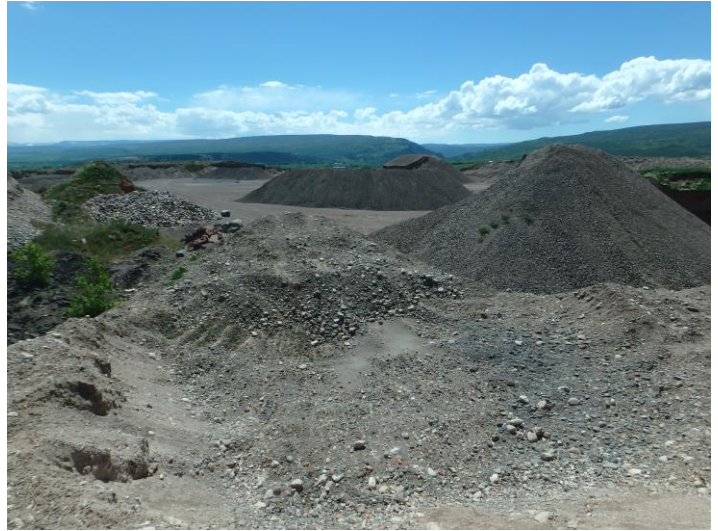
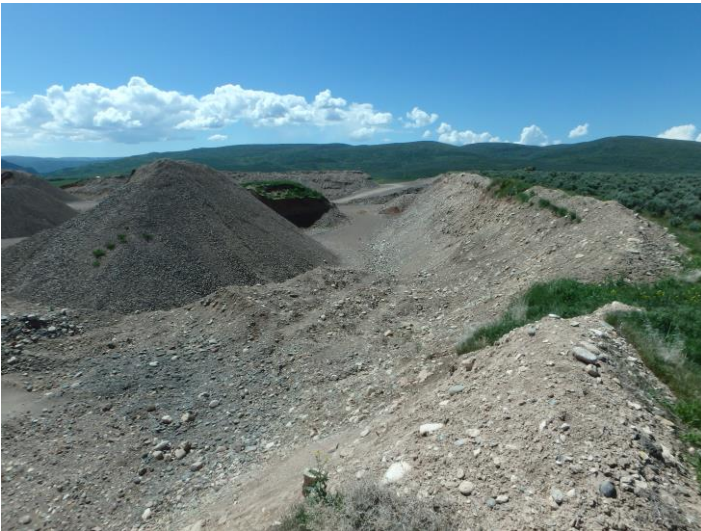
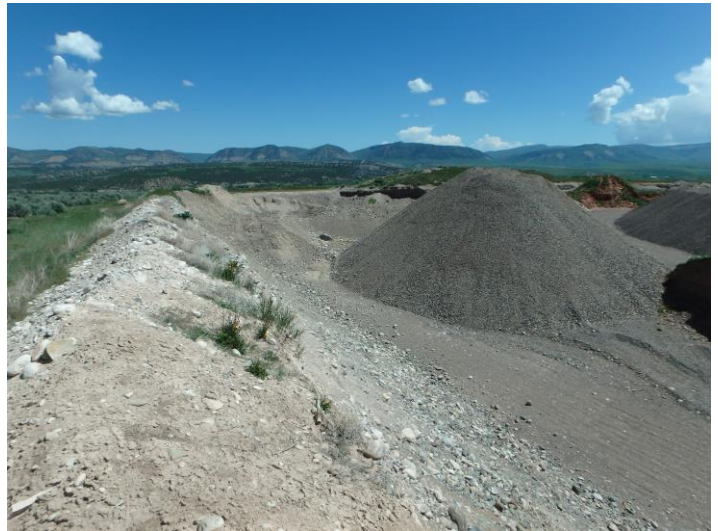
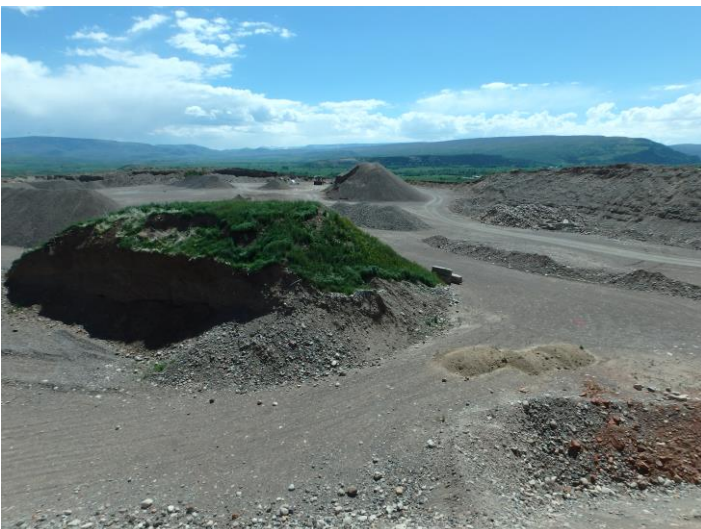
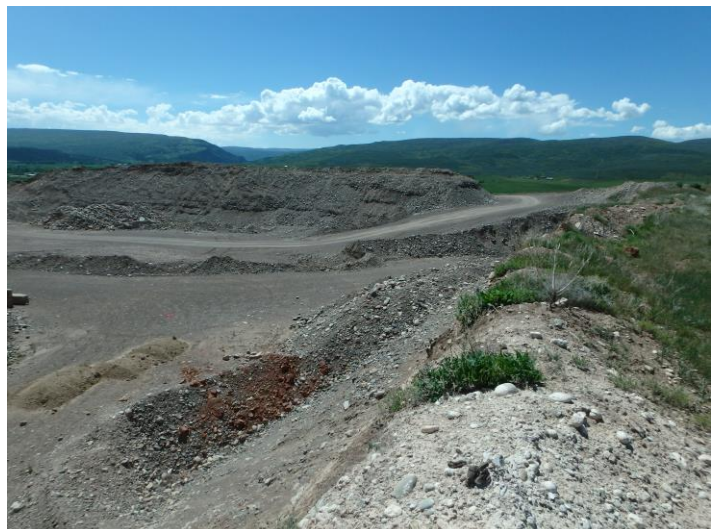
Adequate mine identification signage was not noted at the entrance to the site. This has been noted as a problem. The operator shall post a sign at the entrance to the site that includes the name of the operation and the permit number, in accordance with the requirements of Rule 3.1.12(1).

Nearly the entire permit area has been disturbed by the operation. Highwalls roughly 20-30 feet in height and 1H:1V slope surround the pit. Materials stockpiles are located throughout the pit. The topsoil stockpile located in northeast part of the pit appeared stable. A scale and scalehouse are located in the processing area in the southeast part of the pit.

CORRECTIVE ACTIONS: The operator shall, at the entrance of the mine site, post a sign which shall be clearly visible from the access road with the following: the name of the operator, a statement that a reclamation permit for the operation has been issued by the Colorado Mined Land Reclamation Board; and the permit number. The operator shall submit photo documentation that a proper sign has been posted by the corrective action date.
