MINERALS PROGRAM INSPECTION REPORT
PHONE: (303) 866-3567

MINE NAME: Climax Mine	MINE/PROSPECTING ID#: M-1977-493	MINERAL: Molybdenum	COUNTY: Summit
INSPECTION TYPE: Monitoring	INSPECTOR(S): Jared L. Ebert	INSP. DATE: June 7, 2019	INSP. TIME: 09:15
OPERATOR: Climax Molybdenum Company	OPERATOR REPRESENTATIVE: James Haag, Megan Graham	TYPE OF OPERATION: 112d-3 - Designated Mining Operation	
REASON FOR INSPECTION: Normal I&E Program	BOND CALCULATION TYPE: None	BOND AMOUNT: \$91,011,850.00	
DATE OF COMPLAINT: NA	POST INSP. CONTACTS: None	JOINT INSP. AGENCY: None	
WEATHER: Cloudy	INSPECTOR'S SIGNATURE:

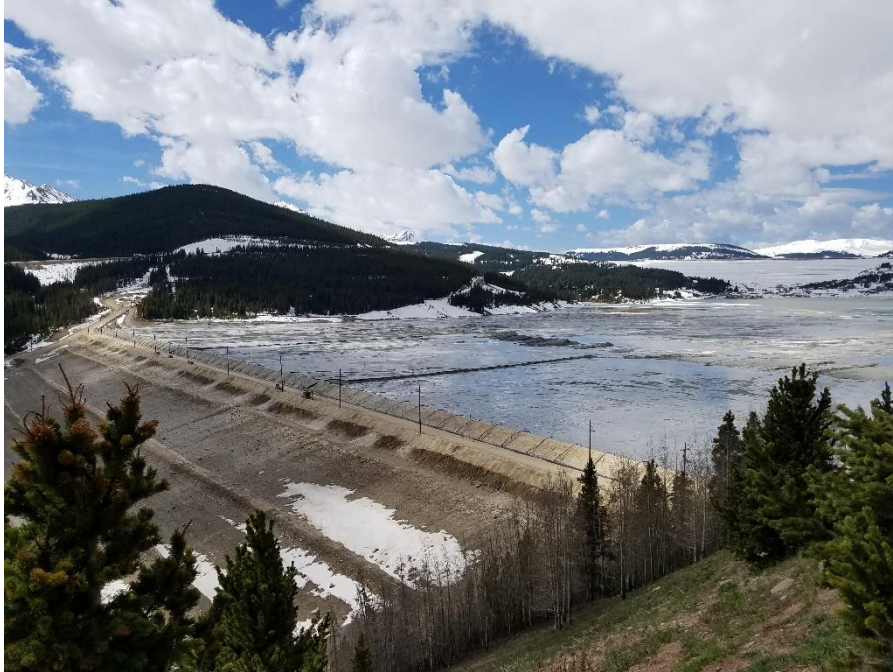
The Mayflower TSF was observed. Most of the snow has melted off of the face of 5 Dam. Climax has begun spigot operations for tailings deposition on the top of 5 dam. The deposition area appeared graded, maintained and functional. The beach length appeared to be in compliance.

Figure 1. 5 Dam, from the northwest side looking southeast.

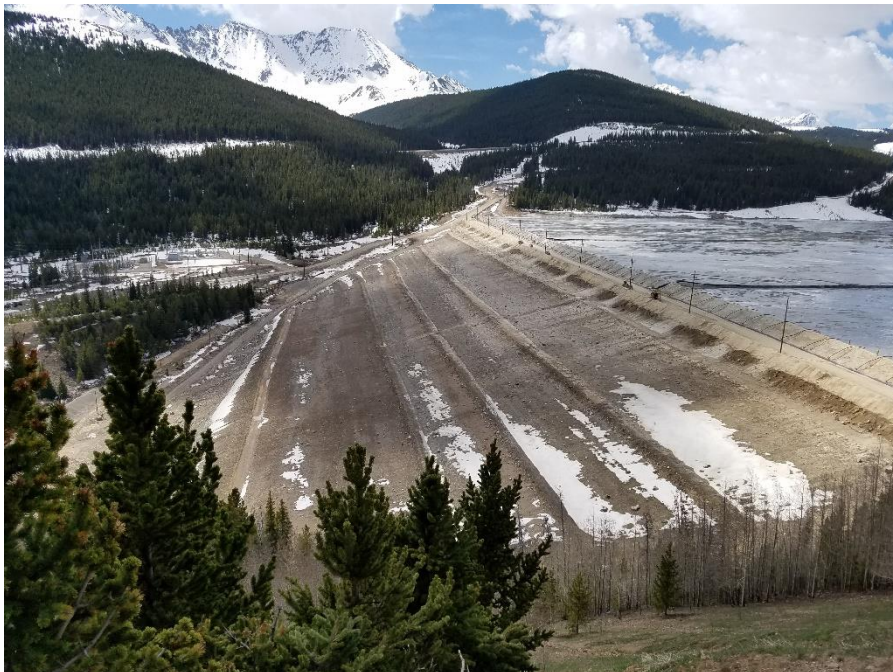
Figure 2. 5 Dam, from the northwest side looking east.

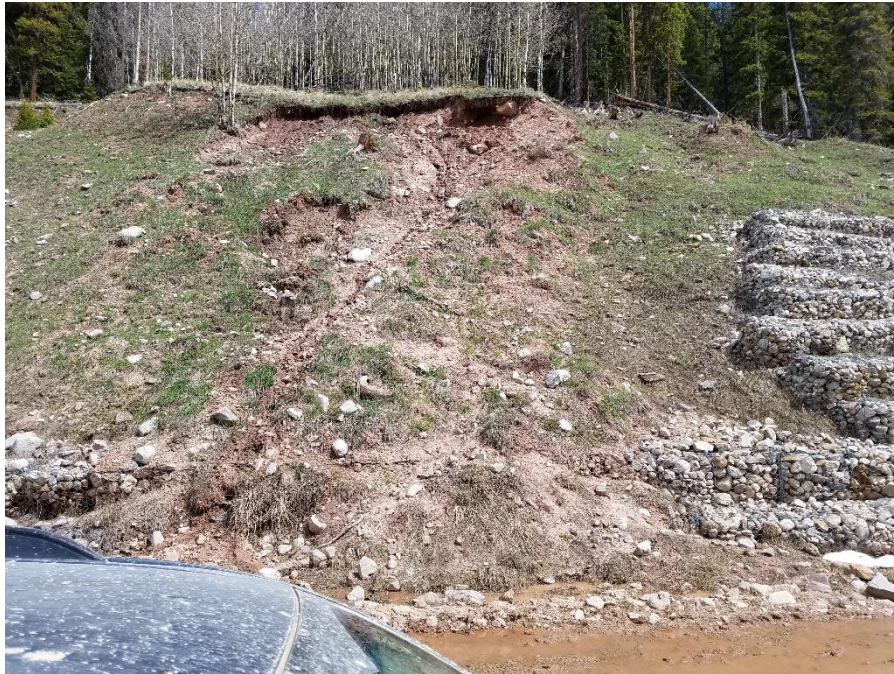
The Division observed the West Interceptor (WI) system beginning near where the WI meets Tucker Gulch to the upper end near Lake Irwin. Climax is required to remove snow and ice from the open channel portions of the interceptor systems as well as clearing culvert opening prior to the snowmelt runoff each spring. Climax has cleared the openings/grates that allows flow into the underground pipe portion of the WI. A small landslide was observed along the road in the underground pipe portion of the WI. The slide material appears to be impeding flow slightly along the roadside ditch leading to the grated opening for the pipe channel. Mr. Haag indicated that Climax would conduct maintenance to insure the road side channel will be cleared to allow flow into the WI. Climax should continue to watch this slide area and conduct additional slope stabilization if necessary to prevent further erosion possibly impacting the road and the WI functionality. Gabion walls are in place adjacent to both sides of the small slide area. Climax has replacement pipe staged onsite for the improvements to be made to the WI as approved in Technical Revision No. 29.

Figure 3. Small slide along the West Interceptor.

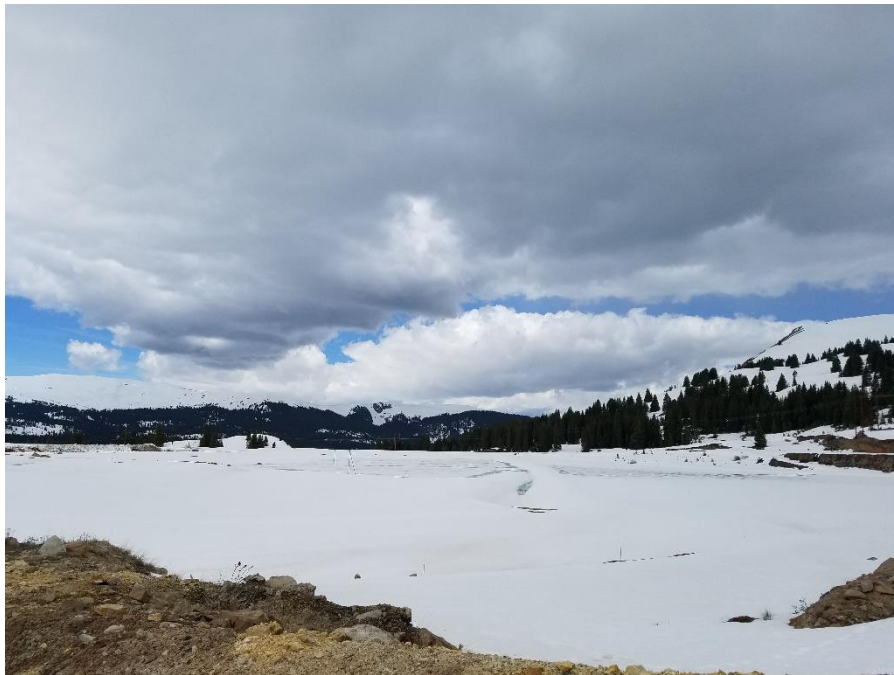
The Lake Irwin area was snow covered.

Figure 4. From the east side of Lake Irwin looking west.
