MINERALS PROGRAM INSPECTION REPORT
PHONE: (303) 866-3567

MINE NAME: Amzak Pit	MINE/PROSPECTING ID#: M-2003-003	MINERAL: Gravel and sand	COUNTY: La Plata
INSPECTION TYPE: Monitoring	INSPECTOR(S): Lucas J. West	INSP. DATE: May 15, 2019	INSP. TIME: 10:35
OPERATOR: Consolidated Constructors, Inc.	OPERATOR REPRESENTATIVE: Robert Johnson, Landowner	TYPE OF OPERATION: 112c - Construction Regular Operation	
REASON FOR INSPECTION: High Priority	BOND CALCULATION TYPE: None	BOND AMOUNT: \$133,165.00	
DATE OF COMPLAINT: NA	POST INSP. CONTACTS: None	JOINT INSP. AGENCY: None	
WEATHER: Clear	INSPECTOR'S SIGNATURE:

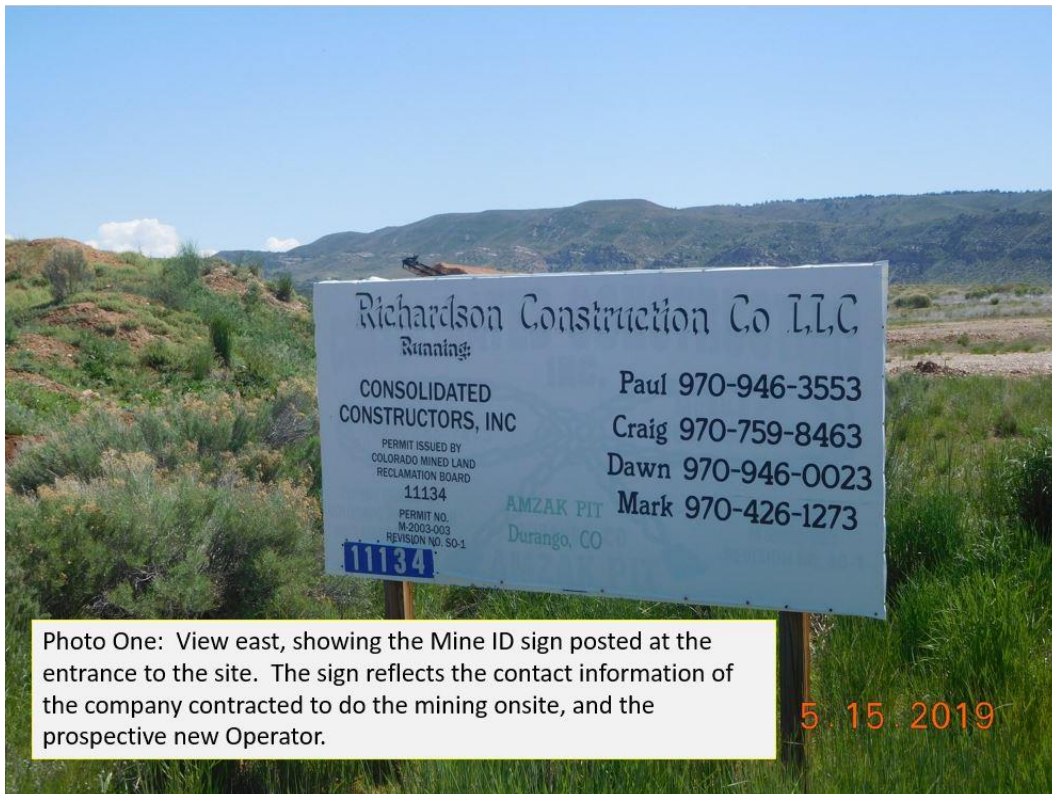
The proper mine identification signage was posted at the entrance to the site and can be seen in Photo One. The permit boundaries were clearly marked with a series of 3 strand barbed wire fence and T-posts. The site was not active during the inspection however mining related equipment was observed on site. Bob Johnson, the landowner, was present during the inspection however no operator representative was present. The current disturbance has been estimated visually and via satellite imagery at 33.5 Acres. The current mining area is located to east of the permit boundary and consist of a large highwall. The highwall is approximately 90 feet tall and nearly 300 feet long. The highwall appears to be stable and no evidence of sloughing or slumping was observed. The highwall can be seen in Photos Two and Three. Immediately adjacent to the highwall is the pit floor. On the pit floor exists several stockpiles, the stockpiles on the pit floor appear to be stable and in a good condition. The pit floor and active mining area occupy approximately 7.5 acres of the affected area.

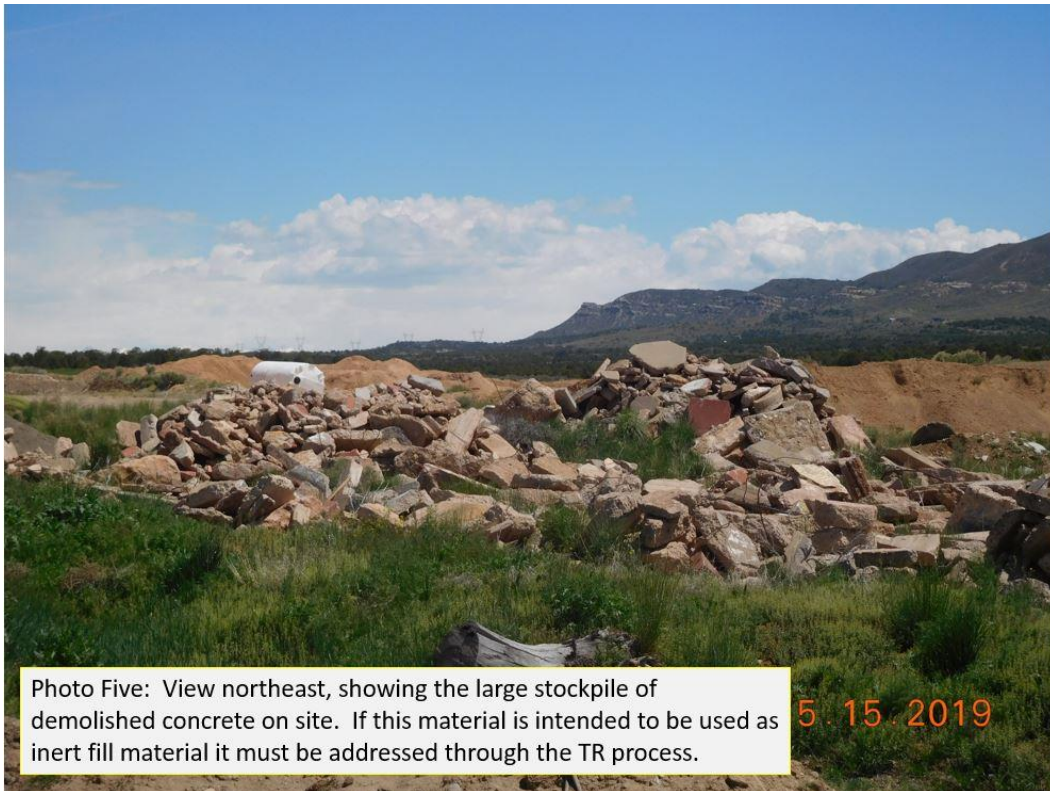
The remainder of the affected area consists of large stockpile areas of various materials. The materials stockpiles included crushed and screened material as well as stockpiles of recycled concrete and asphalt. The stockpiles are range in size from and location. All stockpiles observed appear to be stable and in good condition and examples of the stockpiles can be seen in Photos Four and Five. It appears that demolished concrete is being stockpiled on site for either recycling or disposal. Please note that the current permit does not allow for the importation of offsite fill to be used in backfilling of the pit. To incorporate that change in the permit it would need to be addressed through the Technical Revision Process.

Photo Five: View northeast, showing the large stockpile of demolished concrete on site. If this material is intended to be used as inert fill material it must be addressed through the TR process.

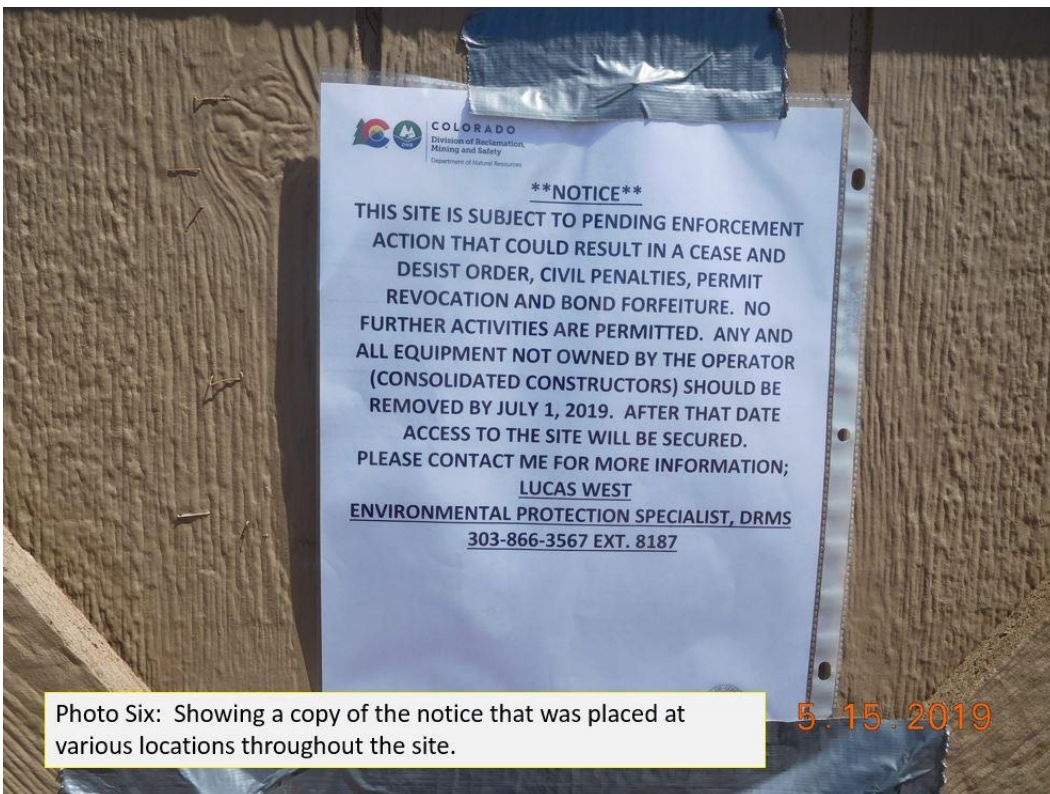
At the time of the inspection there was a possible enforcement action pending due to the notice of cancellation of the financial warranty. During the inspection several notices of the pending enforcement action were posted at various locations around the site including the front gate, scale house, and on each piece of equipment. An example of those notices can be seen in Photo Six. Since the date of the inspection the Financial Warranty has been replaced and the permit is now in good standing.

Photo Six: Showing a copy of the notice that was placed at various locations throughout the site.
