COLORADO

MINERALS PROGRAM INSPECTION REPORT

MINE NAME: Wagner Rock Pit	MINE/PROSPECTING ID#: M-1999-018	MINERAL: Gravel	COUNTY: Moffat
INSPECTION TYPE: Monitoring	INSPECTOR(S): Amy C. Yeldell	INSP. DATE: June 12, 2019	INSP. TIME: 07:30
OPERATOR: Wagner Construction Inc.	OPERATOR REPRESENTATIVE: Jay Wagner	TYPE OF OPERATION: 112c - Construction Regular Operation	
REASON FOR INSPECTION: Normal I&E Program	BOND CALCULATION TYPE: Complete Bond	BOND AMOUNT: \$48,307.00	
DATE OF COMPLAINT: NA	POST INSP. CONTACTS: None	JOINT INSP. AGENCY: None	
WEATHER: Clear	INSPECTOR'S SIGNATURE:

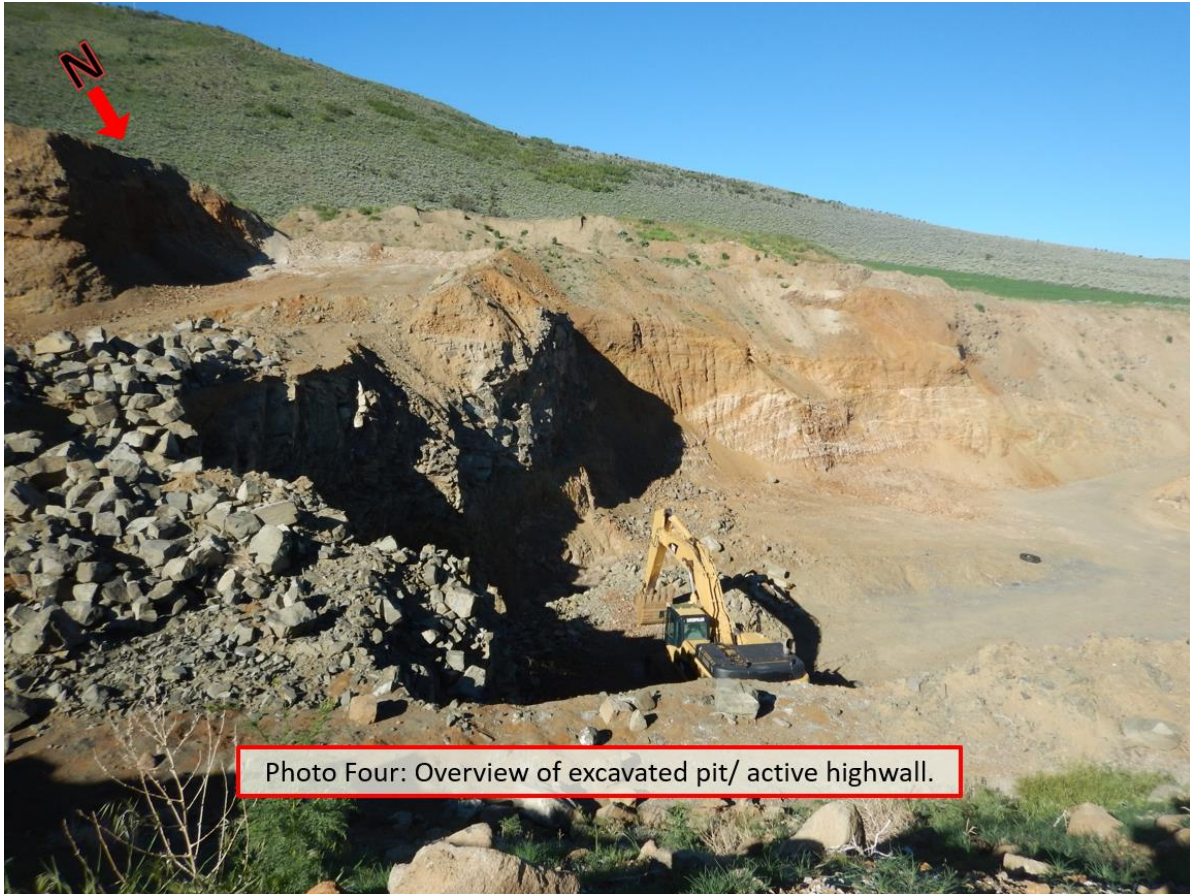
Mining is continuing to progress in the box cut with the 40-60 foot deep pit floor slowly moving to the east. Currently there are 3 levels within the pit. The far eastern end of the cut remains approximately 30 feet wide by 20 feet deep. Mining has not yet progressed to the point of daylighting out the north highwall. High walls throughout the mine appear to be near vertical to 1:1 sloping. Some vegetation has established on older slopes where sloughing and fine material has collected over the years.

Photo Four: Overview of excavated pit/ active highwall.

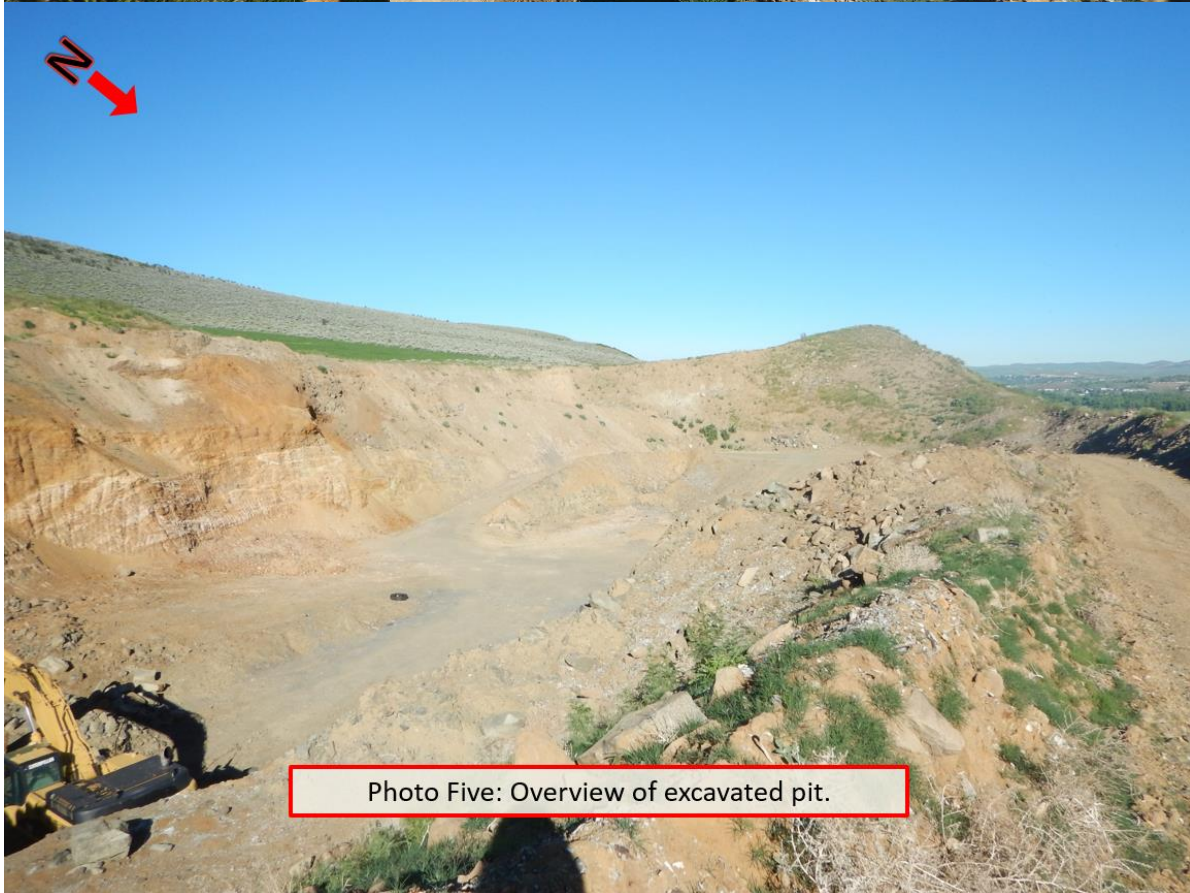
Photo Five: Overview of excavated pit.

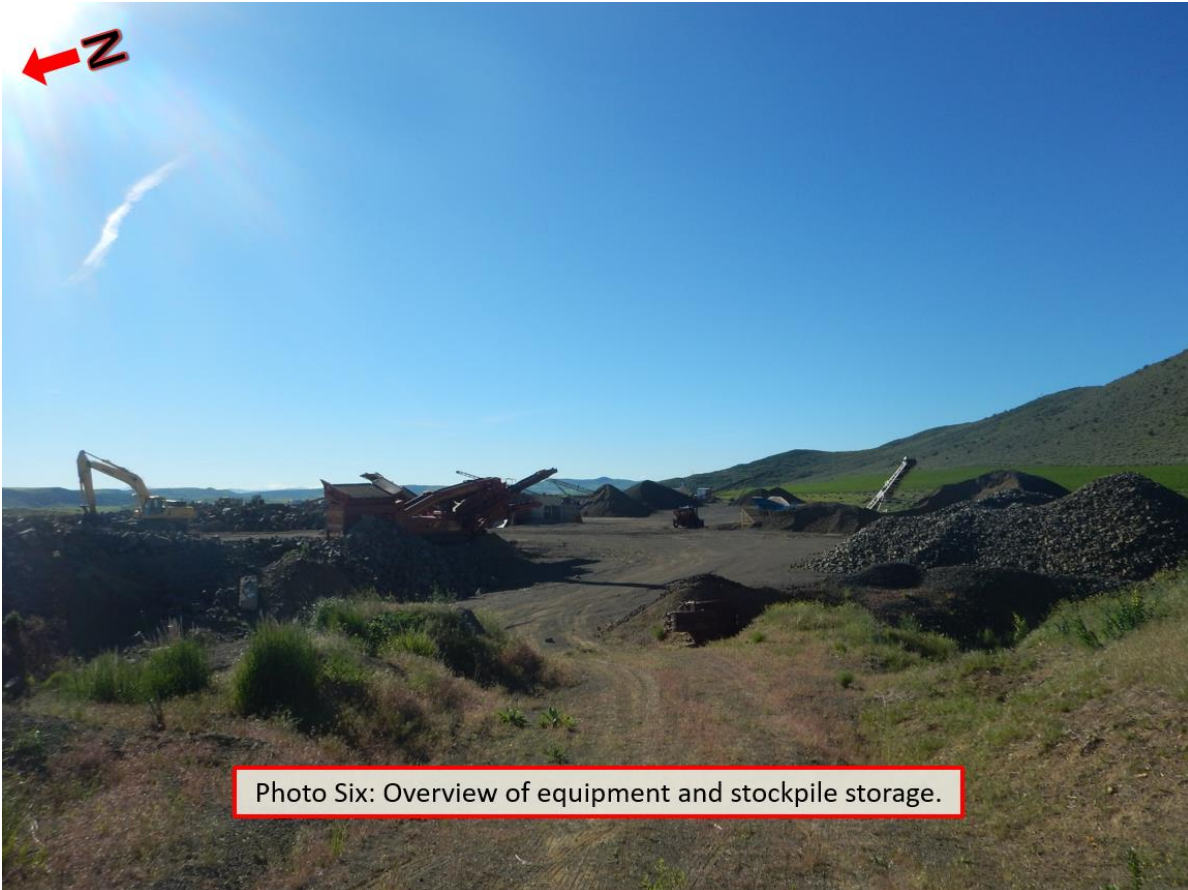
The eastern side of the pit continues to be used for stockpile storage and material processing. No excavations have taken place outside of the approximately 5 acre pit. Several pieces of equipment are also stored within the affected lands. Overall the affected lands remains around 16 acres. An empty 5-gallon bucket of lubricant was observed outside of secondary containment. These items need to be removed from the site. This site is not authorized for storage of hazardous materials or fuel on site.

Photo Six: Overview of equipment and stockpile storage.

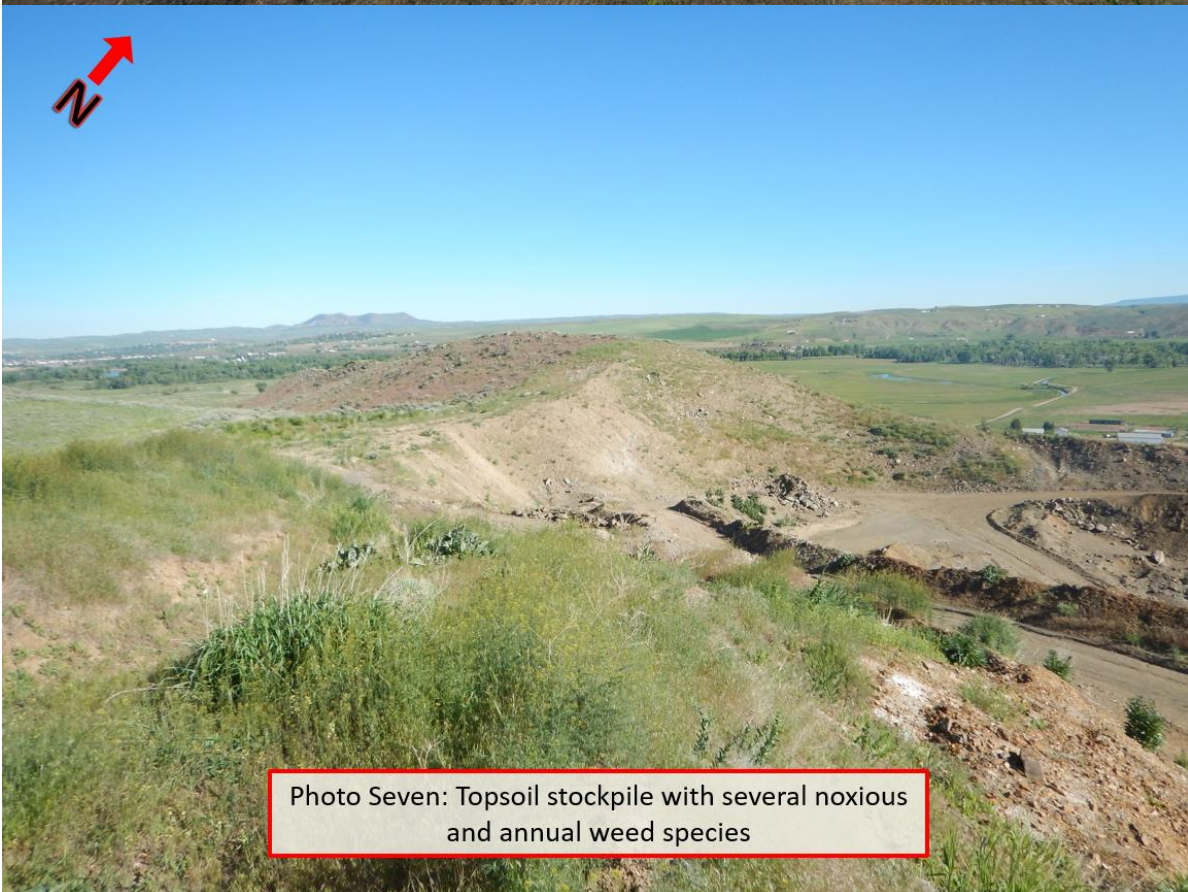
The topsoil piles are mostly located along the south side of the pit. The operator is encouraged to more aggressively manage weeds on the topsoil piles to avoid accidental seeding of non-desired species.

Photo Seven: Topsoil stockpile with several noxious and annual weed species
