**MINERALS PROGRAM INSPECTION REPORT**  
**PHONE: (303) 866-3567**

<b>MINE NAME:</b> Loloff Mine	<b>MINE/PROSPECTING ID#:</b> M-1985-112	<b>MINERAL:</b> Sand and gravel	<b>COUNTY:</b> Weld
<b>INSPECTION TYPE:</b> Surety-Related Inspection	<b>INSPECTOR(S):</b> Peter S. Hays	<b>INSP. DATE:</b> June 6, 2019	<b>INSP. TIME:</b> 13:30
<b>OPERATOR:</b> Loloff Construction, Inc.	<b>OPERATOR REPRESENTATIVE:</b>	<b>TYPE OF OPERATION:</b> 112c - Construction Regular Operation	
<b>REASON FOR INSPECTION:</b> Surety Related	<b>BOND CALCULATION TYPE:</b> Partial Bond	<b>BOND AMOUNT:</b> \$1,104,455.00	
<b>DATE OF COMPLAINT:</b> NA	<b>POST INSP. CONTACTS:</b> None	<b>JOINT INSP. AGENCY:</b> None	
<b>WEATHER:</b> Clear	<b>INSPECTOR'S SIGNATURE:</b>

June 6, 2019 Inspection Map for SR-01

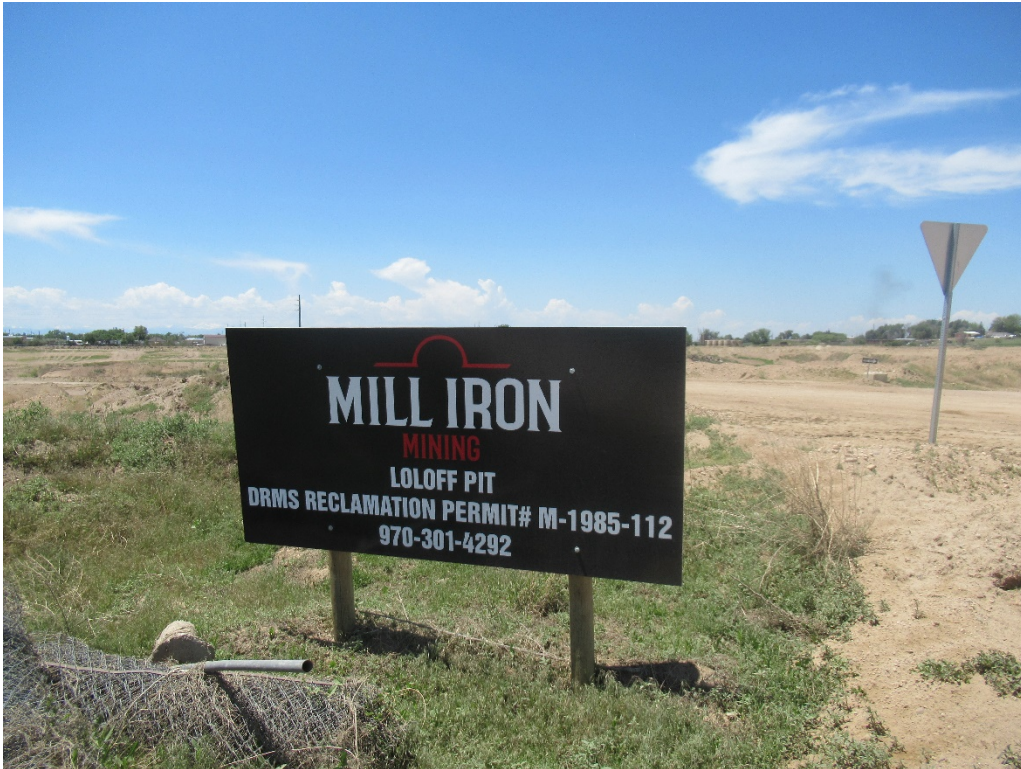
An entrance sign was posted and permit boundary markers were observed as required by Rule 3.1.12. Photographs taken during the inspection are attached.

Lolloff Pit mine sign

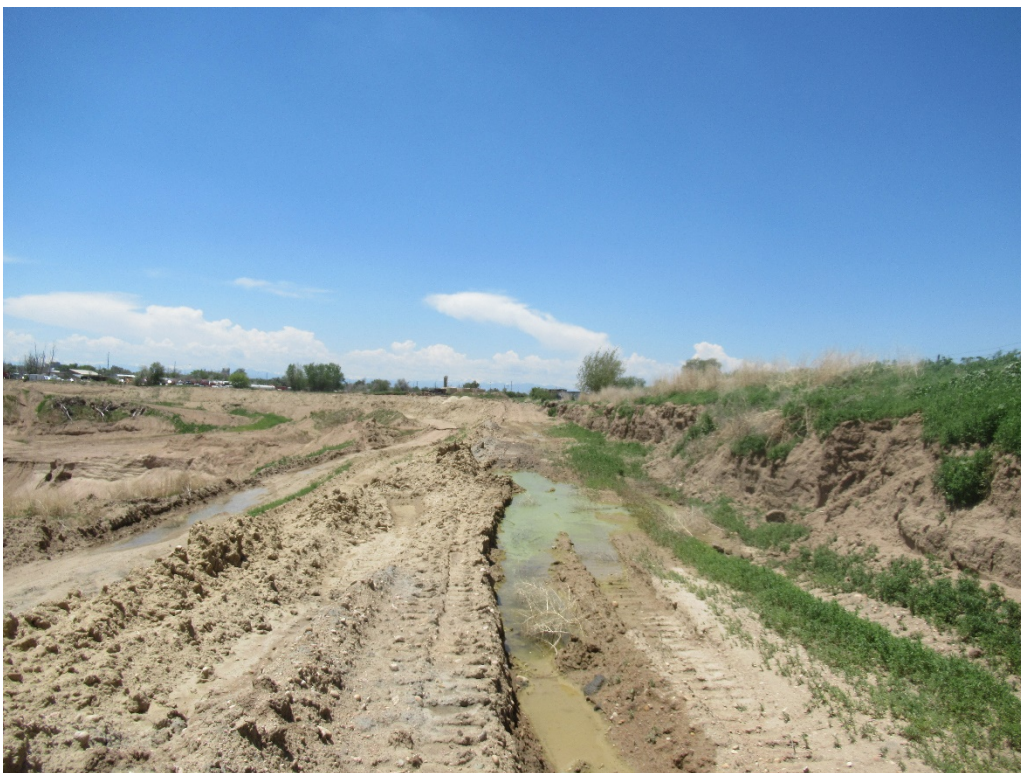
The approved post-mining land use is developed water resource with the construction of a 43 acre reservoir. The construction of the slurry wall and clay liner above the slurry wall in the northern portion of the site were completed in 2018. The Division of Water Resources approved the liner leak test on April 26, 2019. The southern portion of the site has been graded to the approved 3H:1V slope. The area has not been topsoiled or seeded. A few minor erosion features were observed on the southern slopes. The Operator stated the erosion feature would be repaired prior to placement of topsoil. The northern portion of the site will require the importation of fill material from the adjacent Derr Pit to complete the grading to the approved 3H:1V reclamation slope.

View of the north slope requiring material placement and grading

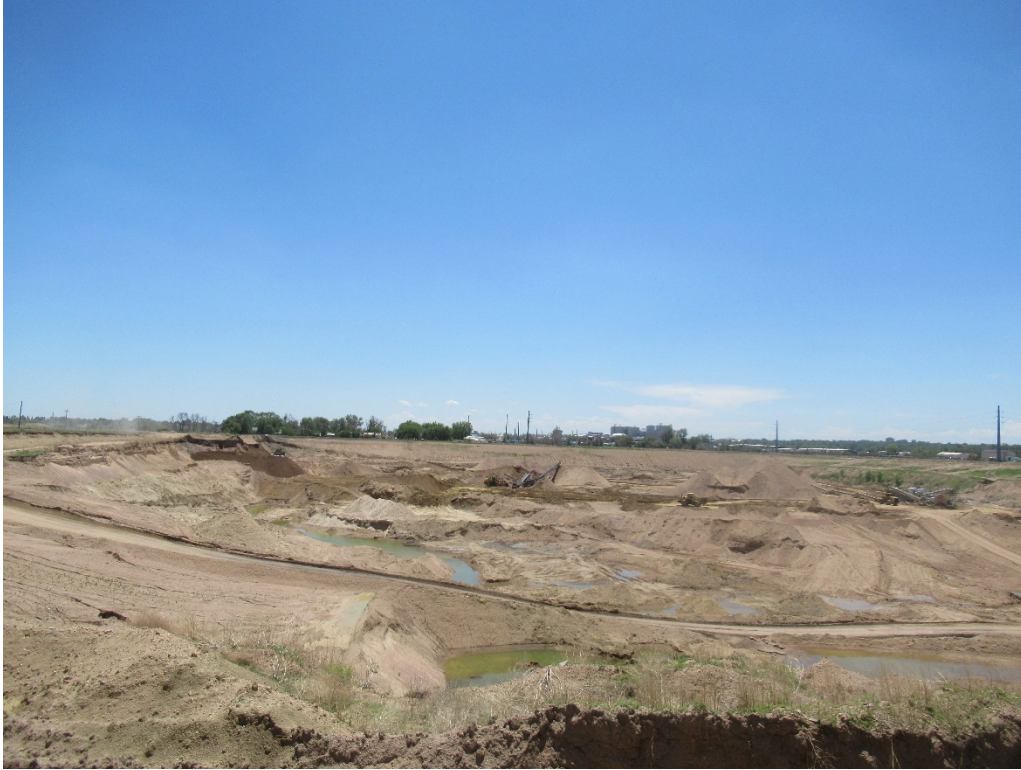
View of the site activity from the north looking south

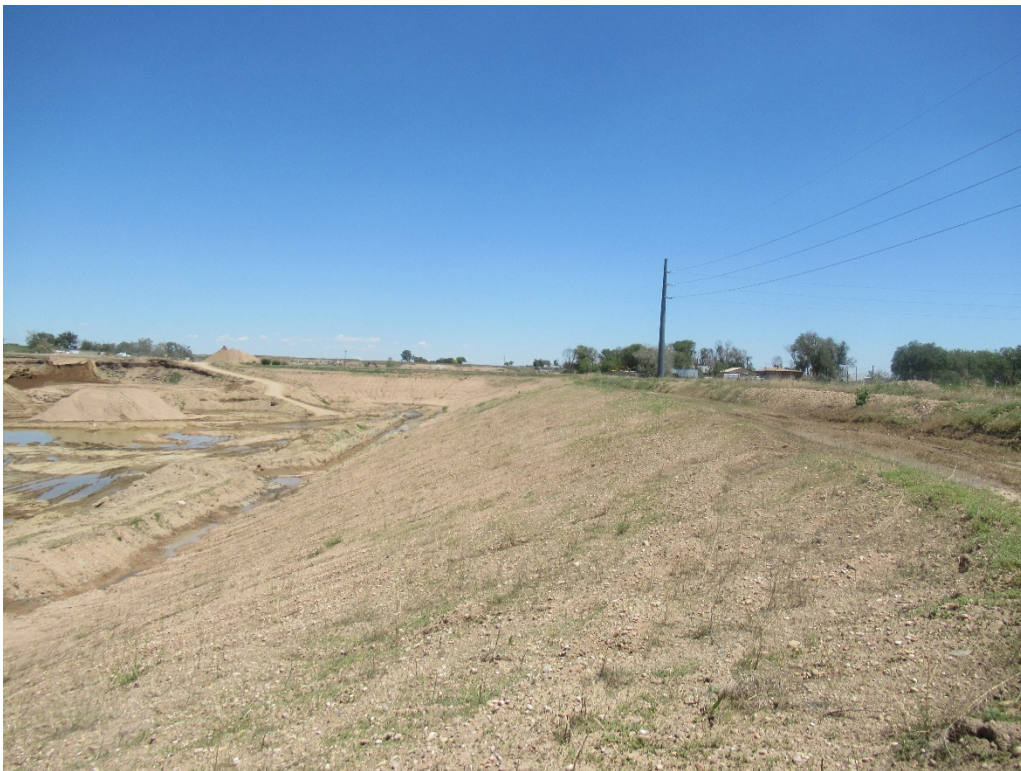
View of the southern slope from the southwest corner looking east

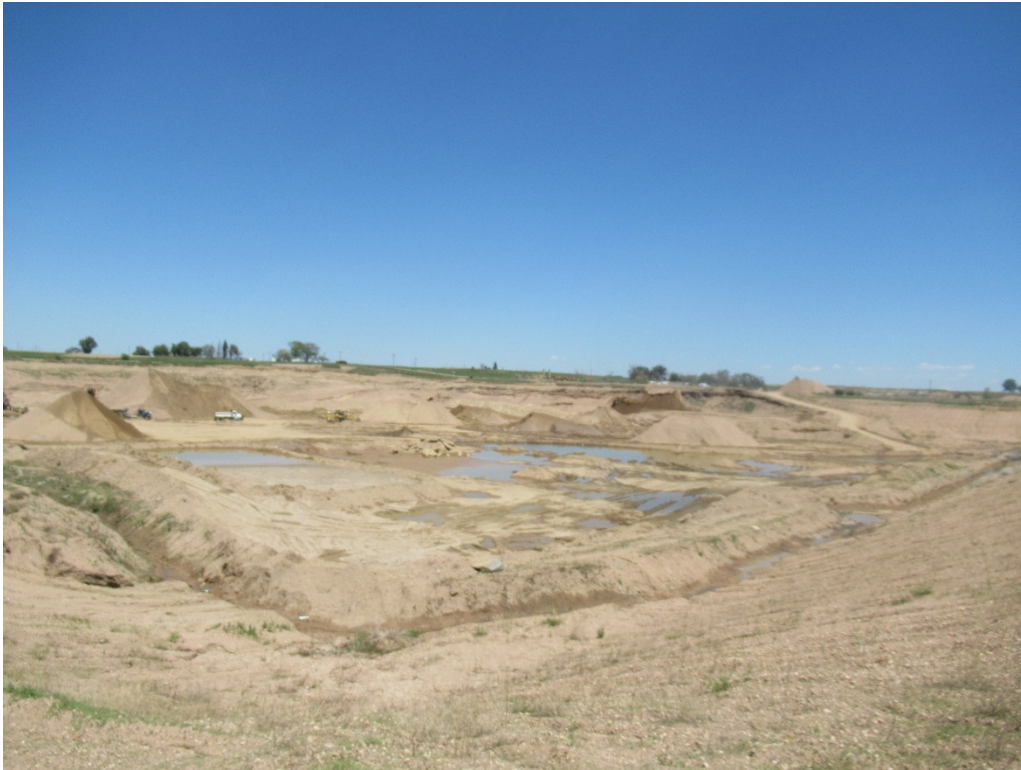
View of the site from the southwest corner looking northeast

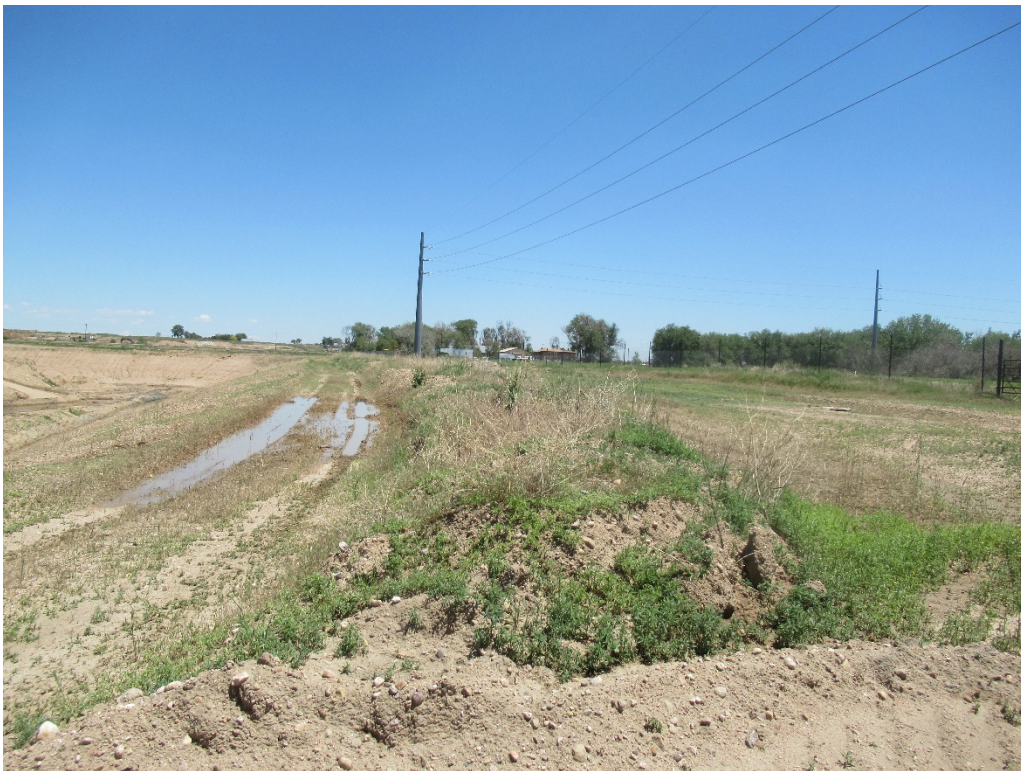
View of the slurry wall berm along the southern boundary looking east

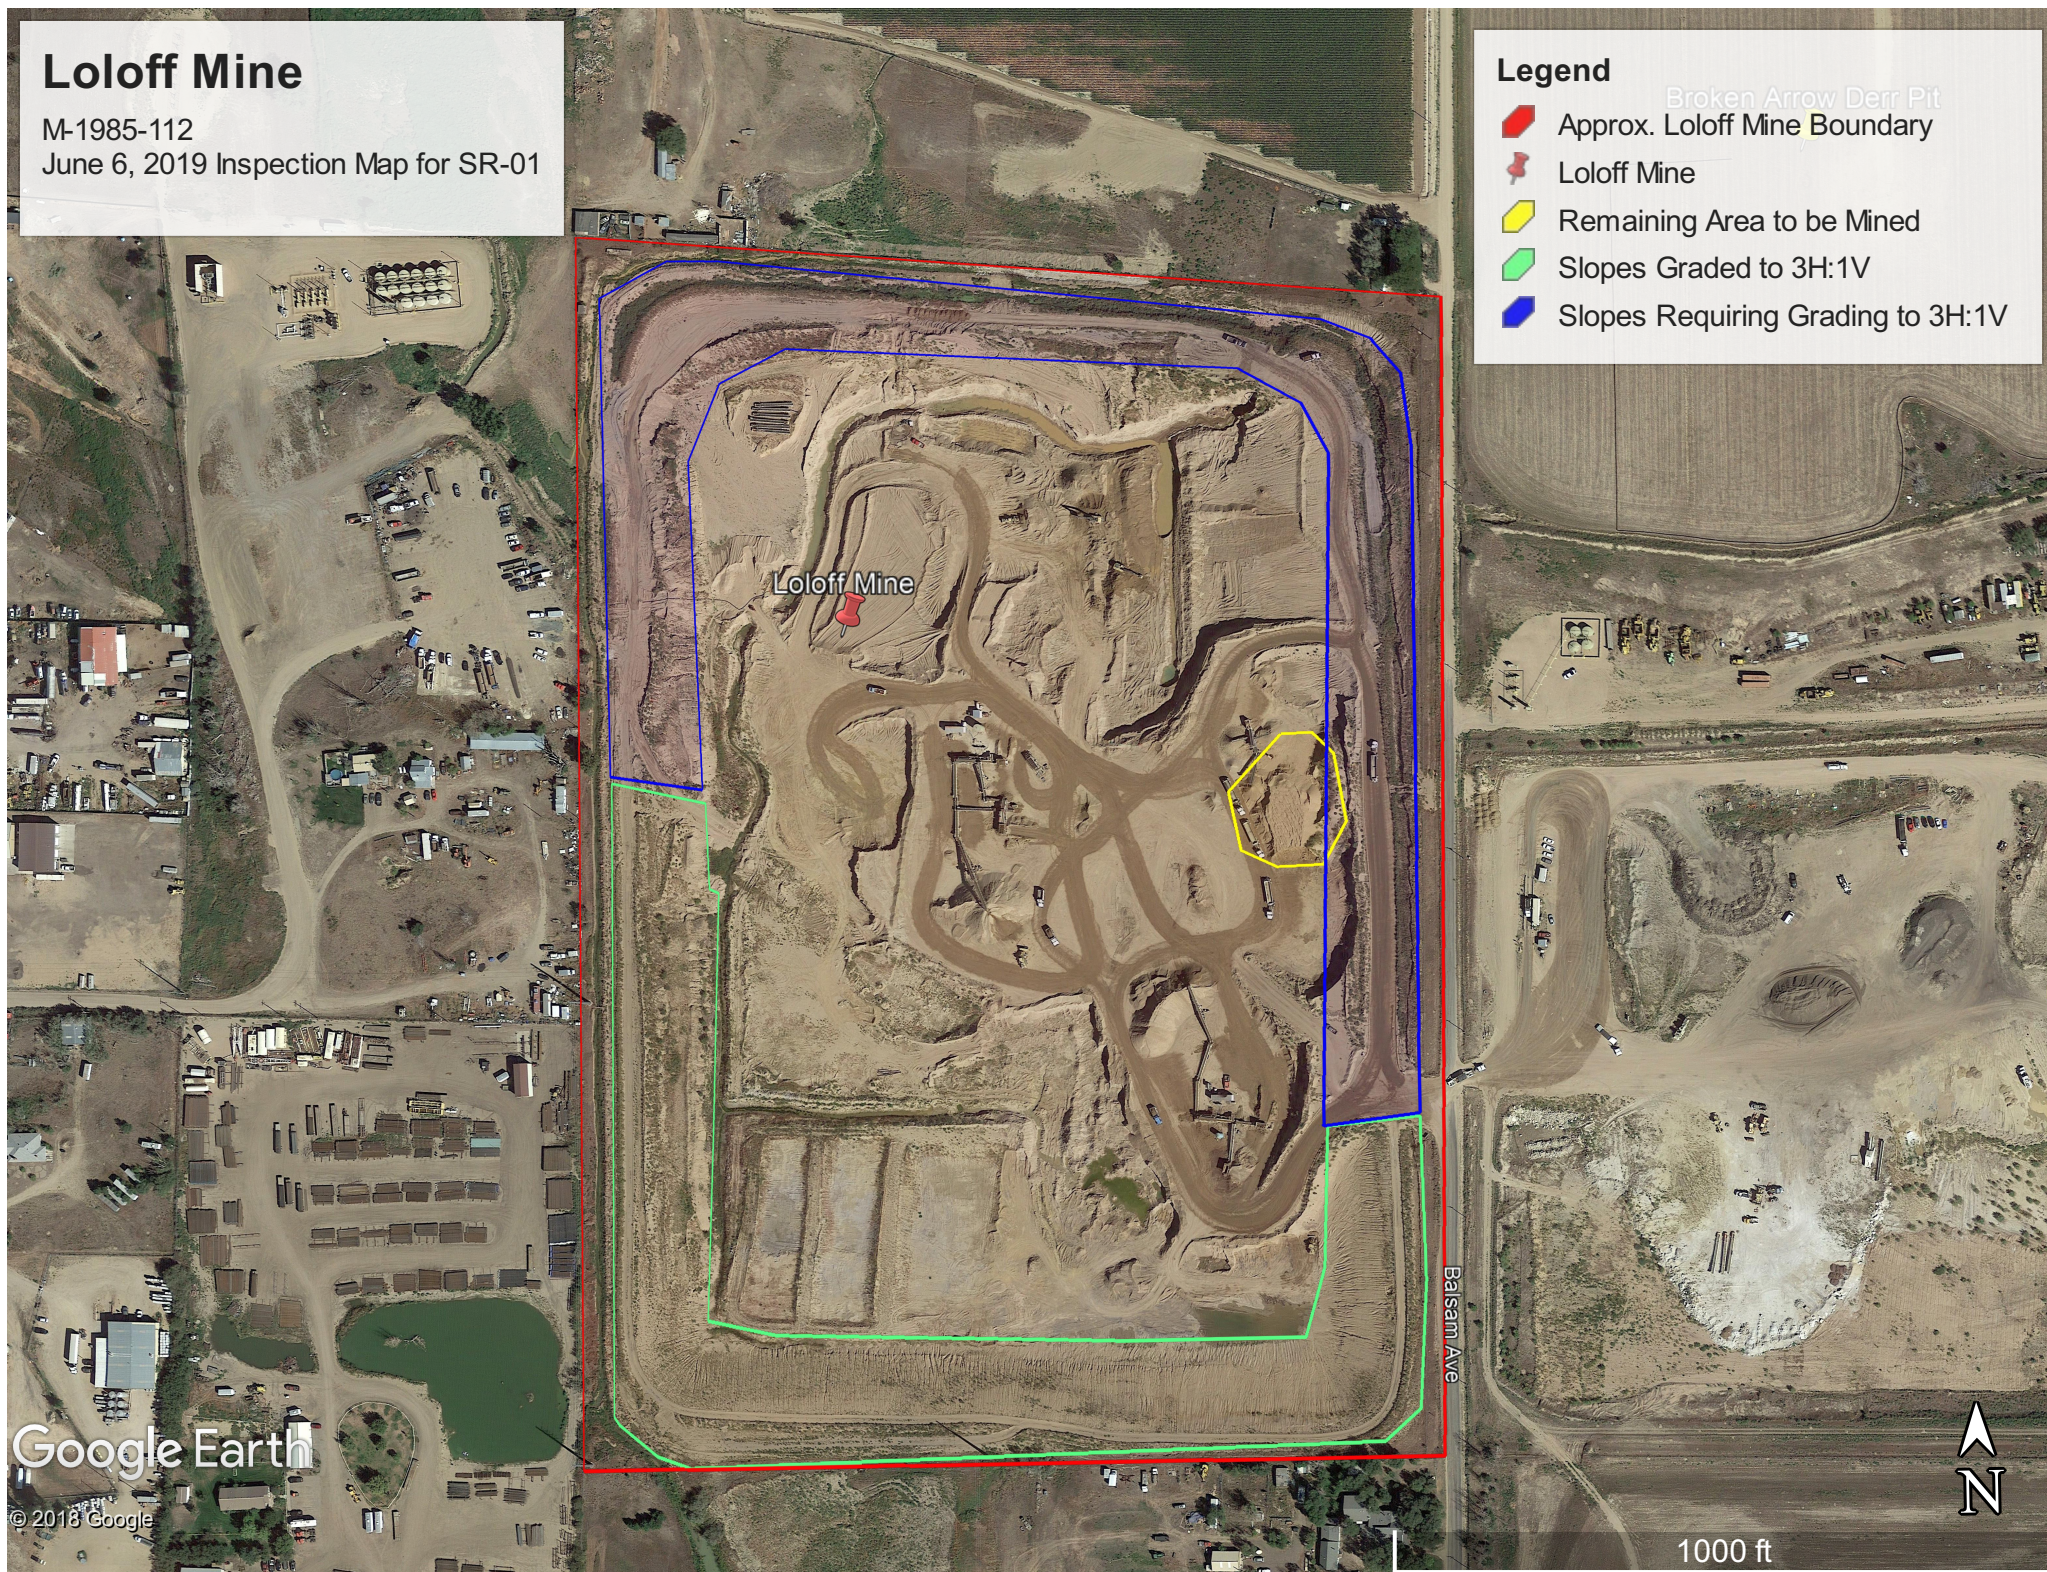
The Loloff Mine was inspected by Peter Hays with the Division of Reclamation, Mining and Safety (Division/DRMS) in response to a surety reduction request (SR-01) submitted by the Operator on May 6, 2019. The surety reduction request was considered filed by the Division on May 6, 2019. The Division is required by Rule 4.17.2 to inspect the site within 60-days from the filed date to determine if the Permittee has complied with all applicable requirements of the Reclamation Plan. The decision due date for approval of the surety reduction request is July 5, 2019 pursuant to Rule 4.17.2(5). Mr. Jeff Anderson with Loloff Construction, Inc. present during the inspection. An inspection map created based on the observations made during this inspection is attached.
