MINERALS PROGRAM INSPECTION REPORT PHONE: (303) 866-3567

MINE/PROSPECTING ID#:	MINERAL:	COUNTY:	
	M-2004-022	Sand and gravel	Weld	
INSPECTION TYPE:		INSP. DATE:	INSP. TIME:	
	Peter S. Hays	June 6, 2019	11:30	
	OPERATOR REPRESENTATIVE:	TYPE OF OPERATION:		
C	Cody Wooldridge	112c - Construction Regular Operation		
DELICAL FOR INCREGATION ROLL CALL CALL ATTION TAYED. DON'T AMOUNT				
REASON FOR INSPECTION:		BOND AMOUNT:		
Normal I&E Program		\$28,000.00		
DATE OF COMPLAINT:		JOINT INSP. AGENCY:		
	None	None		
INSPECTOR'S SIGNATURE:		SIGNATURE DATE:		
Ω_{I}		June 24, 2019		
6	Ahr			
		INSPECTOR(S): Peter S. Hays OPERATOR REPRESENTATIVE: Cody Wooldridge BOND CALCULATION TYPE: None POST INSP. CONTACTS: None	M-2004-022 INSPECTOR(S): Peter S. Hays OPERATOR REPRESENTATIVE: Cody Wooldridge BOND CALCULATION TYPE: None POST INSP. CONTACTS: None INSPECTOR'S SIGNATURE: Sand and gravel INSP. DATE: TYPE OF OPERA' 112c - Construction BOND AMOUNT: \$28,000.00 JOINT INSP. AGE None INSPECTOR'S SIGNATURE: SIGNATURE DATE

PERMIT #: M-2004-022 INSPECTOR'S INITIALS: PSH INSPECTION DATE: June 6, 2019

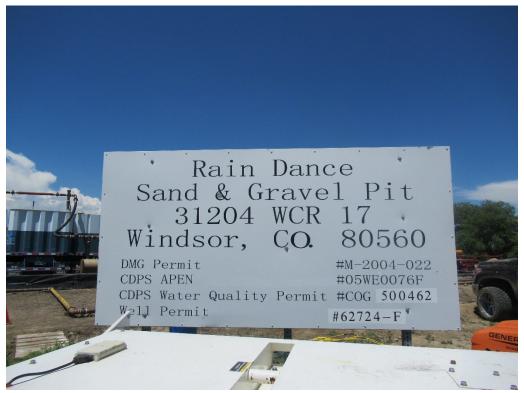
An entrance sign was posted and permit boundary markers were observed as required by Rule 3.1.12. Photographs taken during the inspection are attached.

Raindance Mine sign

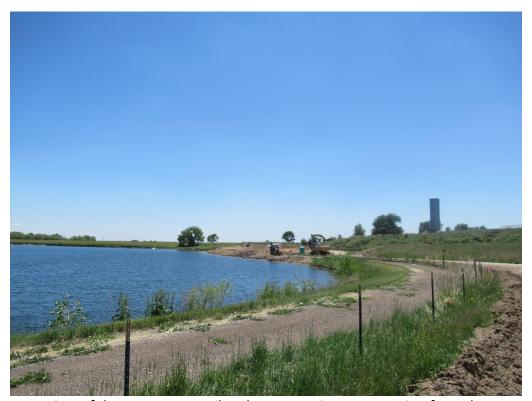
The Division will require the Operator to submit another technical revision to update the Reclamation Plan Map due to the following site changes since the approval of TR-02. The construction of the pump station was under construction on the south side of the reservoir. The location of the pump station is different than the location approved under TR-02. A new oil and gas facility was construction in the northwest corner of the site. TR-02 lists this area as Lots 4 and 5 approved by the Town of Windsor, not an oil and gas facilities. The oil and gas facilities installation were recently completed and the area was being regraded during the inspection. The Operator was required to construct a temporary section of the Poudre River Trail around the west side of the reservoir while the oil and gas facilities construction blocked the trail. The temporary trail consists of a crusher fines surface. The Operator stated the southern portion of the temporary trail would be removed and reclaimed. The northern portion of the temporary trail will remain for access to an adjacent property per an agreement between Raindance and the property owner.

View of the temporary trail and pump station construction from the southwest corner of the reservoir looking east

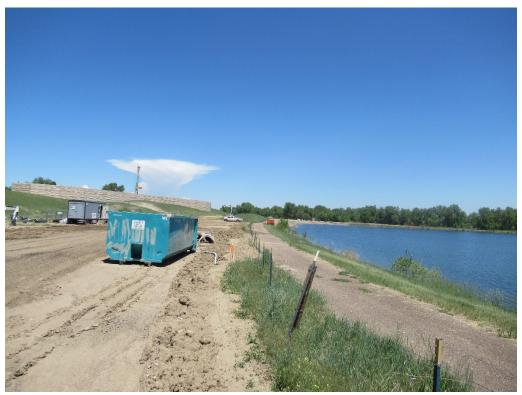
The approved post-mining land use is pastureland and developed water resource. The Operator stated tamarisks were recently removed from the shoreline of the reservoir. No noxious weeds were observed during the inspection. As stated above, the oil and gas area located in the northwest area of the site was being regraded for reclamation. A temporary access road along the northern portion of the site and a temporary culvert located in the northeast corner of the site will be removed and reclaimed by the Operator. The northeast corner of the reservoir shoreline was backfilled and will require reclamation by the Operator. The remaining site reclamation associated with the oil and gas facilities is expected to be completed soon.

View of the temporary trail and oil and gas facilities from the southwest corner of the reservoir looking north

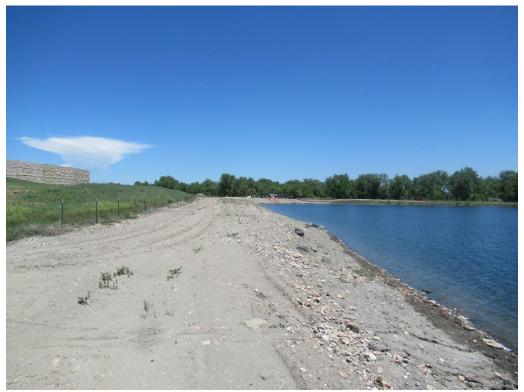
Backfill area located in the northwest corner of the reservoir

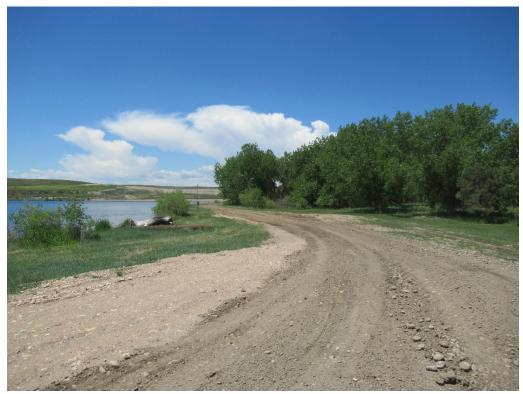
View of the temporary road in the northern portion of the site
