MINERALS PROGRAM INSPECTION REPORT
PHONE: (303) 866-3567

MINE NAME: Green/Croissant Mine	MINE/PROSPECTING ID#: M-2001-022	MINERAL: Sand and gravel	COUNTY: Weld
INSPECTION TYPE: Monitoring	INSPECTOR(S): Peter S. Hays	INSP. DATE: June 6, 2019	INSP. TIME: 10:00
OPERATOR: Loveland Ready-Mix Concrete, Inc.	OPERATOR REPRESENTATIVE: Stephanie Fancher	TYPE OF OPERATION: 112c - Construction Regular Operation

June 6, 2019 Inspection Map

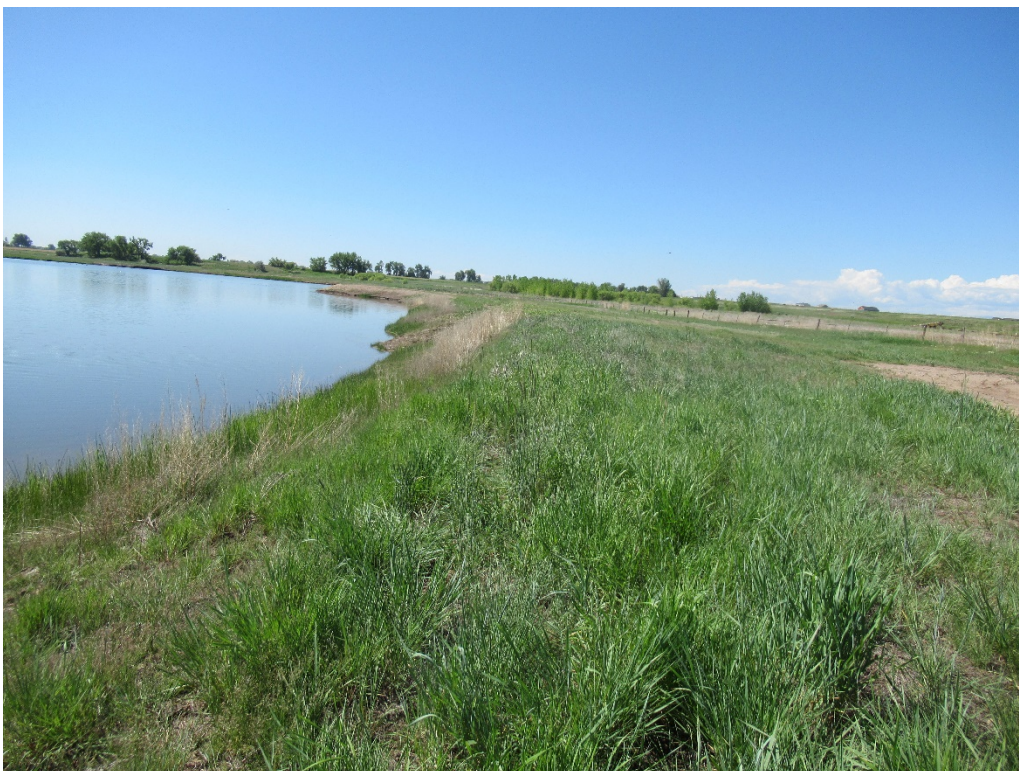
View of Cell 4 shoreline from the northwest corner of the lake looking south

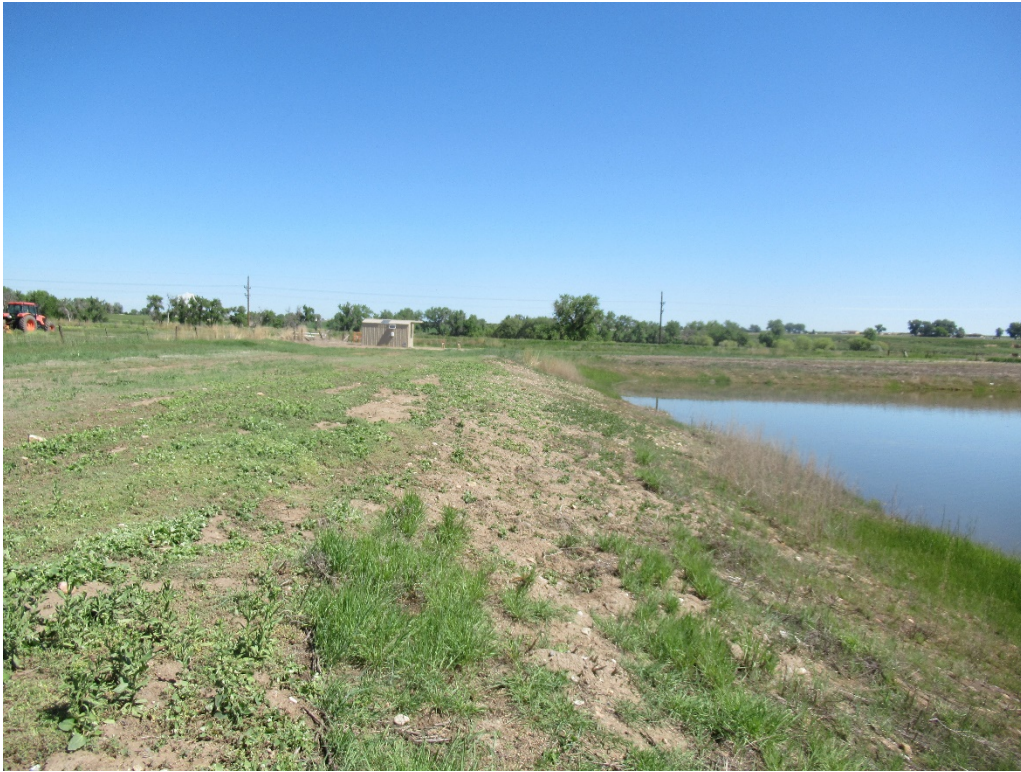
Two areas of the west shoreline were recently repaired by the Operator. The areas are located in the northwest corner of the lake and in the peninsula area of the west shoreline. The Operator believes the shoreline areas failed due to drains installed during the mining of Cell 4 not being removed during reclamation, which directed water toward the areas. The drains were removed and the shorelines were repaired by the Operator. The areas will be monitored by the Operator. The affected areas will need to be topsoiled and revegetated by the Operator in accordance with the approved Reclamation Plan.

View of the repaired western shoreline of Cell 4 in the northwest corner looking north

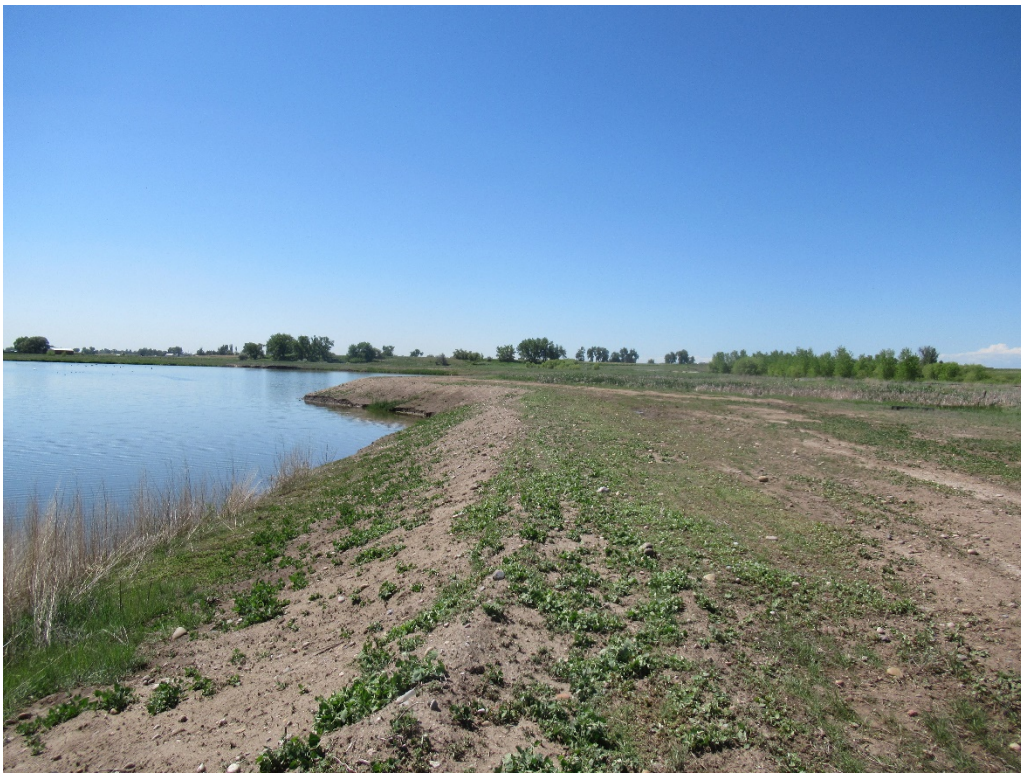
View of the repaired western shoreline of Cell 4 near the peninsula looking south

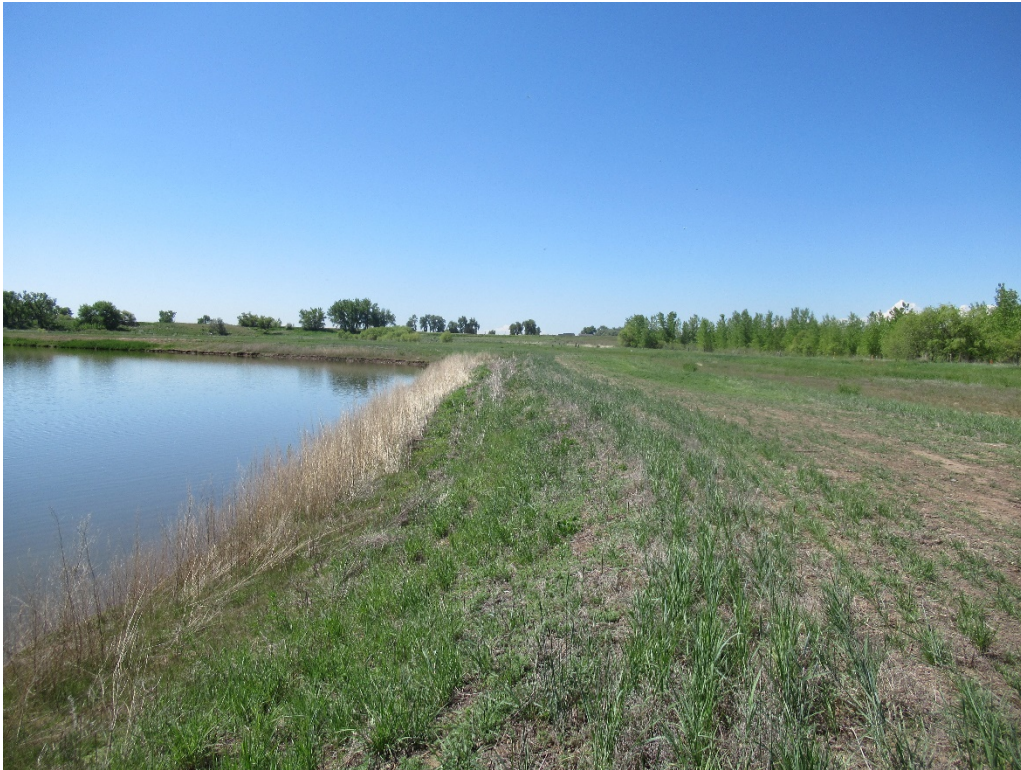
View of Cell 4 shoreline from the southwest corner of the lake looking south

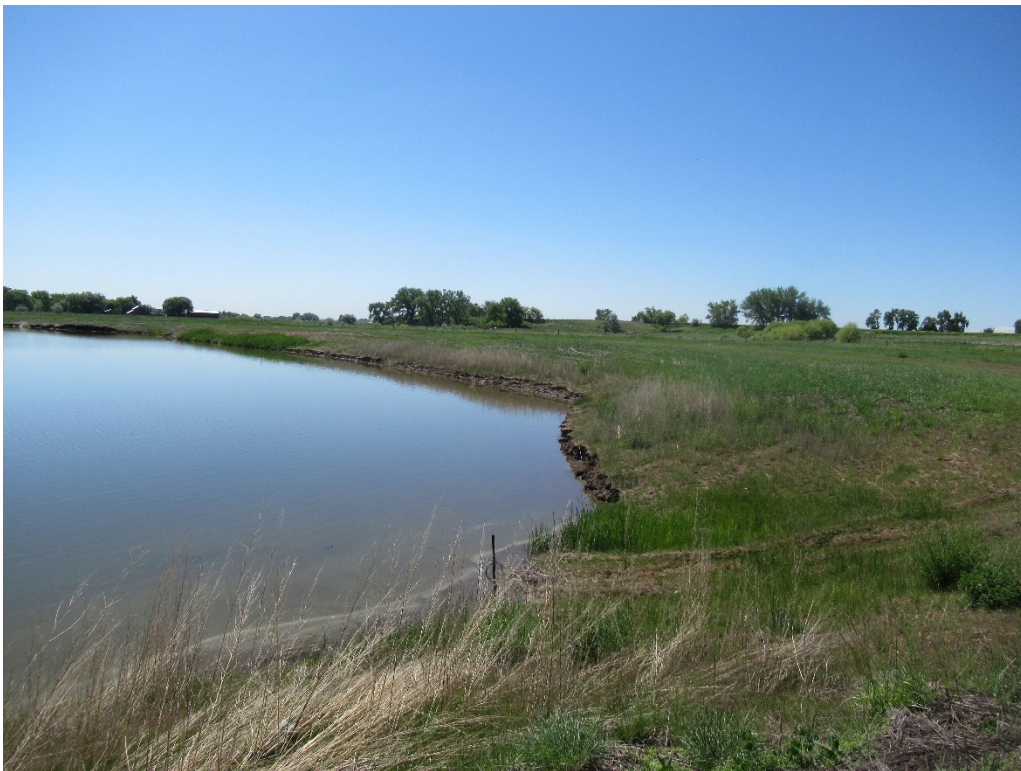
The mining activity in the cell has concluded and the cell is in final reclamation. The Division observed the erosion of the south shoreline mentioned as a concern by Ms. McGill. The Division agrees the erosion is more than typical for an open-water lake due to wave action. The south shoreline was saturated, unstable and several areas of the shoreline had failed and slid into the lake. The Operator agrees there is a problem with the shoreline and had already contacted a consultant to evaluate the issue. The preliminary assessment was water from the wetlands located south of the shoreline as not able to pass through the shoreline resulting in the saturation and failure of the slope. The consultant recommended a permeable filter layer of gravel be added to slope to allow the groundwater to pass through the shoreline. This solution would require the Operator to remove the existing topsoil and vegetation, install the filter material, replace the topsoil and revegetate the affected shoreline areas.

View of the shoreline erosion in the southwest corner of the Cell 4 lake looking southeast

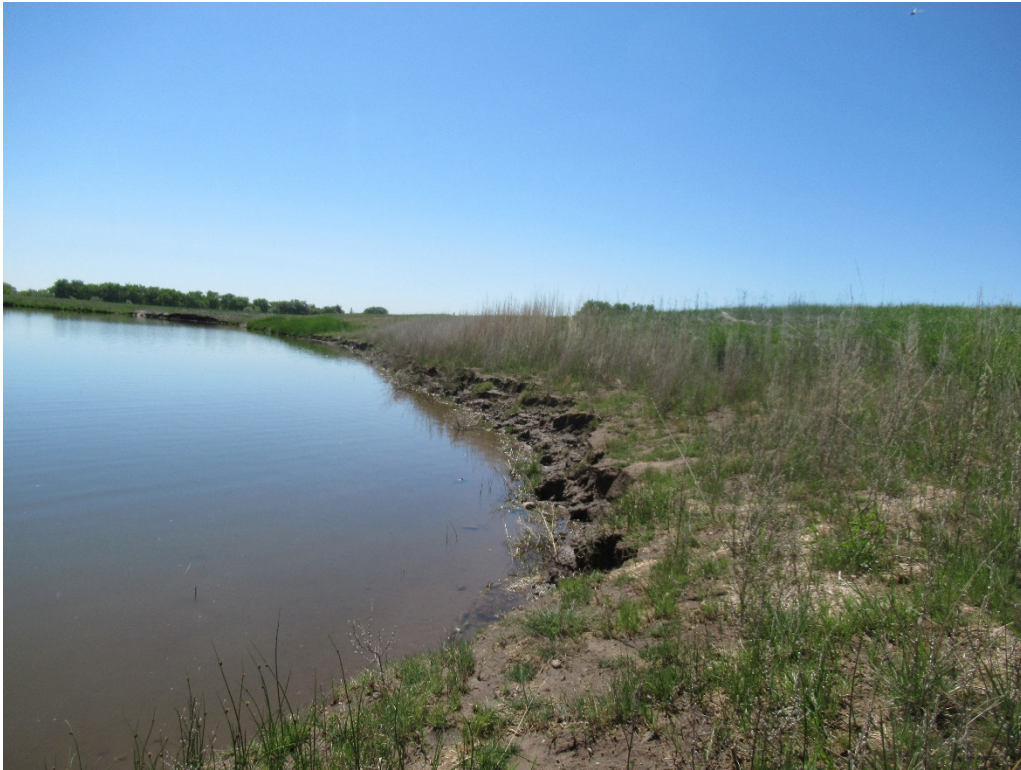
View of the erosion in the south shoreline of the Cell 4 lake looking east

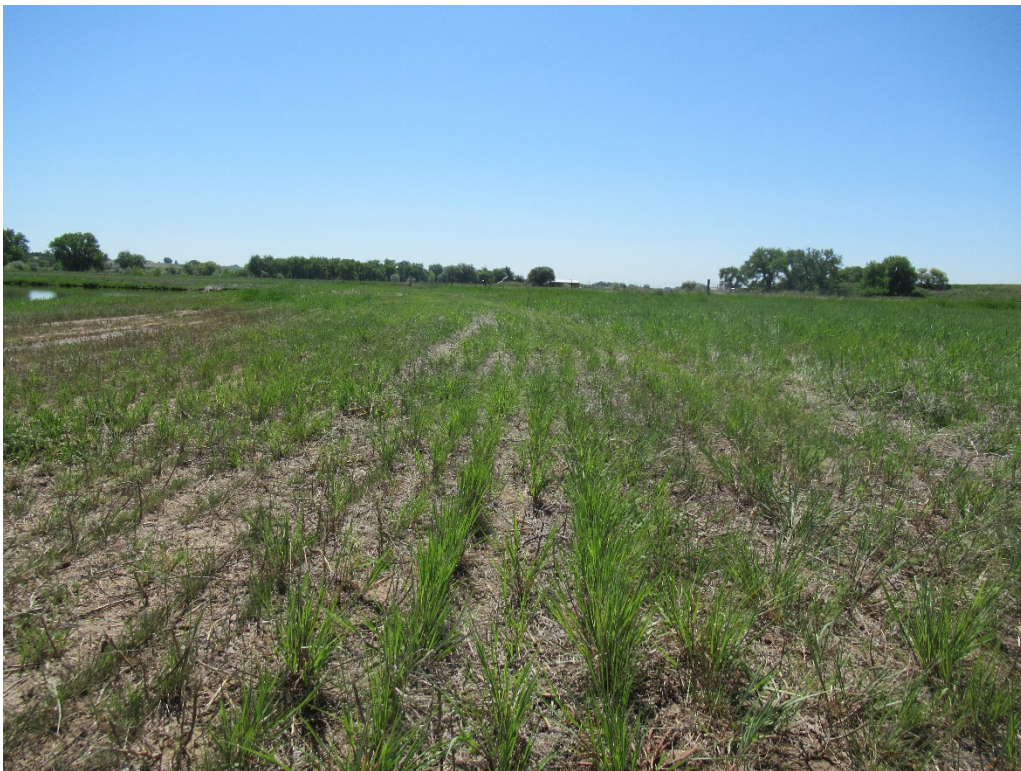
The Cell 4 shoreline and upland areas were vegetated with the approved seed mixture in 2017 according to the Operator. Four (4) of the five (5) grass species included in the seed mixture were observed during the inspection; western wheatgrass, blue grama, pubescent wheatgrass and Indian ricegrass. The remaining grass species, sideoats grama, was not observed during the inspection. Noxious and annual weeds including; kochia, Canada thistle, downy brome (cheat grass), yellow sweet clover and hoary crest (white top) were observed during the inspection. Evidence of weed control spraying was observed during the inspection. The Operator stated monitoring and chemical weed control spraying would be completed this year.

View of establishing vegetation in drill rows in the upland area south of the Cell 4 lake

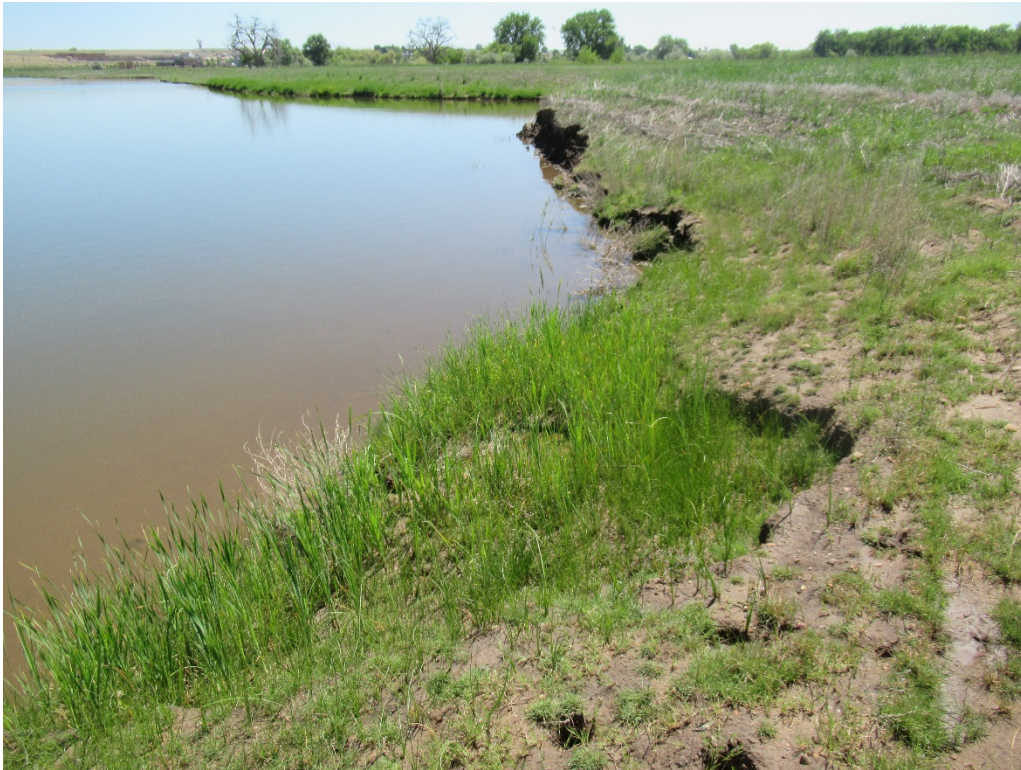
View of eroded and failed slope in the southeast corner of the Cell 4 lake

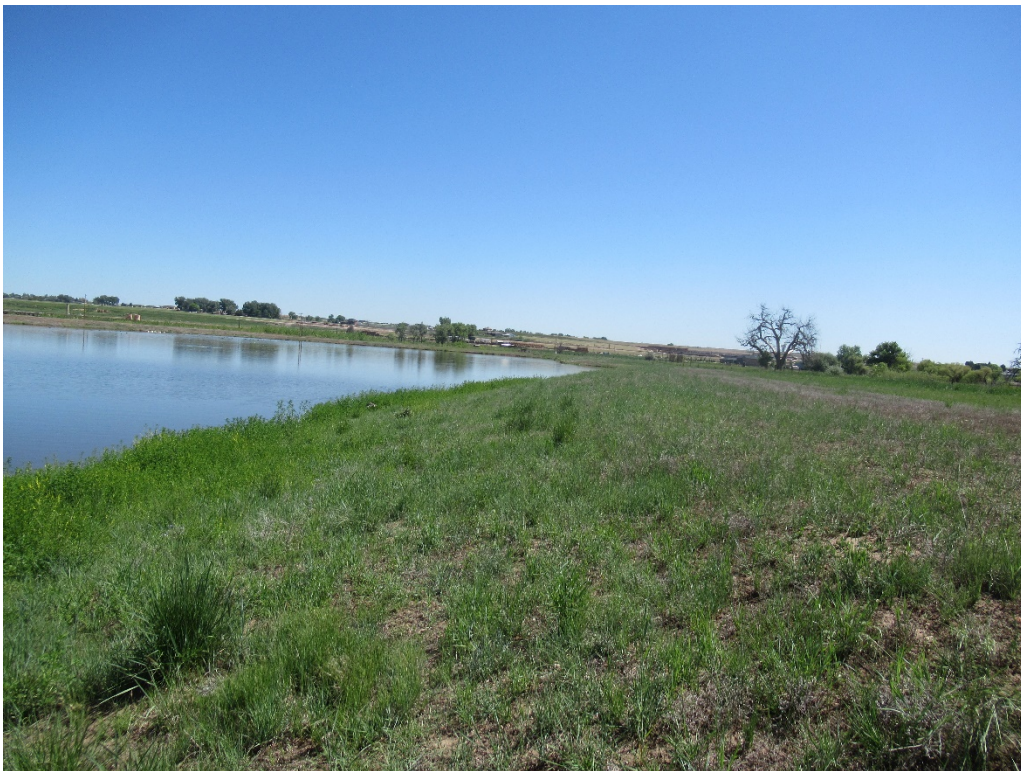
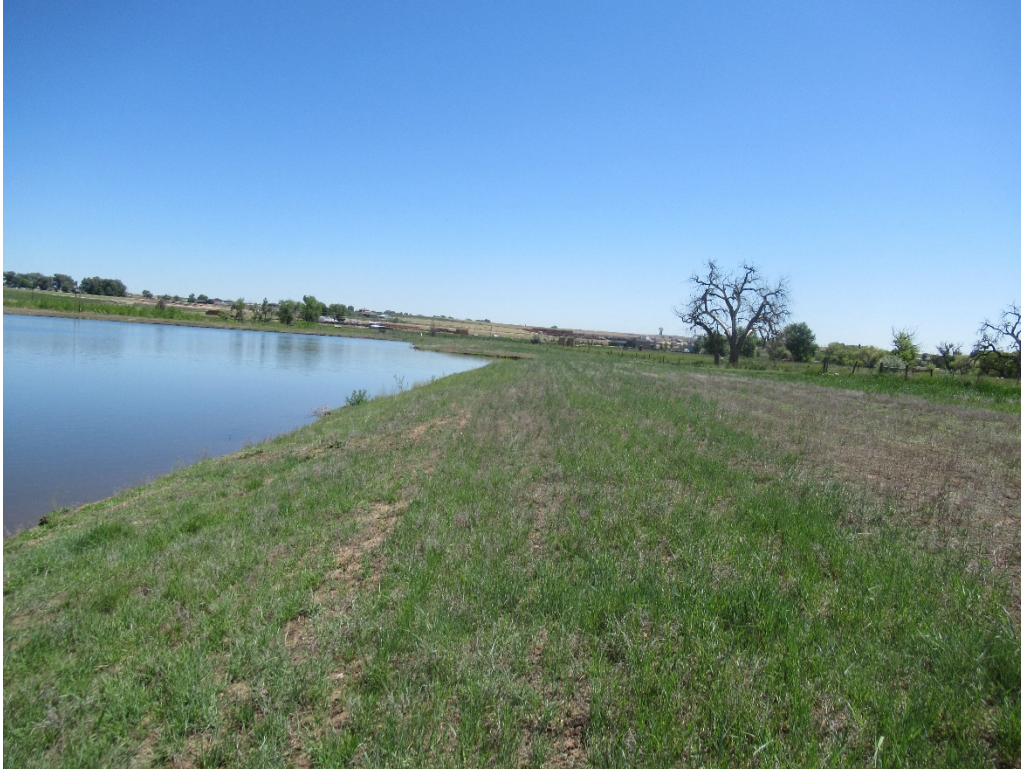
View of establishing vegetation on the east shoreline of the Cell 4 lake looking north

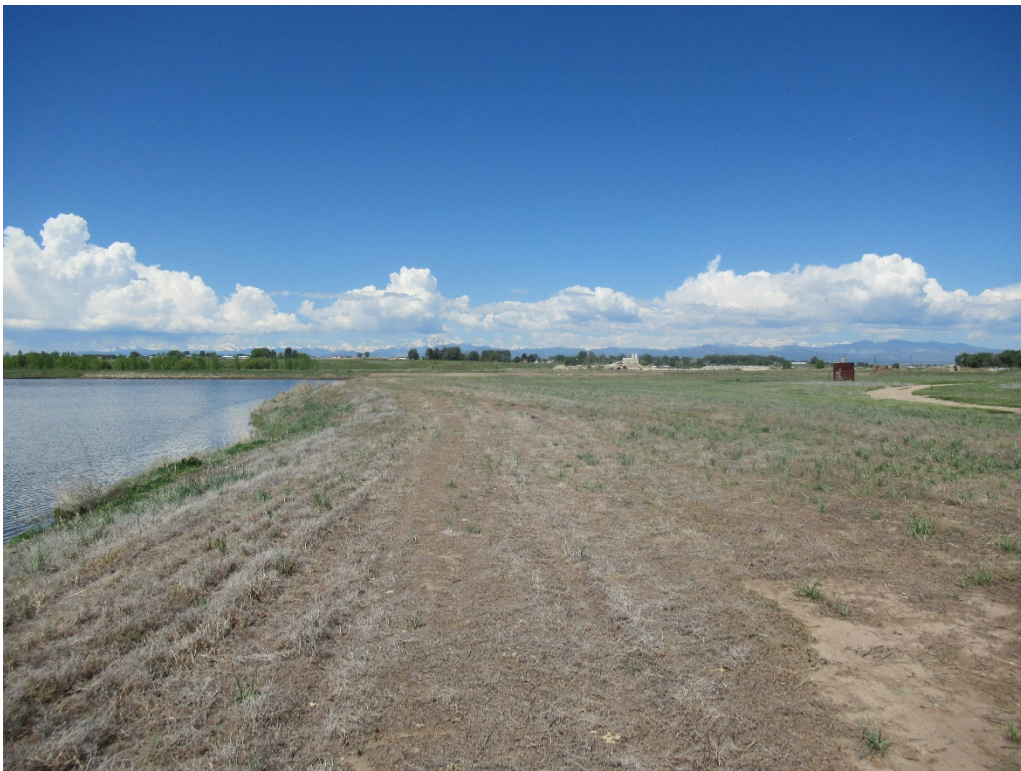
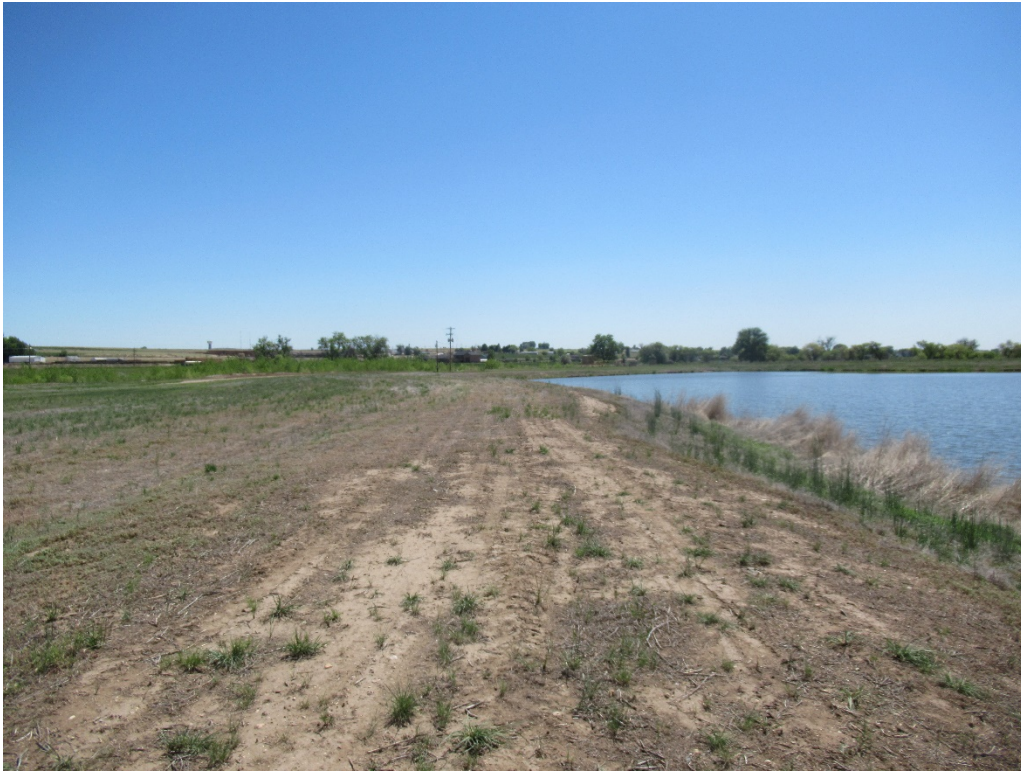
The vegetation in the northeast portion of the Cell near the oil and gas well was poorly established with areas of bare ground. The Division recommends the Operator conduct soil samples to determine if soil amendments are need to establish vegetation in the area. Overall, the site vegetation was establishing well for two (2) growing seasons. The Division recommends the Operator continue to perform weed control methods, evaluate the areas of bare ground for soil amendments and inter-seed areas as required to establish self-sustaining vegetation at the site required for future release of the reclamation permit by the Division.

Poorly vegetated and bare ground area near the oil and gas well
in the northeast corner of Cell 4 looking west

Poorly vegetated and bare ground area near the oil and gas well
in the northeast corner of Cell 4 looking southeast

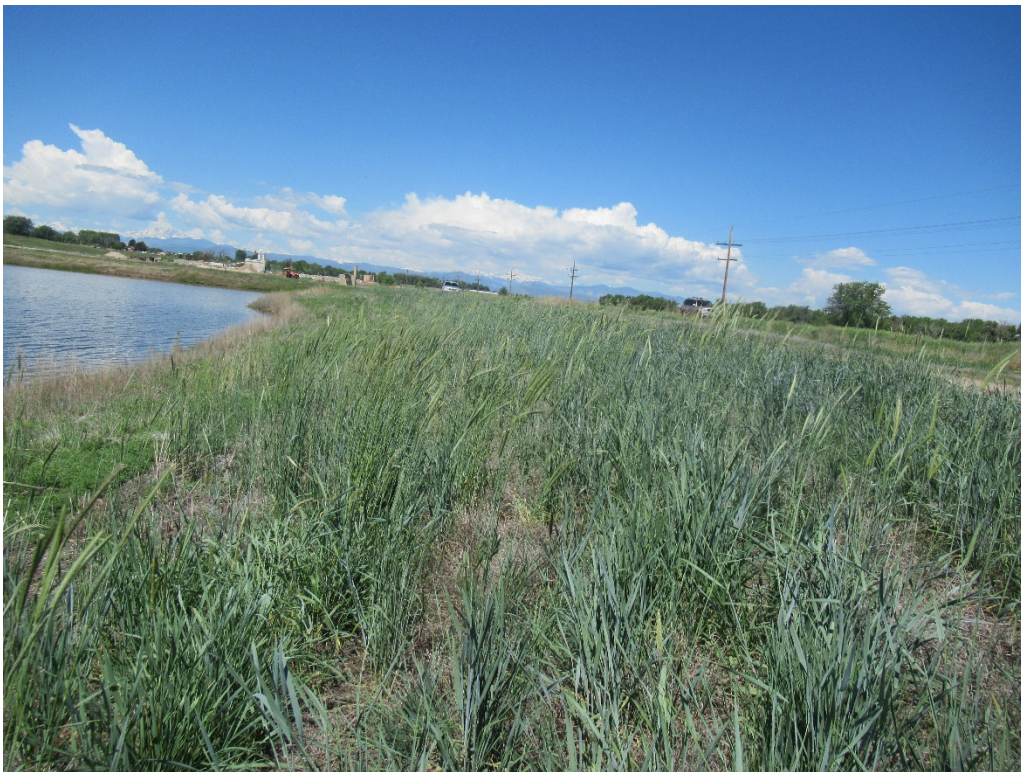
Shoreline erosion typical of wave action erosion, approximately six (6) to twelve (12) inches in height was observed along the north, east and west shoreline in sections. The erosion areas were not saturated and the slopes were stable. The Operator will not be required to repair these erosion features, since they appear to be typical wave erosion features.

View of vegetation along the north shoreline of Cell 4 looking west
