MINERALS PROGRAM INSPECTION REPORT
PHONE: (303) 866-3567

MINE NAME: Kues Gravel Pit	MINE/PROSPECTING ID#: M-1983-187	MINERAL: Sand and gravel	COUNTY: Logan
INSPECTION TYPE: Monitoring	INSPECTOR(S): Peter S. Hays	INSP. DATE: June 5, 2019	INSP. TIME: 10:00
OPERATOR: Logan County	OPERATOR REPRESENTATIVE: Jeff Reeves	TYPE OF OPERATION: 112c - Construction Regular Operation	
REASON FOR INSPECTION: Normal I&E Program	BOND CALCULATION TYPE: None	BOND AMOUNT: \$0.00	
DATE OF COMPLAINT: NA	POST INSP. CONTACTS: None	JOINT INSP. AGENCY: None	
WEATHER: Clear	INSPECTOR'S SIGNATURE:

The Kues Gravel Pit was inspected by Peter Hays with the Division of Reclamation, Mining and Safety (Division/DRMS) as part of the Division's monitoring inspection program. The site was previously inspected by the Division on March 9, 2016. Mr. Jeff Reeves with Logan County was present during the inspection. An inspection map based on the observations from this inspection is attached for reference.

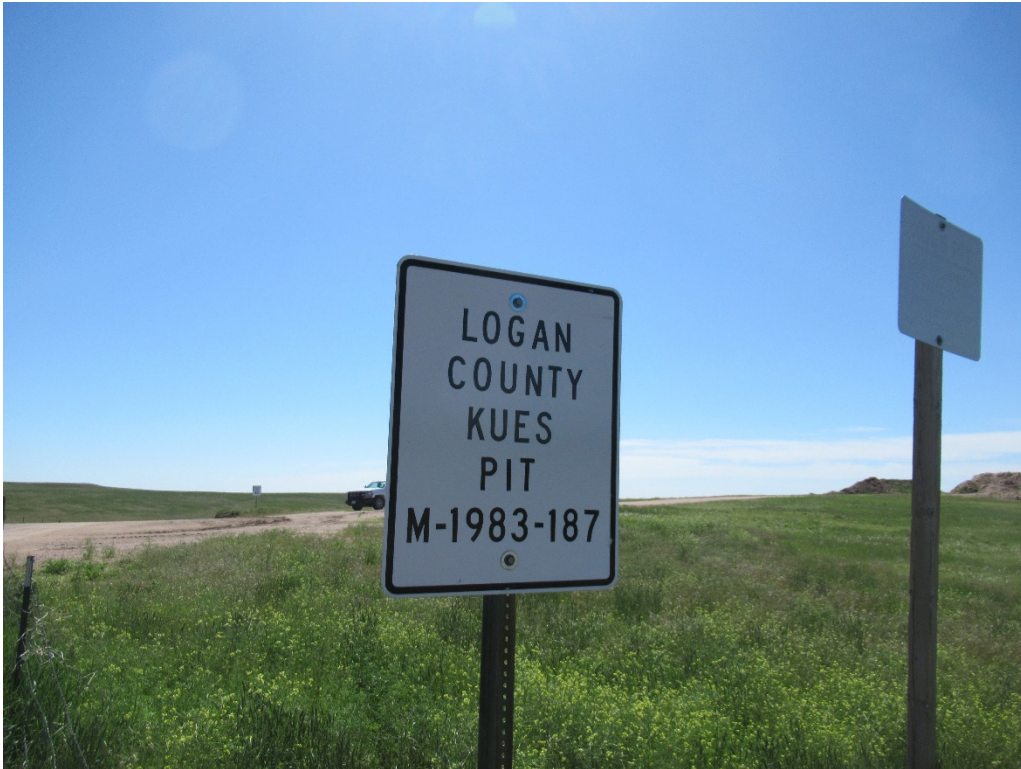
Kues Pit mine sign

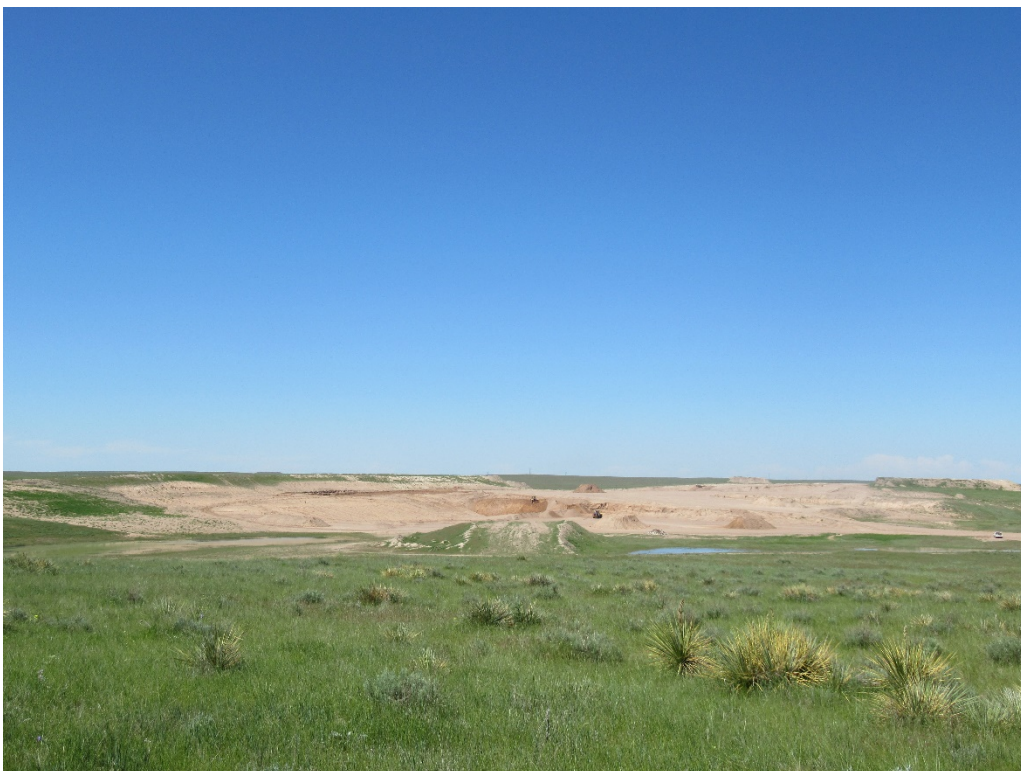
View of site from the northeast corner looking southwest

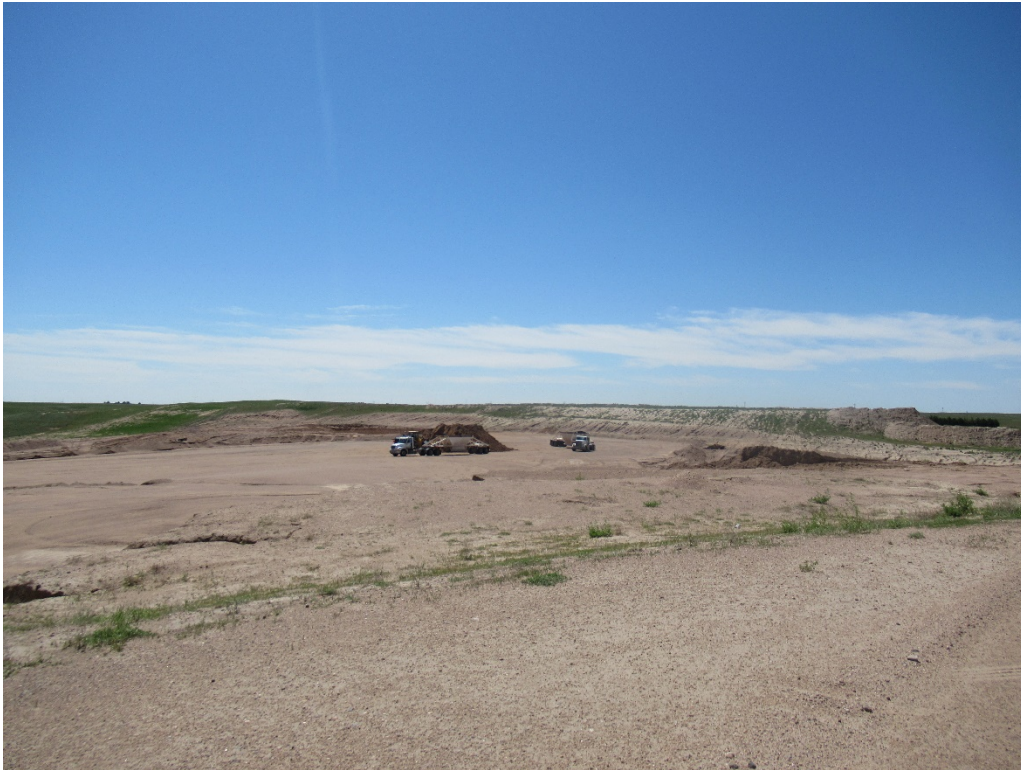
View of site from above the highwall looking southeast

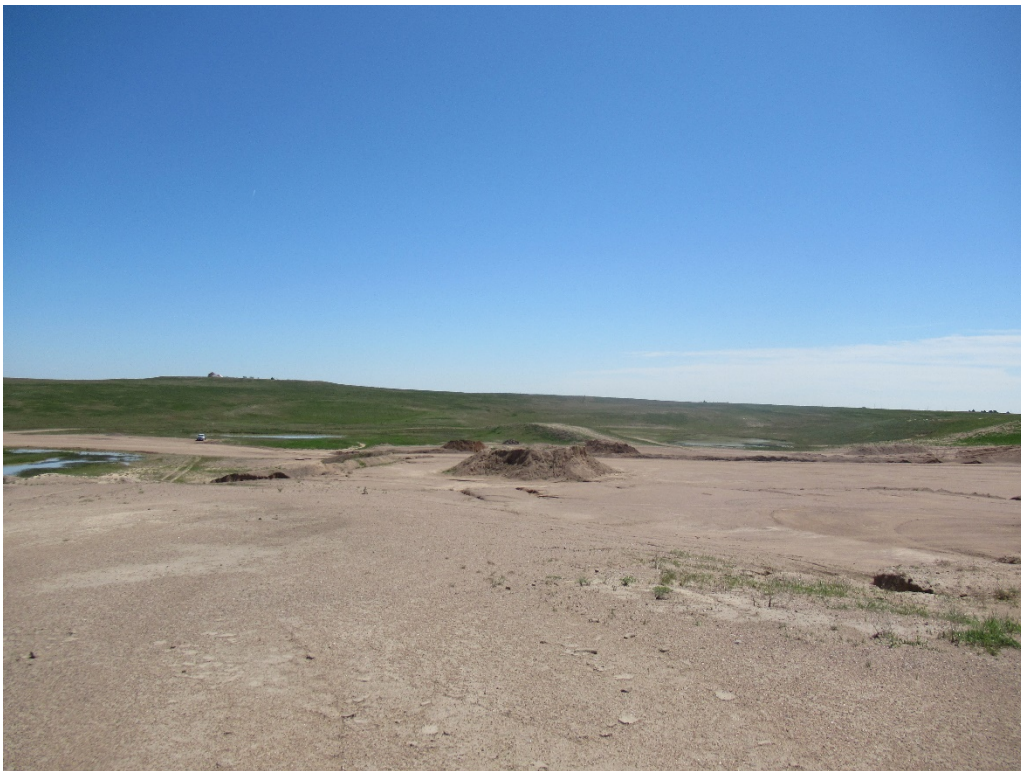
View of site from above the highwall looking east
