MINERALS PROGRAM INSPECTION REPORT
PHONE: (303) 866-3567

MINE NAME: Raymond Duell Pit	MINE/PROSPECTING ID#: M-1989-004	MINERAL: Sand and gravel	COUNTY: Kit Carson
INSPECTION TYPE: Monitoring	INSPECTOR(S): Elliott R. Russell	INSP. DATE: April 30, 2019	INSP. TIME: 09:30
OPERATOR: Kit Carson County	OPERATOR REPRESENTATIVE: Dave Hornung	TYPE OF OPERATION: 110c - Construction Limited Impact	
REASON FOR INSPECTION: Normal I&E Program	BOND CALCULATION TYPE: None	BOND AMOUNT: NA	
DATE OF COMPLAINT: NA	POST INSP. CONTACTS: None	JOINT INSP. AGENCY: None	
WEATHER: Cloudy	INSPECTOR'S SIGNATURE:

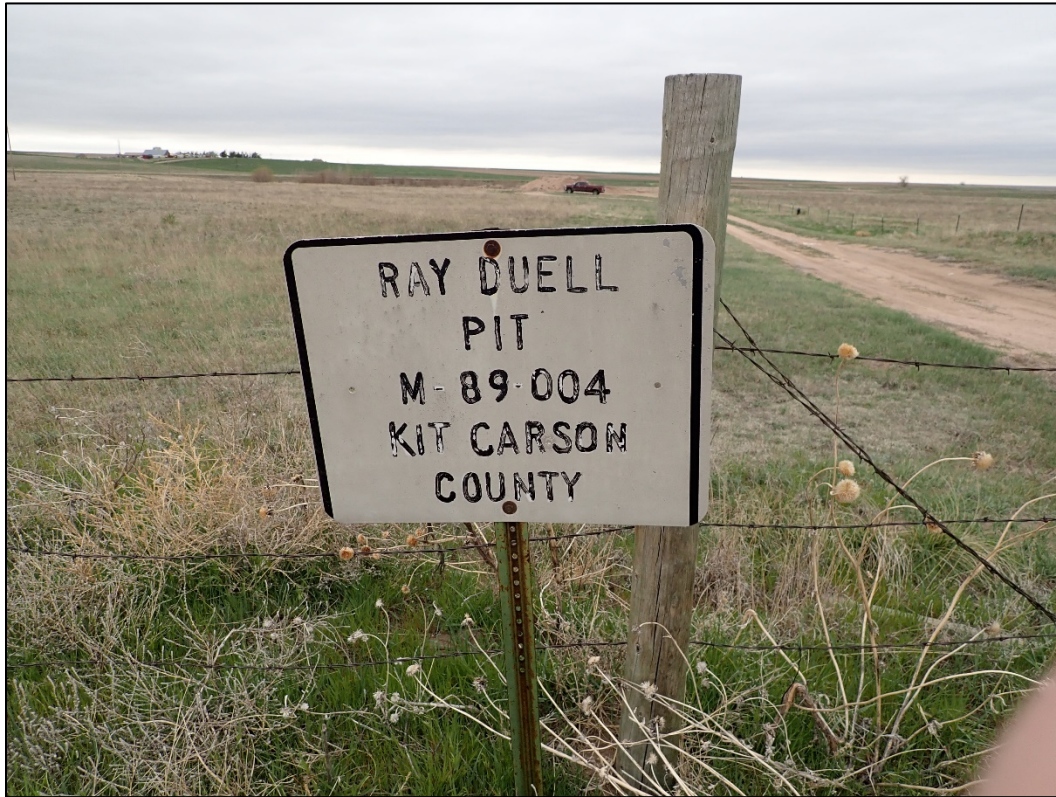
Signs and Markers: The permit sign was properly posted and boundary markers delineated the permit boundary.

Photo 1. Mine identification sign; looking north.

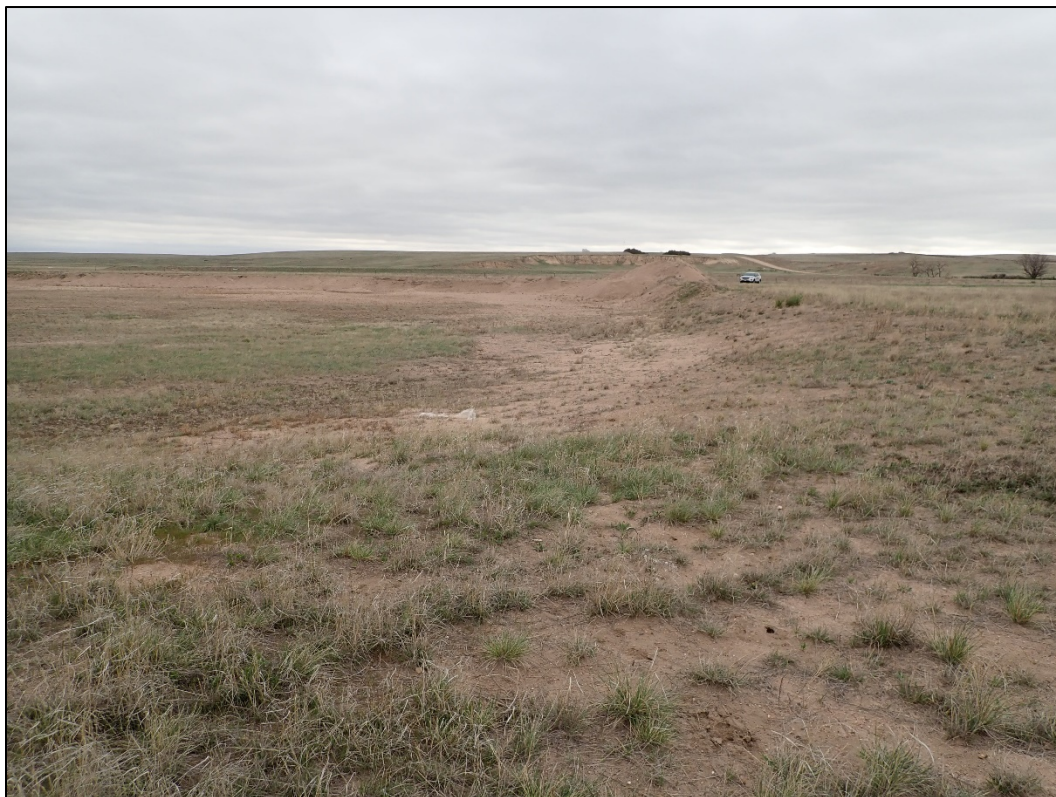
Topsoil: Topsoil had been stripped from the site and piled along the crest of the southern slope of the pit. There appears to be sufficient topsoil stockpiled at the site to complete reclamation.

Photo 2. Southern portion of the pit; looking east.

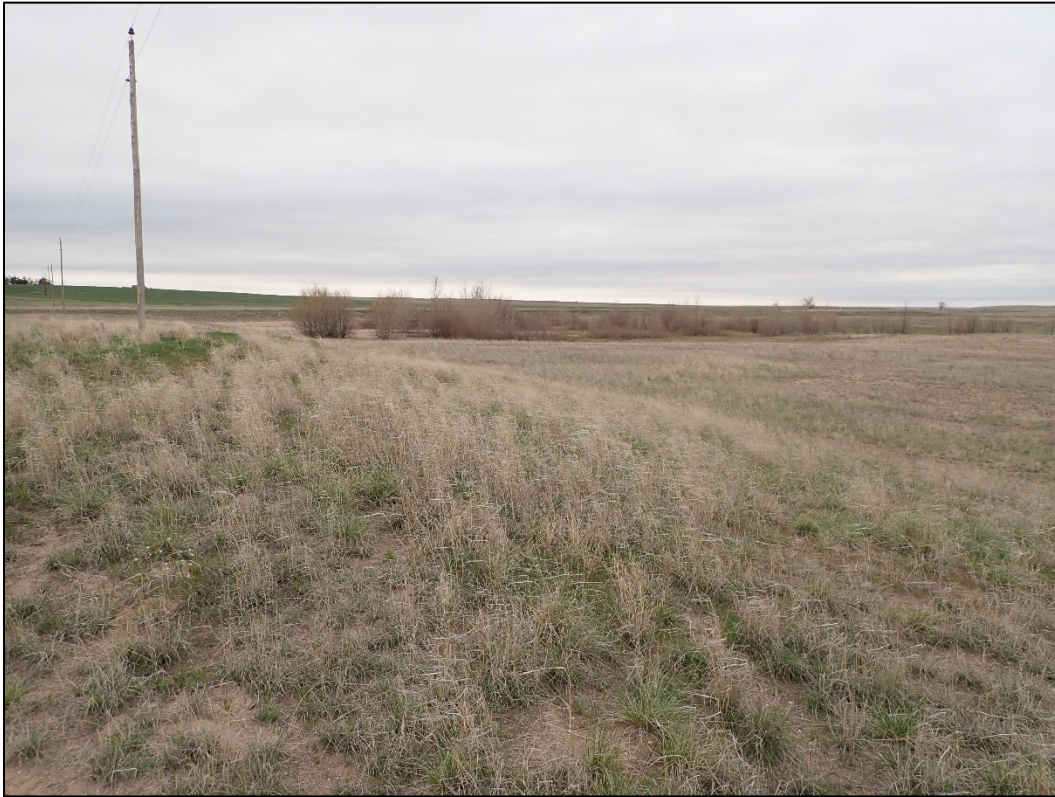
The site consists of a single excavated area, approximately 3 acres in size, just south of the ephemeral stream channel known as Sand Creek. The pit consists of a western, southern, and eastern slope and "daylights" on the north side to the creek channel. A large product stockpile was located along the southeast corner of the pit. The Operator stated they intend to advance the pit to the west, mining around the power poles after working with utility company to establish appropriate buffers.

Photo 3. Western slope of pit, currently near power line; looking north.

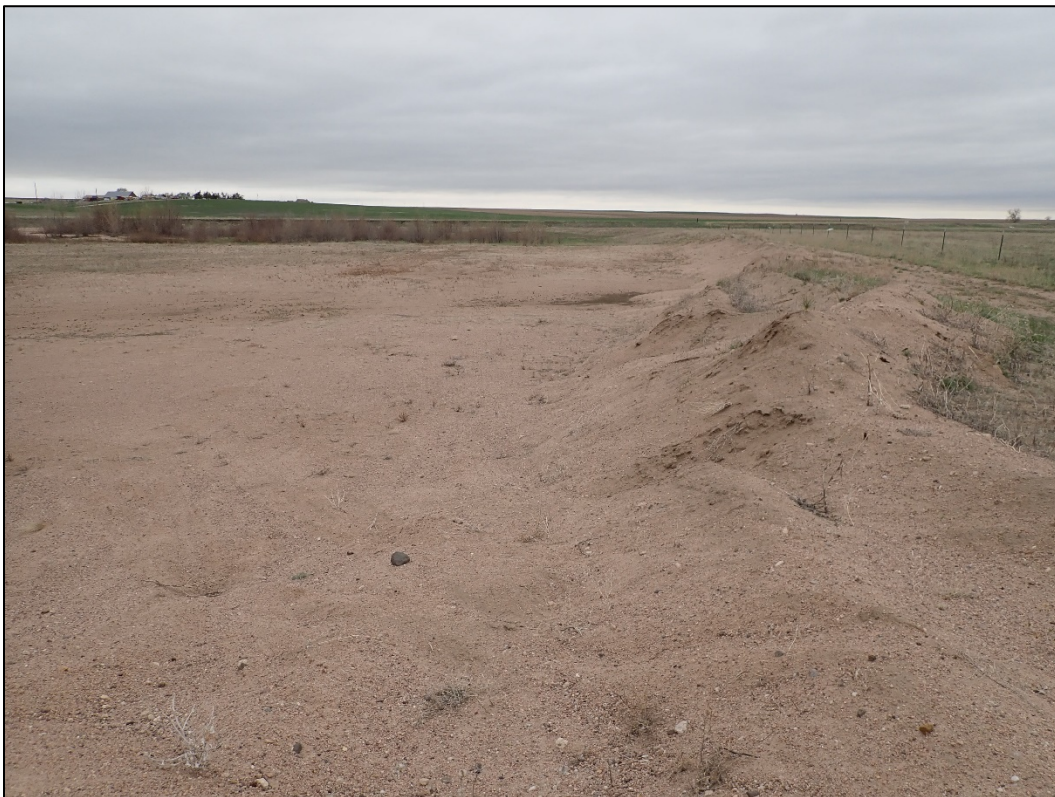
Photo 4. Southeast portion of the pit; looking north.

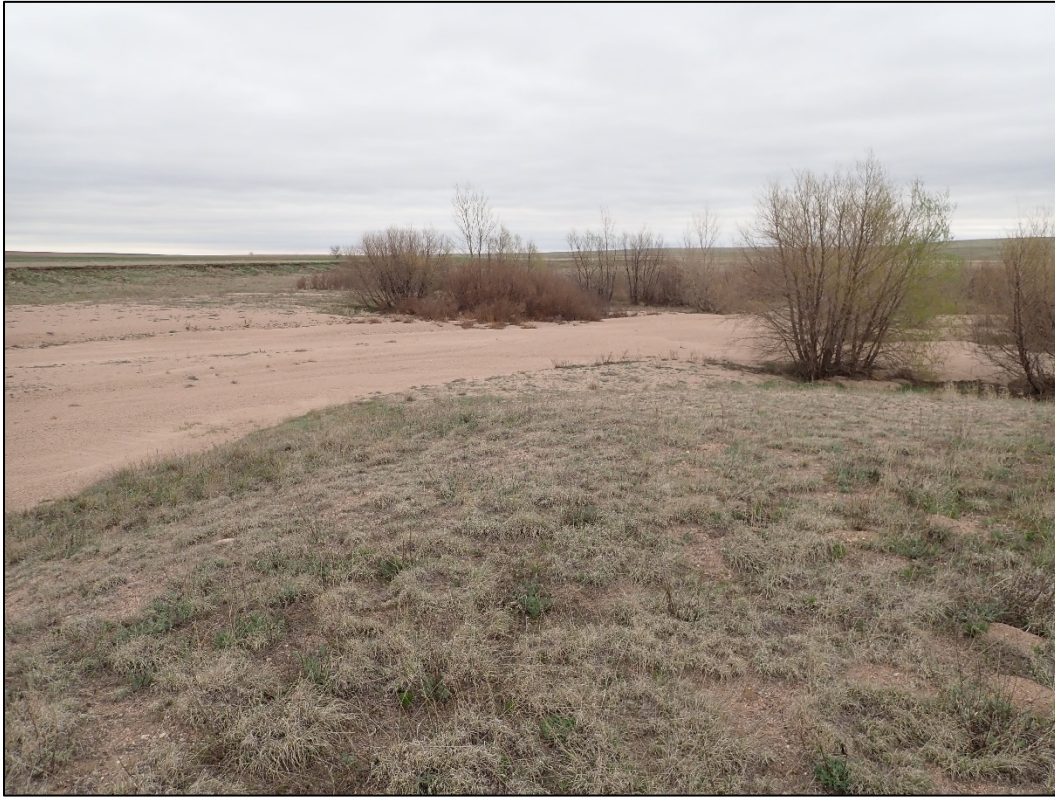
Photo 5. Northern end of permit where Sand Creek and excavation meet; looking northeast.
