MINERALS PROGRAM INSPECTION REPORT
PHONE: (303) 866-3567

MINE NAME: Dorsch Pit	MINE/PROSPECTING ID#: M-1998-060	MINERAL: Sand and gravel	COUNTY: Kit Carson
INSPECTION TYPE: Monitoring	INSPECTOR(S): Elliott R. Russell	INSP. DATE: April 30, 2019	INSP. TIME: 10:10
OPERATOR: Kit Carson County	OPERATOR REPRESENTATIVE: Dave Hornung	TYPE OF OPERATION: 112c - Construction Regular Operation	
REASON FOR INSPECTION: Normal I&E Program	BOND CALCULATION TYPE: None	BOND AMOUNT: NA	
DATE OF COMPLAINT: NA	POST INSP. CONTACTS: None	JOINT INSP. AGENCY: None	
WEATHER: Cloudy	INSPECTOR'S SIGNATURE:

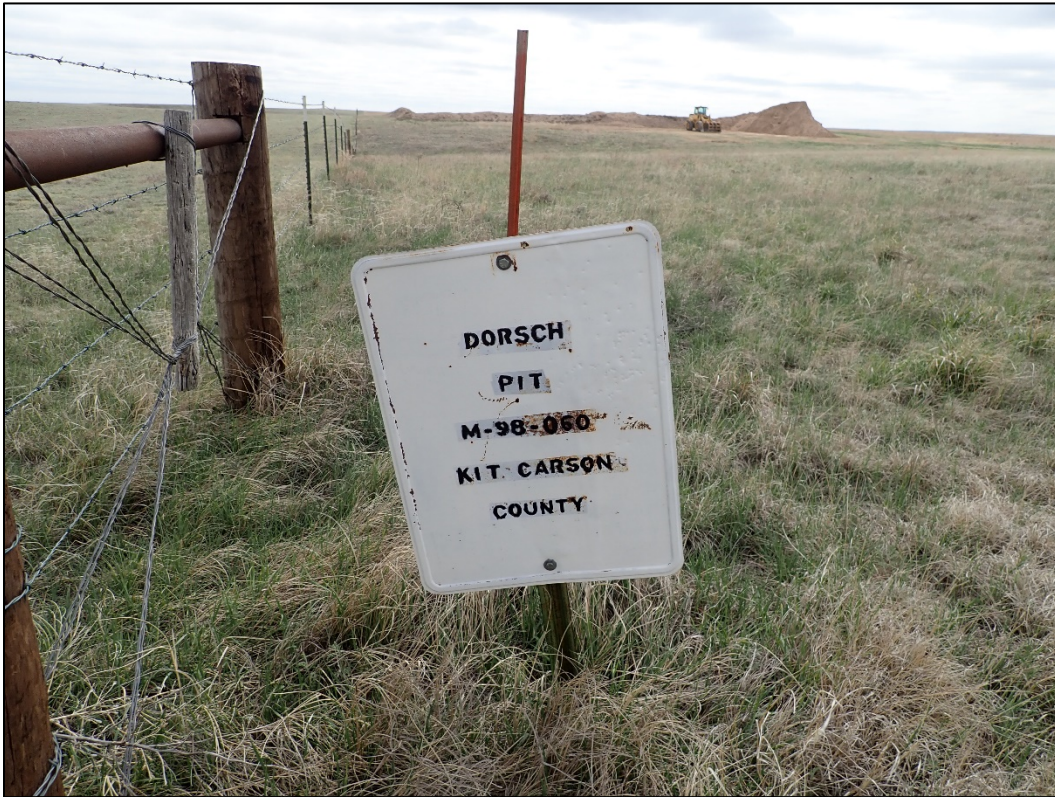
Signs and Markers: The permit sign was properly posted and boundary markers delineated the permit boundary.

Photo 1. Mine identification sign and northwest boundary marker; looking east.

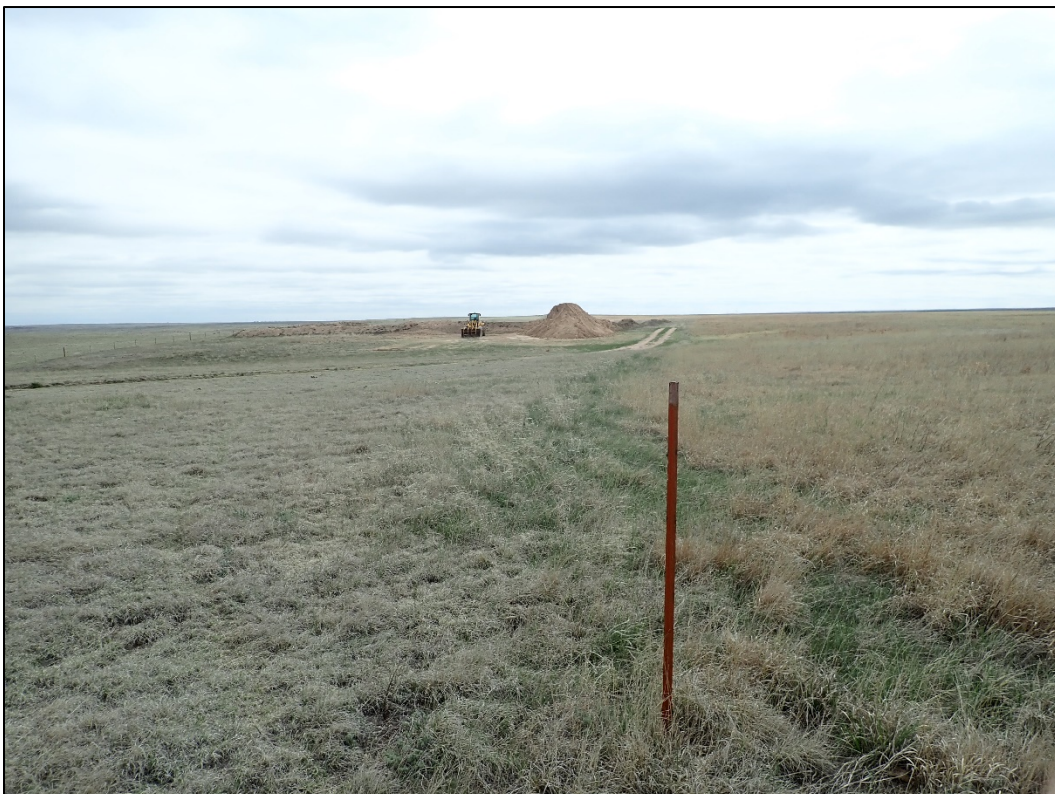
Photo 2. Southwest boundary marker; looking east.

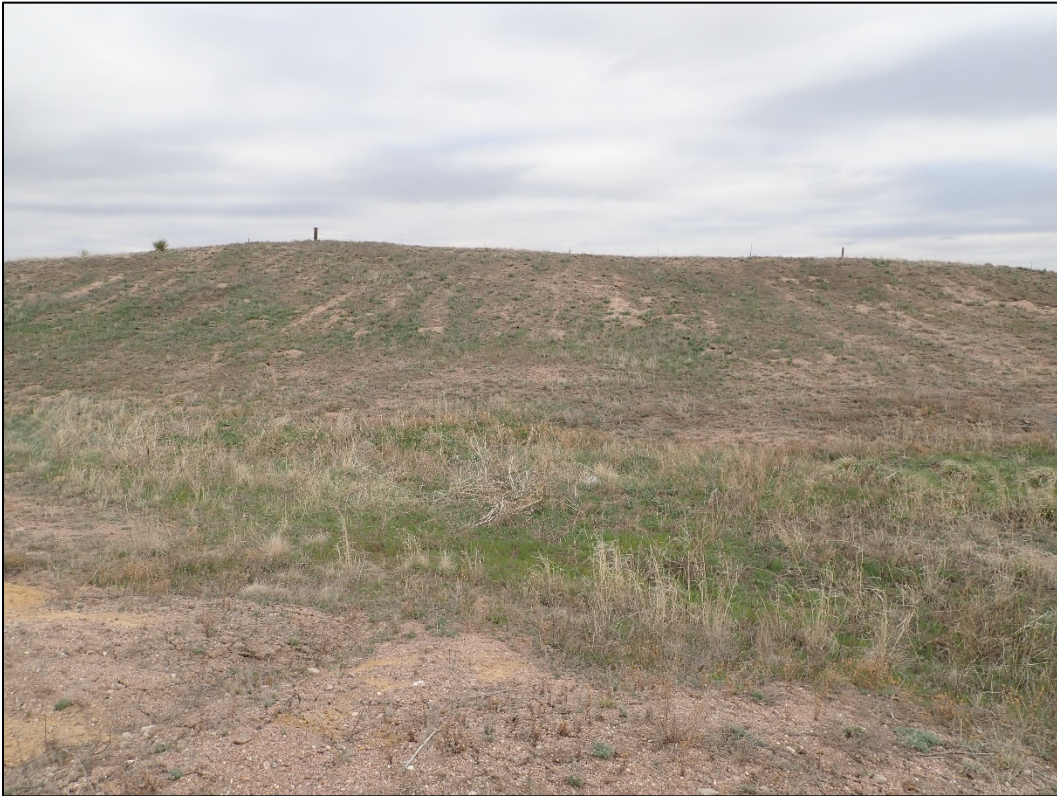
Photo 3. Eastern most area, reclaimed south-facing slope; looking north.

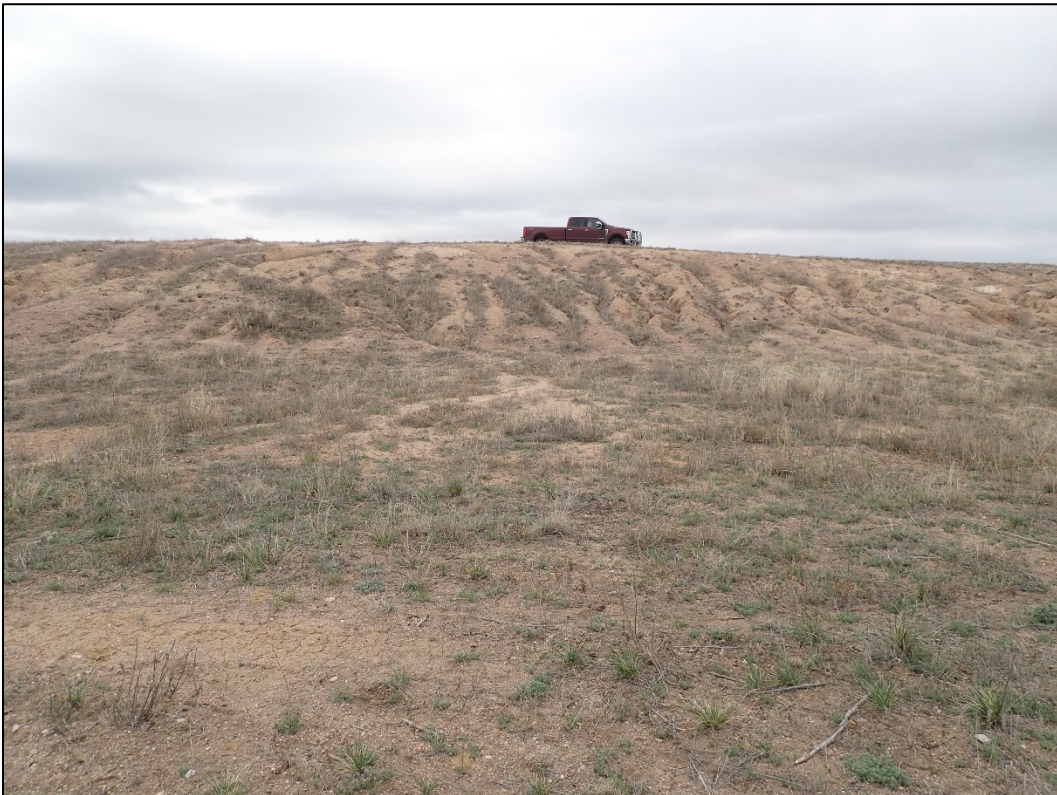
Photo 4. Eastern most area, north-facing slope in need of erosion repair and re-seeding; looking south.

The site consists of three mining areas in an east-west fashion. The eastern-most area had been mined and nearly reclaimed. The operator will need to repair the numerous erosion gullies on the northern facing slope and re-seed this repaired area on the south side of the pit. The Division recommends the Operator place additional topsoil on this area after regrading as it appears this area had limited topsoil replaced originally. The central and western mining areas were active and consist of active mining faces on each area's western side. These mining faces are approximately 10-15 feet in height.

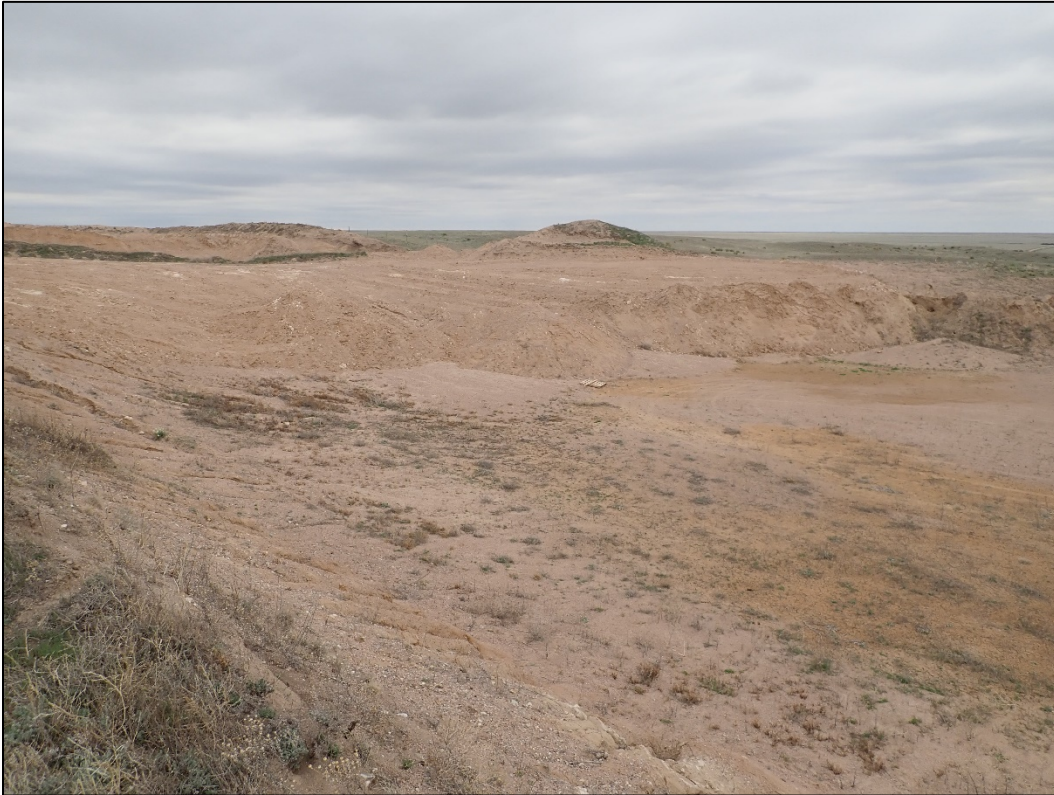
Photo 5. Central mining area; looking northwest.

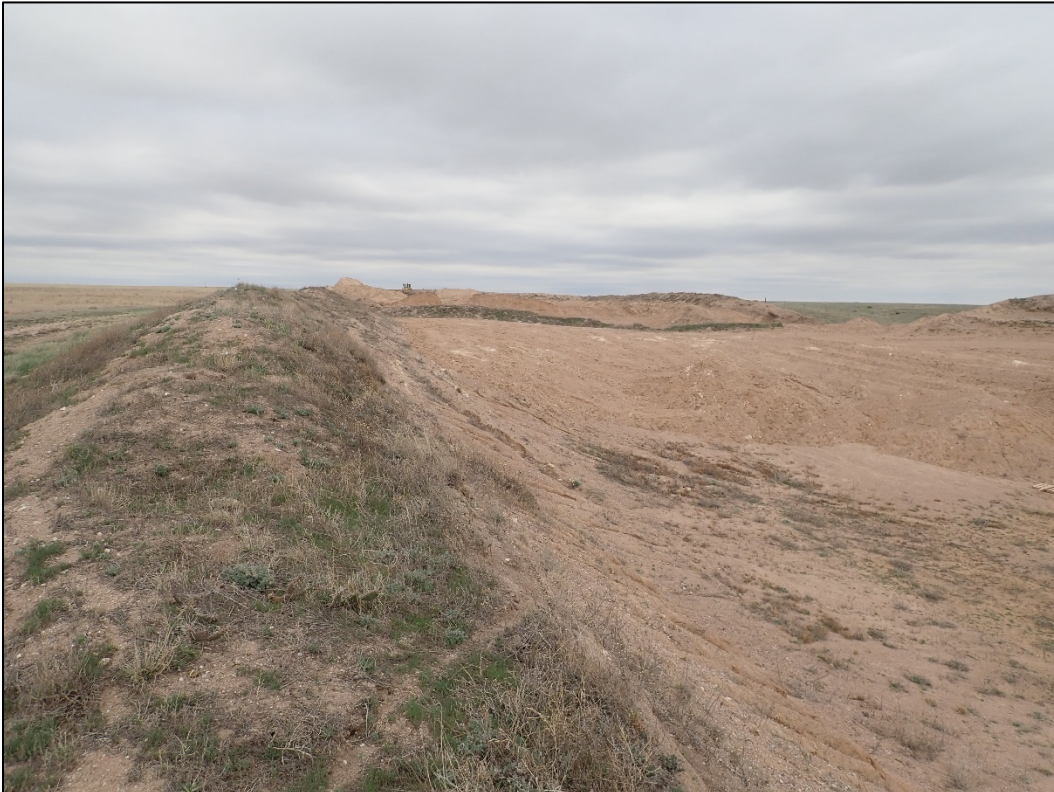
Topsoil: Topsoil had been stripped from the western active mining areas and piled along the southern, western, and northern sides of the pit. Topsoil had also been stripped from the central mining area and stockpile along the southern and northern side of the pit. There appears to be sufficient topsoil stockpiled at the site to complete reclamation.

Photo 6. Central mining area and southern topsoil stockpile; looking west.

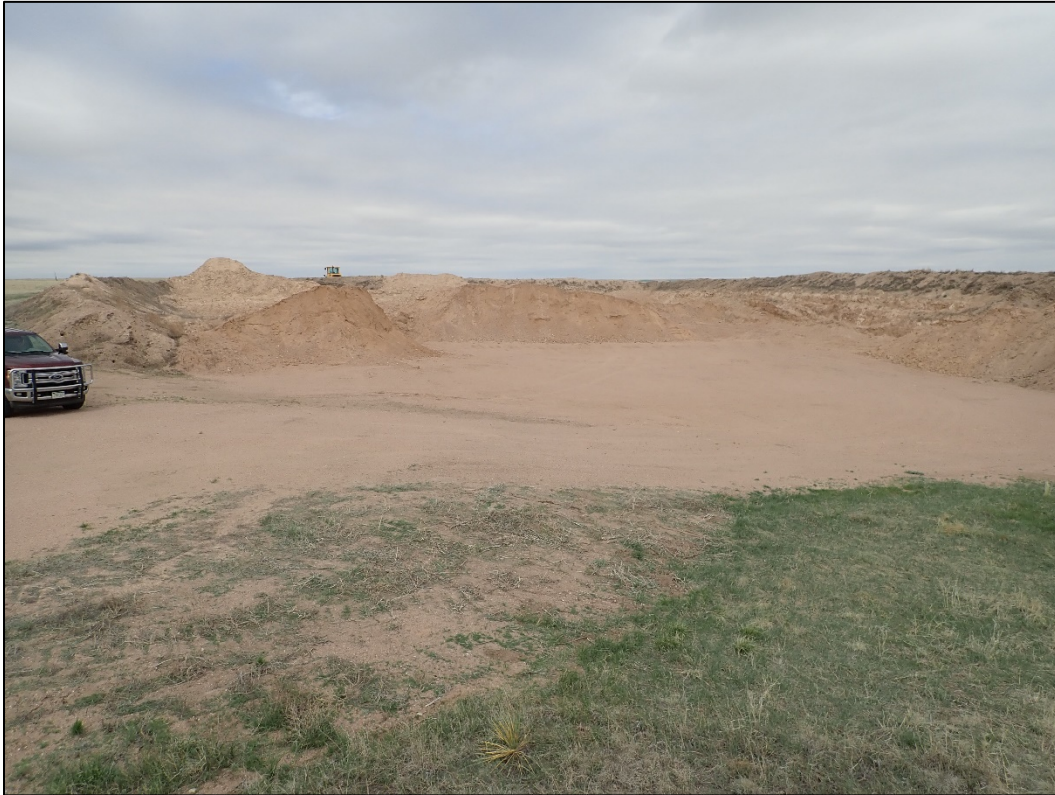
Photo 7. Western mining area; looking west.
