MINERALS PROGRAM INSPECTION REPORT PHONE: (303) 866-3567

MINE NAME:	MINE/PROSPECTING ID#:	MINERAL:	COUNTY:	
Bledsoe Pit	M-1982-067	Sand and gravel	Kit Carson	
INSPECTION TYPE:	INSPECTOR(S):	INSP. DATE:	INSP. TIME:	
Monitoring	Elliott R. Russell	April 30, 2019	11:00	
OPERATOR:	OPERATOR REPRESENTATIVE:	TYPE OF OPERA	TYPE OF OPERATION:	
Kit Carson County	Dave Hornung	110c - Construction	110c - Construction Limited Impact	
REASON FOR INSPECTION:	BOND CALCULATION TYPE:		BOND AMOUNT:	
Normal I&E Program DATE OF COMPLAINT:	None POST INSP. CONTACTS:		JOINT INSP. AGENCY:	
NA	None	None		
WEATHER:	INSPECTOR'S SIGNATURE:	SIGNATURE DATE:		
Cloudy	At Pmill	June 26, 2019

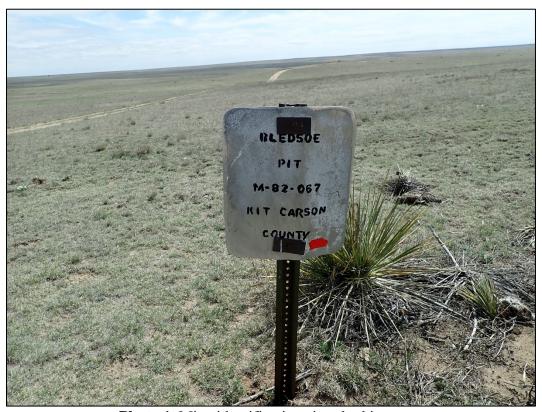
Signs and Markers: The permit sign was properly posted and boundary markers delineated the permit boundary.

Photo 1. Mine identification sign; looking east.

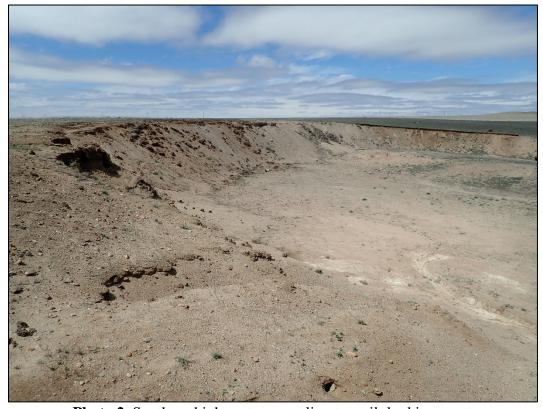
<u>Topsoil:</u> Topsoil has been stockpiled at the southeast crest of the pit. There appears to be sufficient topsoil stockpiled at the site to complete reclamation. Some in-situ topsoil was observed unraveling into the pit from the highwall. The Division recommends the Operator strip topsoil in advance of the pit highwall to ensure no topsoil is lost, aid in future reclamation, and to comply with Rule 3.1.9(1).

Photo 2. Southern high, note unraveling topsoil; looking west.

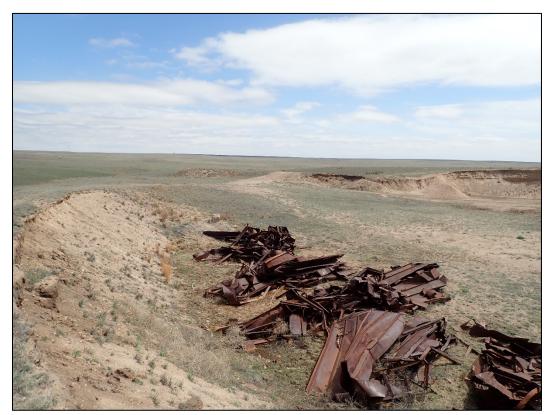
Photo 3. Northern portion of the site which daylights to the north; looking northeat.

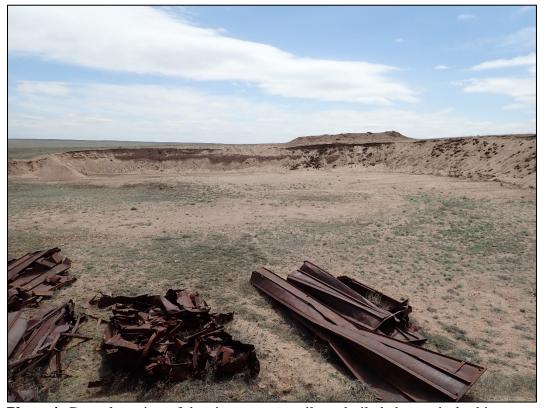
Photo 4. Central portion of the site, note topsoil stockpiled above pit; looking east.

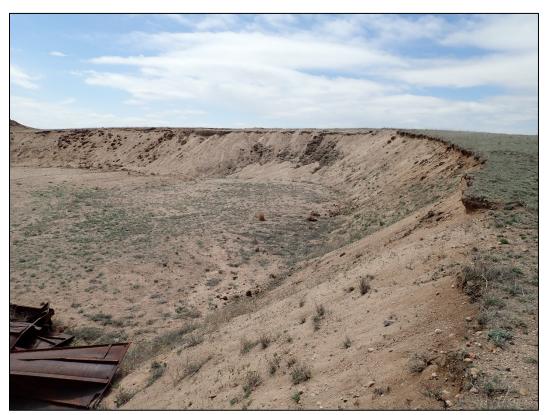
Photo 5. Southwestern portion of site; looking south.
