MINERALS PROGRAM INSPECTION REPORT
PHONE: (303) 866-3567

MINE NAME: Jarnagin Pit	MINE/PROSPECTING ID#: M-2018-022	MINERAL: Clay, sand, gravel	COUNTY: Kit Carson
INSPECTION TYPE: Monitoring	INSPECTOR(S): Elliott R. Russell	INSP. DATE: April 30, 2019	INSP. TIME: 10:40
OPERATOR: Kit Carson County	OPERATOR REPRESENTATIVE: Dave Hornung	TYPE OF OPERATION: 110c - Construction Limited Impact

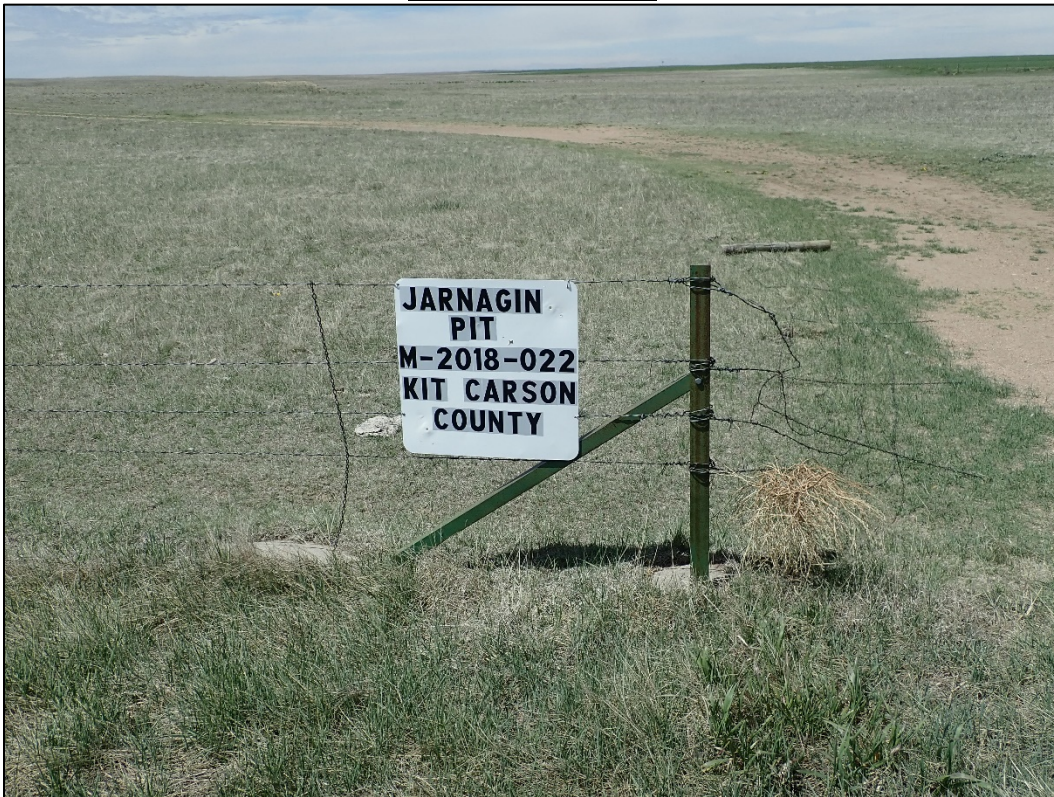
Signs and Markers: The permit sign was properly posted and boundary markers delineated the permit boundary.

Photo 1. Mine identification sign; looking west.

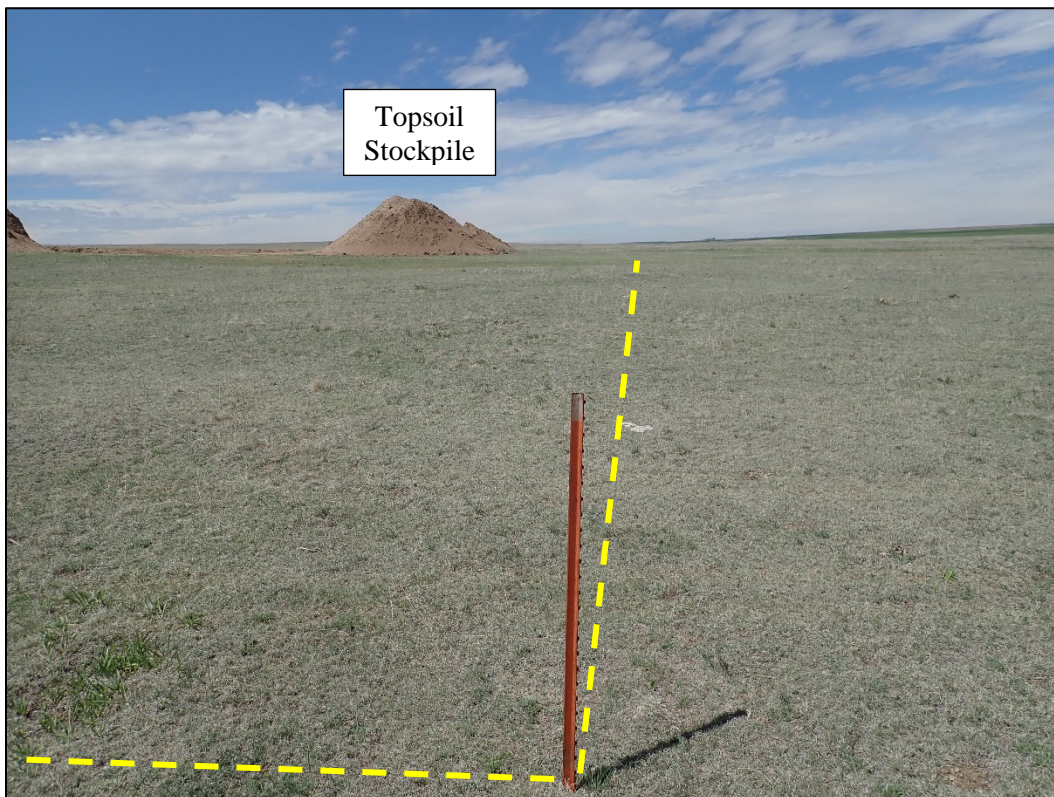
Photo 2. Northeast boundary marker, permit boundary approximated by yellow-dashed line; looking west.

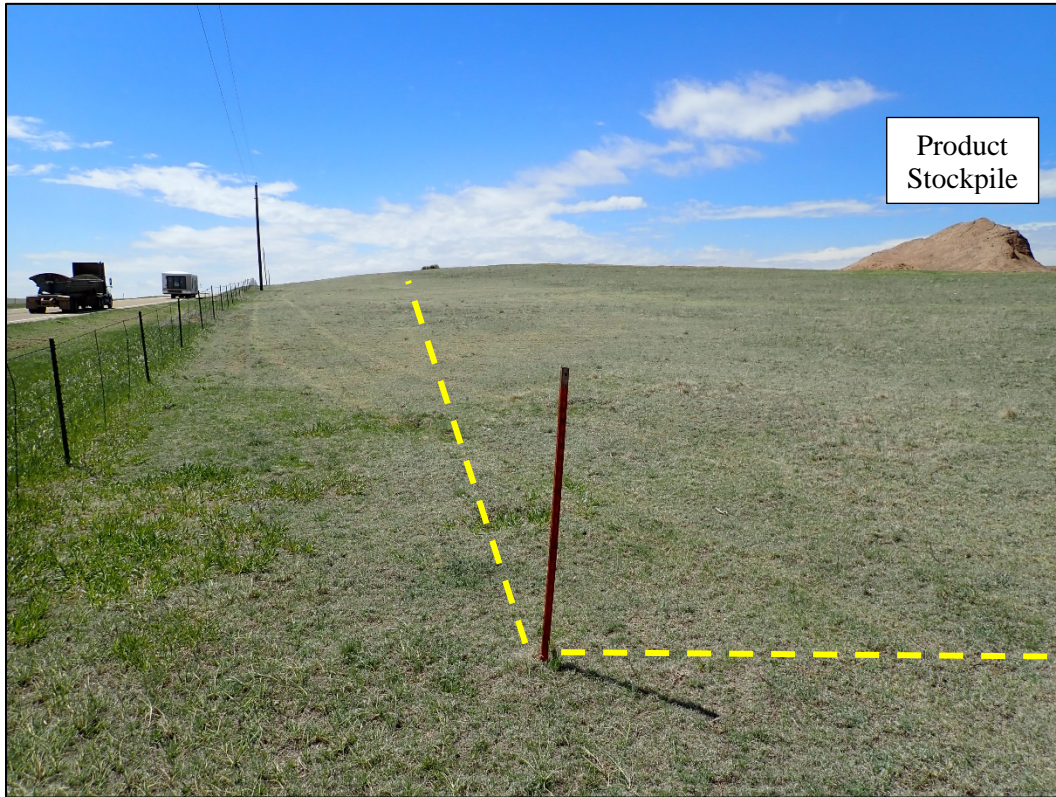
The Division observed structures located within 200 feet of the permit boundary which were not accounted for in the permit application. State Highway 59 and its associated ROW fence, as well as, a buried fiber optic line along the west side of the highway are all within 200 feet of the affected lands and require compliance with Rule 6.3.12. On June 13, 2019, prior to the Division issuing this inspection report, the Operator complied with the compliance problems identified and discussed during the inspection. This problem has been resolved.

Photo 3. Northeast boundary marker, State Highway 59 on left, permit boundary approximated by yellow-dashed line; looking south.

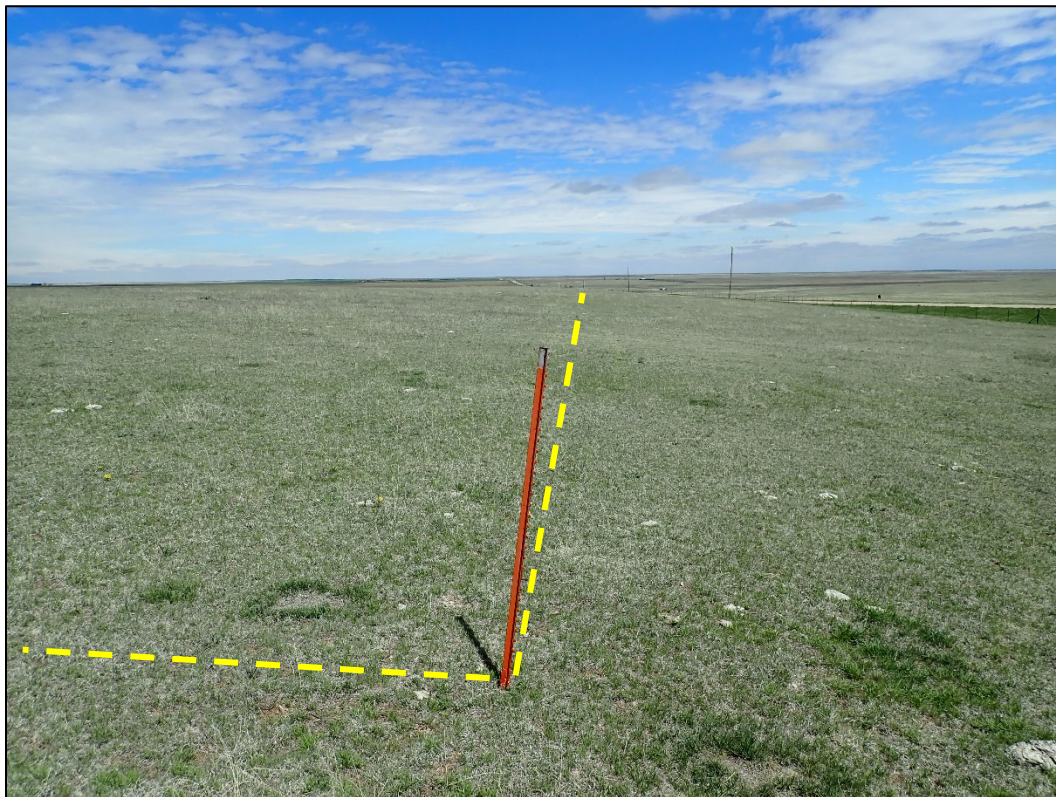
Photo 4. Southeast boundary marker, permit boundary approximated by yellow-dashed line; looking north.

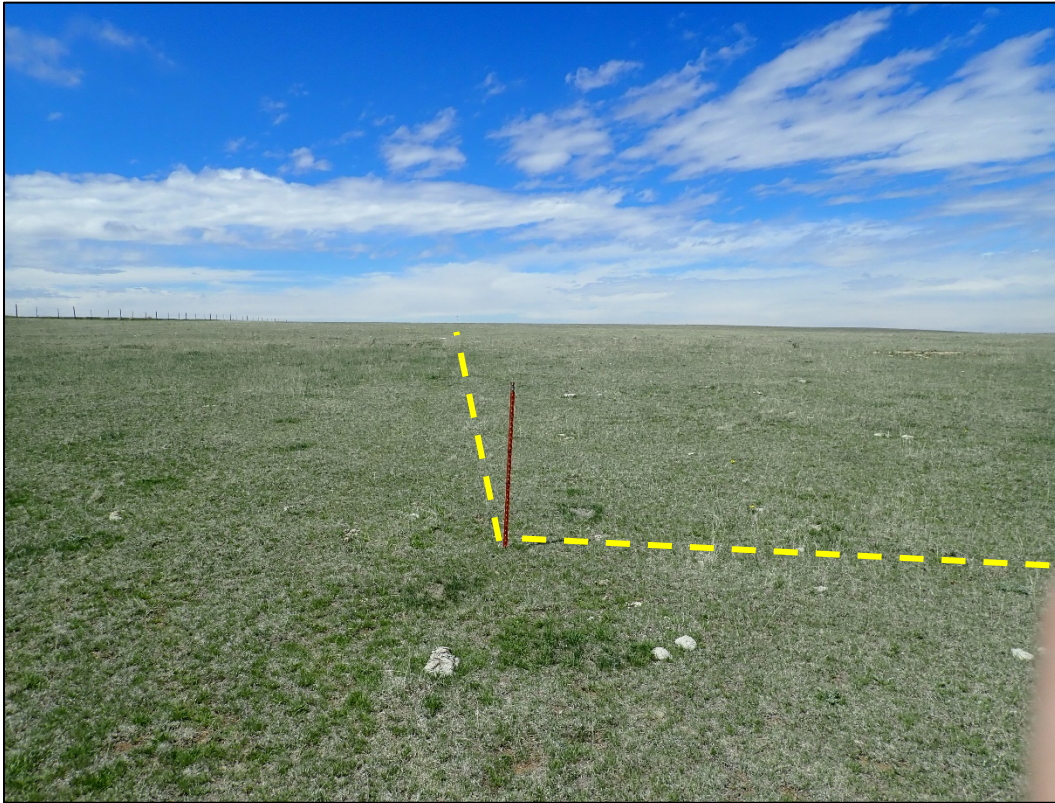
Photo 5. Southeast boundary marker, permit boundary approximated by yellow-dashed line; looking west.

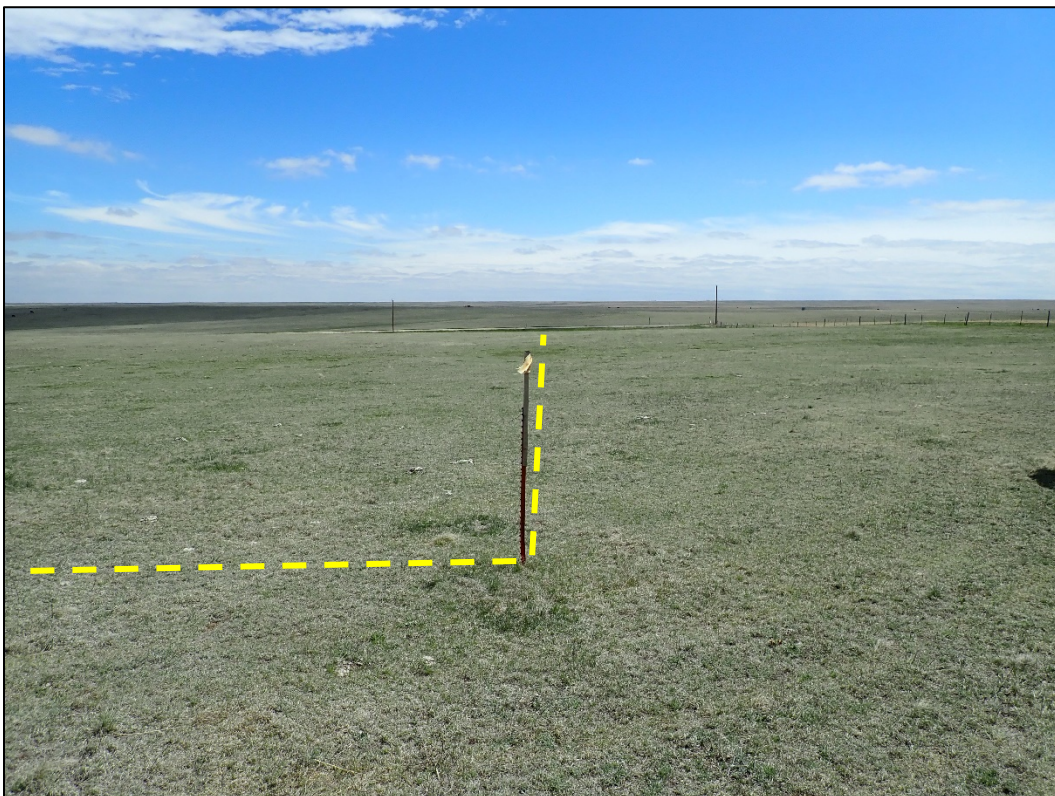
Photo 6. Southwest boundary marker, permit boundary approximated by yellow-dashed line; looking east.

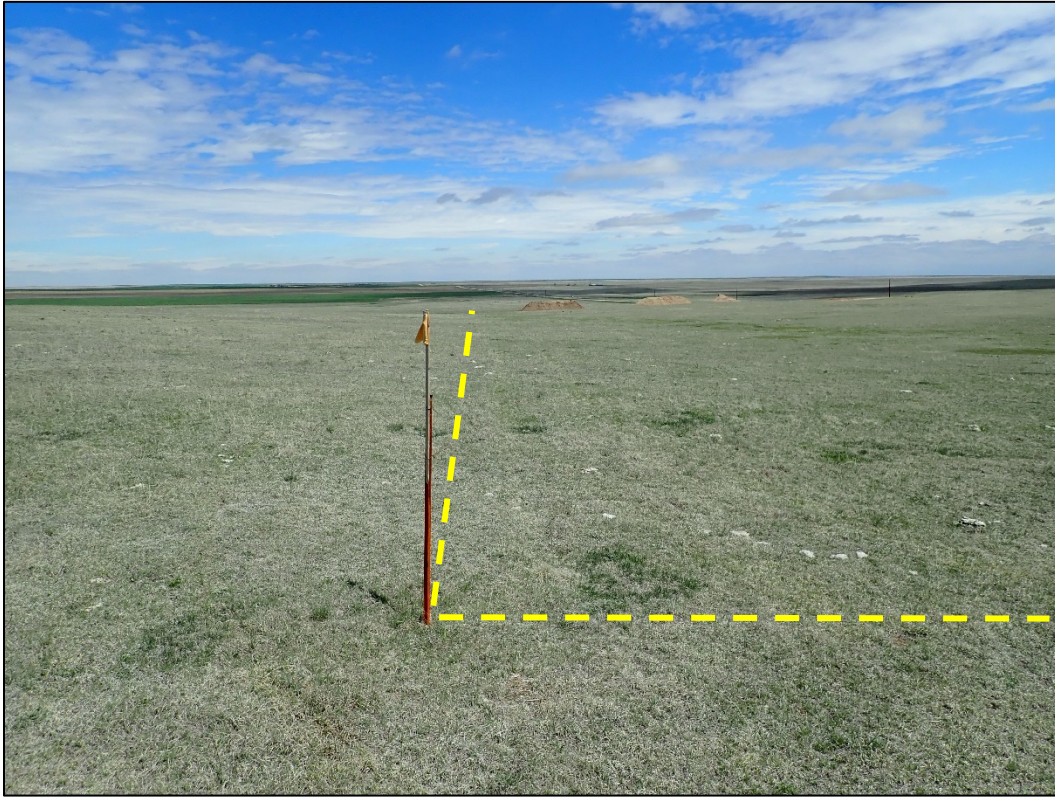
Photo 7. Southwest boundary marker, permit boundary approximated by yellow-dashed line; looking north.

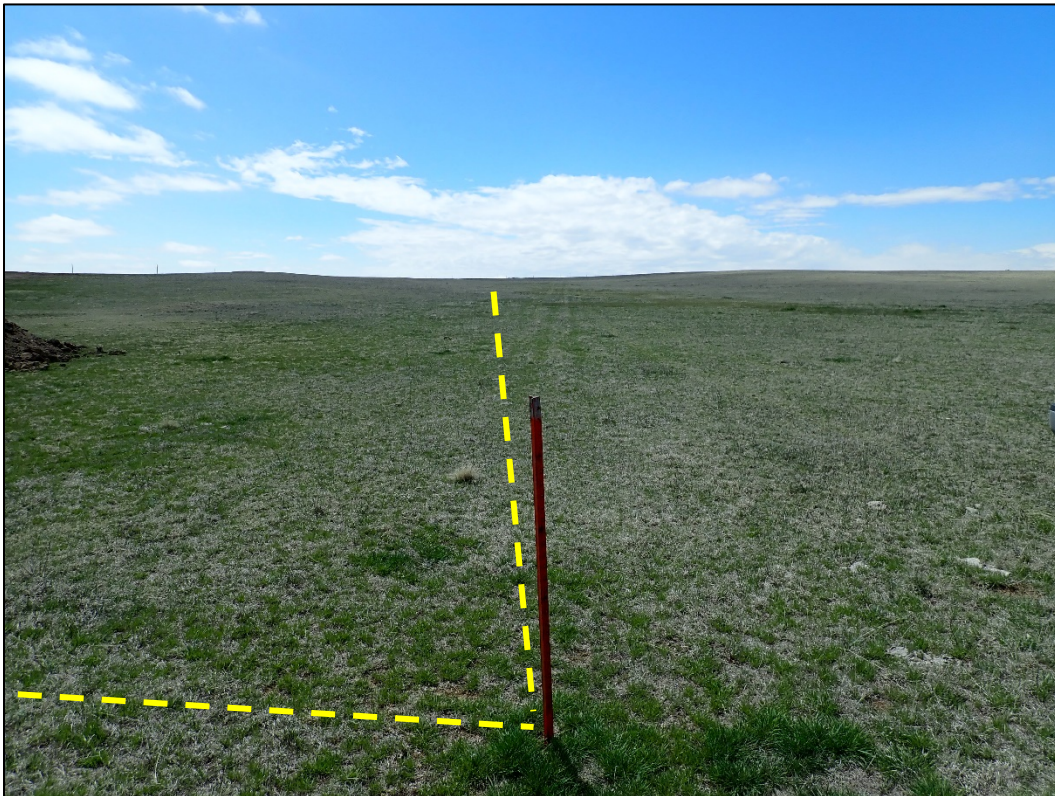
Photo 8. Northwest boundary marker, permit boundary approximated by yellow-dashed line; looking south.

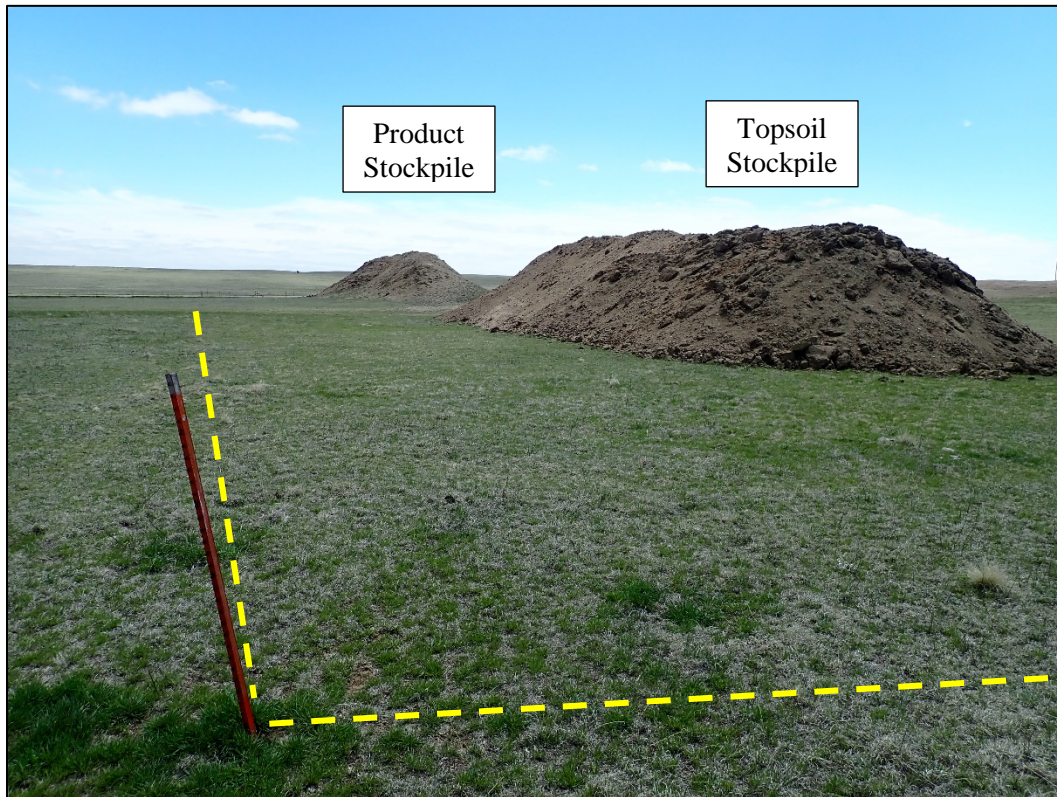
Photo 9. Northwest boundary marker, permit boundary approximated by yellow-dashed line; looking east.

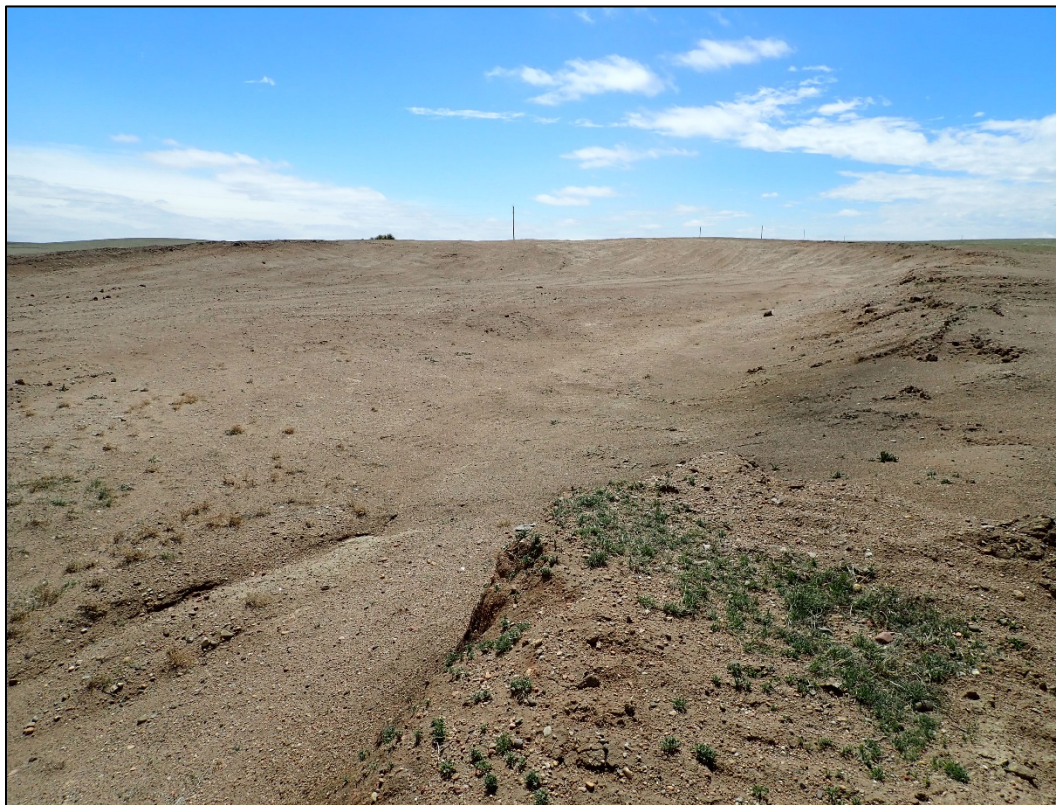
The site consists of a single pit which daylights to the north and has small mining faces on the west, south, and east sides. Mining slopes were gentle with a slope of approximately 3H:1V. The pit was currently 5-10 feet deep. A product stockpile was located northeast of the pit.

Photo 10. Pit area; looking southeast.

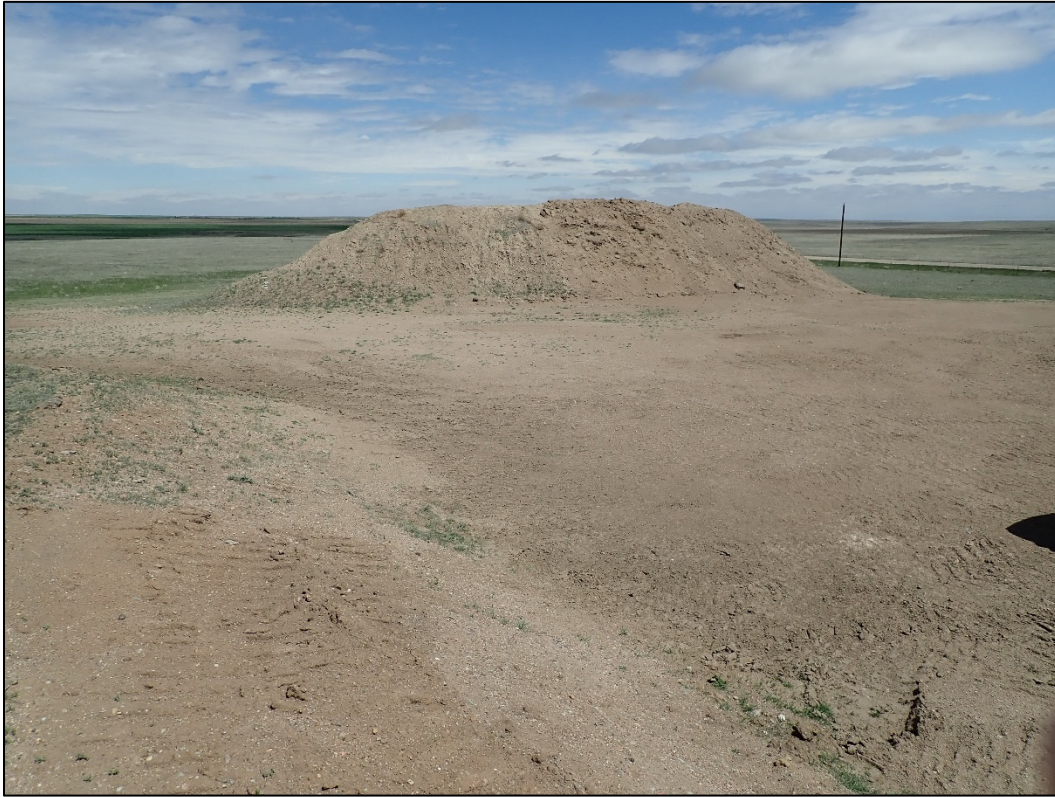
Photo 11. Product stockpile; looking northeast.
