MINERALS PROGRAM INSPECTION REPORT
PHONE: (303) 866-3567

MINE NAME: Kit Carson County	MINE/PROSPECTING ID#: M-1982-094	MINERAL: Sand and gravel	COUNTY: Kit Carson
INSPECTION TYPE: Monitoring	INSPECTOR(S): Elliott R. Russell	INSP. DATE: April 30, 2019	INSP. TIME: 12:20
OPERATOR: Kit Carson County	OPERATOR REPRESENTATIVE: Dave Hornung	TYPE OF OPERATION: 110c - Construction Limited Impact	
REASON FOR INSPECTION: Normal I&E Program	BOND CALCULATION TYPE: None	BOND AMOUNT: NA	
DATE OF COMPLAINT: NA	POST INSP. CONTACTS: None	JOINT INSP. AGENCY: None	
WEATHER: Cloudy	INSPECTOR'S SIGNATURE:

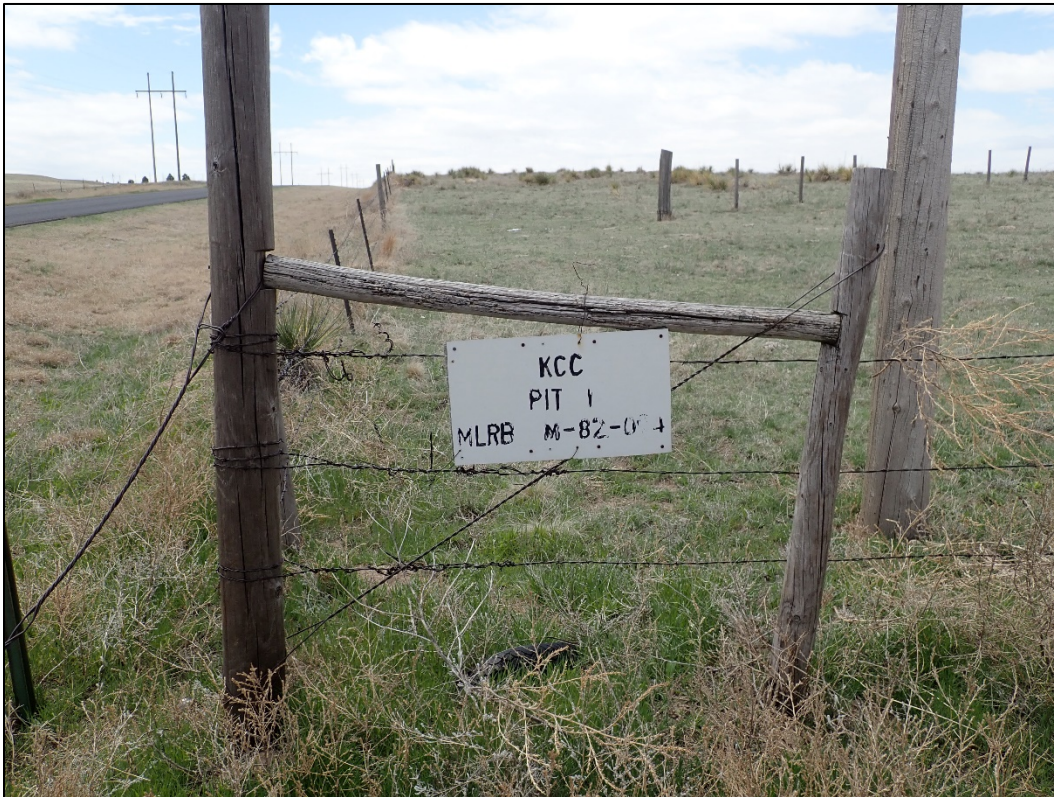
COMPLIANCE PROBLEM #1: The mine identification sign was posted at the entrance of the mine site, but was faded and needs to be refreshed. This is a problem for failure to post a mine identification sign as required by Rule 3.1.12(1).

Signs and Markers: The permit sign was posted at the southeast corner of the site along County Road 30. The sign has faded and the permit number is difficult to read. This has been cited as Compliance Problem #1 requiring the operator to re-fresh the mine identification sign or post a new sign. The permit boundary was delineated by markers.

Photo 1. Faded mine identification sign posted at the southeast corner of the permit; looking south.

CORRECTIVE ACTIONS: The operator shall, at the entrance of the mine site, post a sign which is at least 187 square inches (e.g. 11" x 17") and is clearly visible from the access road with the following:

- 1) the name of the operator,
- 2) the name of the operation,
- 3) a statement that a reclamation permit for the operation has been issued by the Colorado Mined Land Reclamation Board (such as "Issued by MLRB"); and
- 4) the permit number.

The operator shall submit photo documentation that a proper sign has been posted by the corrective action date.

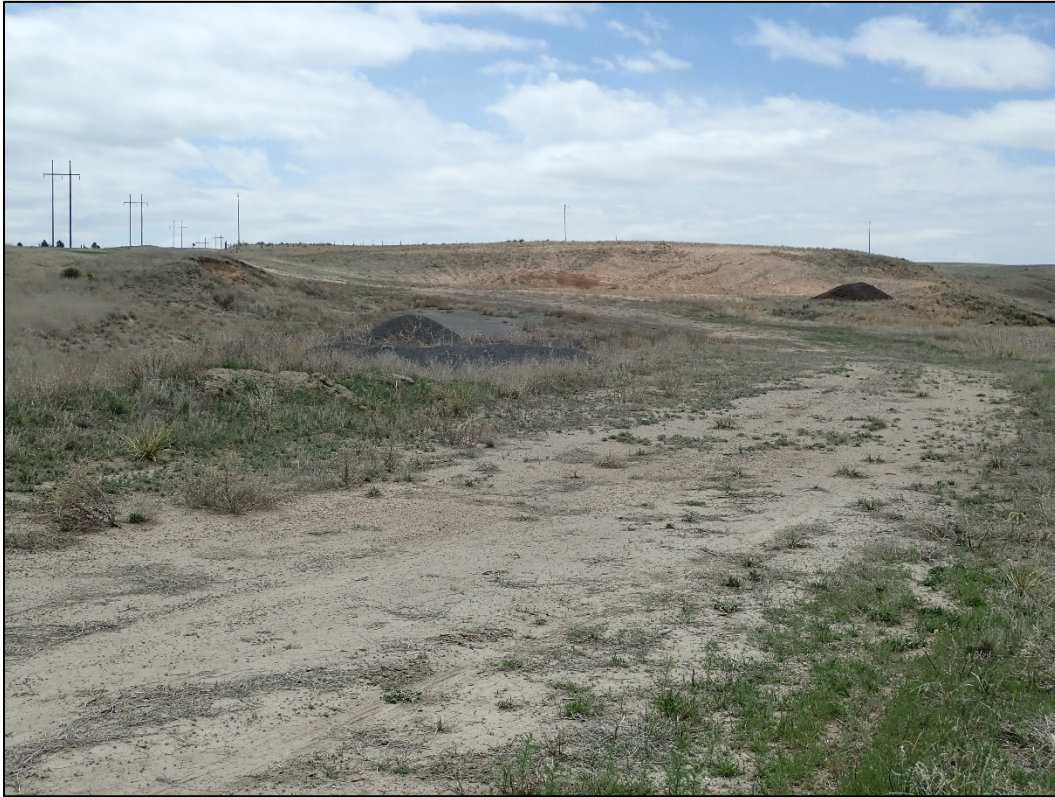
Photo 2. Site overview from northern portion of the site; looking south.

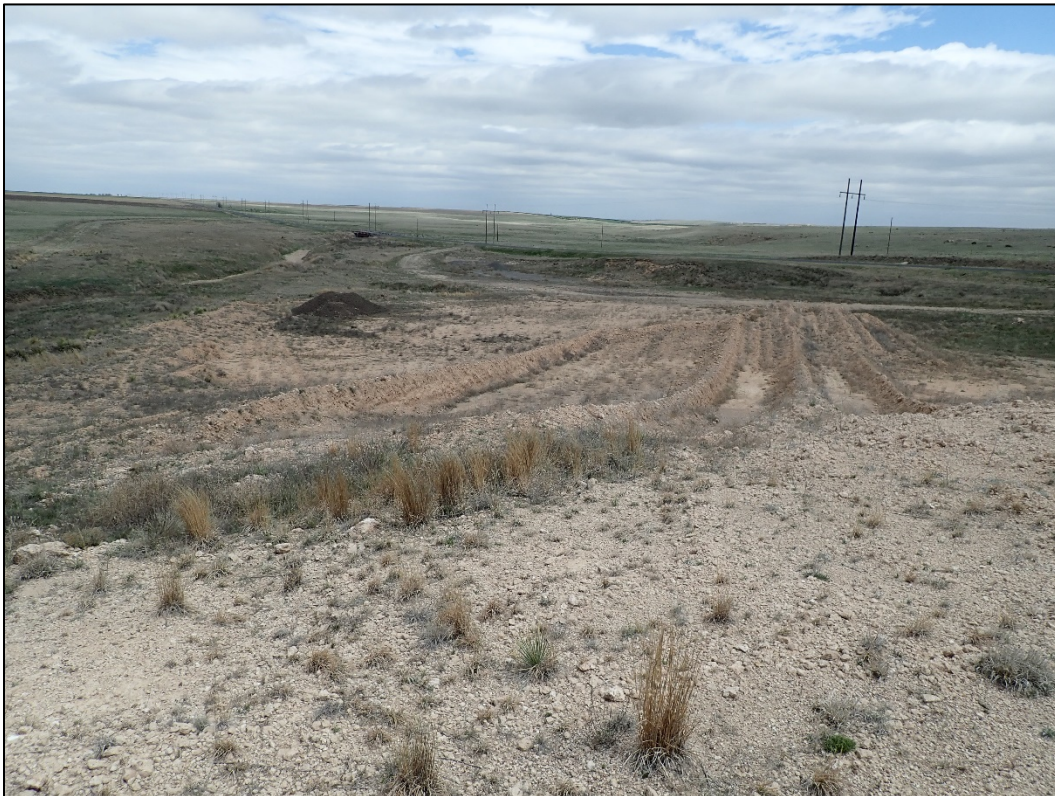
The site consists of an excavated bluff which faces north which has been advanced to the south and is approaching the southern permit boundary. Total disturbance at the site is estimated at 4.5 acres of disturbance. The active mining face is on the western half of the southern slope where it appears a bulldozer has been used to push material down the slope. A product stockpile was located at the base of the mining slope on the pit floor. Two stockpiles of recycled asphalt and chip-seal fragments were also located on the pit floor.

Photo 3. Dozer slots on the western side of the southern mine slope; looking northeast.

Backfill & Grading: The site is approved to have a maximum slope of 3H:1V. If the Operator intends to keep advancing the southern slope, the Division recommend establishing the final 3H:1V grade by pushing material down and stockpiling the remainder of minable material to ensure that the mining face does not come too close to the southern boundary. If the mining face advances much further south, the Operator would need to backfill the slope to meet the 3H:1V maximum slope or expand the permit to the south to acquire enough material to cut/fill the slope.

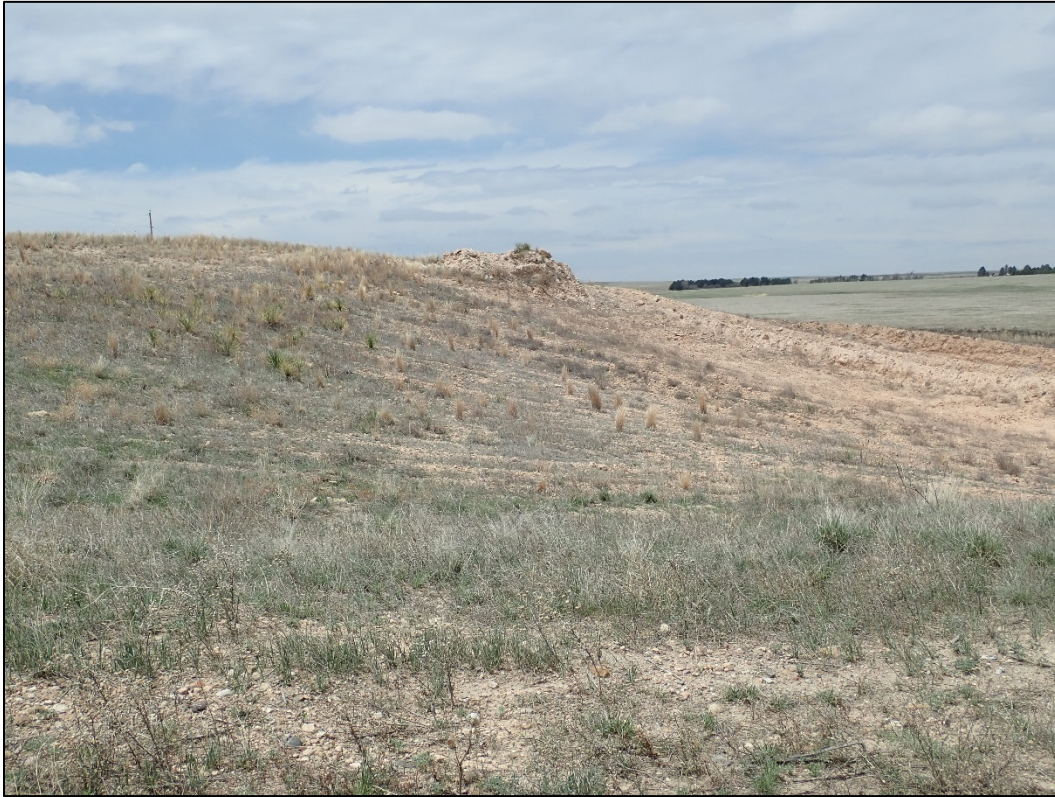
Photo 4. Eastern side of the southern mine slope; looking west.
