MINERALS PROGRAM INSPECTION REPORT

MINE NAME: Heintges Pit	MINE/PROSPECTING ID#: M-1991-069	MINERAL: Sand and gravel	COUNTY: Cheyenne
INSPECTION TYPE: Monitoring	INSPECTOR(S): Elliott R. Russell	INSP. DATE: April 30, 2019	INSP. TIME: 14:00
OPERATOR: Kit Carson County	OPERATOR REPRESENTATIVE: Dave Hornung	TYPE OF OPERATION: 110c - Construction Limited Impact	
REASON FOR INSPECTION: Normal I&E Program	BOND CALCULATION TYPE: None	BOND AMOUNT: NA	
DATE OF COMPLAINT: NA	POST INSP. CONTACTS: None	JOINT INSP. AGENCY: None	
WEATHER: Cloudy	INSPECTOR'S SIGNATURE:

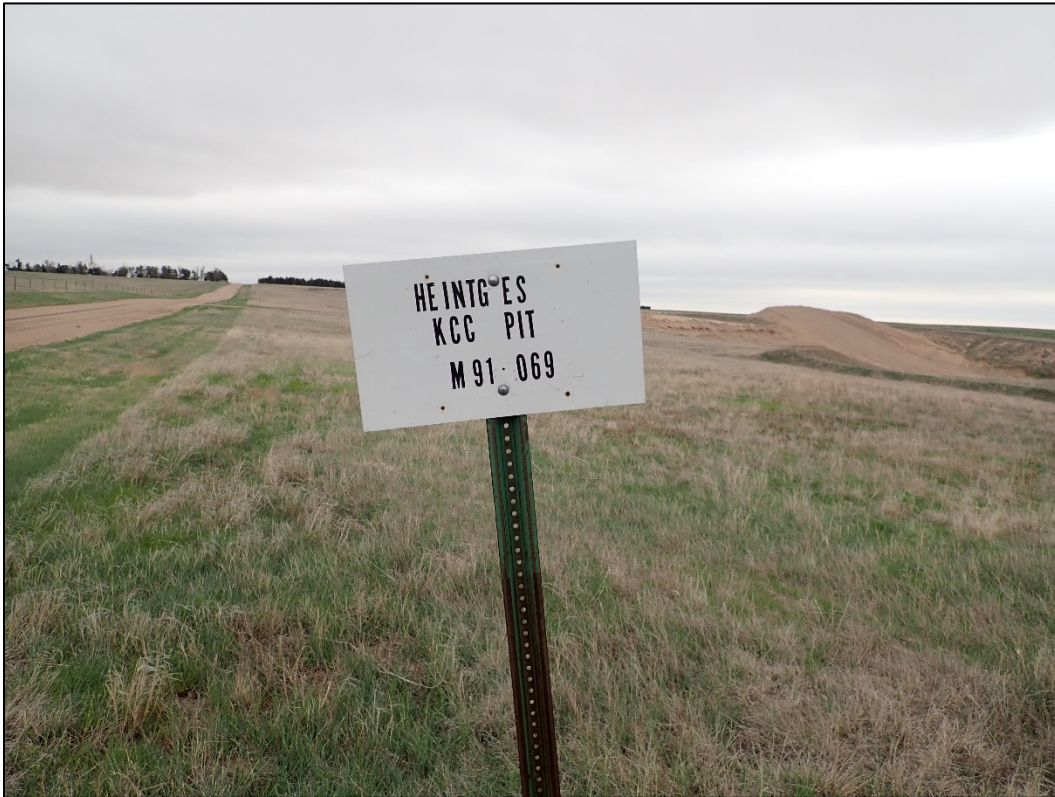
Signs and Markers: The permit sign was properly posted and boundary markers delineated the permit boundary.

Photo 1. Mine identification sign; looking south.

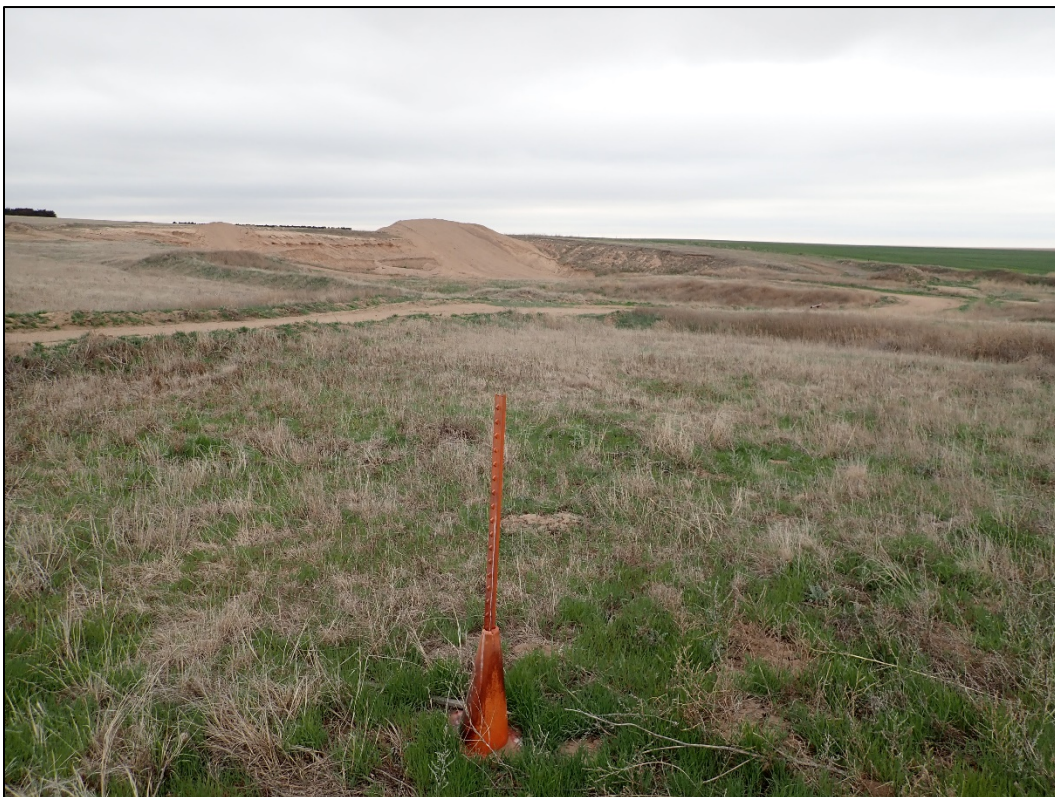
Photo 2. Northeast boundary marker; looking southwest.

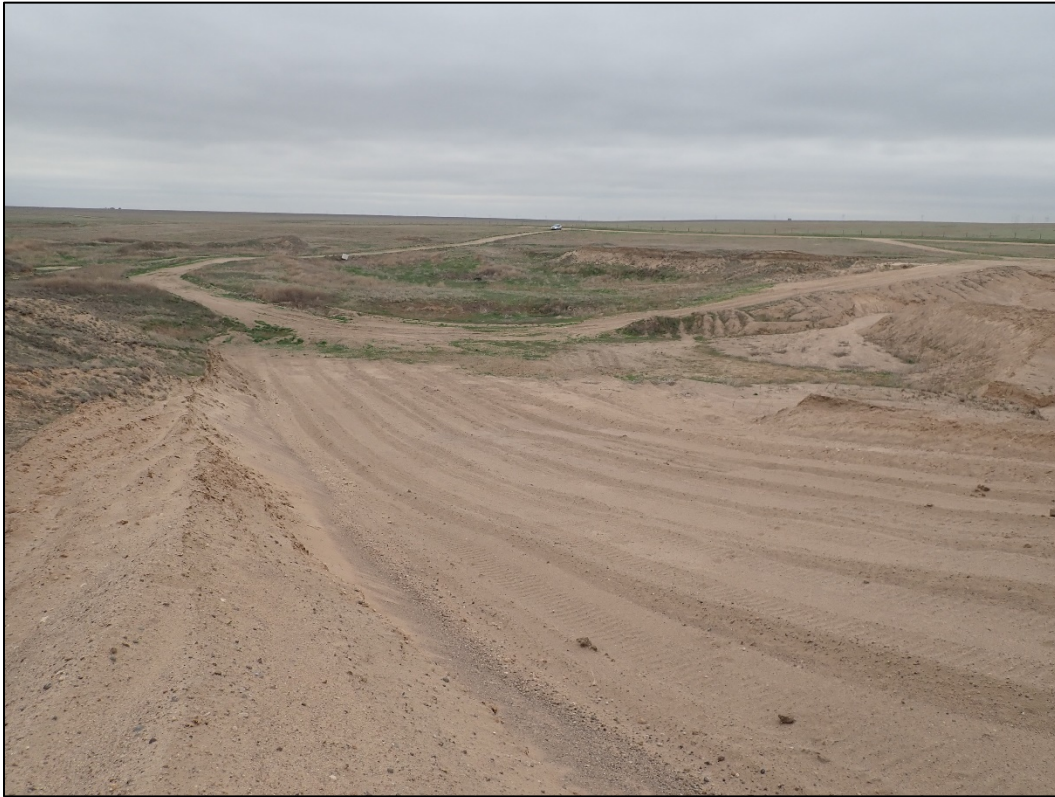
The site consists of a single pit, approximately 5 acres in size, with an active mining face along the southern portion. Material is currently being pushed up out of the pit and stockpiled at the crest of the southwest corner of the pit. The pit is approximately 20-30 feet deep.

Photo 3. Pit overview and southern mining slope; looking northeast.

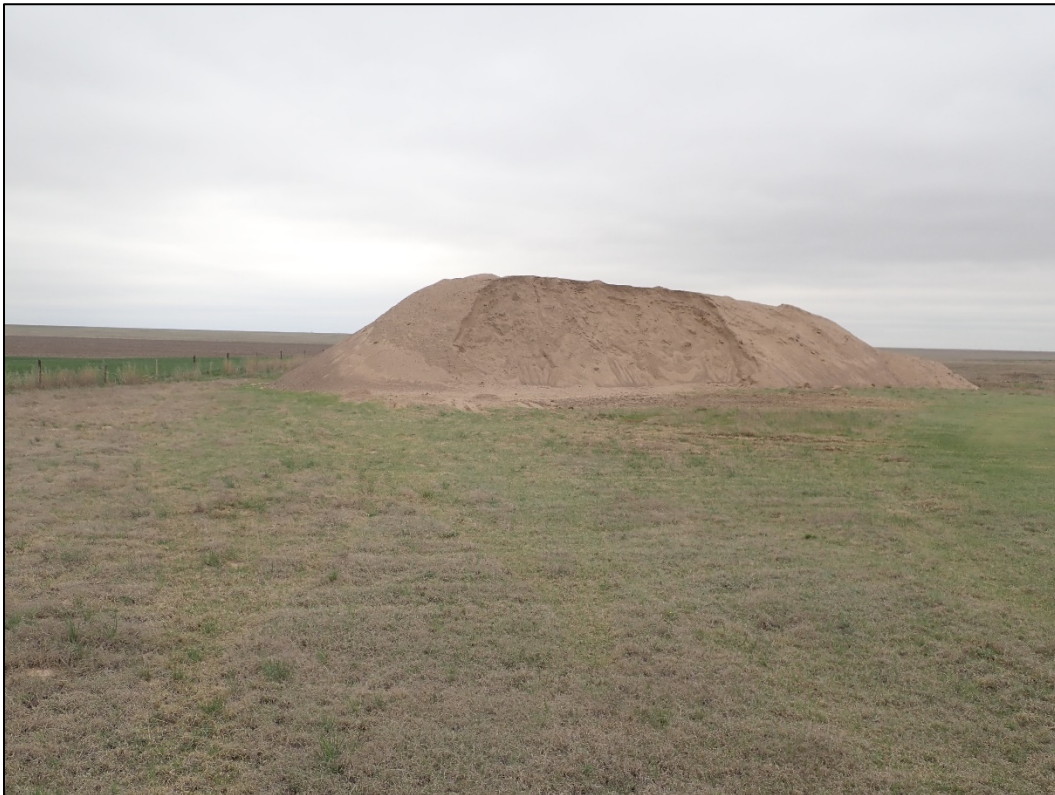
Photo 4. Product stockpile located at the crest of the southwest corner of the pit; looking northwest.

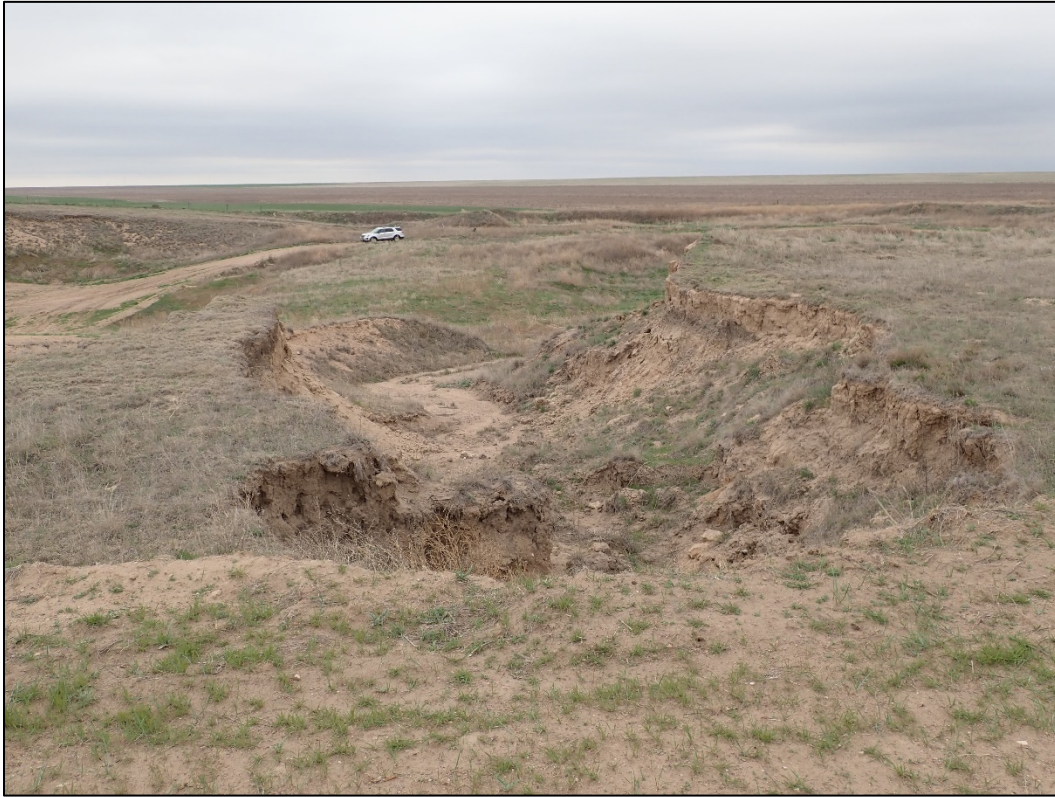
Sediment Control: A substantial head cut has developed along the eastern side of the pit, just north of the mid-pit access road. This erosional feature will likely continue to advance east and could eventually impact off-site lands if the Operator does not repair and mitigate it. The Division recommends the Operator backfill and grade the head cut, then establish a small berm or ditch furrow along the crest of the slope to help prevent future erosion issues with storm water flowing into the pit area.

Photo 5. Head cut along eastern side of pit; looking west.

Backfill & Grading: The Division recommends when the Operator repairs the erosional feature discussed above, to grade and slope the small highwall in the northeast portion of the site to assist in contemporaneous reclamation.
