MINERALS PROGRAM INSPECTION REPORT
PHONE: (303) 866-3567

MINE NAME: Revenue Mine	MINE/PROSPECTING ID#: M-2012-032	MINERAL: Lead, silver and gold	COUNTY: Ouray
INSPECTION TYPE: Monitoring	INSPECTOR(S): Lucas J. West	INSP. DATE: June 5, 2019	INSP. TIME: 09:15
OPERATOR: Ouray Silver Mines Inc.	OPERATOR REPRESENTATIVE: Brian Briggs	TYPE OF OPERATION: 112d-1 - Designated Mining Operation	
REASON FOR INSPECTION: Normal I&E Program	BOND CALCULATION TYPE: Complete Bond	BOND AMOUNT: \$476,269.41	
DATE OF COMPLAINT: NA	POST INSP. CONTACTS: None	JOINT INSP. AGENCY: None	
WEATHER: Clear	INSPECTOR'S SIGNATURE:

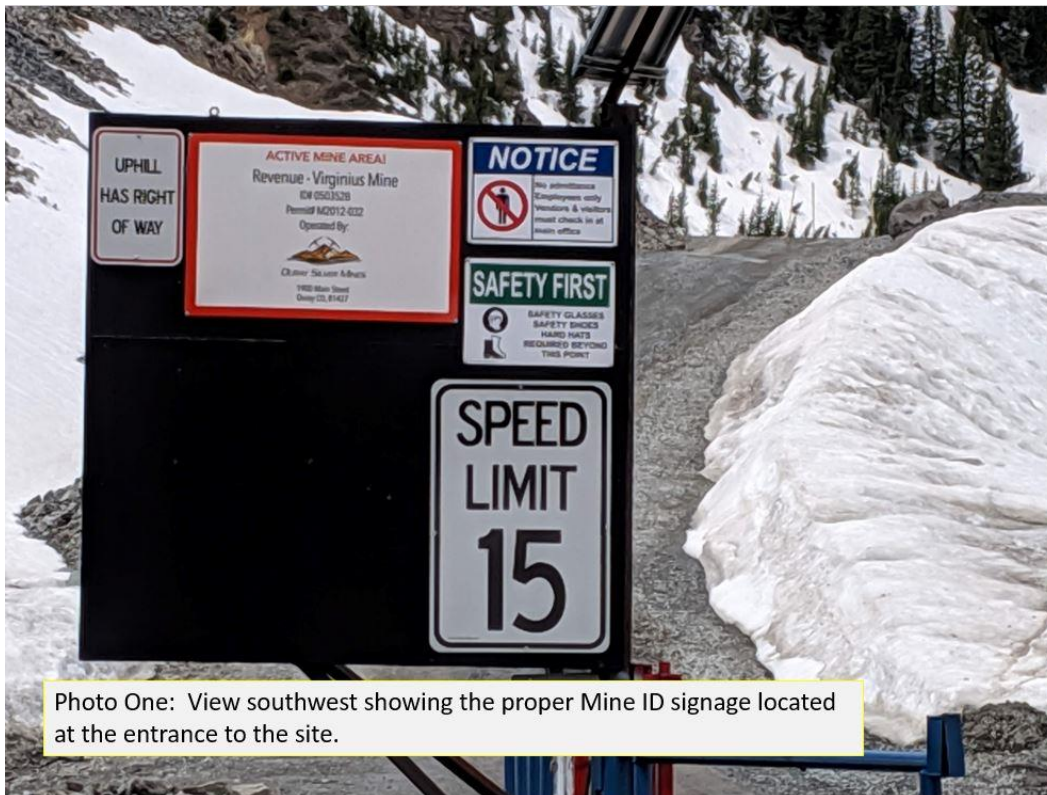
Proper mine identification signage was observed at the entrance to the mine site and can be seen in Photo One and permit boundary markers in the form of tall white PVC posts were observed around the perimeter of the permitted area. The site was active during the inspection, however it was only minor construction and site maintenance. No mining or milling was taking place at the time of the inspection. Various maintenance and construction activities were taking place on site during the inspection. Cleanup of debris and scrap around the surface facilities was observed. The underground facilities were inspected starting with the Coarse Ore Bin, leading through the Crusher Gallery, Mill Room and filter building. All underground facilities were in excellent condition and free from trash and debris. The mill remains in an idle status awaiting more pieces of equipment to begin final configuration. A view of the mill area can be seen in Photo Two.

Photo One: View southwest showing the proper Mine ID signage located at the entrance to the site.

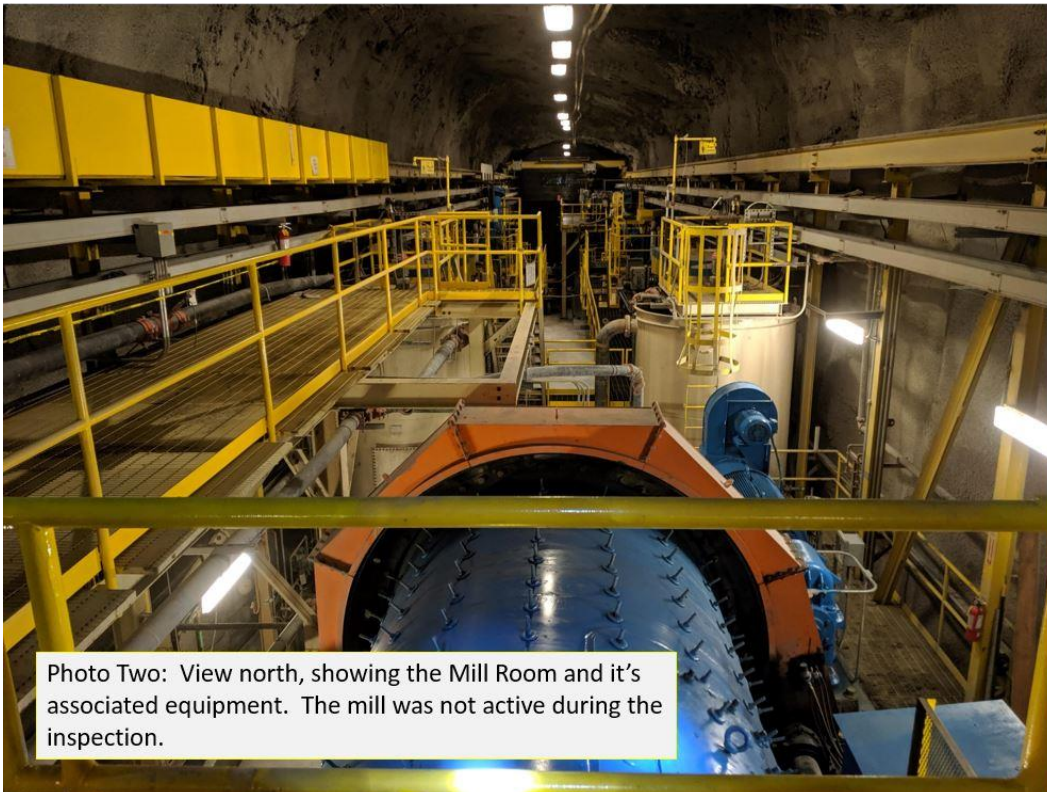
Photo Two: View north, showing the Mill Room and it's associated equipment. The mill was not active during the inspection.

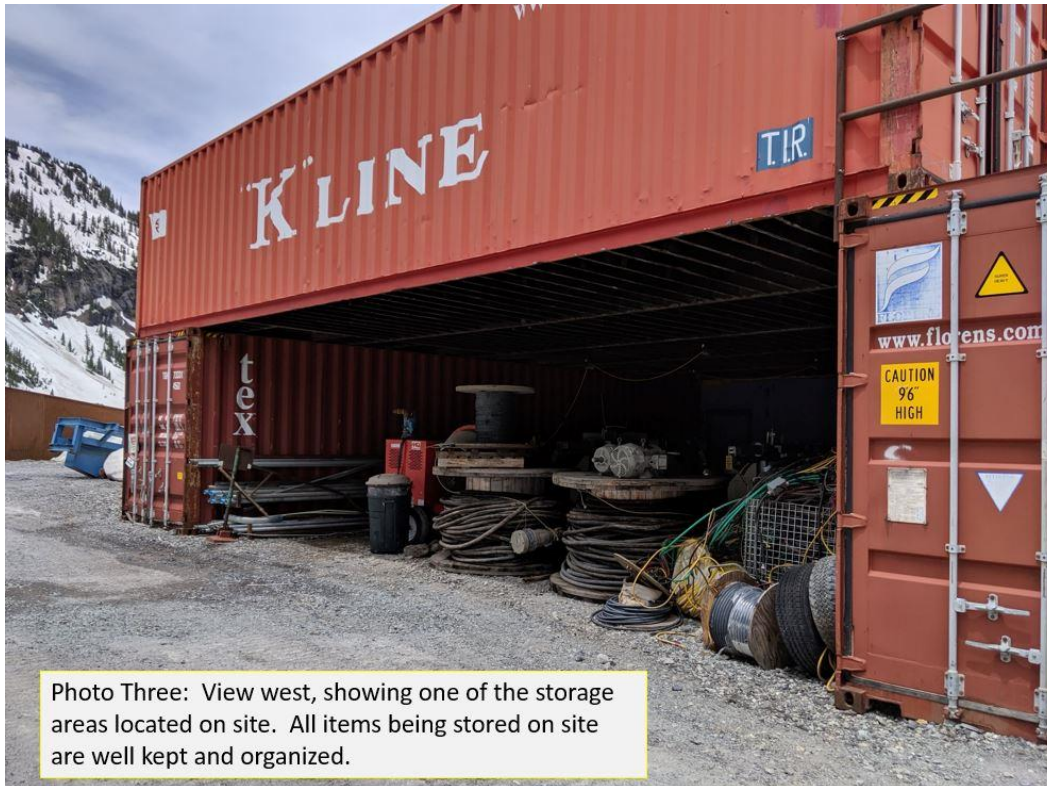
Due to the significant snowfall during the past winter, a majority of the site and its surface facilities were still under snow cover. The main portal and its associated structures are in good condition. All storage areas were clean and well kept, all items being stored on site were done so in a neat and orderly fashion. An example of one of the storage facilities can be seen in Photo Three. All fuel and potentially hazardous materials is stored within proper secondary containment structures and are in good condition. Also, under TR-09 the Operator is approved to manufacture road base for sale, several small stockpiles of the road base material was observed on site and appear to be stable. An example of one of the stockpiles can be seen in Photo Four. As approved through TR09 the Operator will conduct SPLP testing on the road base materials and submit the results to the Division prior to sale. No material has been sold in recent years, but the Operator expects some material to be sold during the coming summer months.

Photo Three: View west, showing one of the storage areas located on site. All items being stored on site are well kept and organized.

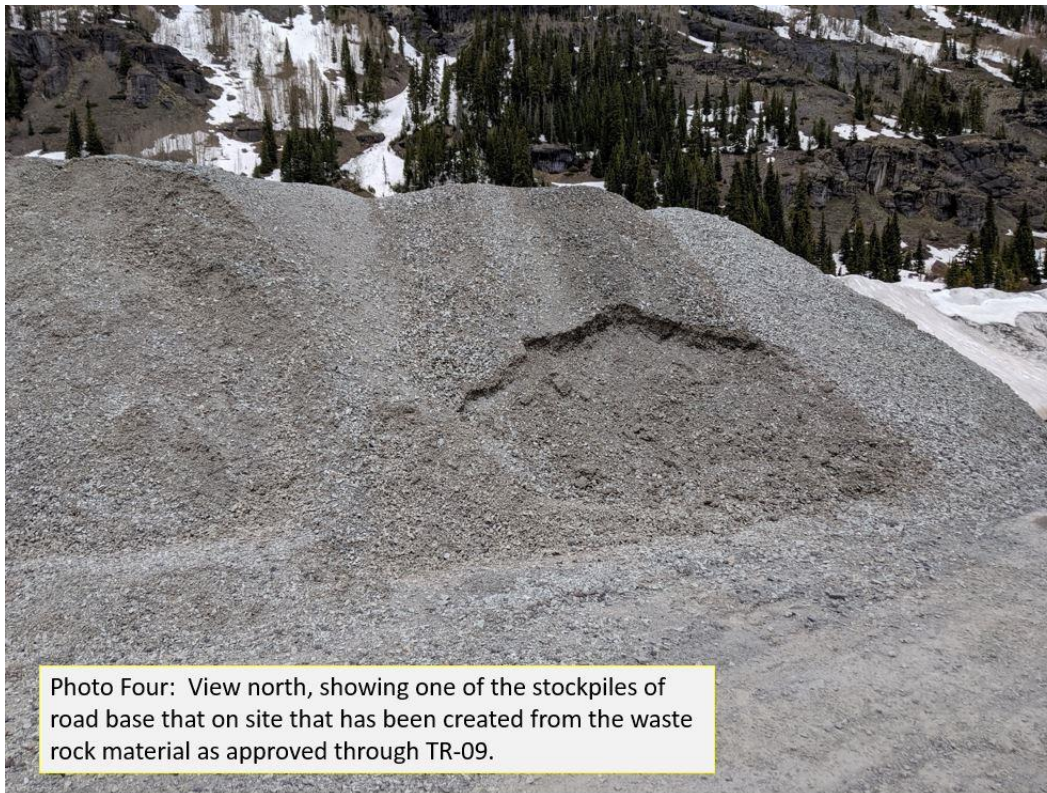
Photo Four: View north, showing one of the stockpiles of road base that on site that has been created from the waste rock material as approved through TR-09.

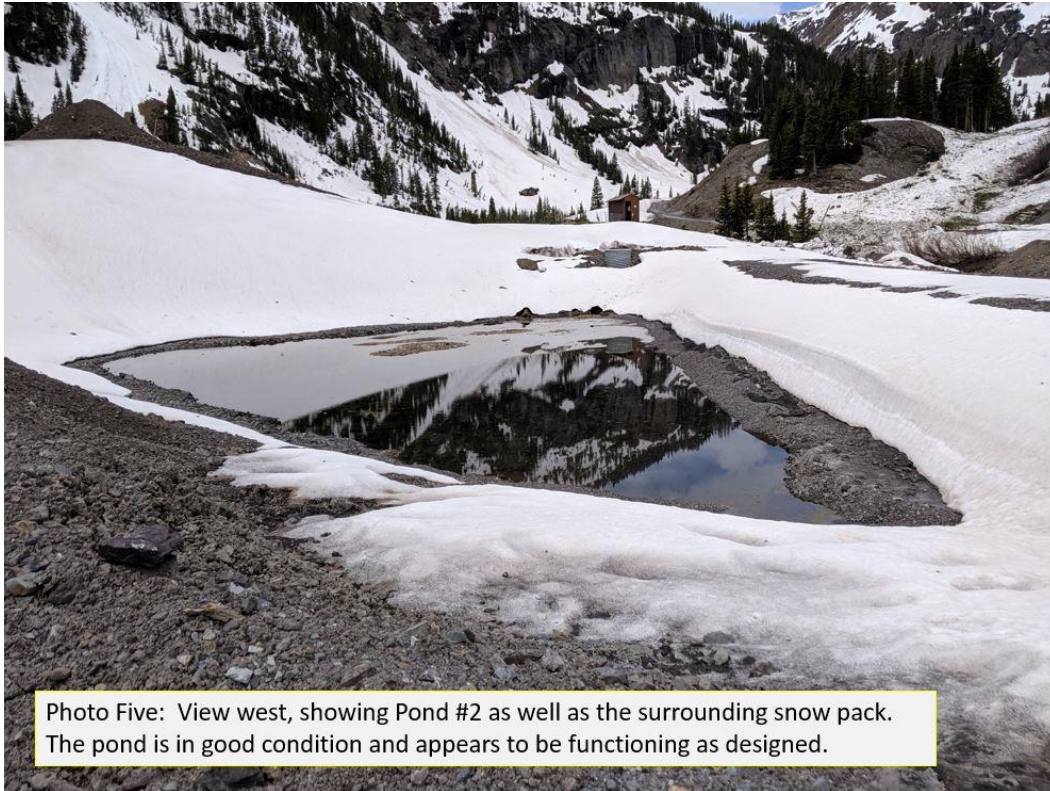
All avalanche protection measures appear to be functioning as designed as several slides occurred over the winter and apart from minor damage to mobile equipment were mitigated. The mine water pond area was observed however was under snow cover. Pond 2, as seen in Photo Five, was observed and appears to be functioning as designed and approved. On site discussions indicate that this coming summer construction of the greater water management system which includes Pond 2 will be conducted.
