**MINERALS PROGRAM INSPECTION REPORT****PHONE: (303) 866-3567**

<b>MINE NAME:</b> Deakins Pit	<b>MINE/PROSPECTING ID#:</b> M-2001-060	<b>MINERAL:</b> Sand and gravel	<b>COUNTY:</b> Moffat
<b>INSPECTION TYPE:</b> Monitoring	<b>INSPECTOR(S):</b> Amy C. Yeldell	<b>INSP. DATE:</b> June 12, 2019	<b>INSP. TIME:</b> 09:00
<b>OPERATOR:</b> 3B Enterprises, LLC	<b>OPERATOR REPRESENTATIVE:</b> Trish Marshall	<b>TYPE OF OPERATION:</b> 112c - Construction Regular Operation	
<b>REASON FOR INSPECTION:</b> Normal I&E Program	<b>BOND CALCULATION TYPE:</b> Complete Bond	<b>BOND AMOUNT:</b> \$66,800.00	
<b>DATE OF COMPLAINT:</b> NA	<b>POST INSP. CONTACTS:</b> None	<b>JOINT INSP. AGENCY:</b> None	
<b>WEATHER:</b> Clear	<b>INSPECTOR'S SIGNATURE:</b>

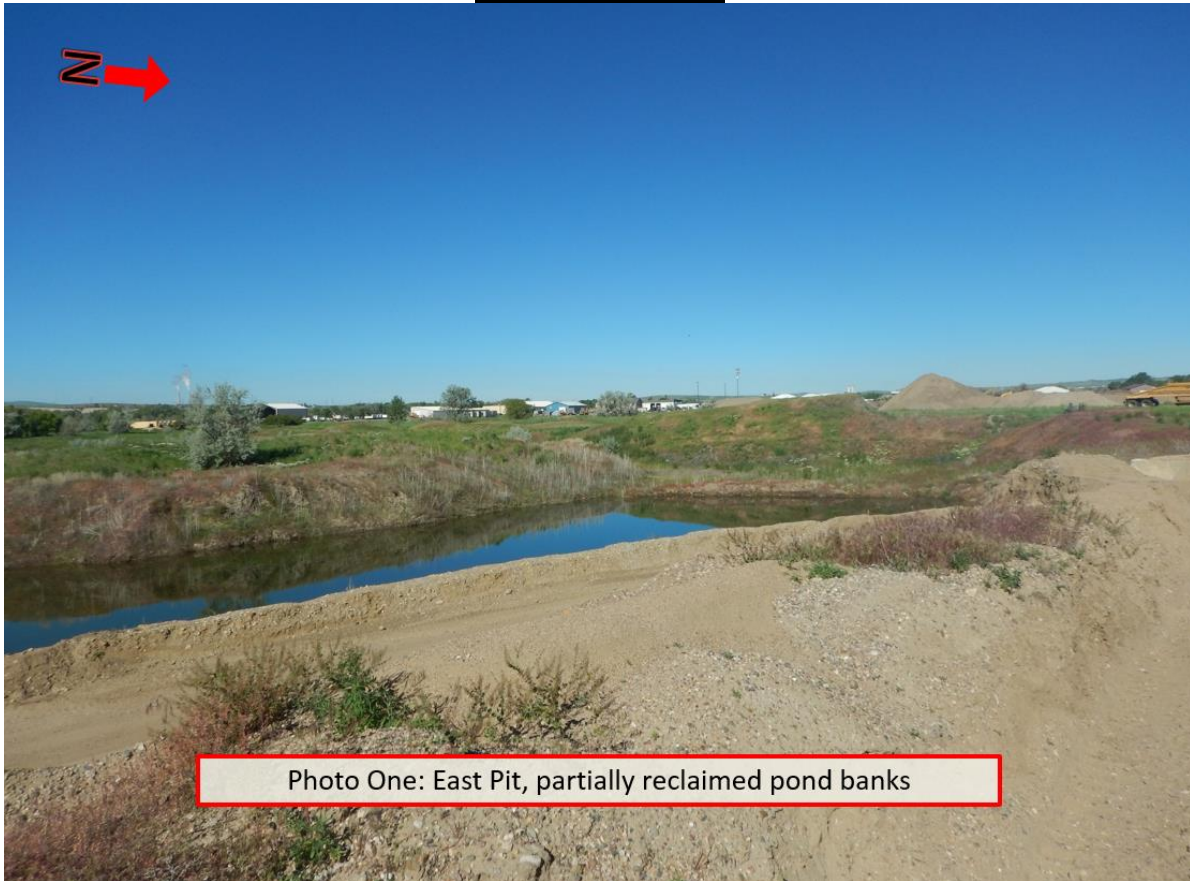
Photo One: East Pit, partially reclaimed pond banks

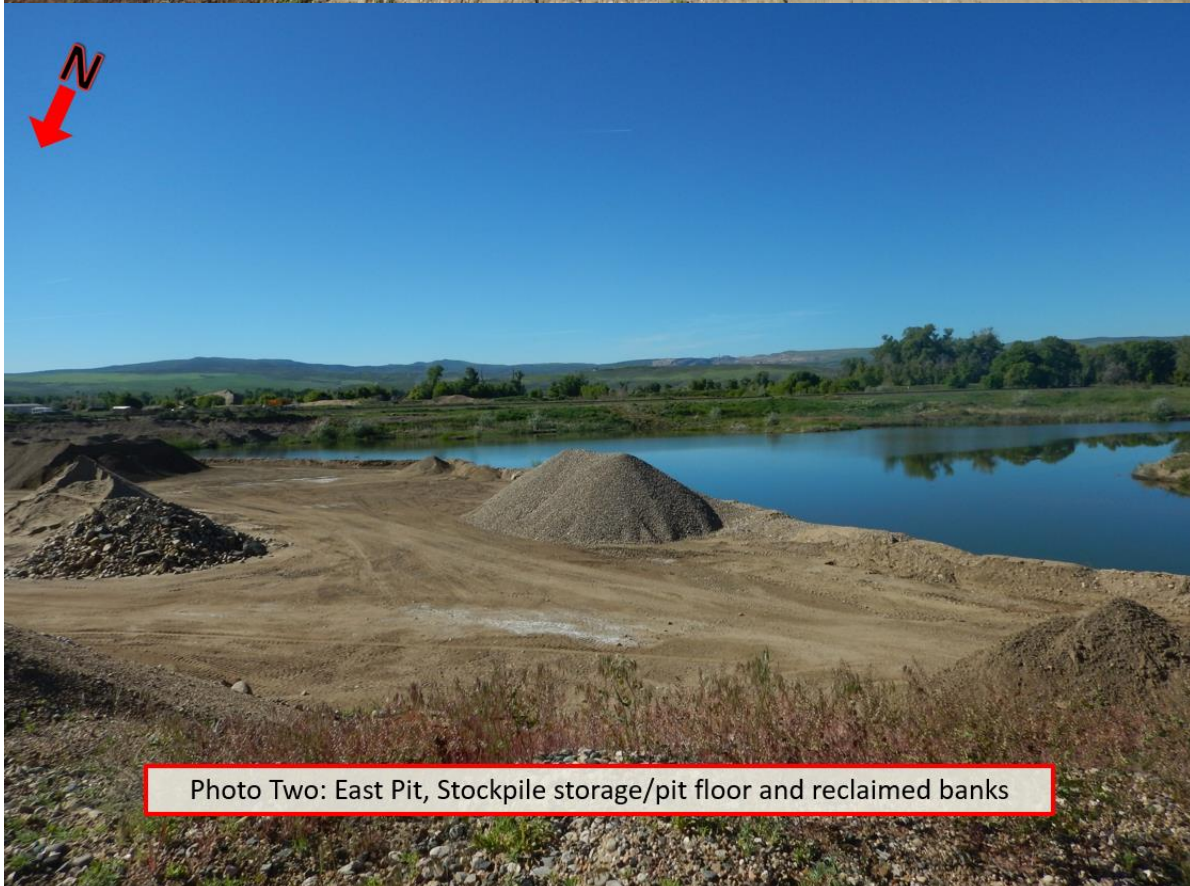
Photo Two: East Pit, Stockpile storage/pit floor and reclaimed banks

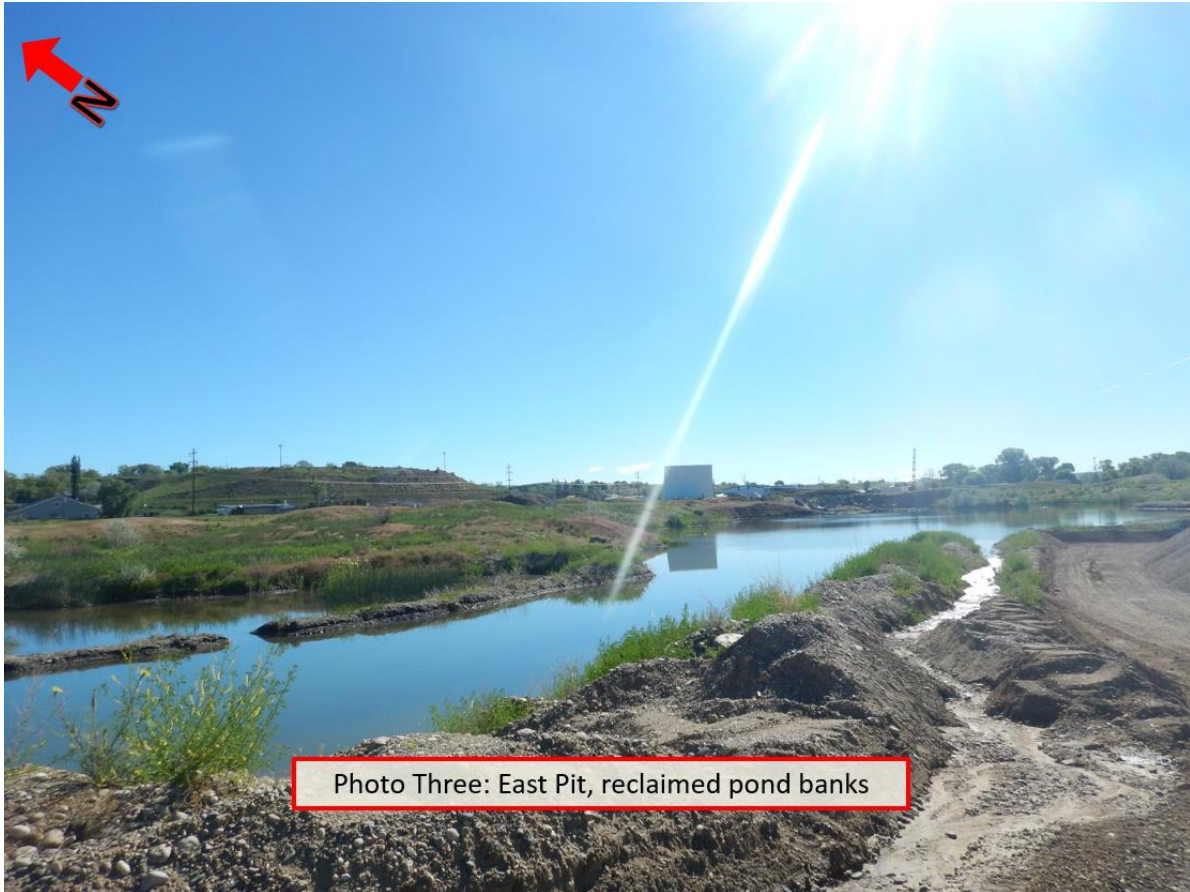
Photo Three: East Pit, reclaimed pond banks

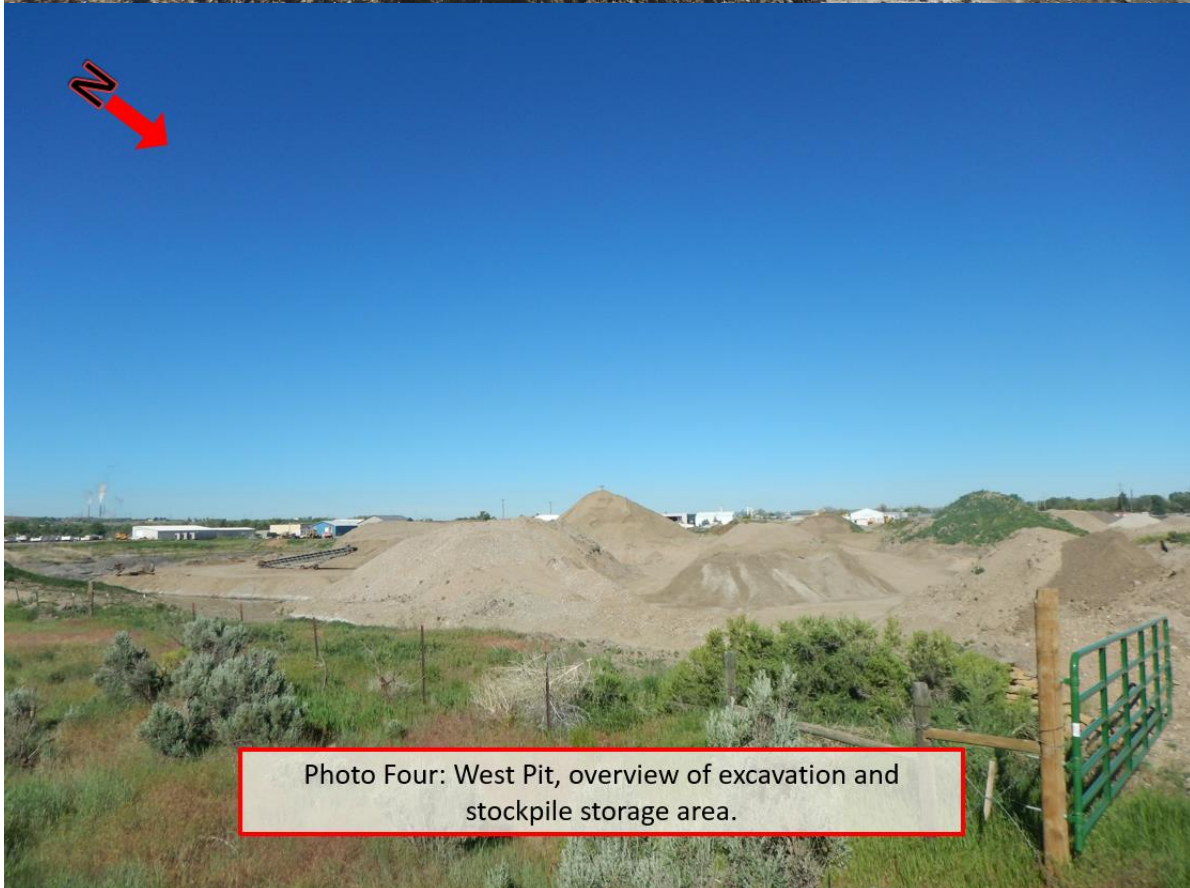
Photo Four: West Pit, overview of excavation and stockpile storage area.
