**MINERALS PROGRAM INSPECTION REPORT**  
**PHONE: (303) 866-3567**

<b>MINE NAME:</b> Lyster Pit	<b>MINE/PROSPECTING ID#:</b> M-2008-009	<b>MINERAL:</b> Sand and gravel	<b>COUNTY:</b> Moffat
<b>INSPECTION TYPE:</b> Illegal(Unpermitted Operation)	<b>INSPECTOR(S):</b> Amy C. Yeldell	<b>INSP. DATE:</b> June 12, 2019	<b>INSP. TIME:</b> 10:30
<b>OPERATOR:</b> Oldcastle SW Group, Inc. dba United Compai	<b>OPERATOR REPRESENTATIVE:</b> Jason Burkey	<b>TYPE OF OPERATION:</b> 112c - Construction Regular Operation

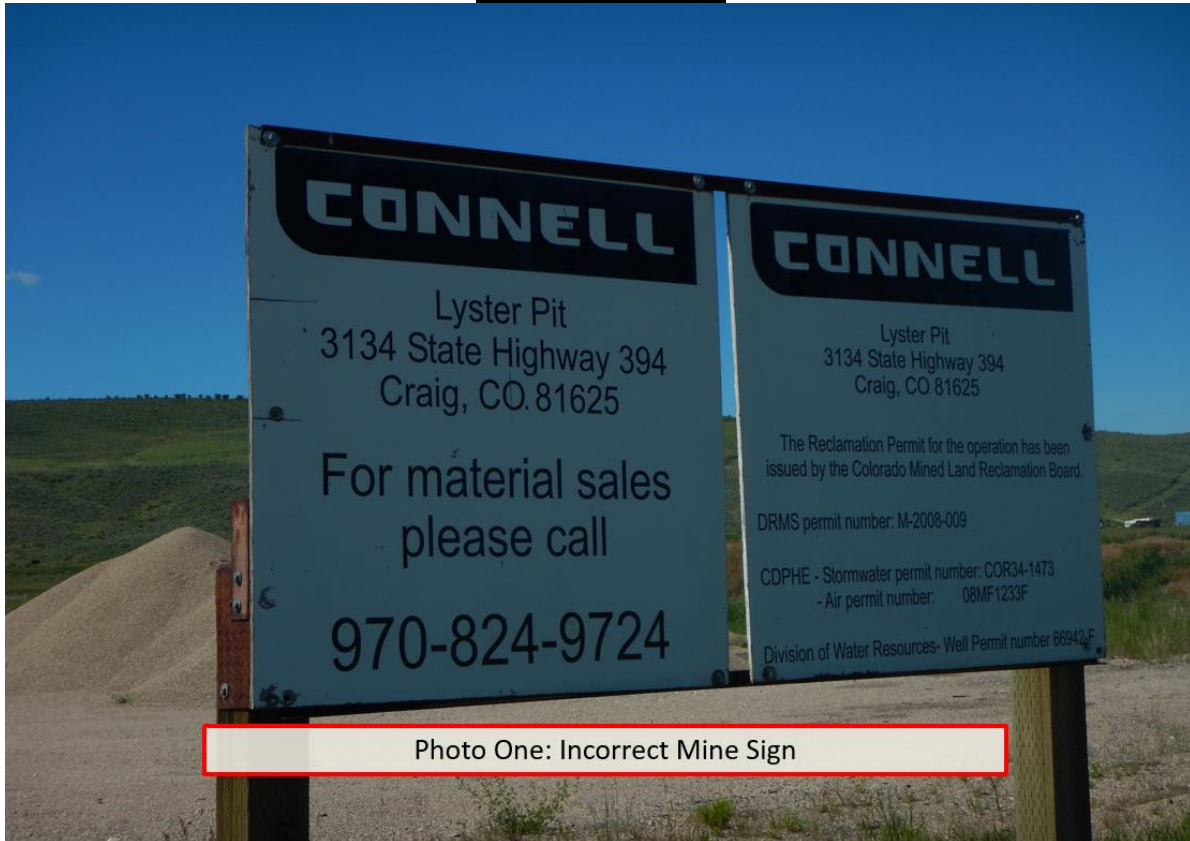
**PROBLEM/POSSIBLE VIOLATION:** Problem: The mine identification sign posted at the entrance of the mine site has the wrong Operator listed. This is a problem for failure to post an accurate mine identification sign as required by Section 3.1.12(1) of the rule.

The mine identification sign and affected area boundary markers are in place. The mine sign still reads Connell Resources, Inc. as the Operator even though the Succession of Operator (SO-2) was approved in July of 2017. United has had ample time to update the sign. This is cited as an inspection problem. Please update/replace the sign by the corrective action due date listed on page 2 of this inspection report.

Photo One: Incorrect Mine Sign

**CORRECTIVE ACTIONS:** The operator shall, at the entrance of the mine site, post a sign which shall be clearly visible from the access road with the following: the name of the operator, a statement that a reclamation permit for the operation has been issued by the Colorado Mined Land Reclamation Board; and the permit number. The operator shall submit photo documentation that a proper sign has been posted by the corrective action date.

**CORRECTIVE ACTION DUE DATE:** 8/26/19

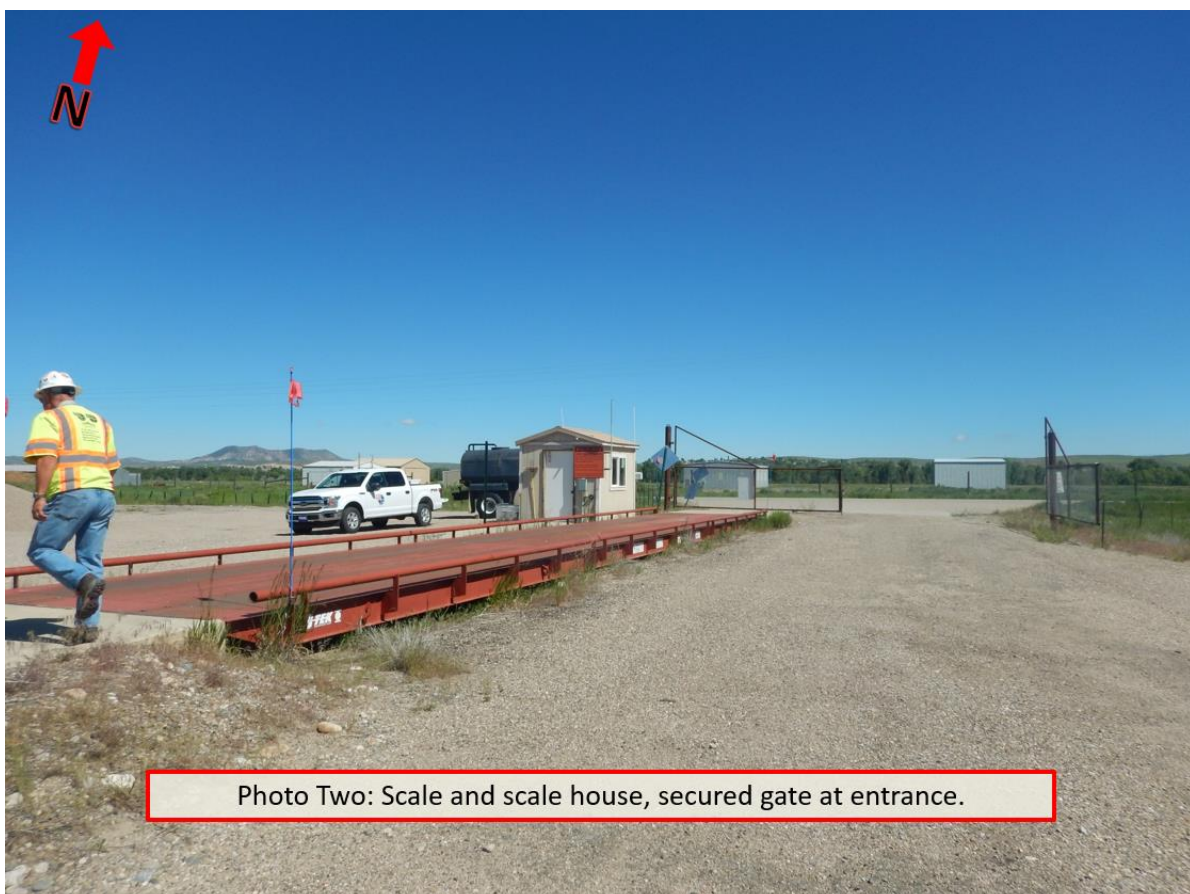
Photo Two: Scale and scale house, secured gate at entrance.

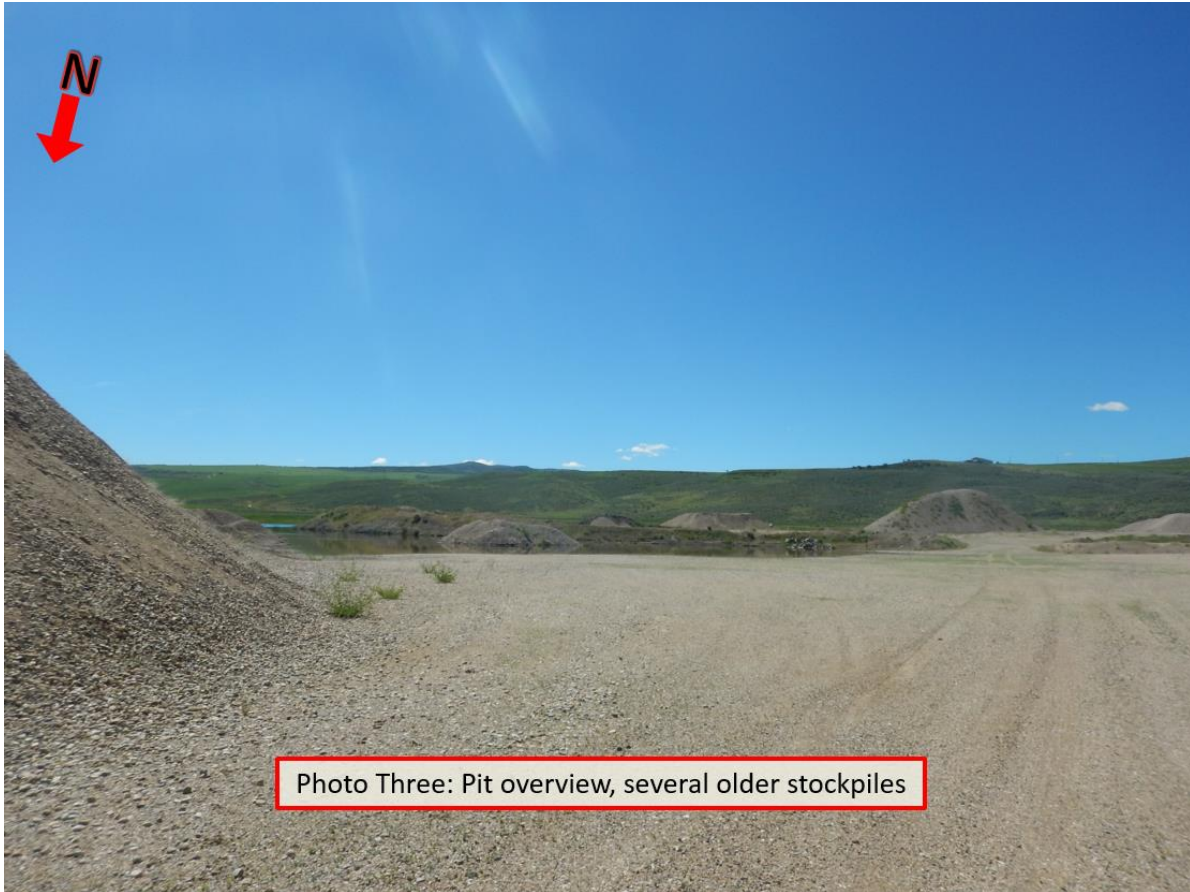
Several large stockpiles of processed material remain on site. No processing or excavation equipment is on site. The scale and scale house remain. No fuel is stored on site. Little to no weeds were observed onsite. Topsoil and overburden berms remain in place and stable. Due to the extremely wet spring portions of the pit were inundated several feet above typical spring/summer conditions. Mr. Burkey indicated that one of the hydrology

Photo Three: Pit overview, several older stockpiles

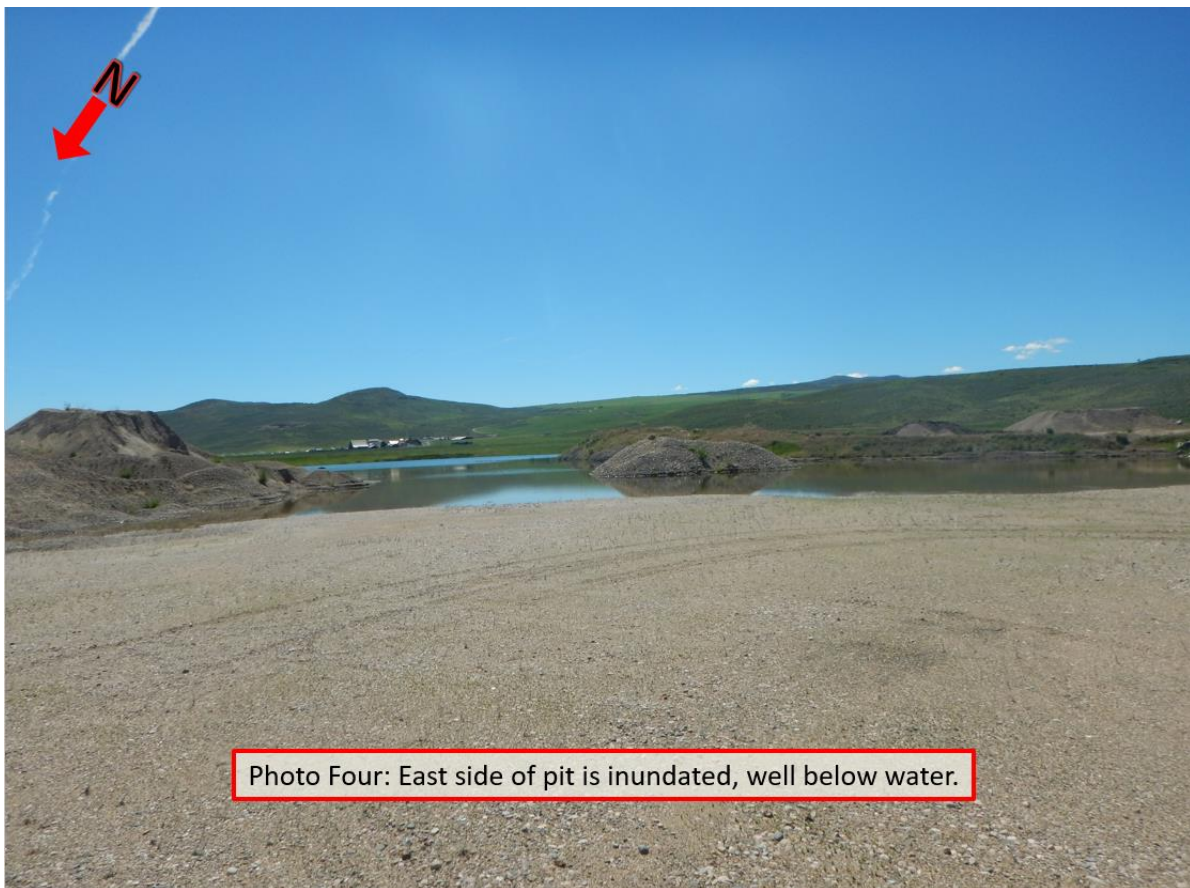
wells was underwater and unable to be sampled upon their last attempt.

Photo Four: East side of pit is inundated, well below water.
